# Evaluation of Damage to a Historic Masonry Building in Nepal through Comparison of Dynamic Characteristics before and after the 2015 Gorkha Earthquake

Aiko Furukawa<sup>1\*</sup>, Junji Kiyono<sup>1</sup>, Rishi Ram Parajuli<sup>1</sup>, Hari Ram Parajuli<sup>2</sup> and Kenzo Toki<sup>3</sup>

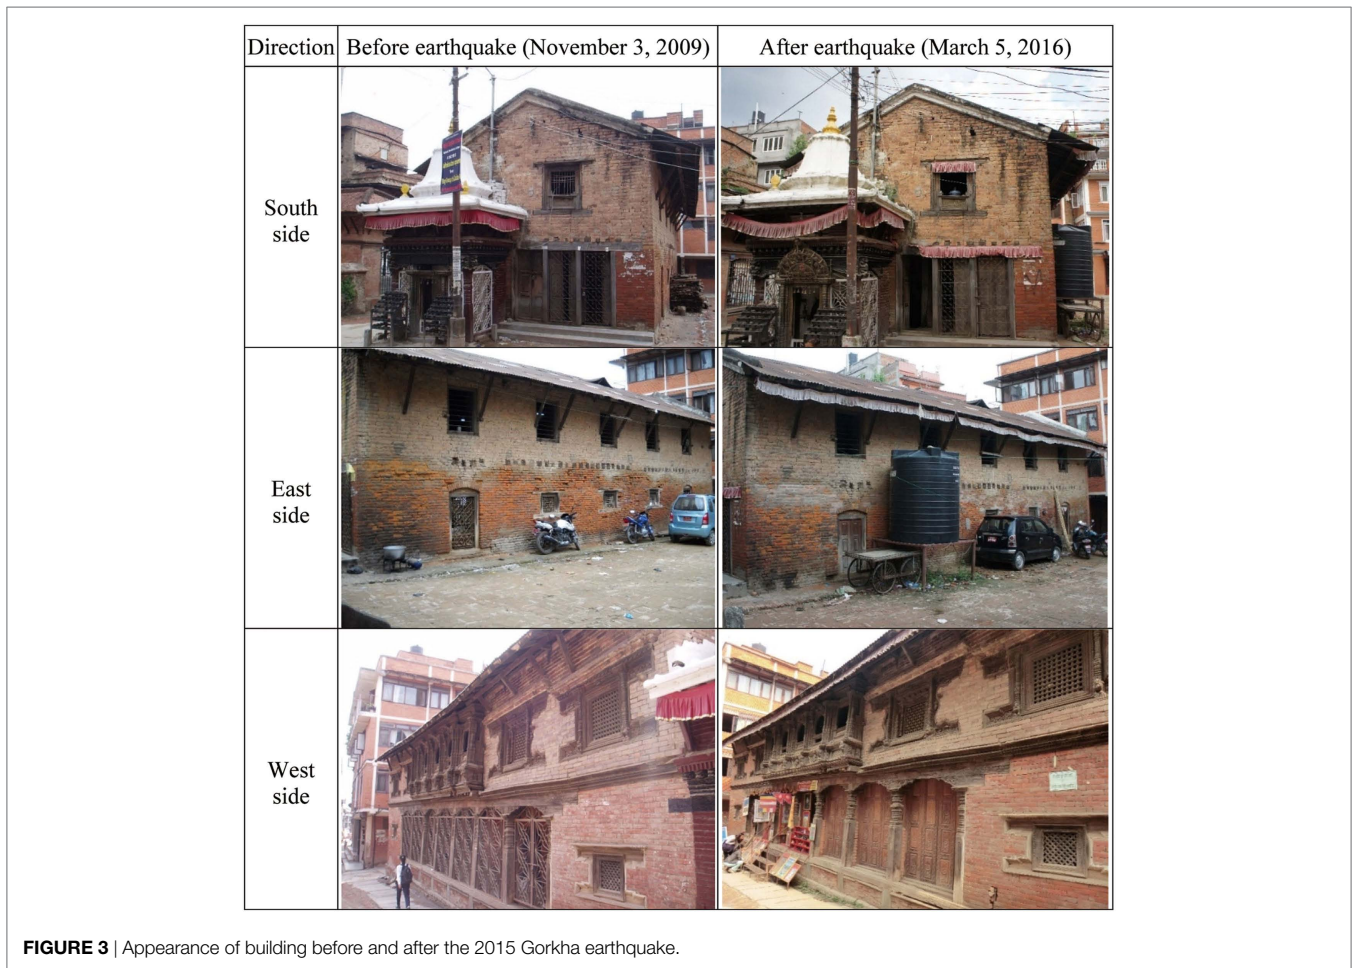
**Figure 3** shows the comparison of the building appearance from the outside before and after the 2015 Gorkha earthquake. The pictures on the left were taken before the earthquake in November of 2009, and the pictures on the right were taken after the earthquake in March of 2016. Although many minor cracks in mortar were visible during the survey in March of 2016, most of those minor cracks were already present in the photo taken in 2009, and it was difficult to find out new cracks from the outside of the building. Then visual inspection of the cracks inside the building was carried out. Several cracks were found on the both ground and first floors as shown in **Figure 5**. Although no comparable photos taken prior to the earthquake are present, those cracks appeared to be new. In **Figure 5**, some walls resemble concrete walls, but they are brick walls covered with plaster. In addition to the cracks shown in **Figure 5**, several cracks were found on the ceiling of the GF and the timbers were seemingly deteriorated on the RF. Nevertheless, it was difficult to distinguish the damage

that already existed before the earthquake through the visual inspection.

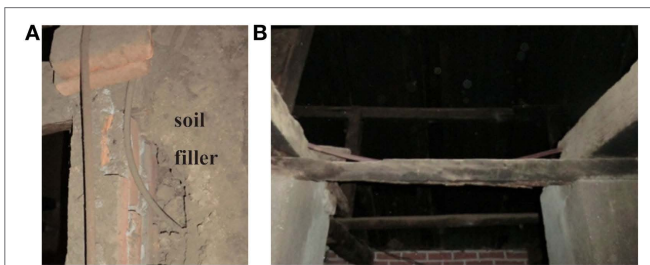
FIGURE 8 | Possible reason of overestimate of stiffness parameters. (A) Soil filled inside the brick wall. (B) Deterioration of timbers and imperfect connection.

Figure 8A that shows the middle wall on the first floor taken from the above, soil filler can be seen. The timber stiffness also is overestimated, seemingly due to the deterioration of the

material and imperfect connection between members as shown in Figure 8B.

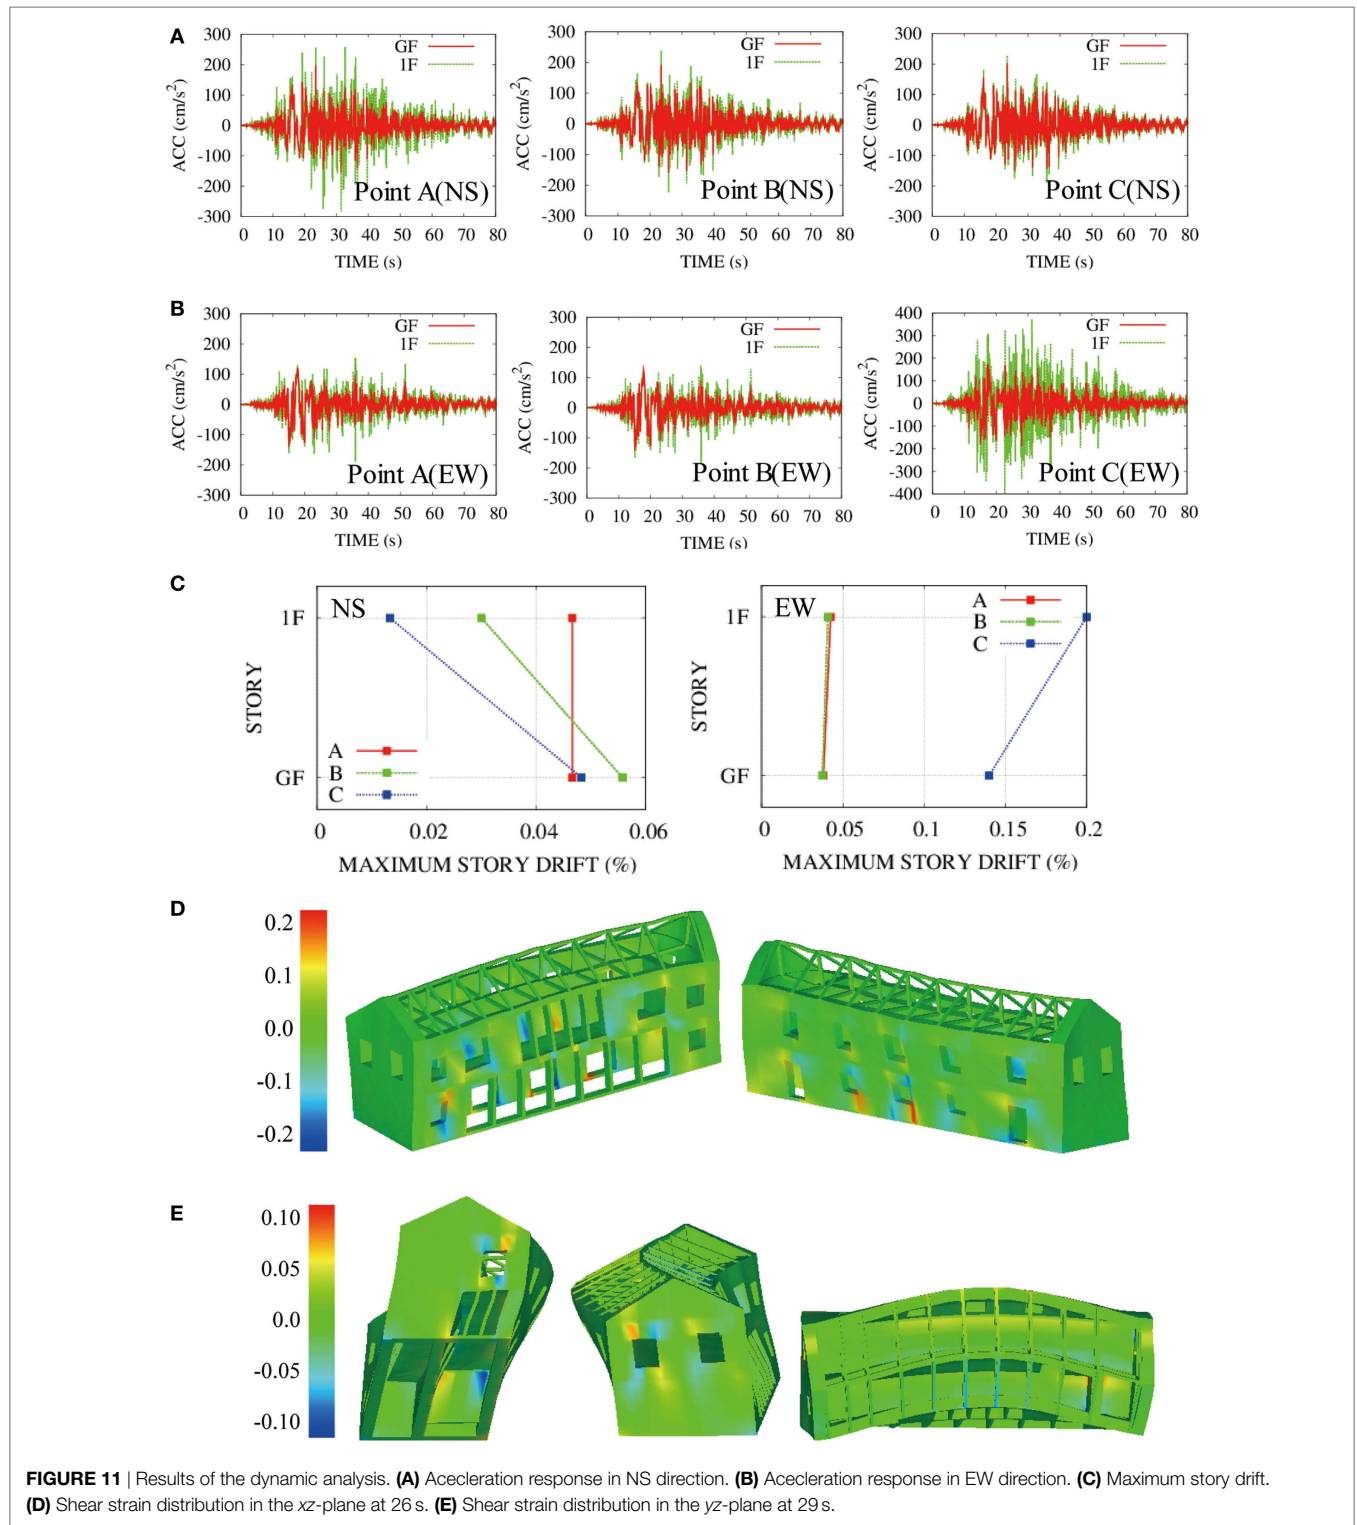
**FIGURE 11** | Results of the dynamic analysis. **(A)** Acceleration response in NS direction. **(B)** Acceleration response in EW direction. **(C)** Maximum story drift. **(D)** Shear strain distribution in the xz-plane at 26 s. **(E)** Shear strain distribution in the yz-plane at 29 s.

On the other hand, when the building deformation is in the *y* direction, significant shear strain of *yz*-component is observed near the corner of openings in the short side walls as shown in **Figure 11E**. It is noteworthy that considerable shear strain takes place on both sides of the partition walls on the GF and at the intersection of two inner walls. These parts coincide

with the places where actual cracks were found in the post-earthquake inspection of the target building as already shown in **Figure 5C**. In this section, the distribution of shear strain is selected since it is found that large shear strain takes place where the actual cracks were found in the post-earthquake inspection.

It is found that the lateral out-of-plane vibration at the center of the long side wall is significant for the both acceleration response and story drift.

The location of structural damage found in the post-earthquake inspection is successfully explained by the shear strain distribution.
