Emergency Survey and Stability Analysis of a Rainfall-Induced Soil-Rock Mixture Landslide at Chongqing City, China

Chang Zhou¹, Dong Ai², Wei Huang^{2*}, Huiyuan Xu², Liwen Ma², Lichuan Chen³ and Luqi Wang⁴

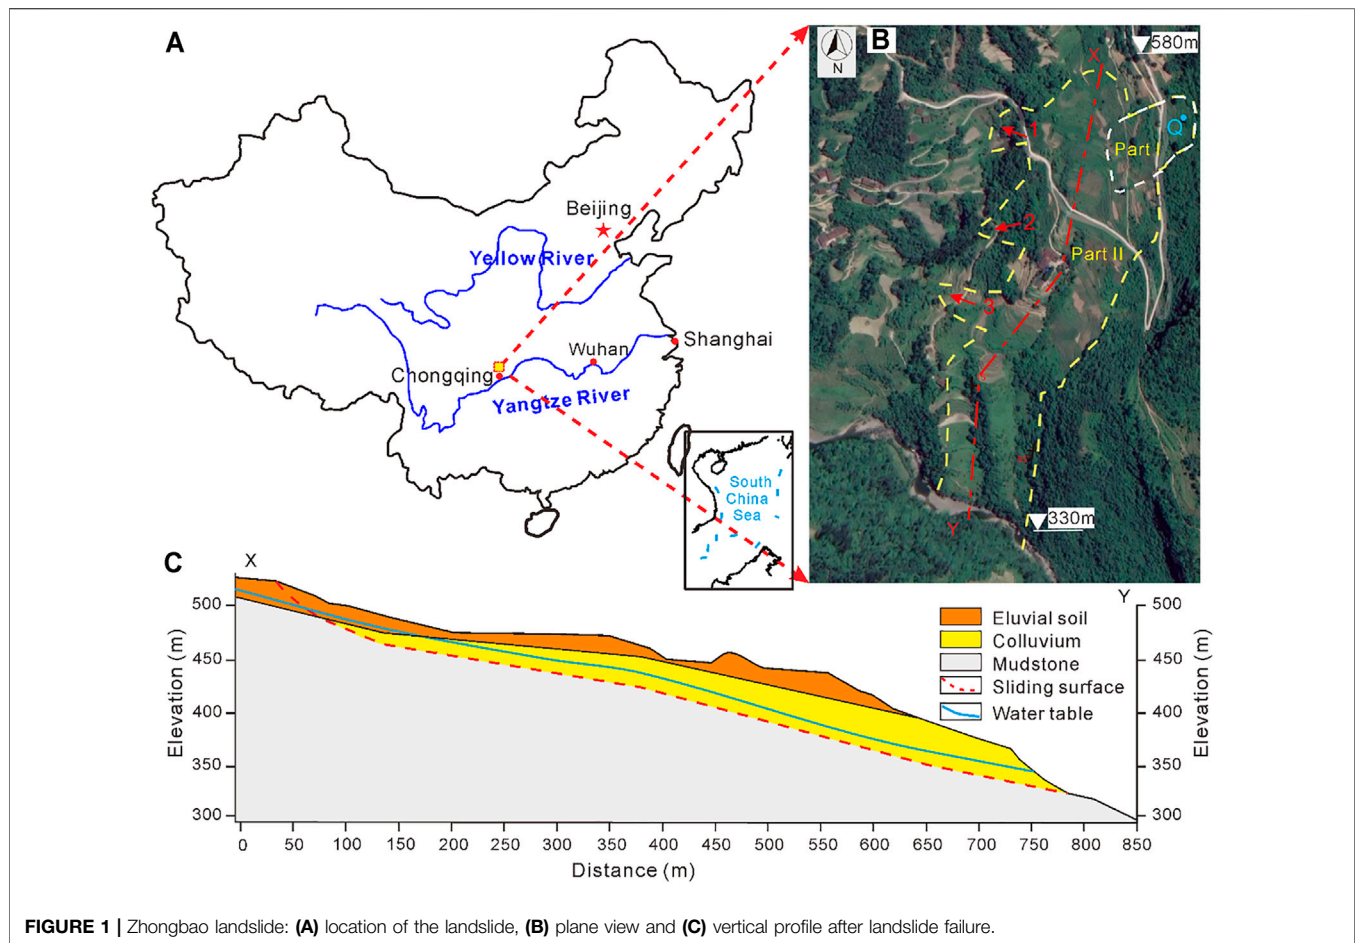
The Zhongbao landslide is located on the north side of the Yancang river, about 59 km to the Wulong District, Chongqing, China (Figure 1A). In plan view, the shape of the Zhongbao landslide can be approximately likened a tongue, being 850 m in length and 200 m in width (Figure 1B). The thickness of the landslide is estimated to be 25–47 m, and its volume approximately $4.6 \times 10^6 \text{ m}^3$ (Figure 1C). The slope of the landslide surface is 25° – 45° . The main sliding direction is 210° , approximately perpendicular to the Yancang River. The Zhongbao landslide began to slide at 16:00 on July 23, 2020, accelerated and slid into the river on July 27, and destroyed three buildings and main roads. Over $1.0 \times 10^4 \text{ m}^3$ of soil and rock mass slipped into the river and formed a barrier lake.

FIGURE 1 | Zhongbao landslide: (A) location of the landslide, (B) plane view and (C) vertical profile after landslide failure.

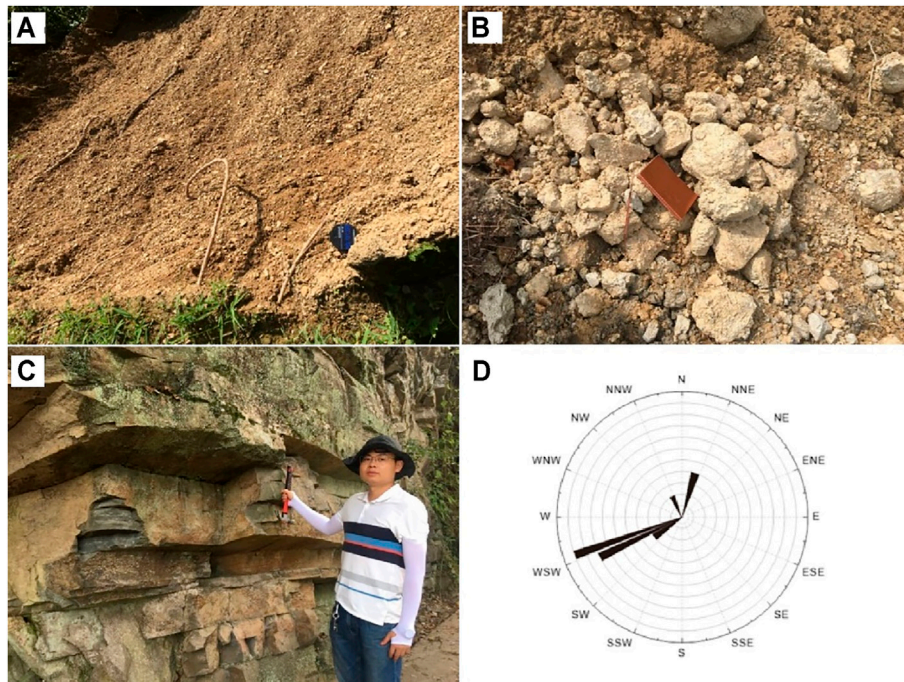
The field investigation indicates that the main geologic units of the area are deposits and shales. The uppermost part of the surficial deposits are eluvial deposits (up to 0.5–3.5 m thick), whereas stratigraphically lower layers comprise mostly alluvial deposits and colluvial deposits. The eluvial deposits consist of clay and 10–45% of gravel clasts (Figures 2A,B). The diameter of the gravel clasts ranges from 50 to 300 mm. *In-situ* exposed outcrops over 10 m high (undisturbed by the landslide) crop out near the western limit of the depictions of the lithological structure (Figure 2C). Dominant pale-yellow shales, 0.2–0.5 m thick, are found in the pelitic structure with developed joints. The main component of shales is smectite and other clay minerals, which are easily weathered and softened by water. The rocks dip 25° toward 130° . Two dominant joints are found in the study area (Figure 2D). The first joint dips 75° toward 5° – 15° with a width of 3–15 mm and a length of 1.5–4.9 m, and the joint spacing is 1.30–4.20 m. The second one dips 80° toward 210° – 230° with a width of 2–12 mm and a length of over 10 m, and the joint spacing is 1.10–2.70 m. The joints are partially filled with clay.

FIGURE 2 | (A) Eluvium, **(B)** gravel soil, **(C)** Hanjiadian Formation Shale (S1h), and **(D)** rose diagram of the joints.

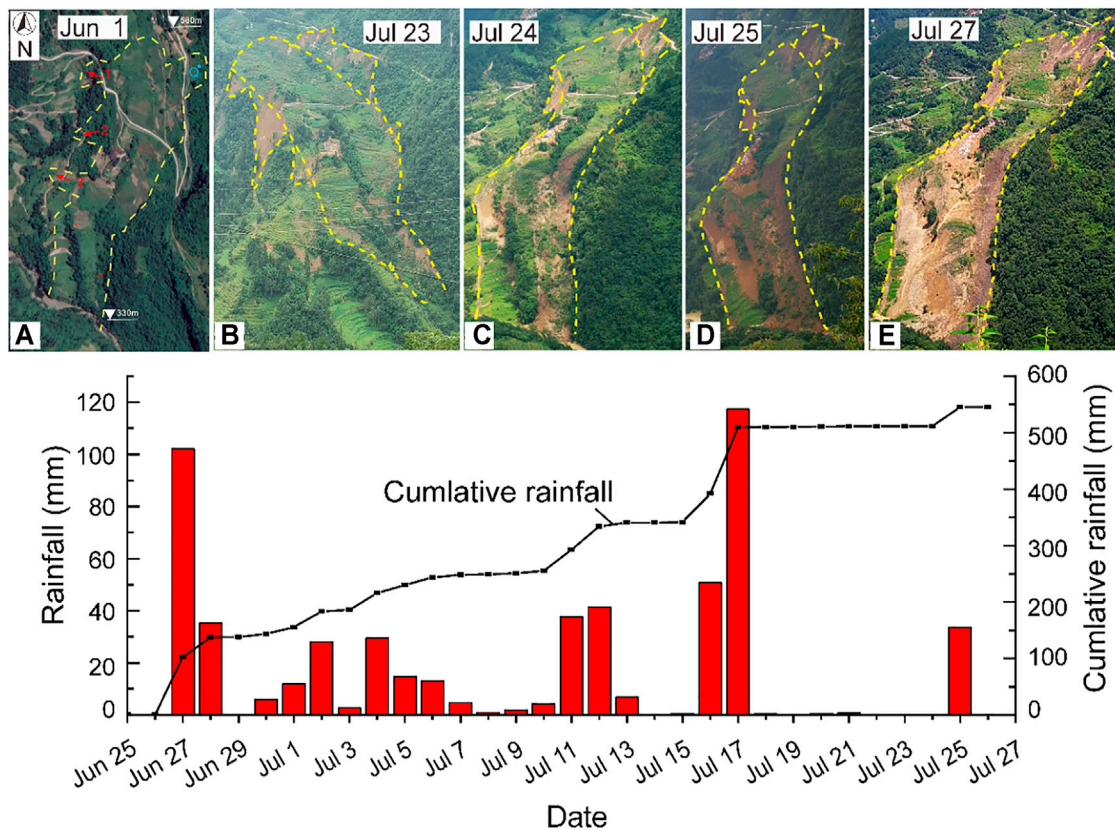
The Zhongbao landslide was first found to have deformed on July 22. Several cracks were recorded on the uphill side of the landslide after a continuous intense rainfall. As the landslide deformed, the eastern boundary of the landslide was generated, then a great many tension cracks formed at Part II while Part I gave way (**Figure 4B**). The uphill slope slid over 20 m, and the downhill slope suffered local deformation. On July 24, the sliding mass was transported to the middle and downhill slopes, causing the downhill slope to gradually collapse (**Figure 4C**). On July 25, there was a strong rainfall, the downslope had obvious deformation, and the sliding mass gradually slid into the Yancang River. The barrier lake and dam were formed (**Figures 4D,E**).

FIGURE 4 | Deformation characteristics and rainfall vs. time.

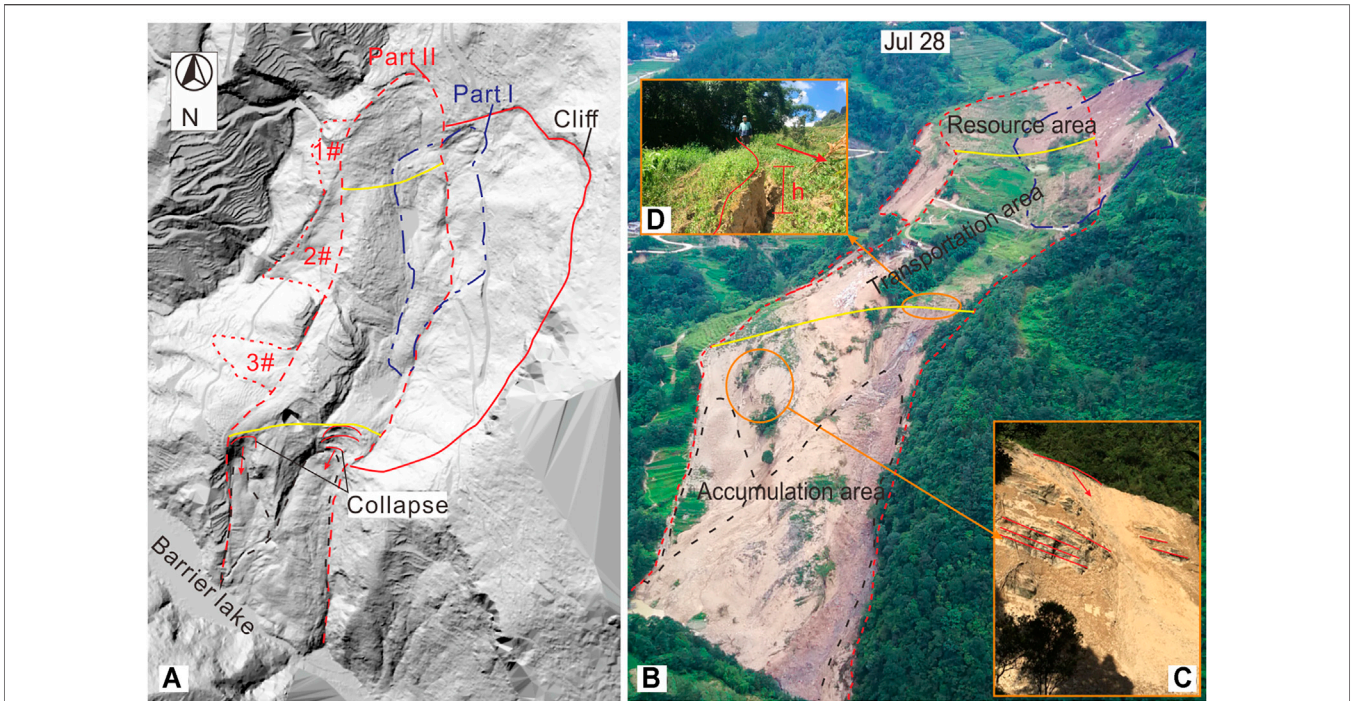
Part I: This portion is located at the northeast side of the landslide (**Figure 5**). Reactivated deposits of Part I covered Part II. This part is 140–245 m wide and 230 m long, about 10 m thick with its largest elevation difference being 102 m. The deformation characteristics of the road showed that the accumulation moved with Part II, inferring that Part I failed before Part II. Due to the steep slope, engineering projection, and continual rainfall, Part I slipped with velocity and compressed Part II, which accelerated the movement of Part II. Therefore, the uplift area and puddle were found in part II.

Source area (Figure 5): The length and elevation difference of this area is approximately 207 and 46 m, respectively. Under the effect of rainfall and part I, the rear section of Part II gradually deformed and developed into scratch (**Figure 6A**) and tension cracks. Those cracks became an infiltration path for rainfall which damaged the yale structure and decreased the shear strength of the soil and rock. The rock became severely fragmented (**Figure 6B**). The deformation of the landslide thus accelerated. Many scarplets and cracks were found in this

Secondary-landslide area: Three secondary-landslides (1–3# in Figure 5) were found at the west side of the landslide because of the V-shaped valley. No. 1 secondary-landslide was caused by the source area sliding along the direction of 230° . No. 2 is located on the cliff, so could be from the collapse of the sliding mass. No. 3, caused by a change in the sliding direction of Part II, occurred and buried a small road.

FIGURE 5 | The result of the Airborne Lidar after filtering out trees. Note the black dashed line is the secondary landslide in the accumulation area. Yellow lines separate the three parts (see text). Sub-photographs are the scarplet and local collapse, respectively.

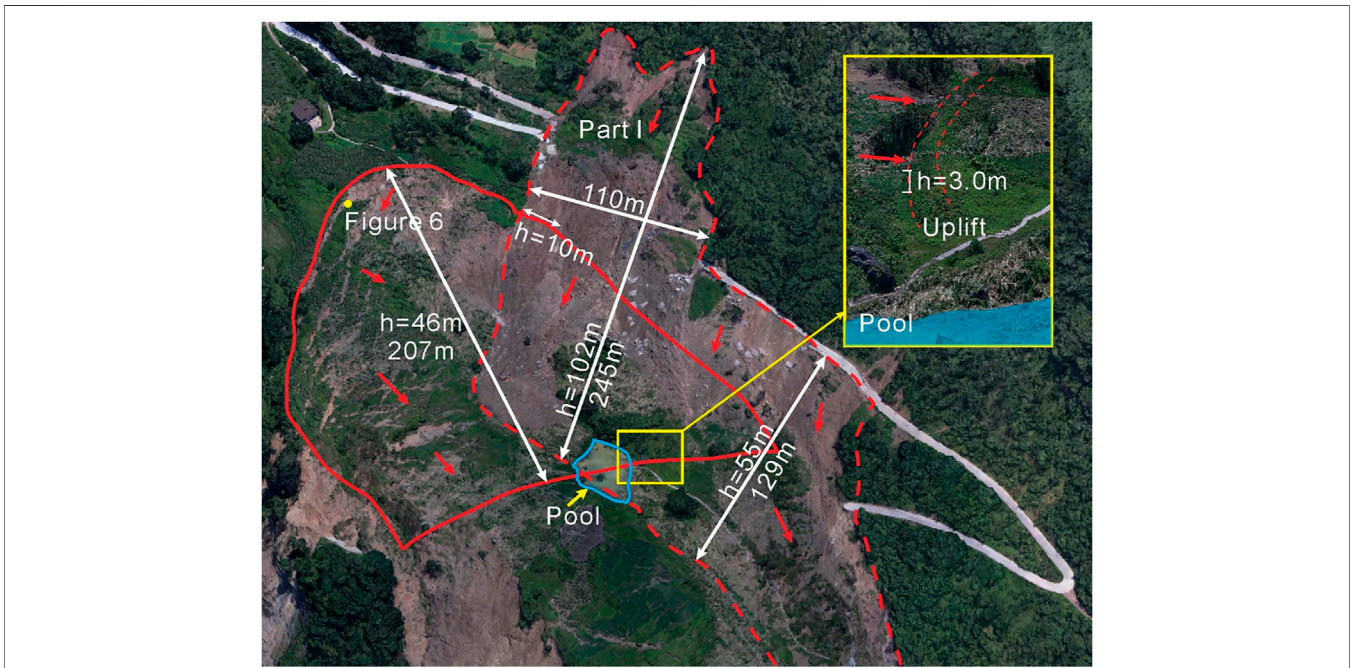
portion. Moreover, the boundary between the source area and the transportation area was an uplift zone with an average height of 3.0 m (**Figure 5**).

FIGURE 6 | Picture of the source area and Part I area. The sub-picture is the uplift zone between the source area (left) and the transportation area (right). Note, “h” represents the elevation difference of the landslide area.

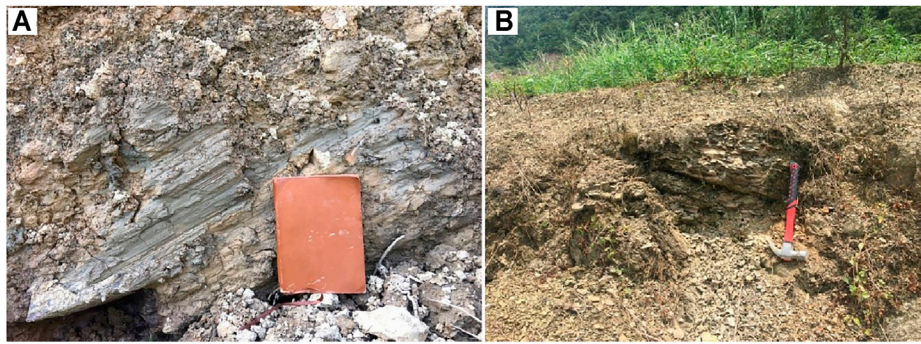
FIGURE 7 | (A) Scratch and (B) broken rock. See Figure 3 for the locations of pictures.

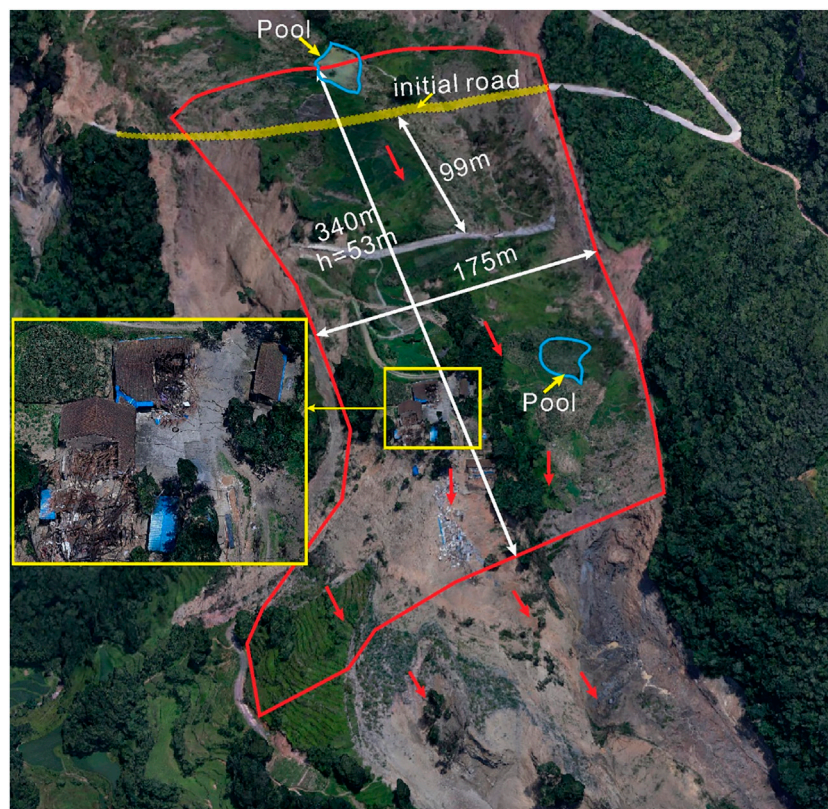
Transportation area (Figure 7): Owing to the rear section sliding and pushing the rock soil mass in the transportation area, some buildings and houses in the middle section only formed tension cracks but were not completely destroyed (**Figure 7**). Some parts were uplifted. In the plane view, this area had an approximately rectangular shape with a length of 340 m and an average width of 175 m. Some pools were found on the landslide. The road debris showed that it slid about 99 m but kept good continuity.

FIGURE 8 | Picture of transportation area. The sub-picture is the village which shows that most of those buildings maintain good integrity. The road also kept good continuity across two sides, even though it slid over 90 m. The blues line are pools.

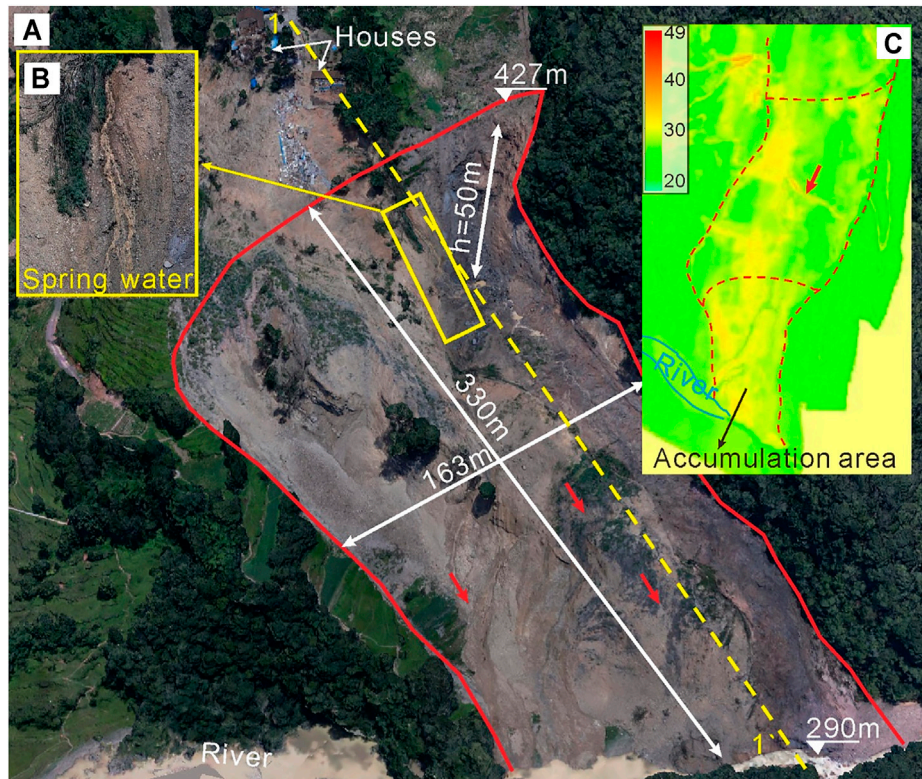
Accumulation area (Figure 8): The rear part became steep again, and the dip direction of the exposed rock was 15° . Thus, the sliding direction of the landslide changed. The sliding mass slipped and mobilized surficial deposits in the accumulation area by scraping, entraining, and pushing them downward. Finally, the reactivated deposits accumulated in the toe of the landslide and formed a barrier dam and barrier lake. The thermal infrared monitoring found that the temperature field appeared abnormal in the place where the groundwater was exposed. Moreover, the temperatures of the accumulation area were higher than in other areas.

The radar technology was used to evaluate the volume and deformation characteristics of the landslide because it can remove the trees on the landslide surface and obtain the rear geography of the landslide. Figure 9 shows that Part I had an obvious boundary with $4.1 \times 10^2 \text{ m}^2$. Its sliding mass accumulated in Part II and slipped to the transportation area of Part II. The downhill slope continued onto progressive retrogressive collapse and slid into the river. Thus, this landslide was still unstable. Moreover, a cliff was observed on the northeast side of the landslide with over $1 \times 10^6 \text{ m}^2$ colluvial deposits where there was also the occurrence of Part I.

FIGURE 9 | Picture of accumulation area (A), the spring water (B), and the temperature of the landslide surface (C).

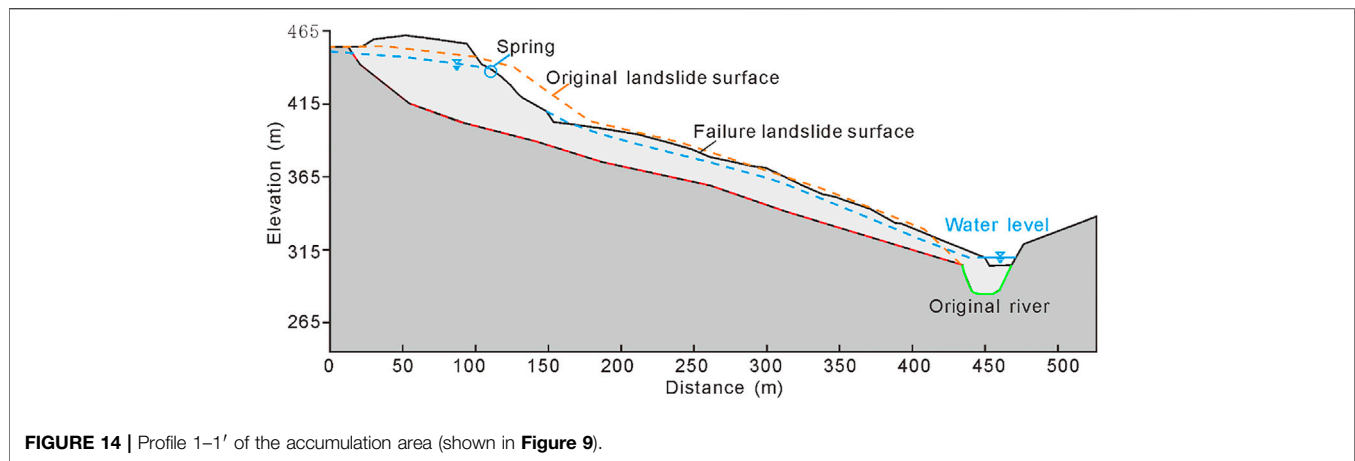
After the landslide failed, the barrier lake formed in front of the landslide increased the groundwater level of the accumulation area (**Figure 14**). The reservoir impoundment could accelerate the landslide deformation and failure (Macfarlane, 2009; Huang et al., 2016; Li et al., 2018b; Wang et al., 2019). When the lake flooded the downhill portion of the deposit, the shear resistance was reduced (He et al., 2018), especially for the destroyed

FIGURE 14 | Profile 1–1' of the accumulation area (shown in Figure 9).

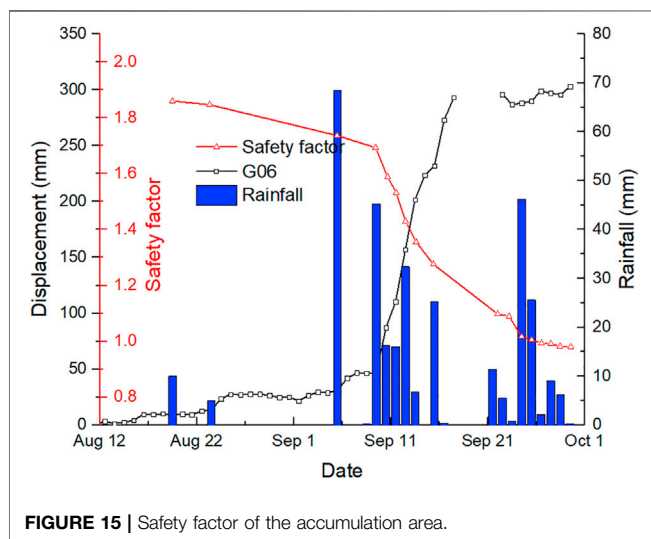
FIGURE 15 | Safety factor of the accumulation area.

deposits, so that the deposit still had a strong response to the rainfall. In the collapse at the shear outlet of the landslide, several springs with a flow velocity of $0.1\text{--}0.6\text{ m}^3/\text{s}$ indicated that the seepage field rapidly declined which could decrease the stability of the landslide (Berilgen, 2007; Della Seta et al., 2013; Hu et al., 2017; Sui and Zheng, 2017; Zhang et al., 2018b; Wu et al., 2020; Yang et al., 2020). The stability of the accumulation area was evaluated using Geo-slope software. Firstly, we evaluated the safety factor of the accumulation area under rainfalls (Figure 15). The safety factor of the accumulation area had a strong response to the rainfall and presented a certain linear change as the displacement increased. During an intensity continuous rainfall, the safety factor significantly decreases, because the groundwater level rapidly increases. If the dammed lake is excavated and drained during this stage, the landslide could slide again and form a larger barrier dam.
