Meng J, Chen A, Yin K and Zhou C (2023),
Study on the clogging mechanism of
upward inclined drainage holes in
cut slopes.
Front. Earth Sci. 11:1103323.
doi: 10.3389/feart.2023.1103323

Study on the clogging mechanism of upward inclined drainage holes in cut slopes

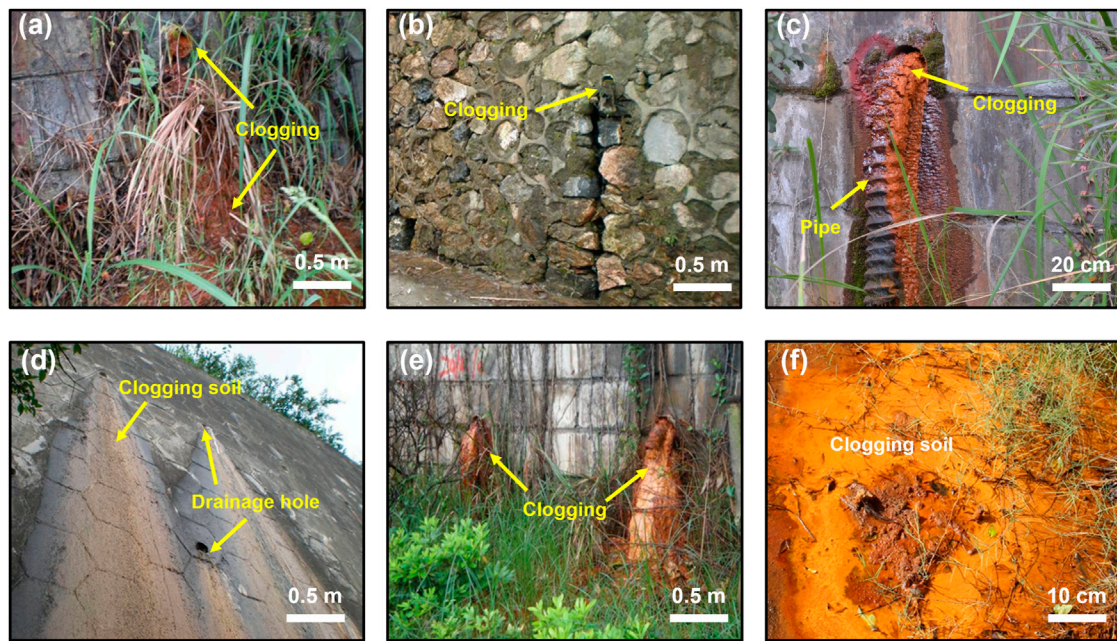
The slopes studied in the paper are characterized with poor drainage or drainage failure, and the old drainage holes have worked more than 10 years (see Figure 1). Most of the clogged drainage holes are blocked with fine-grained soil, and chemical crystallization can be found in the blockages. Most of the drainage holes show traces of algae and other organisms on the surface. Preliminary analysis during the on-site survey shows that the main reasons for the clogging and drainage failure of the upward inclined holes are summarized as follows.

Based on the analysis on the long-time running drainage holes, most of the serious clogging occurred after about 3 years of working.

FIGURE 1
 Inclined drainage holes with poor drainage and clogging problem: **(A)** red clogging soil with plants; **(B)** brown clogging soil; **(C)** soft drainage pipe with red clogging soil; **(D)** clogging materials after rainfall; **(E)** totally clogging drainage holes; **(F)** red clogging soil near the drainage holes

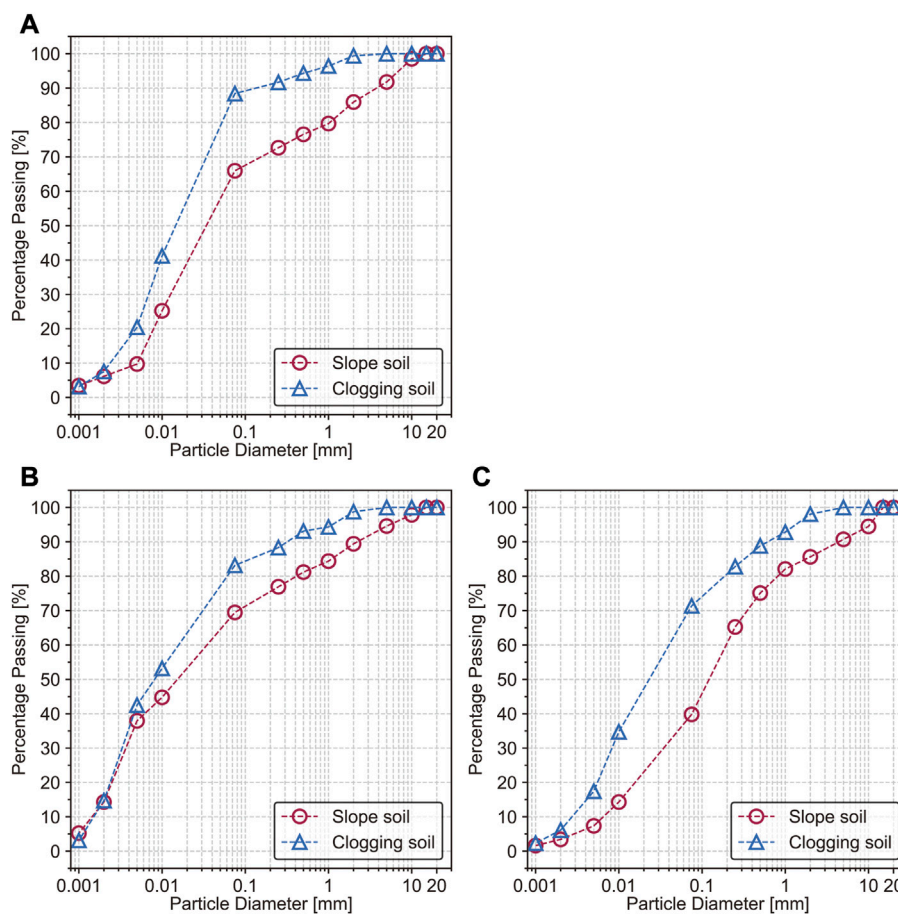
- 1) The right-side slope of section K1858 is made of silty clay with grain size distribution shown in Figure 2A, in which the average soil content with a diameter below 0.075 mm is 66.0%. The drainage hole blockages are mainly clay, and

the content of soils with a diameter below 0.075 mm is 88.4% (Figure 2A).

- 2) The right-side slope of section K1876 is made of clay with grain size distribution shown in Figure 2B, in which the average content of particles below 0.075 mm is 69.5%. The drainage hole blockages are fine-grained soil (Figure 2B) with a diameter lower than 2 mm, of which the total content of particles below 0.075 mm is 83.2%.
- 3) The soil sample from the left slope of section K1925 is silt, mainly composed of sand and clay, and the content of soil particles below 0.075 mm is 39.8% (Figure 2C). The drainage hole blockages are mainly silt and clay, and the content of particles below 0.075 mm is 71.4% (Figure 2C).

Except for the left slope of the section K1925, the fine particle content in the soil of the other two slopes with clogged drainage holes is high, and the content of fine particles below 0.075 mm is above 65%. Although the fine particle content of the left slope of section K1925 is 26.2%–29.7% lower than the other two slopes (K1858 and K1876), the corresponding drainage hole blockages of all the three slopes are mainly fine-grained soil at high contents (71.4%–77.4%). The fine particle content in the drainage hole blockages is larger than that of the slope soil. Therefore, the drainage blockages are formed due to the fine particles from the side slope soil that are transported and accumulated by groundwater.

FIGURE 2 The particle size distribution of the three selected slope soil samples and their corresponding drainage hole blockages: (A) section K1858+930~K1859+260; (B) section K1876+280~670; (C) section K1925+550~875.

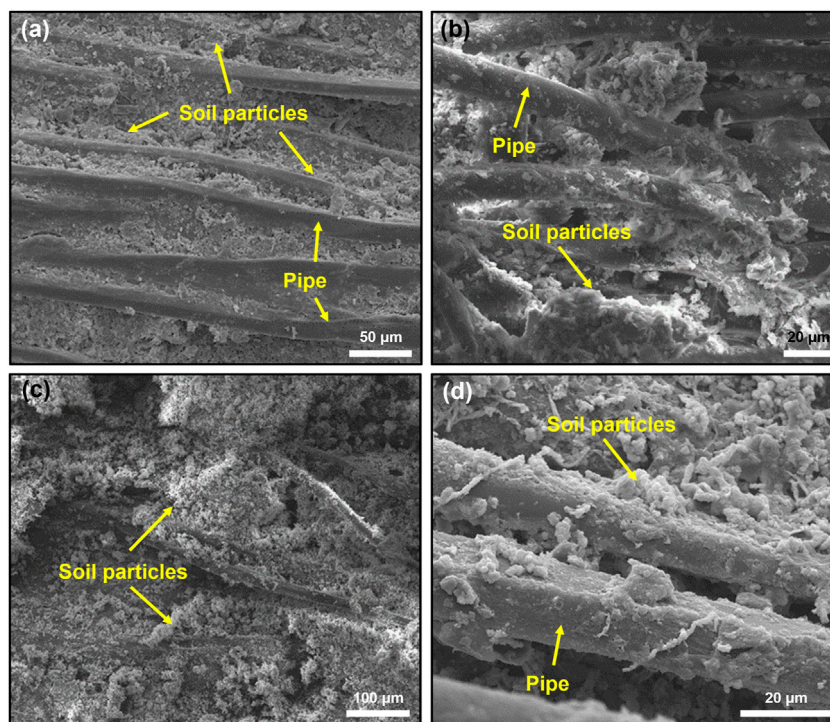
FIGURE 3 SEM images at the outer pipe end: (A), (B) inner surface; (C), (D) outer surface.

drainage pipes are shown in Figures 3A, B, and the outer surface images are presented in Figures 3C, D. The SEM results show significant differences between the blockages on the inside and outside surfaces of the outer section of the drainage pipes. The fiber on the inner surface is still clearly visible, while that on the outer surface is completely covered by the blockage. Therefore, the blockage materials gradually penetrate from the outer surface of the drainage pipes to the inner surface, and eventually reach

saturation on the whole fiber. Thus, blockage materials are prevented from entering the interior and accumulating and just adhering to the outer surface of the drainage pipes.

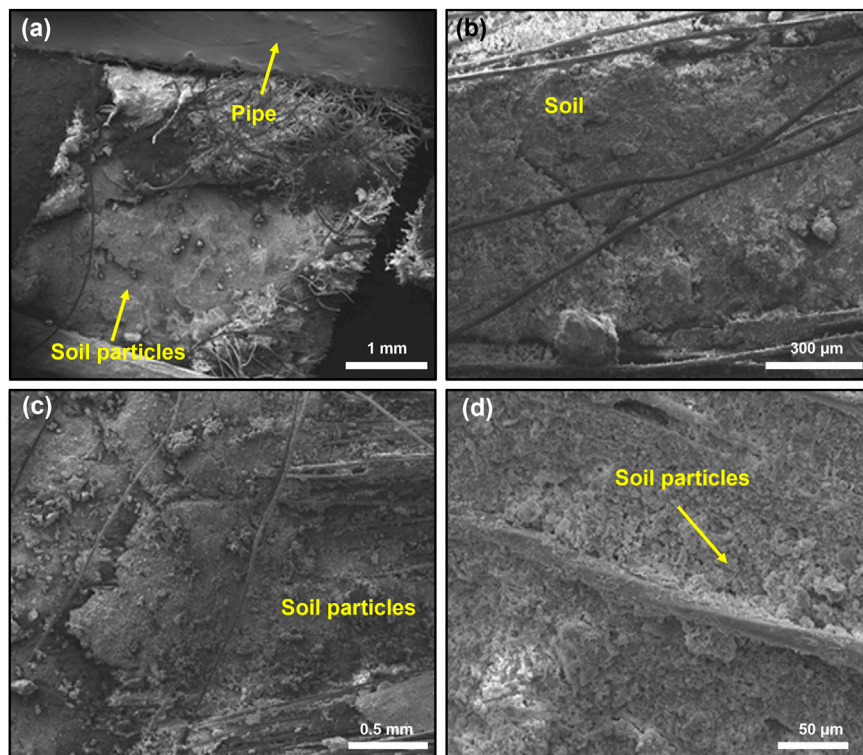
FIGURE 4
SEM images of the inner pipe end: (A), (B) inner surface; (C), (D) outer surface.

Scanning images of the inner and outer surfaces of the inner pipe end are collected in Figure 4. Similar to the scans of the outer ends, at the inner end, fibers are visible on the inner surface but not on the outer surface. SEM images indicate more blockage at the inner end than the outer end of the drainage pipe (see Figure 3 and Figure 4). Therefore, the clogging of the drainage pipe at the inner pipe end is more severe than that at the outer end.

From the SEM images, we can see that the clogging develops from the materials wrapped (geotextile and screen). The fine particles transferred by the underground water accumulate on the wrapped geotextile and screen. More clogging is formed in the bottom of the drainage holes due to the transportation effect of the underground water.

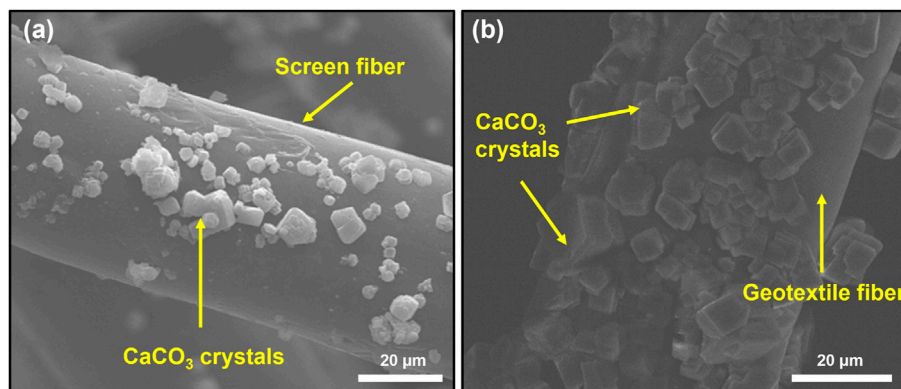
FIGURE 5
The attachment of CaCO_3 crystals on: (A) screen; (B) geotextile.

The screen and geotextile after the first two steps in Section 3 were scanned by SEM to observe the attachment of CaCO₃ crystals. Both the screen and the geotextile have CaCO₃ crystals attached to the fiber surface (see Figure 5). Under the *in situ* condition, as the working time of the drainage holes goes on, precipitated CaCO₃ crystals are accumulating on the screen and geotextile due to their high cohesiveness, thus exacerbating the clogging. From the distribution of the chemical clogging, it can be concluded that the wrapped materials with single-layer structure and larger pore size is more effective than these with multi-layer structure and smaller pore size to prevent the clogging.

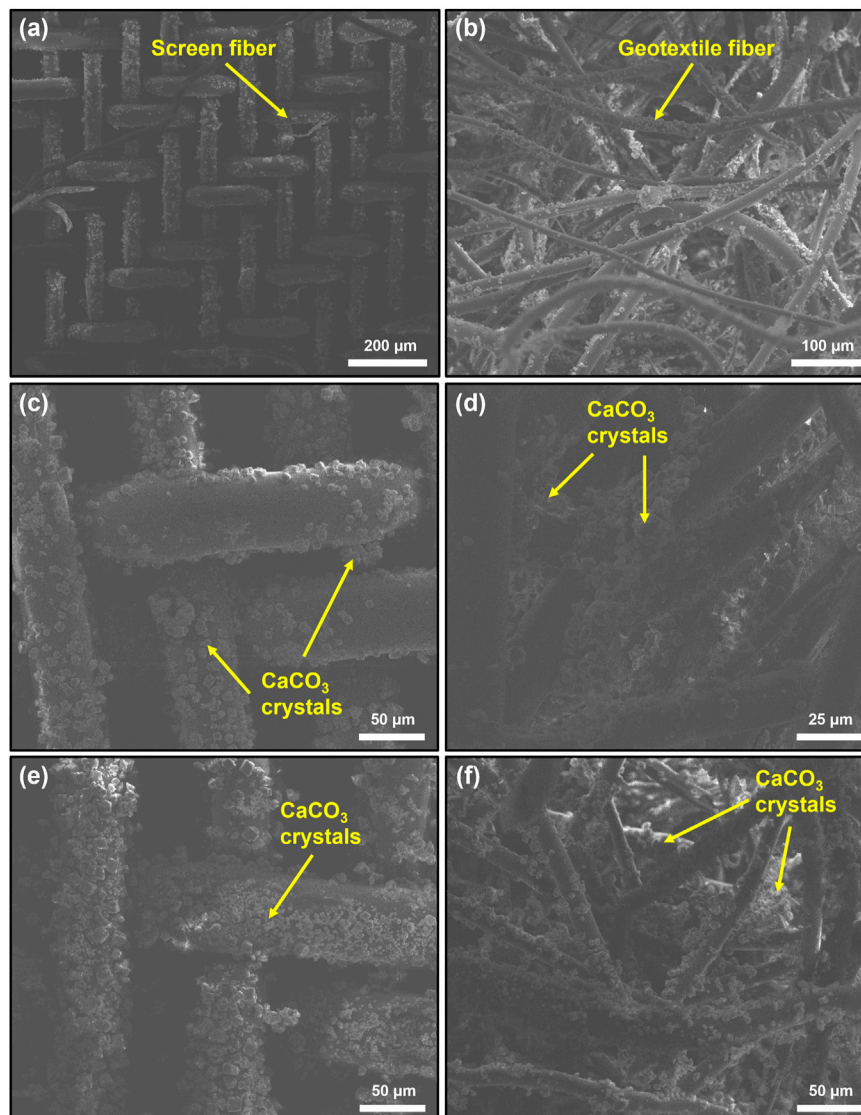
The screens and geotextiles under different titrations: (A), (B): 3 titrations; (C), (D): 6 titrations; (E), (F): 9 titrations.

The CaCO₃ crystal precipitation around the drainage holes with increasing *in situ* operation time was simulated by varying the number of CaCl₂ and Ca(OH)₂ titration. The images of the screens and geotextiles after titration are shown in Figure 6. A comparison of the microstructure of CaCO₃ precipitation indicates that the CaCO₃ crystals attached to the surface of the screen and the geotextile fibers increase with the increasing number of titrations. The CaCO₃ crystals continuously attach to and accumulate on the fibers, leading to blockage. With time going on, the crystal precipitation increases, and then chemical clogging intensifies.

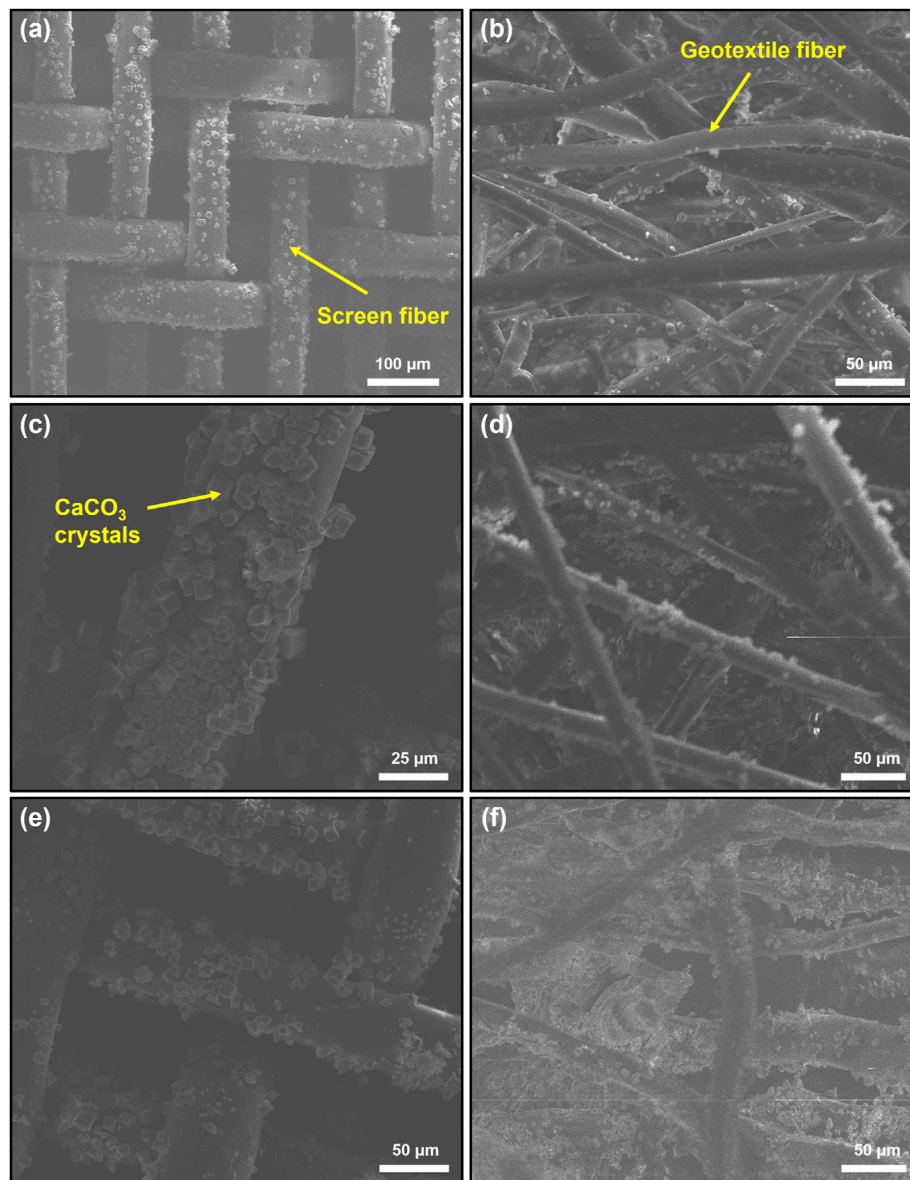
FIGURE 7
SEM images of the screens and geotextiles after: (A), (B): 3 titrations of acid washing; (C), (D): 6 titrations of acid washing; (E), (F): 9 titrations of acid washing.

Since the decrease in the attached CaCO₃ crystals is not so significant after soaking in acid at the pH of 5.0, stronger hydrochloric acids are employed. SEM images of the screen and geotextile soaked with hydrochloric acid at a pH of 3.0 after 6 titrations are shown in Figure 8. The decrease in CaCO₃ crystals attached to the fibers is more significant after soaking in the stronger hydrochloric acid (pH = 3.0) for the same time (i.e., 5 min). Therefore, acid washing is effective for the Fe chemical blockage and Ca blockage.

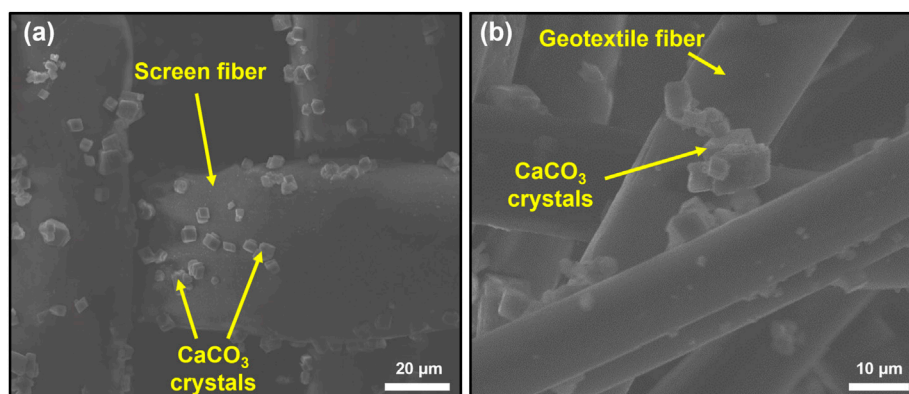
FIGURE 8
SEM images of the (A) screens and (B) geotextiles after 6 titrations of acid washing.

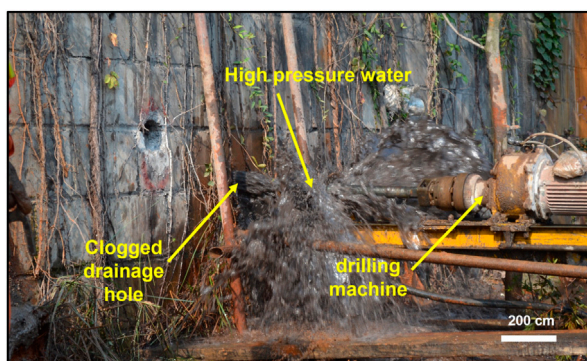
FIGURE 9
Drainage holes washing.

are blockage bonded together in the drainage holes located in the late clogging stage, due to the coupled effect of chemical and biological blockages. The Late clogging stage shows the characteristics of the three-dimensional comprehensive blockage. Therefore, the drainage effect of hole washing is not so effective, with a lower success rate of 18.6%.

The clogged drainage holes in the study area were washed from the outside to the inside with high-pressure water at a pressure of about 0.1 MPa (see Figure 9). After the washing, the cleaning effects on the old and new constructed drainage holes were counted and compared separately. The recovery of drainage after a rain is taken as the judging standard for the success of hole washing. The statistical success of hole washing is shown in Table 6. The data in brackets in the table is the number of drainage holes successfully washed. The operation time of the old drainage holes in this site is more than 10 years, and now it is in the late clogging stage, while the operation of the new drainage hole is working only for 2–3 years, i.e., the initial clogging stage. It can be seen from the statistical data that the drainage holes in the initial clogging stage are mainly physical blockage, and the success rate of washing reaches 47.3%. There
