The 2016 Kumamoto Earthquakes: Cascading Geological Hazards and Compounding Risks

Keywords: 2016 Kumamoto earthquake, earthquake damage survey, surface rupture, ground deformation, ground motion, building damage, infrastructure damage

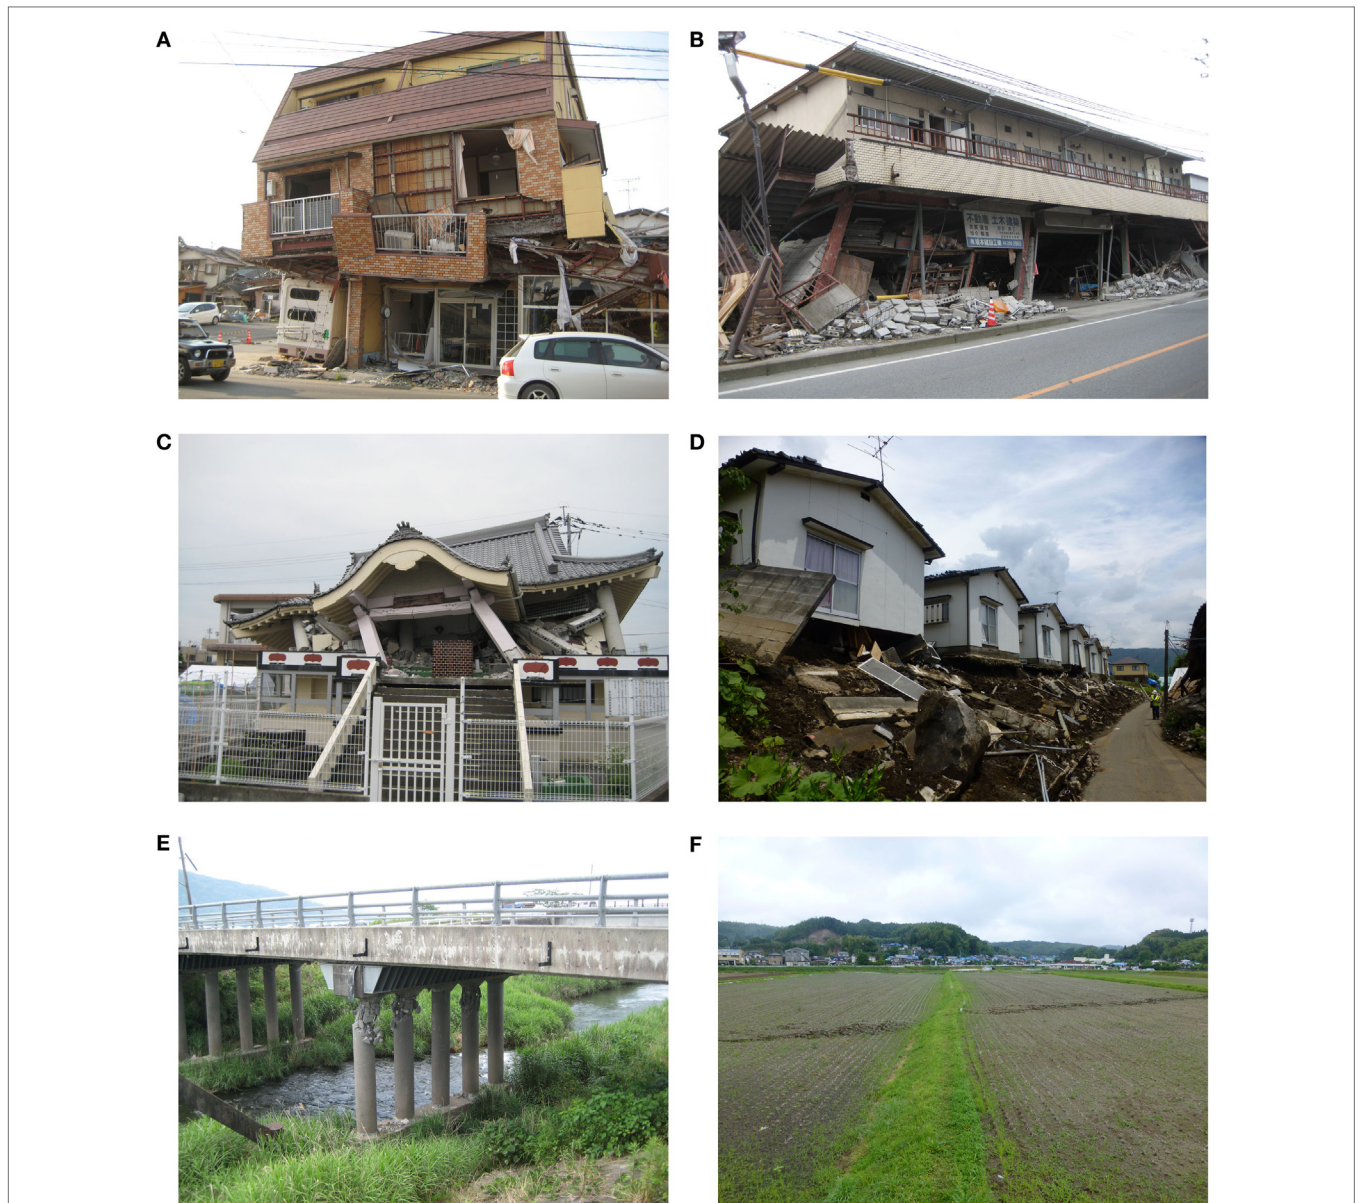
Along Road 28, many buildings were severely damaged or had collapsed. The building shown in Figure 13A was a four-story steel building; the second floor had completely collapsed in a soft-story collapse mechanism. The majority of the buildings that had suffered a soft-story collapse had predominantly deformed/collapsed in the EW direction (more toward west), approximately parallel with Road 28 (e.g., Figures 13A,B). This coincides with the major response axes of the ground motion experienced in Mashiki Town (Figure 8). It has been reported that the effects due to the double-shock ground motions in Mashiki Town were significant. For example, a two-story steel building (Figure 13B) suffered minor-to-moderate damage due to the foreshock; however, it was destroyed by the subsequent mainshock. Several steel as well as RC buildings also suffered extensive damage. For instance, a RC-frame temple (Figure 13C) had collapsed due to the failures of beam-column joints (note: this building did not

collapse after the foreshock but only suffered noticeable damage; it then collapsed due to the mainshock). Moreover, houses that were built on embankments suffered ground failures, and local soil conditions appear to be an important factor in the earthquake damage. For example, one row of six houses had collapsed partially due to foundation failures (Figure 13D). In the southern part of Mashiki Town (mainly agricultural areas along Kiyama river), uplifts of manholes were observed and settlements of the embankments along Kiyama river were seen (see also Figure 15), resulting in major gaps between the bridge deck and abutments. Typically, the bridge deck remained in its original position, while both sides of the embankments subsided by 0.4–0.5 m. RC piers of Daiichi Hatanaka bridge failed due to the ground deformation/failures (Figure 13E; Location 5 in Figure 11B; see also Figure 15). At the time of the survey, large sand bags (height of about 1 m) were placed along Kiyama river as temporary flood defenses. During the heavy rainfall on June 20 and 21, 2016 in Kumamoto, these temporary defenses were breached and Kiyama

FIGURE 13 | (A) Collapsed steel building along Road 28 (location 5 in region 2). (B) Collapsed steel building along road 28 (location 5 in region 2). (C) Collapsed RC temple near the Mashiki town office (location 5 in region 2). (D) Building damage due to foundation failures (location 5 in region 2; near KMMH16). (E) Failures of RC piers of Daiichi Hatanaka bridge (location 5 in region 2). (F) Fault surface rupture (location 6 in region 2).

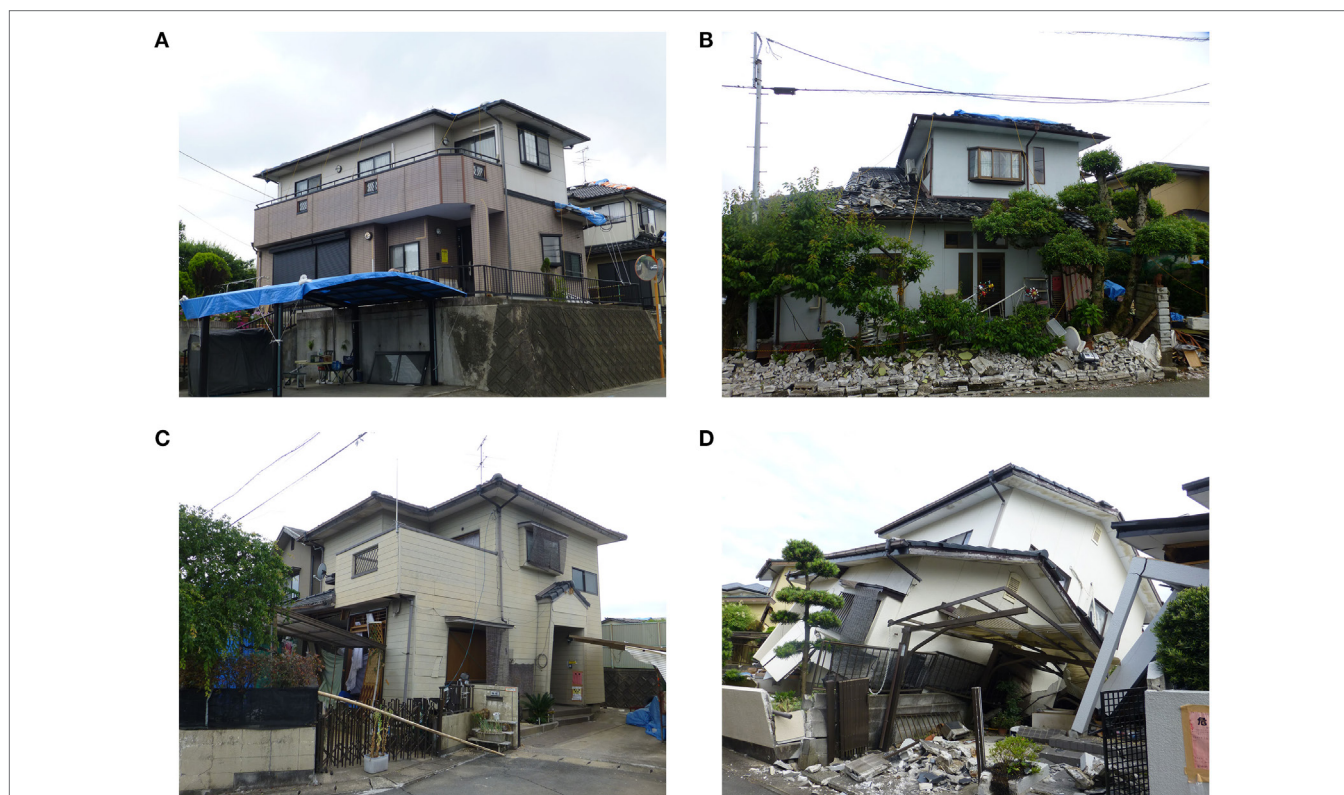
FIGURE 14 | Examples of damaged and collapsed timber buildings in Mashiki Town: (A) slight damage, (B) moderate damage, (C) heavy damage, and (D) collapse.

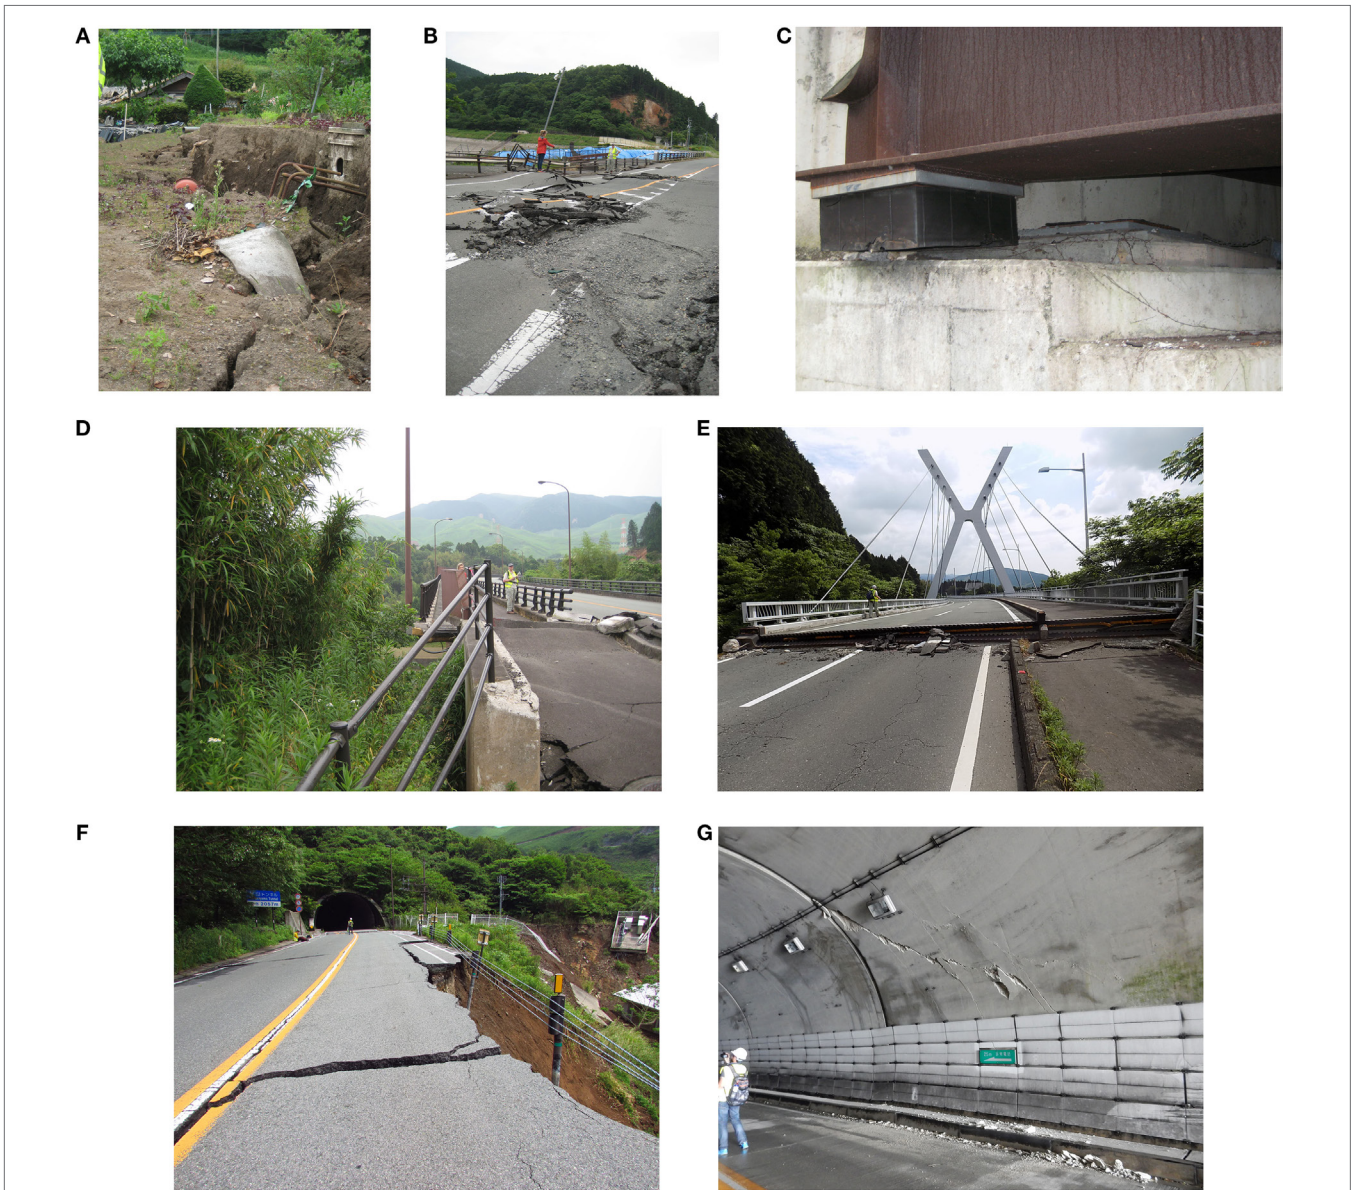
The major damage was observed near the Oogiribata reservoir (Location 8 in **Figure 11B**), which was essentially located directly above the Futagawa fault. The 23 m high earth-fill Oogiribata dam constructed in 1975 has been utilized for irrigation as well as fire-fighting purposes, and has played an important role in local communities. At the crest of Oogiribata dam, major surface rupture was observed (**Figure 16B**). The road pavements were destroyed due to compressional forces. The retaining walls of the spillway were damaged and were tilted significantly. Due to damage to the control gate for releasing water, a large volume of the stored water had leaked accidentally after the mainshock; no fatalities/casualties were reported to have been caused due to this damage.

In the same area, Oogiribata bridge, a curved 5-span steel girder bridge constructed in 2000, was damaged significantly. The bridge was constructed to bypass a valley, where a major landslide occurred along the slope; the slipped soils might have affected the bridge piers at their base. Large cracks and gaps were observed at both sides of the abutments/roads. At the upper side of the bridge, all five bridge supports, i.e., laminated rubber bearing, had sheared/ruptured completely (**Figure 16C**). Consequently, the bridge deck was dismantled and displaced by about 0.3–0.4 m toward the valley side of the slope (**Figure 16D**).

Along Road 28 to Tawarayama tunnel, which is about 2 km long and connects Nishihara Village and Minami Aso Village (i.e., outside and inside of Aso Caldera), major damage to bridges and roads was caused. For instance, Kuwatsuru bridge, a cable-stayed bridge constructed in 1997, was damaged severely due to significant settlements of bridge abutments, resulting in a gap of 0.3–0.4 m (**Figure 16E**). At Tawarayama bridge near the tunnel, similar abutment/ground failures were observed. In addition, several landslides/slope failures were observed along Road 28; some of them caused major damage to roads (**Figure 16F**). Tawarayama tunnel was also damaged due to the mainshock and was not passable at the time of the survey. Large cracks were observed on the concrete cover near the entrance of the tunnel (**Figure 16G**).

FIGURE 16 | (A) Fault surface rupture in Mashiki Town (location 7 in region 2). (B) Fault surface rupture at the crest of Oogiribata dam (location 8 in region 2). (C) Shear fracture of bridge support underneath Oogiribata bridge (location 8 in region 2). (D) Damage to Oogiribata bridge (location 8 in region 2). (E) Damage to Kuwatsuru bridge (location 9 in region 2). (F) Road failure near Tawarayama tunnel (location 10 in region 2). (G) Cracks inside Tawarayama tunnel (location 10 in region 2).

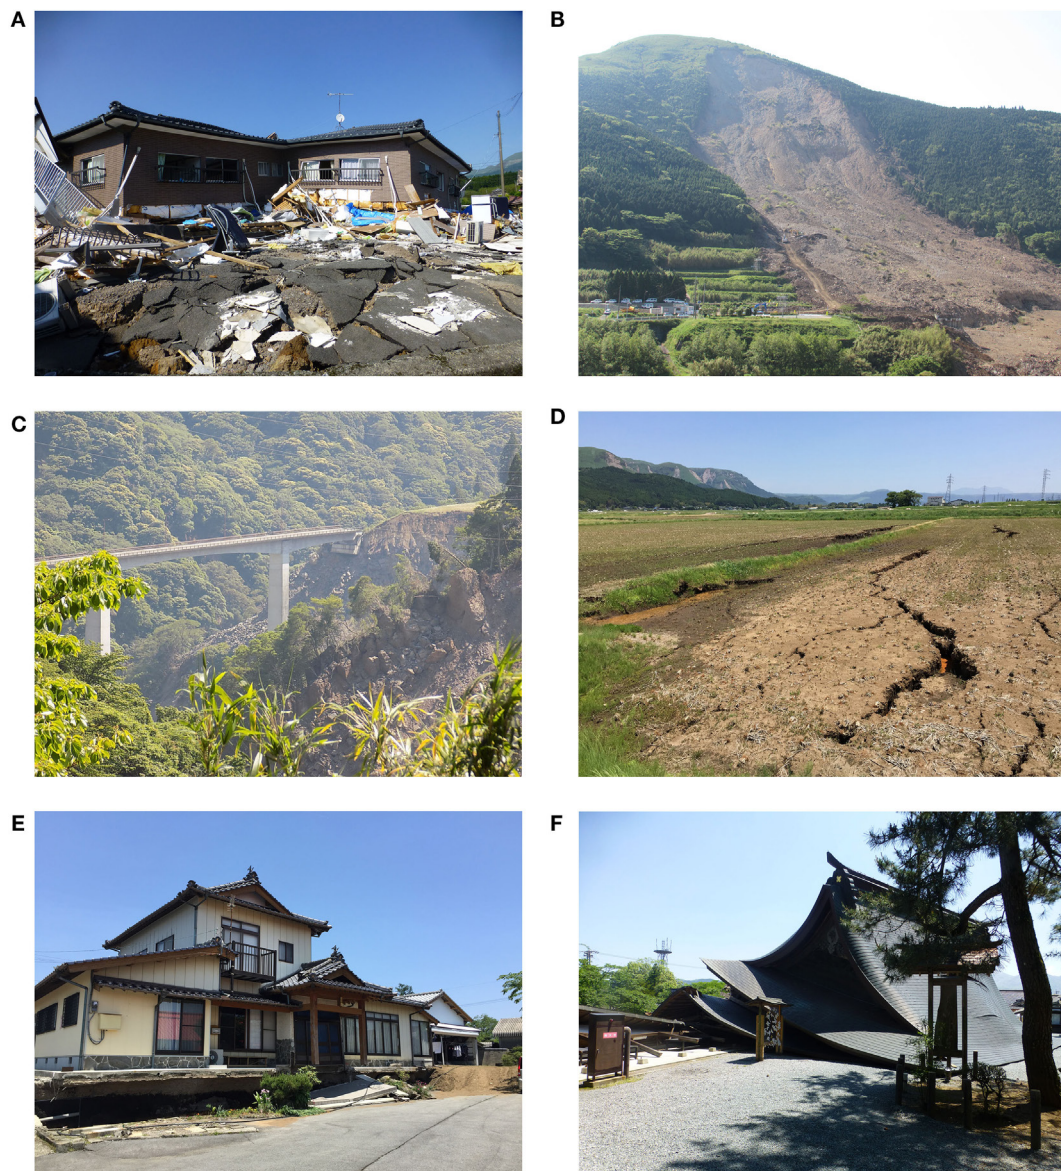
(**Figure 17B**; approximately, 700 m long and 200 m wide), which destroyed Route 57, which connected Kumamoto Prefecture and Oita Prefecture *via* Aso Caldera. The landslide caused the collapse of Aso bridge (Location 11 in **Figure 11C**). Aso bridge was a steel reversed Langer bridge constructed in 1970 crossing over Kurokawa river, and was a part of the regional road network, connecting the Tateno district and the Kurokawa district of Minami Aso Village (i.e., outside and inside of Aso Caldera). It is important to recognize that the Futagawa fault cut underneath of Aso bridge; henceforth, differential ground deformations at both sides of the bridge could have been significant (because of the strike-slip faulting and the locations are very near to the fault strike; see **Figure 4**). The collapse of Aso bridge may be due to the combined effects of the ground deformation and the landslide. More investigations are warranted regarding the exact cause of the bridge collapse.

FIGURE 17 | (A) Collapsed timber building in the Kurokawa district of Minami Aso Village (Location 11 in Region 3). **(B)** Route 57 blockage due to the landslide near Aso bridge (location 11 in Region 3). **(C)** Damage to Choyo bridge (location 11 in Region 3). **(D)** Ground cracks near the Akamizu railway station (location 12 in region 3). **(E)** Ground settlement over a timber house (location 13 in region 3). **(F)** Collapse of Aso Shrine (location 14 in region 3).

designated as important cultural properties of the nation. The main structures of Aso Shrine had been destroyed by the mainshock (**Figure 17F**). On the other hand, in the surrounding areas of Aso Shrine, no obvious ground failures were observed. Because large long-period ground motions were recorded at the KMM004 station (**Figure 8**) and roof structures were heavy, the main cause of the collapse of Aso Shrine may be attributed to the shaking. Nonetheless, more investigations are warranted to understand the exact cause of the exceptionally large ground motions in these areas, which are remote from the fault rupture zone.

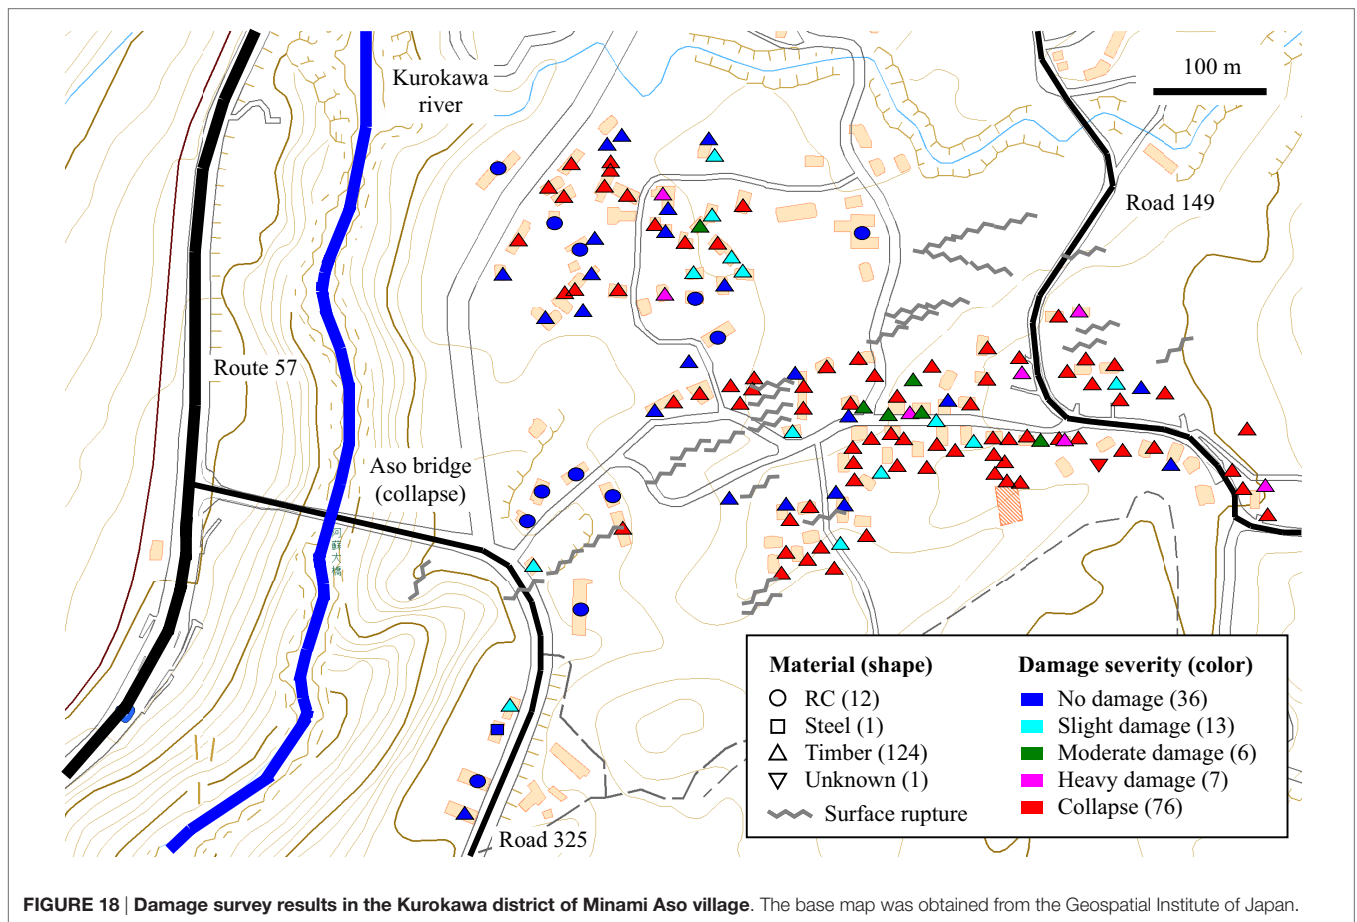
University group. The results are presented in **Figure 18** (the format is similar to those shown in **Figure 15** for Mashiki Town). In total, 138 buildings were inspected; the majority of the surveyed structures were residential timber houses, while RC buildings were an elementary school and apartment buildings. **Figure 18** shows that more than a half of the timber houses had collapsed due to the mainshock. On the other hand, larger RC structures were not damaged. To examine the correlation between observed surface ruptures and building damage, videos taken from a UAV (unmanned aerial vehicle) that were provided by the GSI were analyzed. The identified surface ruptures in the Kurokawa district are indicated in **Figure 18**. It can be observed that some of the surface ruptures cut underneath buildings, which were destroyed.

FIGURE 18 | Damage survey results in the Kurokawa district of Minami Aso village. The base map was obtained from the Geospatial Institute of Japan.
