# Leveraging Remote-Sensing Data to Assess Garage Door Damage and Associated Roof Damage

Rachel N. Kovar<sup>1</sup>, Tanya M. Brown-Giammanco<sup>2\*</sup> and Franklin T. Lombardo<sup>1</sup>

<sup>1</sup> University of Illinois at Urbana-Champaign, Urbana, IL, United States, <sup>2</sup> Insurance Institute for Business and Home Safety, Richburg, SC, United States

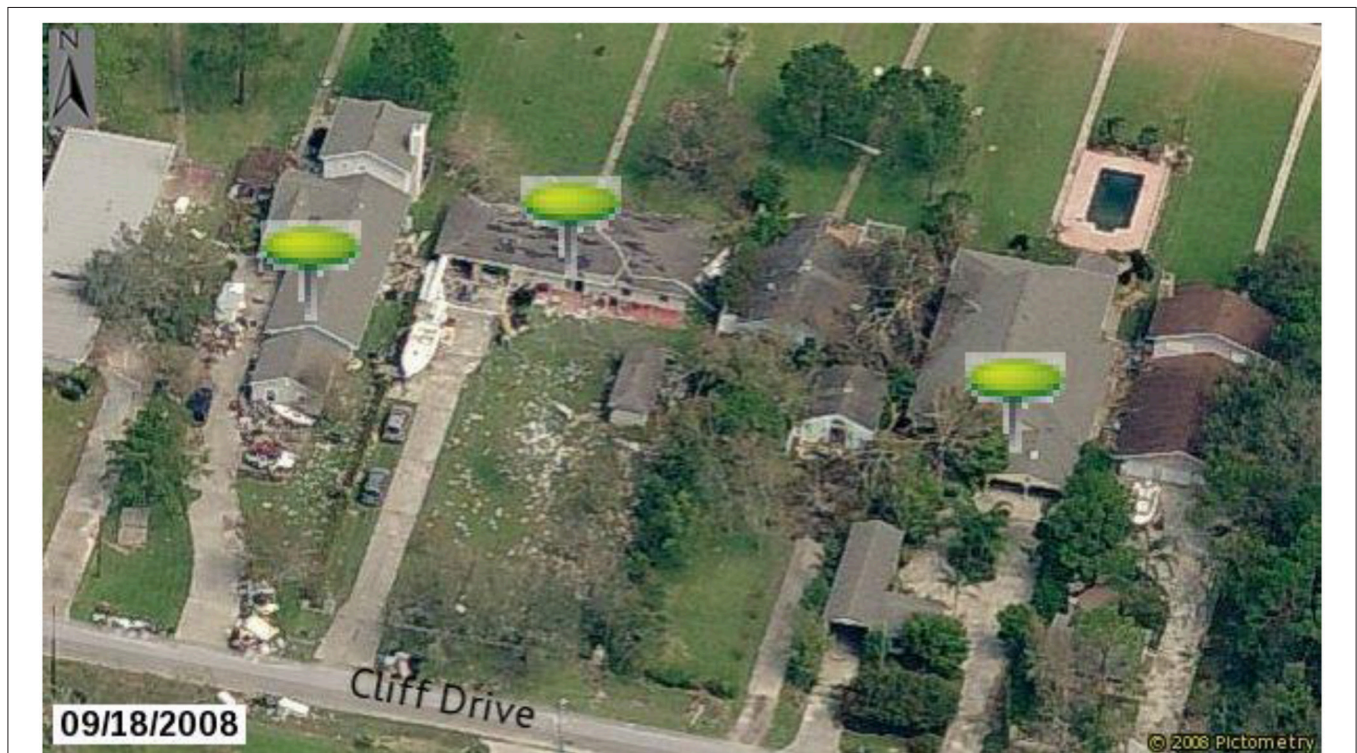
FIGURE 2 | Example oblique Pictometry image shows the condition of roofs and walls for one elevation. Data from additional viewpoint angles can be used to assess damage to the other three elevations of each building. Image resolution and quality reduced for publication. Pin icons denote houses that were included in the dataset. Varying colors of pins were for internal organization purposes only. Image courtesy of Eagleview Technologies, Inc.

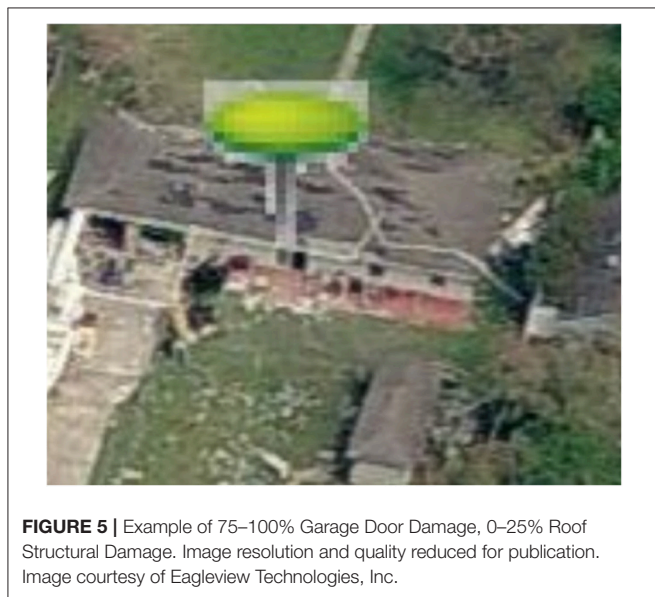
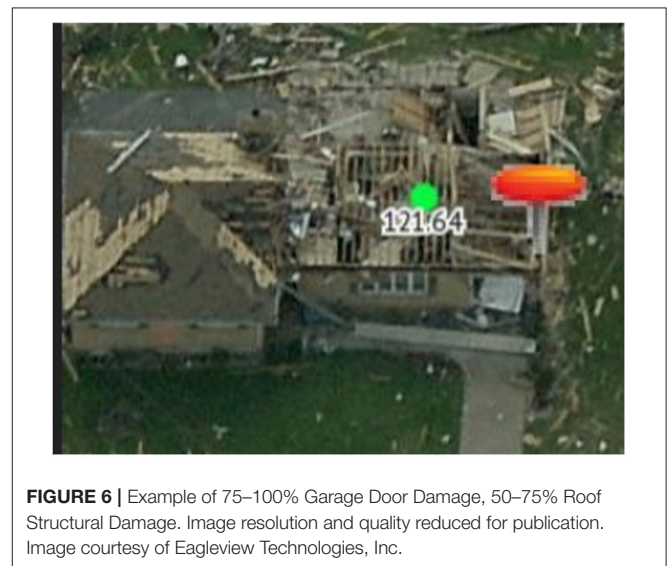
However, what is not shown is the extent of the garage door and/or roof structure damage that is likely to occur in each event type. **Figures 5–8** provide illustrative examples of varying damage severity levels observed for garage doors and roof structural damage. Minimal garage door damage, less than 25%, included homes that had minor displacements of the garage door, small breakages, or no damage. The homes labeled between 25 and 75% garage door damage included doors that were partially removed from their framework, categorized by how much of the door was still intact. Homes within the over 75% damage category had suffered full garage door losses, where the door was completely removed from the home. While garage doors were more likely to be damaged in the 90–109 mph wind speed range in Hurricane Ike, the severity of the damage that occurred was fairly consistent across event types. **Table 4** shows that in all cases, the majority of garage door damages were complete or nearly complete failures, which means that if a garage door is damaged at all, it is likely to fail completely.

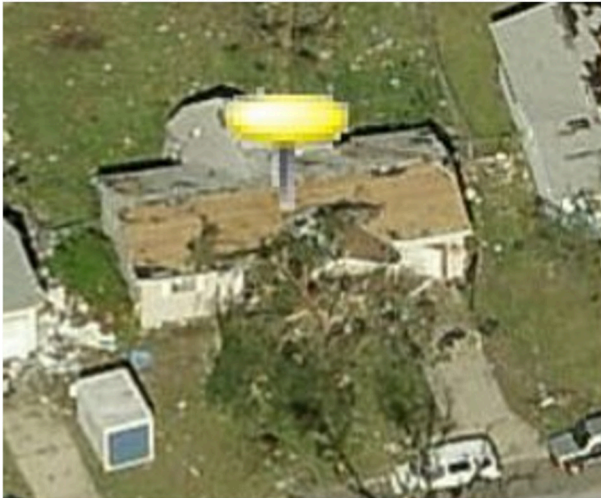
**FIGURE 7** | Example of 50–75% Garage Door Damage, <25% Roof Structural Damage. Image resolution and quality reduced for publication. Image courtesy of Eagleview Technologies, Inc.

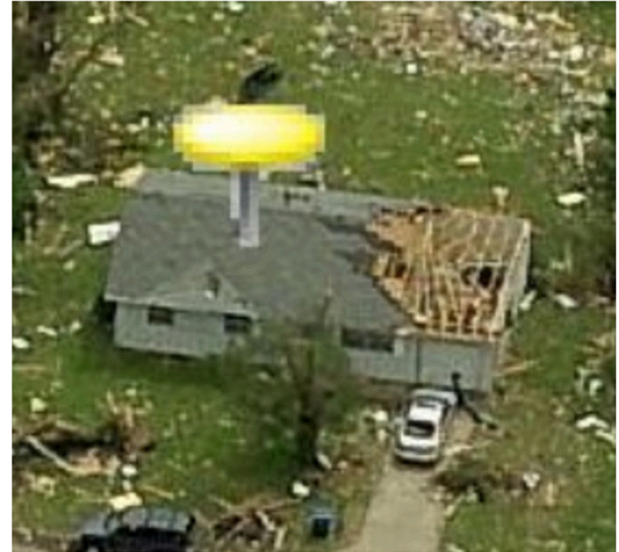
**FIGURE 8** | Example of <25% Garage Door Damage, 25–50% Roof Structural Damage. Image resolution and quality reduced for publication. Image courtesy of Eagleview Technologies, Inc.

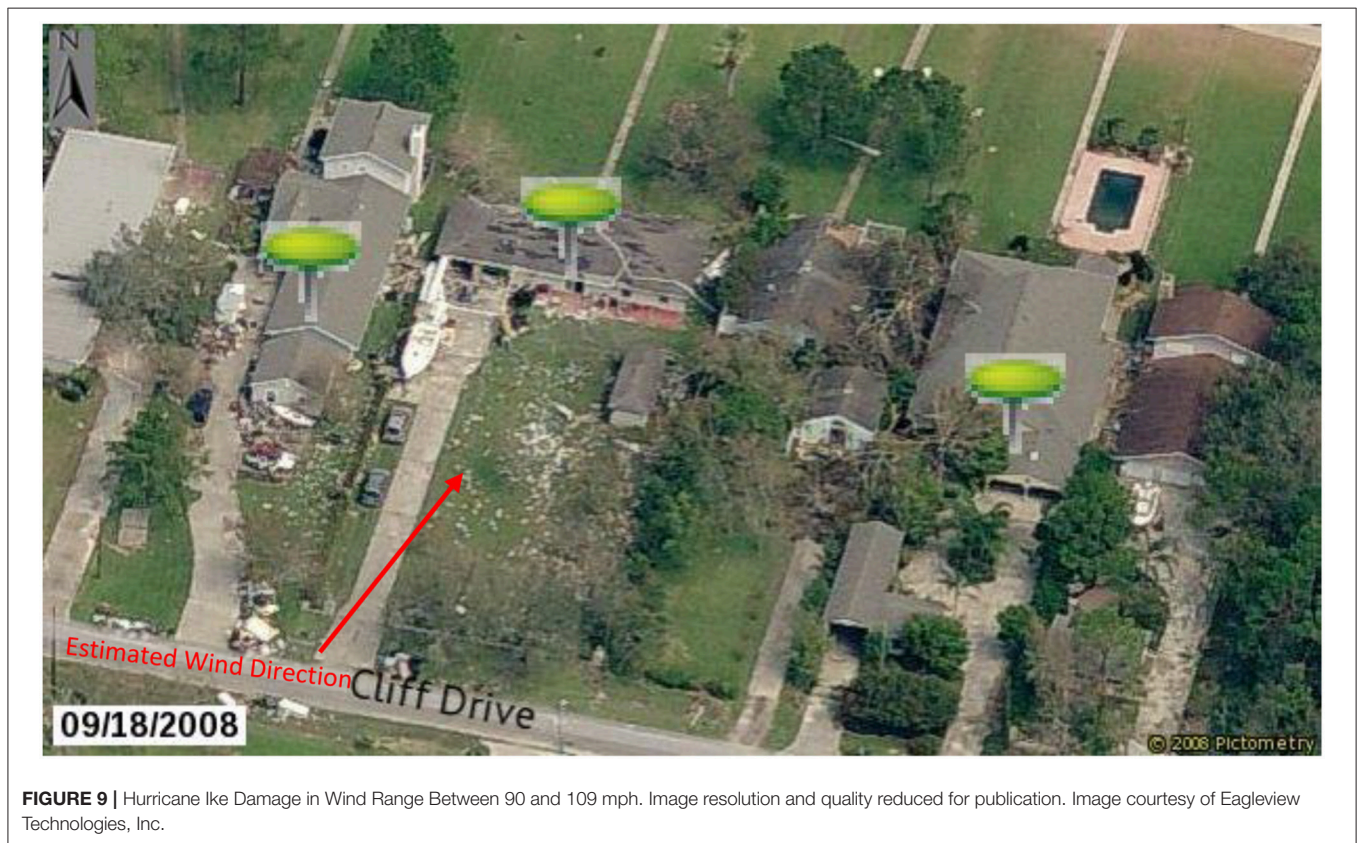
**Figures 9–11** illustrate examples of the differences between the resulting damage in the three events in the same wind speed range. Damage in Hurricane Ike (**Figure 9**) in this wind speed zone is less severe; none of the homes shown in this example have suffered any roof structure damage, and only one indicates shingle damage. In the Joplin event (**Figure 10**), there is a significant increase in the amount of debris found near the homes, as well as a noticeably larger amount of roof structure damage than the other two events, with more structural damage and large areas of shingle loss. In the Moore, OK event (**Figure 11**), at these wind speeds the roof structure damage does not appear to be as severe as the Joplin case, but there is still more damage than observed in Hurricane Ike.

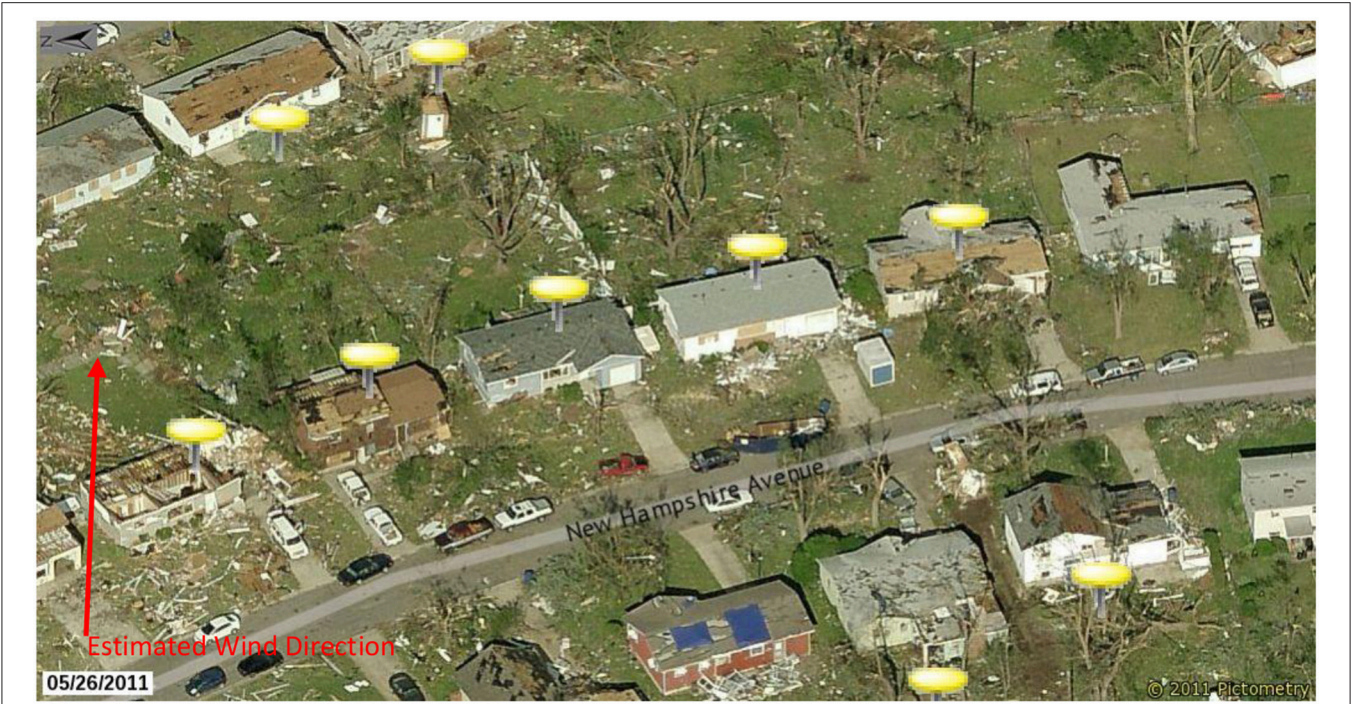
**FIGURE 10** | Joplin, MO Tornado Damage at Windspeeds between 90 and 109 mph. Image resolution and quality reduced for publication. Image courtesy of Eagleview Technologies, Inc.

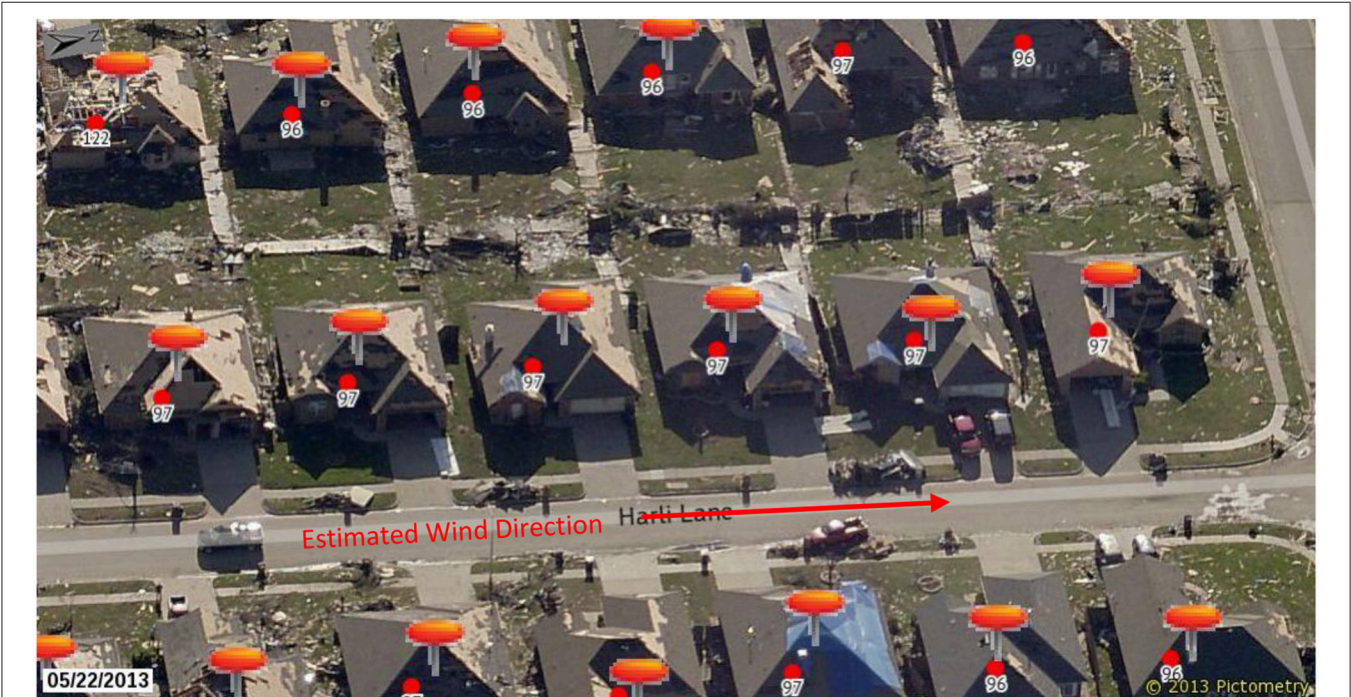
**FIGURE 11** | Moore, OK Tornado Damage at Windspeeds Between 90 and 109 mph. Image resolution and quality reduced for publication. Image courtesy of Eagleview Technologies, Inc.

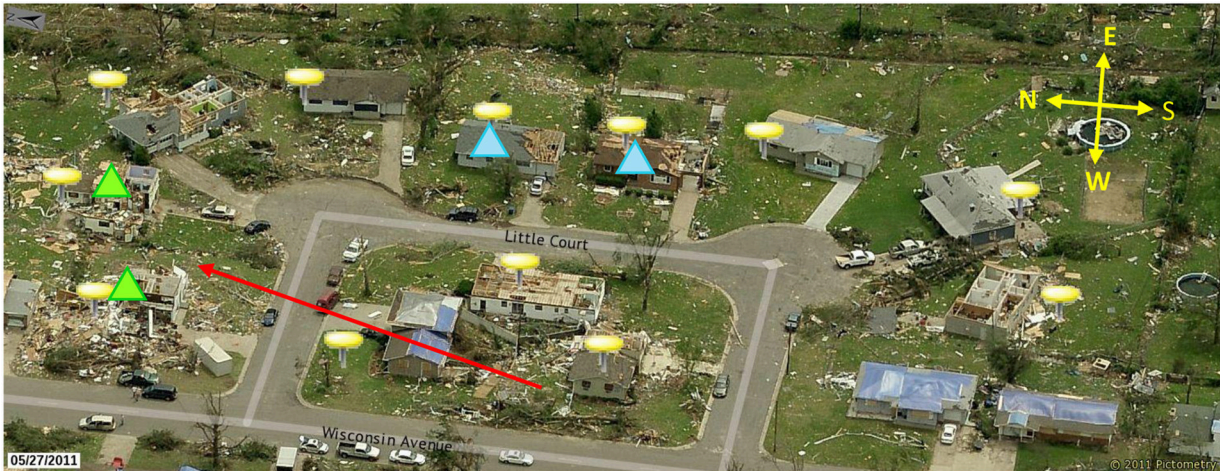
While there are many factors that affect garage door damage, one of the most prominent was the orientation of the home and garage door relative to the wind. Marshall and McDonald (1982) and Marshall (2002) found that houses with garage doors facing the wind were typically more severely damaged than those where garage doors faced away from the wind, for the Grand Island, NE 1980 and Moore, OK 1999 tornadoes, respectively. In the current study, the direction that the garage door was facing relative to the path of the storm and subsequent wind field affected the damage as well. **Figure 12** provides an example of homes that were facing north and south that appear to have more damage than the homes that were facing west in this particular neighborhood in Joplin. In this location, the wind direction was estimated to be from the south-southwest, as indicated per debris and treefall patterns. Homes that had garage doors nearly perpendicular to the direction of the wind were more affected than those whose garage doors were facing

parallel to the wind or were located on the leeward side of the house.

**FIGURE 12** | Joplin, MO Home Damage at Various Orientations. Image resolution and quality reduced for publication. Image courtesy of Eagleview Technologies, Inc.

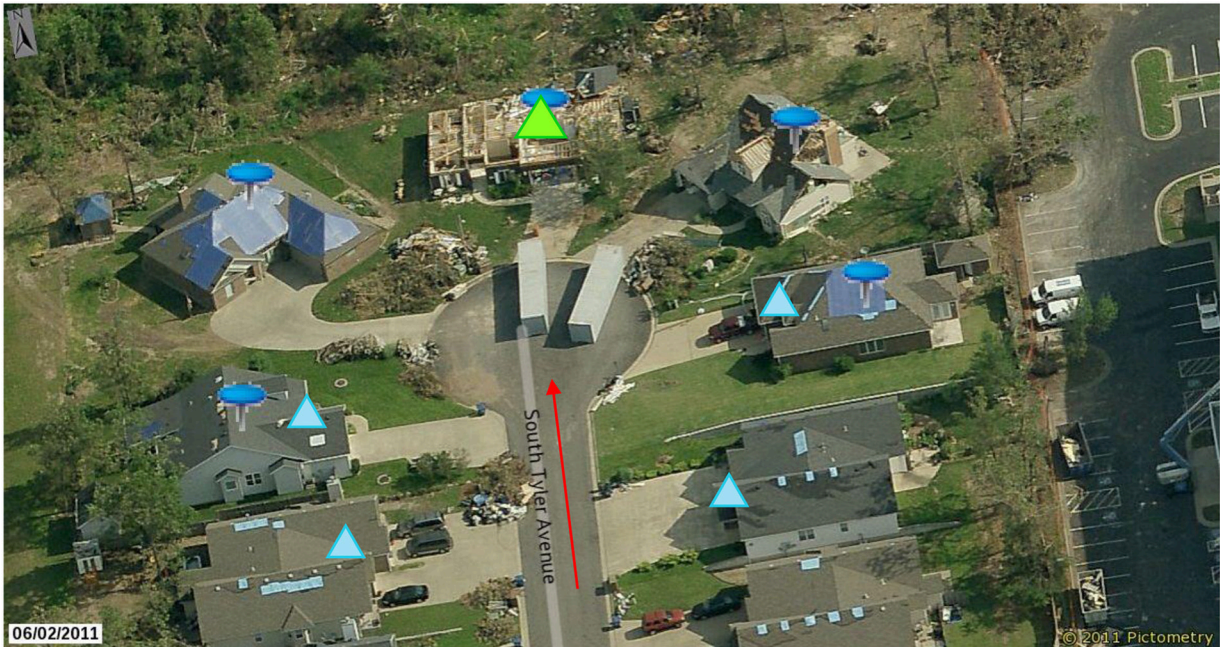
In another case in Joplin, shown in **Figure 13**, the street was of considerable length and continued into a cul-de-sac with a single home with its front face perpendicular to the street orientation. Significant damage occurred to this home (and a home on the cul-de-sac immediately adjacent) with the wind direction estimated to be from the south. Minimal damage was observed for the homes with their front faces parallel to the wind direction (and street).

**FIGURE 13** | Joplin, MO Cul-de-Sac Damage. Image resolution and quality reduced for publication. Image courtesy of Eagleview Technologies, Inc.
