Investigation of microtremors observed at historic masonry townhouse buildings after Nepal earthquake

Yoichi Mukai^{1*}, Hayato Hoshino², Naohiko Yamamoto³, Masaya Masui⁴, Anri Miyauchi⁵ and Ram Prasad Suwal⁶

The Gorkha earthquake in 2015 was a recent large-scale earthquake that caused severe damage to many historic masonry buildings in the Kathmandu Valley, Nepal. The authors conducted a visual inspection survey of seismically damaged buildings after the earthquake in the historic town district of Bhaktapur in the Kathmandu Valley. The first part of this paper reports the distribution of the historic masonry buildings for each damage level in the surveyed area. A concentrating zone of severely-damaged buildings was explicitly found in the damage-level distribution map. Almost half of all the surveyed buildings were severely damaged during the earthquake, and most of these were historic masonry townhouse buildings. In the second part, the ambient vibration characteristics of the conventional historic masonry buildings in Bhaktapur are investigated. Typical dwelling houses in a historic town district in Nepal, which generally formed terraced houses built around a courtyard, were t

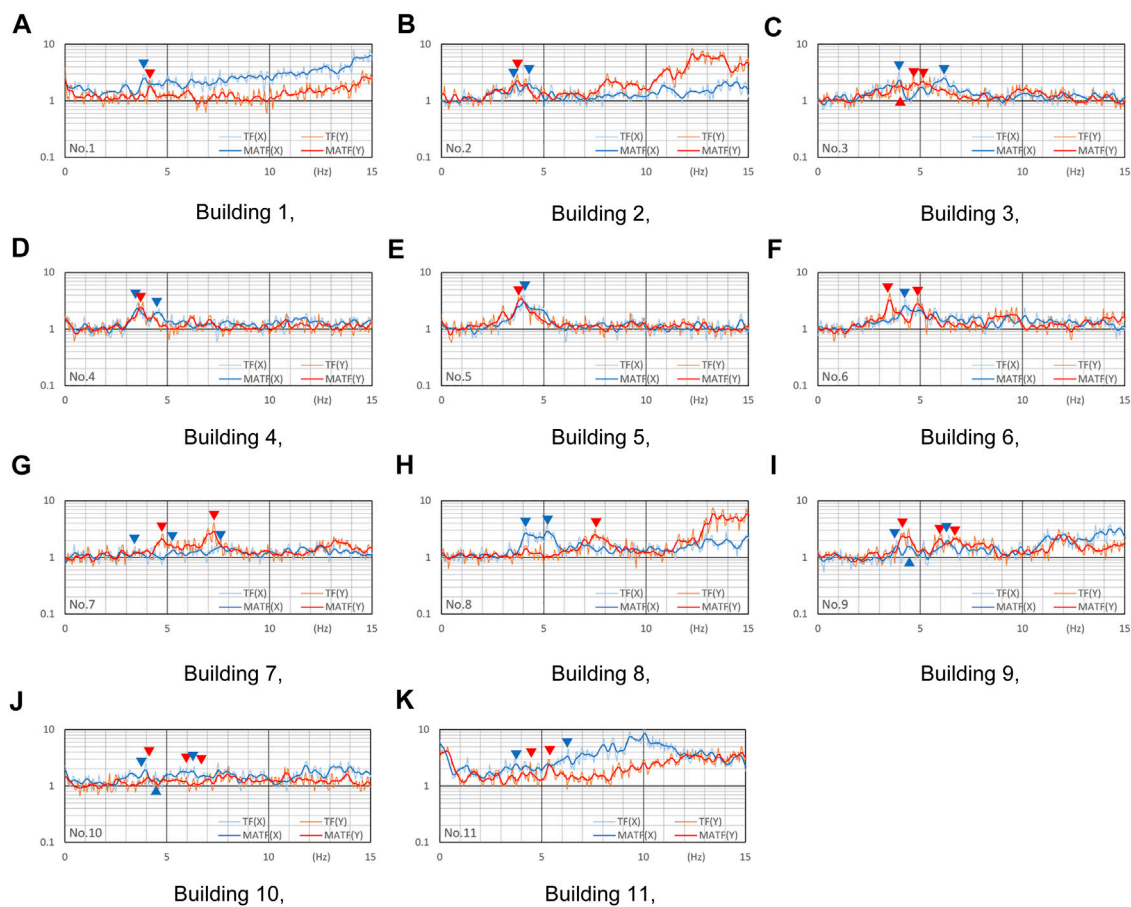
FIGURE 5

TF and MATF of the top vs. ground floor levels. (A) Building 1, (B) Building 2, (C) Building 3, (D) Building 4, (E) Building 5, (F) Building 6, (G) Building 7, (H) Building 8, (I) Building 9, (J) Building 10, (K) Building 11.

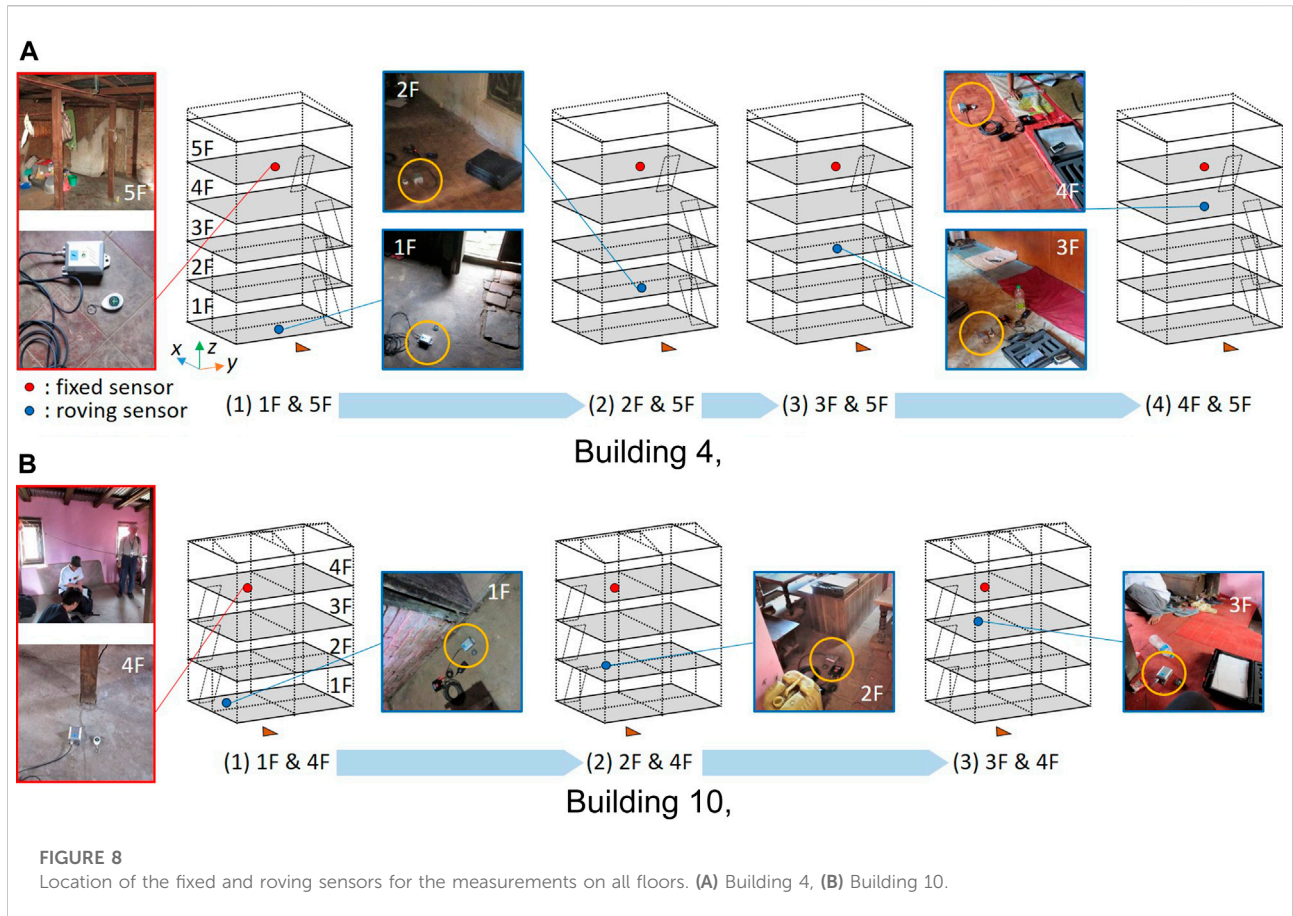
FIGURE 8 Location of the fixed and roving sensors for the measurements on all floors. (A) Building 4, (B) Building 10.

considered. Thus, the correlation between floors mainly focused on this additional measurement. Figure 8 shows schematic drawings of measurement sequences to evaluate TF of every floor of Buildings 4 and 10. The positions of the fixed and the roving sensors are shown in these figures.

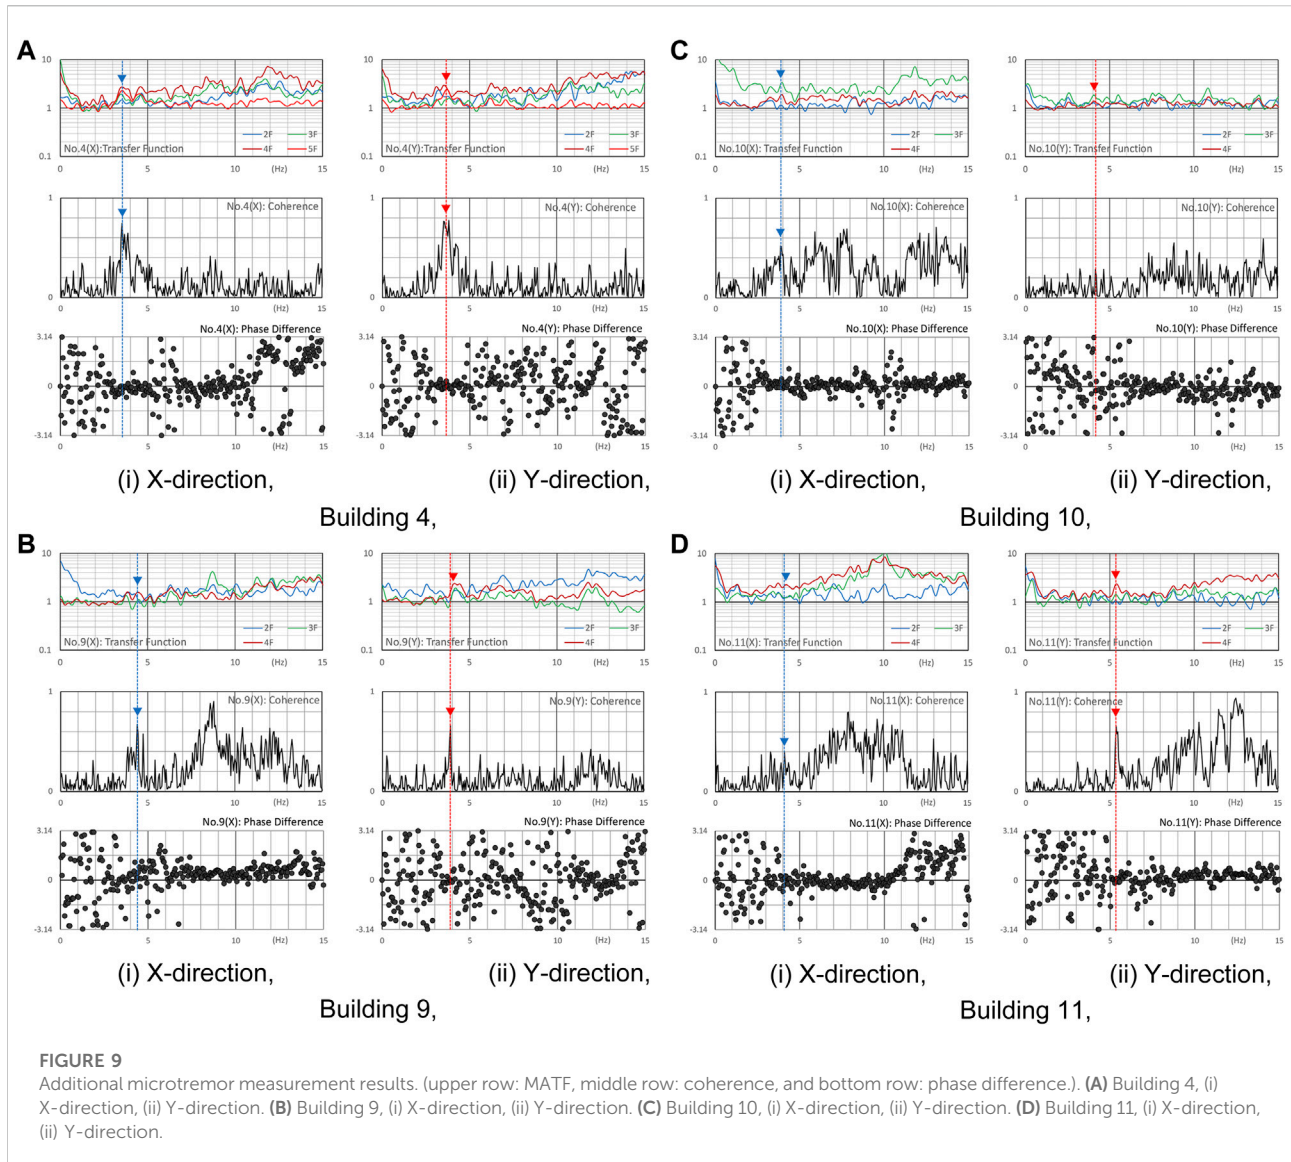
The MATF was also calculated using the procedures mentioned in Section 3.2. The MATF curves are shown at the top from 1) to 4) of Figure 9. The MATF of every floor above the ground floor level is plotted on a single figure. The MATF of the X (depth) and Y (frontage) directions correspond to the left 1) and right 2) figures. The first natural frequencies of the measured buildings are indicated by the inversed triangular marks "▼".

The rest of the evaluation results are shown in Figure 9 to clarify the results based on the MATF. The middle and bottom rows from 1) to 4) in Figure 9 correspond to the coherence and phase difference of the cross-spectrum, respectively. These results were obtained through additional measurements conducted on the top floor. The measurement at Building
