Practical methods to identify seepage paths in dam abutments in semi-arid areas: The Mujib dam in Jordan

The Mujib Dam in Jordan experienced high seepage in 2004 in the right abutment. Initial examination of the cause blamed the rocks there and excluded the clay core hydro-fracturing. The problem later was resolved by grouting the right abutment heavily. This work believes that the grouting quantity was excessive and can be minimized if seepage paths were identified. For this purpose, the excavation cut photos were revisited during construction, the piezometric levels of wells drilled after the seepage event were examined, and the physio-chemical characteristics of seepage water were correlated to those in the reservoir. All those methods combined succeeded in finding the seepage paths and their percentage contribution to the total seepage volume. They found that three-fourths of the seepage water occurred through a small area circling the right abutment gallery stair shaft walls and suggested that the remaining one-fourth can be stopped over time by sediment deposition on the reservoir floor. Therefore, the previously applied grouting volume was high. In conclusion, the methods u

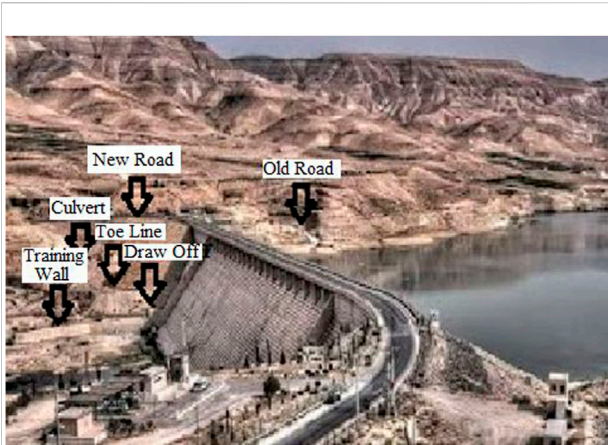
As mentioned previously, the dam's first fill reached 174 m level (29 m depth) on 2 December 2003, and the seepage rate was below the designed rate of 30 L/s in the following year on 24 November 2004, the dam received over a one-night large quantity of runoff water, and once the level exceeded 177 m seepage water observed next morning at high rates (>140 L/s) inside the right gallery stairs shaft top steps and along the embankment toe line near the water draw-off structure. In 2 weeks, the situation aggravated, and seepage water appeared

FIGURE 5 Location of various dam appurtenances.

all along the embankment toe line up to the new road culvert head side and registered 240 L/s (Figure 5). The Jordan Valley Authority was obliged to drill holes in the training wall to dispose off safely the seepage water gushing out of the right embankment toe line and culvert.

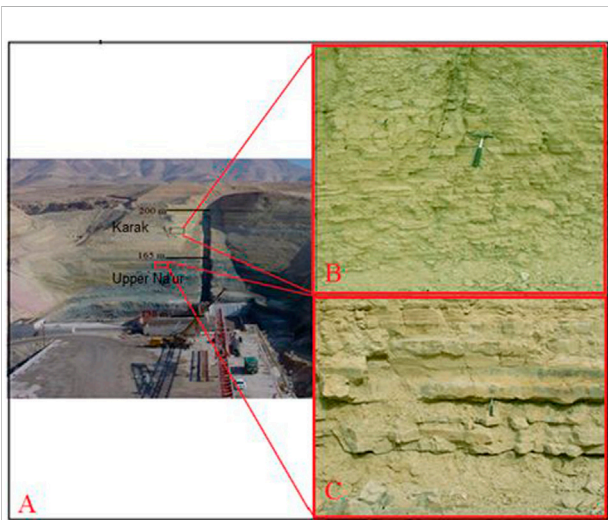
FIGURE 6 (A) Dam excavation cut in the right abutment. (B), (C) Wiesner pictures of discontinuities.

Initially, a geological mapping of the area near the right abutment along the new road excavation cut was conducted by Wiesner in December 2004 (Wiesner and Ewert, 2013). At least 258 discontinuities were documented, including fractures and cavities, and upon those, the right abutment rocks were described as karst and seepage was expected.

The photos of observed discontinuities, as shown in Figure 6B,C, were taken by them. By comparison with those taken during the dam construction, one concludes that the fracture’s aperture was so small (Figure 6A), and a zoom-out photo was needed to identify them. Even the construction workers were unable to identify them, and thus, no documentation was made of their presence.

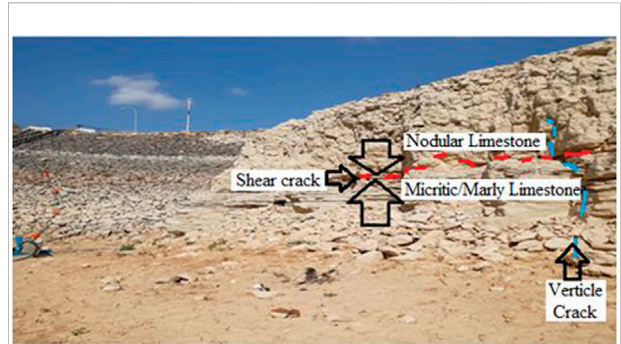
FIGURE 7 Shear cracks in the right abutment rock formations.

Additionally, a visit to the site was made in early December 2019, when the reservoir water level was low. It showed that the right abutment rocks, where dam cuts went through, contain shear cracks. Those cracks are a result of nodular limestone sliding on a harder micritic limestone, and the sliding process left behind cracks filled with pebbles in the space between the two rocks (Figure 7). It should be noted that the crack’s aperture is wide and can allow water to flow.

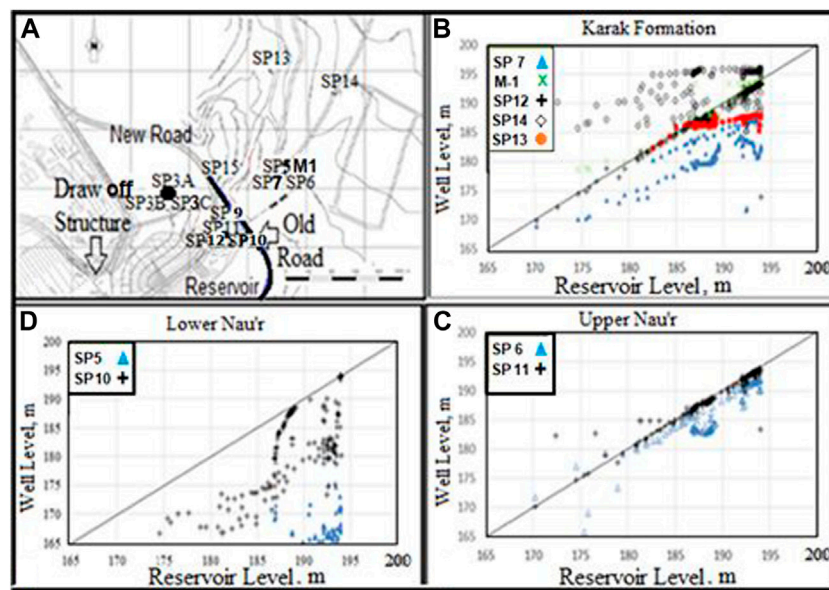
FIGURE 8

Correlation plots of right abutment wells level with the reservoir level. (A) Wells location, (B) The wells tapping Karak formation, (C) The wells tapping upper Na'ur formation, and (D) The wells tapping the lower Na'ur formation.

plotted against the reservoir water level for correlation (Figures 8B–D). The correlation plots were preferred over calculating the coefficient of correlation because the correlation and its variation with the levels in the reservoir can be seen. Based on those plots, the following can be inferred: 1) the wells SP14 and SP13, which tap the upper Karak formation but are located far away from the dam site, have a weak level correlation with the reservoir level, implying that the groundwater there did not originate from the reservoir (Figure 8B). On the contrary, the wells SP12, SP7, and M1 which tap the Karak formation and are located at a shorter distance from the reservoir in the right abutment, have a strong level correlation with the reservoir level (Figure 8B). Contrary to SP7 well levels, M1 and SP12 levels match the reservoir level fully, which means that their connectivity with the reservoir water is high, and this behavior cannot be explained without assuming the highly cracked Karak formation; 2) the wells SP6 and SP11, which tap the upper Na'ur, have a strong correlation with the reservoir level, and this means that the upper Na'ur formation is cracked like Karak. 3) The well SP5 tapping the lower Na'ur and is located within the M1, SP6, and SP7 wells field, and has a weak level correlation with the reservoir, but SP10, which is located within the wells SP9, SP11, and SP12 area, has a strong level correlation with the reservoir at reservoir's levels below 187 m, above it, its level jumps to match the reservoir level. Such behavior is strange and cannot be explained without assuming that the well plastic tube was broken at levels

above 187 m, which consequently made the upper Na'ur groundwater enter the well's tube wall.

From the abovementioned details, one can conclude that both the Karak and upper Na'ur formations are highly cracked, and the lower Na'ur is not and has low permeability.

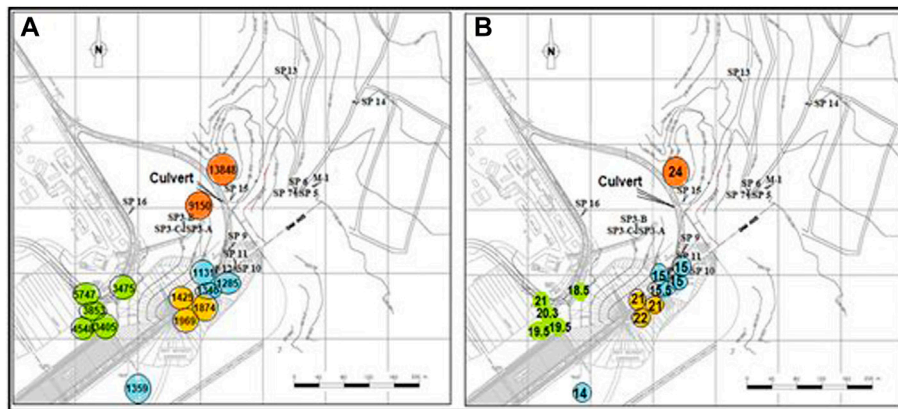
Seepage water samples collected on December 1 through 15, 2005, were analyzed for EC and temperature (T). The sampling sites were the dam toe near the draw-off structure, training wall weep holes, the new road culvert headwater side, and dam gallery drains. The analysis results are presented in Figures 9A,B and can be grouped based on the T and EC values into four groups. Group 1 is seepage water with T and EC like the reservoir water. The samples collected from the gallery stairs shaft belong to this group (blue circles, $T = 15\text{--}15.5^{\circ}\text{C}$, and $\text{EC} = 1,131\text{--}1,346 \mu\text{S}/\text{cm}$). Group 2 are water samples collected from the right gallery ceiling and side walls' drains (orange circles, $T = 21\text{--}22^{\circ}\text{C}$, and $\text{EC} = 1,425\text{--}1,969 \mu\text{S}/\text{cm}$). Group 3 are water samples collected at the dam toe near the draw-off structure, training wall weep holes, ditch, or manhole (green circles, $T = 18.5\text{--}21^{\circ}\text{C}$, and $\text{EC} =$

FIGURE 9 (A) Seepage water T (°C) and (B) EC (μS/cm) at various exit points. Samples of similar characteristics were grouped together and colored with the same color.

3,475–5,747 μS/cm). Finally, group 4 is water collected at the culvert headwater and right gallery bottom drains (red circles, T = 24°C, and EC = 9,150–13,848 μS/cm).

The T and EC values of each group reflected the path seepage water took during the event. Group 1 water represents the reservoir water which circled the contact area between the right abutment rocks and gallery stairs shaft wall. It is a short path as it did not seep into rocks. Group 2 water reflects the seepage water which seeped from the reservoir into the embankment soil, it was higher than the reservoir water in EC and T. Group 4 reflects the longest path that water took from the reservoir into the right abutment rocks till it emerged at the culvert headwater. Certainly, it was mixed with groundwater rich in residues of dissolved minerals as shown in Figure 4. Finally, group 3 water is a mixture of the three groups of water, all mixed together as they went downstream.

By inserting the average EC of each group (groups 1 + 2 together has 1,500 μS/cm, group 3 has 4,206 μS/cm, and group 4 has 1,1500 μS/cm) into the mass balance equation of seepage around the right abutment assuming the total seepage flow is 1 m³/s, and one can find that the seepage water through the gallery stairs shaft and ceiling and sidewalls drains represents 0.75 m³/s of the total seepage. Assuming that the ceiling and sidewall drains flow is small, seepage from water circling the stairs shaft is nearly 0.75 m³/s, and this might be the cause of the 2004 seepage event.

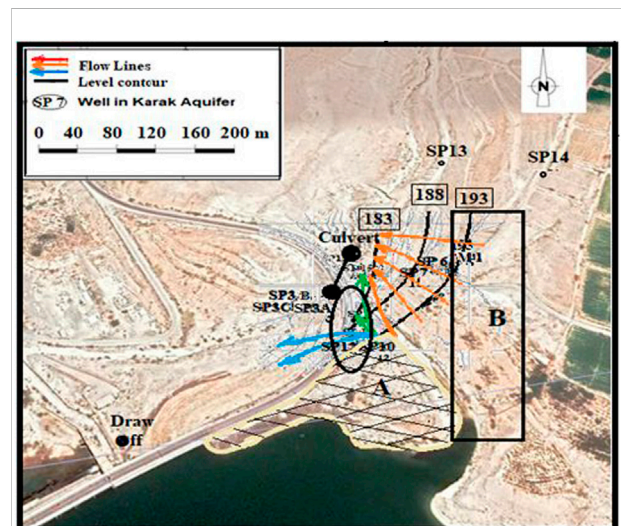
FIGURE 10 Probable seepage paths from areas (A), (B) colors indicate the different paths.

right abutment far away from the stair shaft. A contour plot of the wells' water level at times of seepage, excluding wells SP13 and SP14, is presented in Figure 10. The plot confirms what was found in Section 4.3. The contour gradient is much steeper in the area surrounding the stairs shaft than in those areas further away (Figure 10). On such a basis, one can delineate two areas through which reservoir water seeped: areas A and B (Figure 10). In area A, the reservoir water seeped through it and then diverged into two paths: the first went into the embankment soils and appeared in the gallery ceiling drains (blue arrows in

Figure 10), and the second flooded the area around the gallery stairs shaft walls and emerged inside the gallery at the top stair steps (green arrows in Figure 10), and it seems a small portion of this water went further down to appear at the culvert headwater side. In area B, the reservoir water seeped through it and continued its way downstream to emerge in the culvert headwater side too. The analysis in Section 4.3, last paragraph, found that the seepage volume through areas B and A represented 25 and 75%, respectively, of the total seepage water.

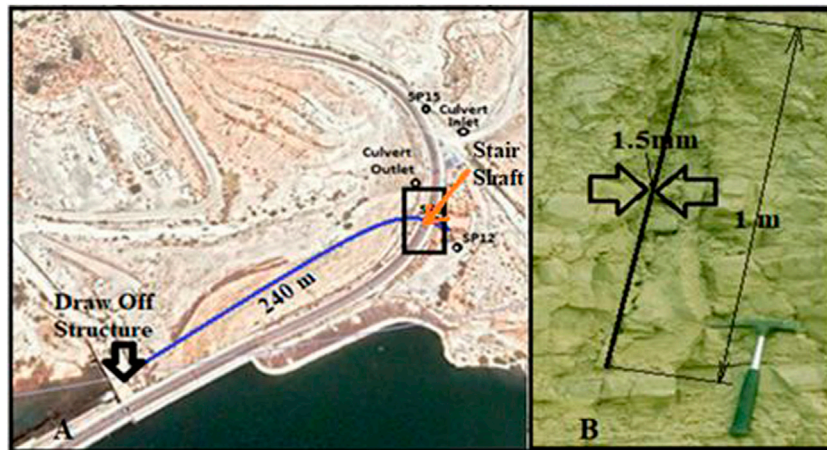
FIGURE 11
 (A) The seepage assumed length from area A to draw off structure, and (B) the observed fracture dimensions as shotted by Wiesner.

Now, let the fracture exists on average at 39 m depth (=194–155); then, the hydrostatic pressure difference ∂P will be equaled to 382.6 kPa ($39 \text{ m} \times 9.81 \text{ kN/m}^3$). When the seepage travel length (∂x) equals 240 m (Figure 11A), average fracture width (H) is 35 m, and fracture aperture (w) equals 1.5 mm (Figure 11B); then, the discharge (Q) in the fracture will be 15.7 L/s. Let 16 fractures, like this one, exist; then, the calculated discharge will be 244 L/s (>240 L/s). A total of 16 fractures to exist in the right abutment is not a big number.

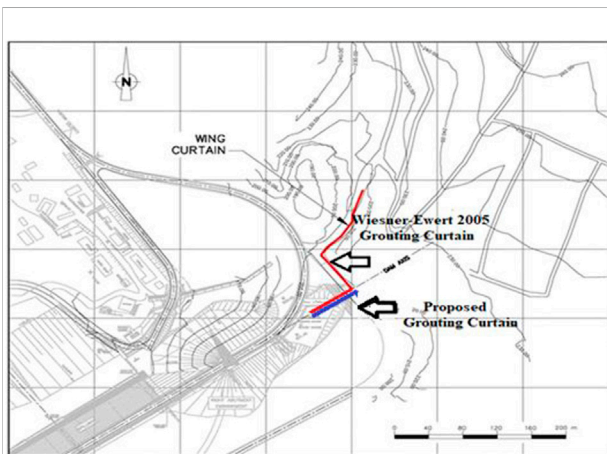
FIGURE 12
 Grouting curtain length the one proposed by Wiesner and Ewer in 2005 (red line) and by this work (blue line).

cracked, and the 2004 seepage event was expected. It was also found that by analyzing the groundwater flow around the dam's right abutment and the physio-chemical analysis of seepage water that 75% of seepage water was confined to a small area surrounding the right gallery stair shaft walls. On such a basis, the 2005 grout curtain (shown in red line in Figure 12) could be shortened to blue line length shown in Figure 12, and the cost would be much lower.
