Sredniawa W, Skawina B, Garcia JR and
Rapp J (2023), Analyzing degradation of
ore pass walls in Kiirunavaara mine using
scanning data.

Front. Built Environ. 9:1250671.
doi: 10.3389/fbuil.2023.1250671

Analyzing degradation of ore pass walls in Kiirunavaara mine using scanning data

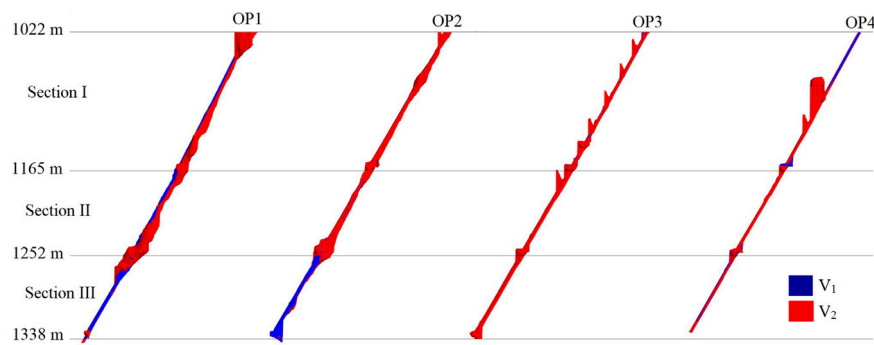
FIGURE 2
Scans of selected ore passes.

conducted, so there was a limited quantity of available data. In some cases, the scanning process was conducted only in one section, thus requiring the extrapolation of data from previous scans. In such cases, it is possible that the ore passes may have already undergone enlargement, but this was not visually observed. To determine the rate of wear of the ore passes, the volume growth between each scan was estimated by subtracting the volume of the previous scan from the volume of the current scan. The scans were processed in Deswik.CAD (Figure 2). The designed volume of the ore passes is indicated by V₀, and they were put into operation in 2013. The V₁ scans vary: OP1 V₁ stands for the 2017 scan, OP2 V₁ indicates the 2016 scan, and

Table 3 contains the data on the volume of the shafts obtained from scans using Deswik.CAD. Table 4 includes information about the quantity of material passing through the shafts between scans, collected by the GIRON system.

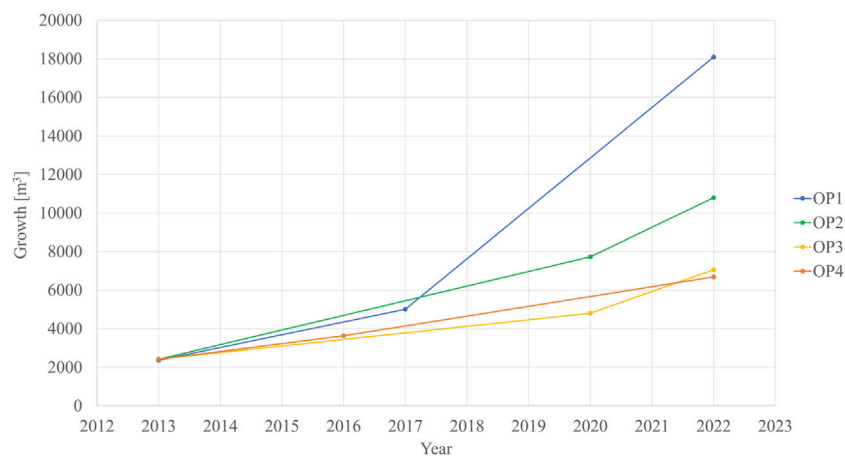
FIGURE 3 Growth chart.

This study evaluated the growth of ore passes using scanning data and other information collected from the Kiirunavaara mine. The Deswik.CAD software was used during the analysis for estimating the volumes. The volumes from the scans are also used for estimating the costs and time required for rehabilitation activities. The results of the growth rates of the ore passes are shown in Figure 3. As the figure shows, the passes had different growth patterns with the highest growth for OP1.

Based on the information in Figure 3 and Table 3–5, and the scans conducted in OP1 in May 2017 (V₁) and March 2022 (V₂) show a 210% increase from the designed value (V₀) of the first scan,

with a throughput of 1.24 Mt. Between the first and second scans, the ore pass increased 3.6 times and passed a total of 4.17 Mt of material. Over the whole period, the ore pass grew 7.65 times and passed 5.41 Mt of material. This represents a significant increase in volume, indicating the ore pass experienced accelerated growth over time which is a concern for future stability in OP1. Further investigation and monitoring of this ore pass are recommended to ensure its stability and to address any potential issues arising from the growth patterns. Moreover, the presence of water in OP1 poses additional risks, such as

degradation and mud rushes. Scans conducted in OP2 in December 2020 (V_1) and February 2022 (V_2) show an increase of 320%, with a throughput of 8.1 Mt. Between the first and second scans, the ore pass increased 1.4 times and passed 3.73 Mt of material. In total, the ore pass grew 4.4 times and passed 11.8 Mt of material. OP2 exhibited moderate growth between the scans, with the largest increase observed in Section 2. Despite handling the largest amount of material among all ore passes, OP2 did not experience the greatest growth among the others. It is probably relatively better rock quality and lower stress contributing to less structural damage. Regular monitoring and scanning are recommended to manage OP2's growth and ensure safe and efficient mining operations. Scans conducted in OP3 in November 2020 (V_1) and May 2022 (V_2) show an increase of 200%, with a throughput of 3.2 Mt. Between the first and second scans, the ore pass increased 1.4 times and passed 1.2 Mt of material. Overall, the ore pass grew almost 3 times and passed 4.4 Mt of material. The largest increase was observed in the last section. OP3 exhibited a relatively lower growth rate than the other passes. The shape of the enlargements in Section 1 is caused by the finger raises. While no immediate rehabilitation is needed, regular monitoring and scanning are recommended to ensure the continued safe operation of OP3. Scans conducted in OP4 in May 2016 (V_1) and December 2022 (V_2) show an increase of 150%, with a throughput of 0.3 Mt. Between the first and second scans, the ore pass grew 1.8 times and passed 1.86 Mt material. Overall, the ore pass increased its volume 2.8 times and let through 2.17 Mt of material. The biggest increase was observed in the first section, in the finger raise. Rehabilitation and regular inspections are recommended to manage the growth in the finger raise in Section 1 and ensure its continued safe and efficient operation.

The recommendations and potential cause on the ore pass growth is shown in Table 6. As the table shows, in the first two ore passes (OP1 and OP2), the potential cause was the impact of falling and bouncing rock; in the other two (OP3 and OP4), the potential cause was the closeness of nearby infrastructure and other openings. The table also provides recommendations for each ore pass.
