Damage Types and Deterioration Characteristics of Check Dams Built on Mountain Streams in Southeast Korea

Keywords: condition assessment, non-permeable check dams, stream management, check dam deterioration, visual inspection

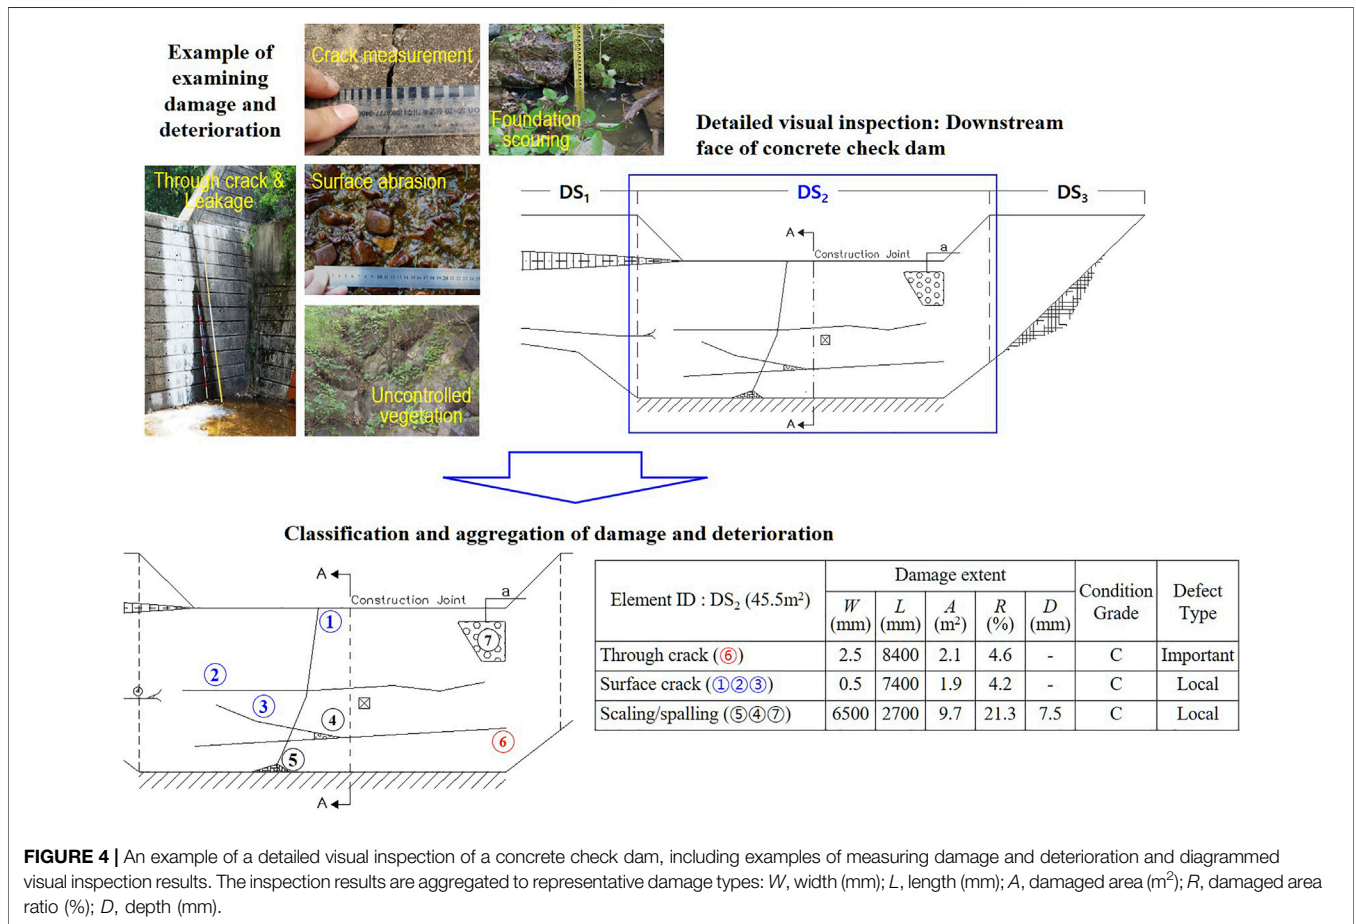
FIGURE 4 | An example of a detailed visual inspection of a concrete check dam, including examples of measuring damage and deterioration and diagrammed visual inspection results. The inspection results are aggregated to representative damage types: W, width (mm); L, length (mm); A, damaged area (m²); R, damaged area ratio (%); D, depth (mm).

The field examination results were analyzed using AutoCAD 2010 and the diagrammed visual inspection results and aggregated results on damage and deterioration in a specific element (*DS*₂) are presented in **Figure 4**. Then, the damage in individual elements of each specific element was classified by type, and its attributes (e.g., width, depth, length, and area) were combined and used as assessment elements for the damage and deterioration analysis in the next section. Each check dam was visually inspected only once, and the field inspection period lasted from March to May 2016.

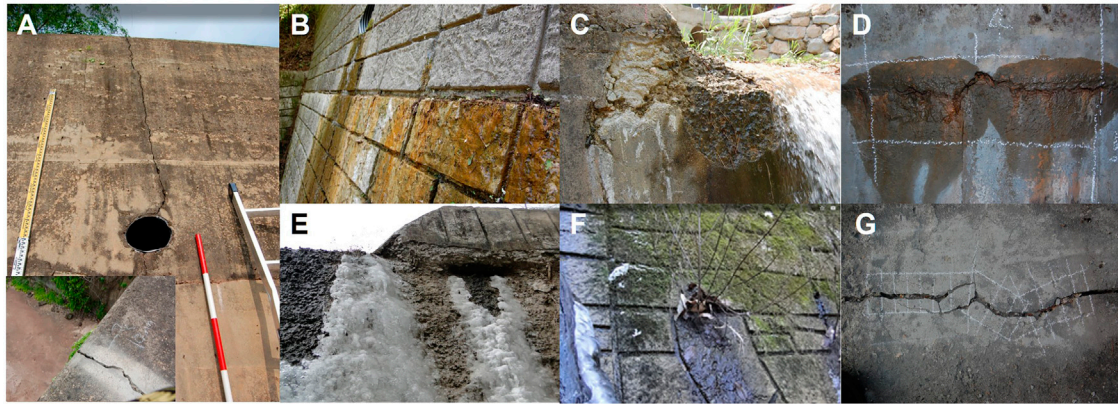
In the case of TC cracks with a width of 0.4–15.0 mm and an area ratio of 0.7–15.0%, which were found on 16 check dams, 31 of the 33 found instances (dam crest: 12 instances; downstream

FIGURE 7 | Various deterioration types observed on concrete check dams. **(A)** vertical through crack and displacement caused by drying shrinkage cracking; **(B)** water leakage from a gap in a horizontal construction joint; **(C)** exposed aggregate and spalling, respectively, due to erosion at the spillway; **(D)** leakage and efflorescence at a horizontal construction joint; scaling and spalling of the downstream face due to freezing and thawing; **(E) (F)** uncontrolled vegetation around a drainage channel; **(G)** through crack and dam crest stepping.

face: 21 instances) were Grades C and D damages; that is, repair/reinforcement was considered and recommended (**Figure 7A**). In contrast, 48 instances of SC (dam crest: 15 instances; downstream face: 33 instances) with widths of 0.2–9.9 mm and area ratios of 0.1–23.7% were found on 23 check dams, but no more than six of these were Grade C defect. Cracking was the most frequent damage type on all the dam crests and downstream faces but not necessarily a problem that directly leads to severe defects in concrete check dams (Korea Concrete Institute, 2014).

JD refers to damage (e.g., cracks and leakages) that occurs at shrinkage and construction joints (**Figure 7B**) and was observed on 19 concrete check dams. Sixteen instances were found on dam crests, and three of these were Grade C damage (with a width of 3.5–7 mm), which occurred at the shrinkage joints and extended to the downstream face. Of the 37 instances of damage on the downstream face, 12 were determined to be of Grades C and one of D damage. In addition, in two of these instances, water continued to leak at the crack surface of the construction joint during the field inspection.

AE was found in 20 inspection targets, including 15 instances at the dam crest and 18 instances at the downstream face (**Figure 7C**). The depths of the damaged surfaces at the dam crests and downstream faces were below 10 mm. Foundation erosion scoured the riverbed directly below the spillway to depths of 0.04–0.7 m. Specifically, there is a tendency that *AE* is concentrated in the spillway (which is directly affected by water flow and debris flow) and its underground foundation (Mizuyama, 1979; Comiti et al., 2010; Piton and Recking, 2014; Ogasawara and Kambara, 2015).

L, *V*, *EF*, and *HD* are deterioration phenomena that specifically occur on the downstream face. Fifteen instances of *L* were found on ten concrete check dams, and six of these were accompanied by *EF* (**Figure 7D**). Of the eight leakages of Grade C, two instances occurred at the cracks, and two and four instances were found at the construction joints and foundations, respectively. The freezing and thawing of leaking areas in winter and summer, respectively, leads to secondary damages, including cracks and scaling/spalling. In the case of concrete

check dams (which are unreinforced concrete structures), the damage was concentrated around the leakage areas that were damaged by frost, as well as in the drainage channel (**Figure 7E**). Of the 16 instances of *SS* found in eight inspection targets, two instances were determined to be of Grade D and one of Grade E. These were observed throughout the entire inspection area at depths of 7.2–11.2 cm. Single instances of *V* were identified in the gap between the shrinkage and drainage channels (**Figure 7F**). *HD* was observed along with *VD* of the dam crest in three inspection targets. Of the three instances of *HD*, two instances were Grade C and one of Grade D. This is believed to be caused by structural deformation produced by growth of the drying shrinkage cracks; as a result, steps with depths of 3.0–7.0 mm were created on the dam crest surface (**Figure 7A** and **Figure 7G**).

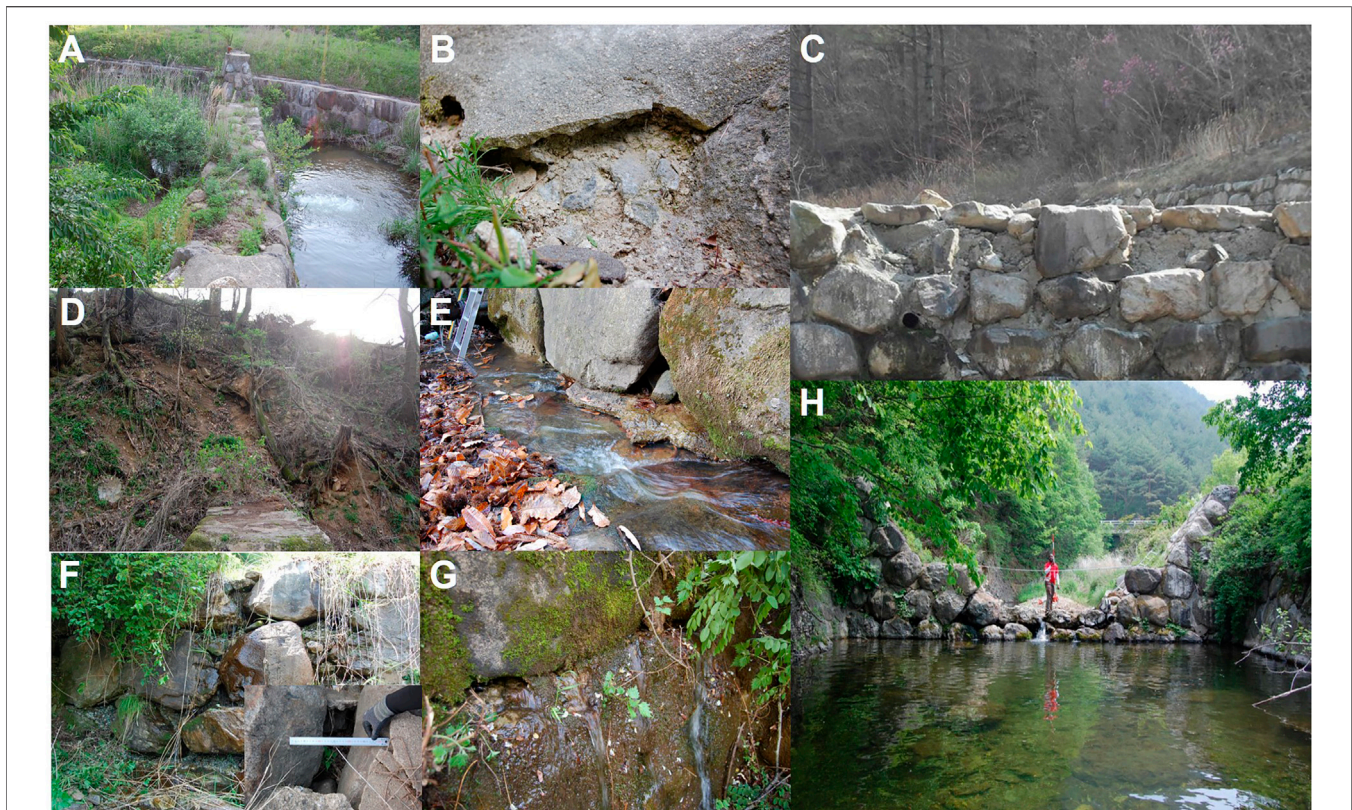
Three instances of F were observed on two stone check dams. Two instances were attributed to impacts from debris flows at the spillway of the dam crest (Figure 9C), which produced cavities with depths of approximately 0.45 m in the damaged area. One instance displayed continuous concrete leakage in a cracked area, attributable to earth pressure, where vertical subsidence proceeded in the damaged area and developed into a Grade E horizontal displacement defect.

two instances occurring at the dam crest and 12 instances occurring at the downstream face (Figures 9D,E). In the ER instances identified in the downstream face, the foundation was scoured to a depth of 0.15–0.65 m in 11 instances of Grades C, D, and E defects. IC indicates an empty cavity that occurs when the flow in leaking areas continually carries away the internal material and discharges it downstream. IC is a significant defect that reduces the durability and stability of a check dam body, by increasing the dam’s internal porosity (Kasahara et al., 2010) (Figure 9F). IC inspection was performed on ten stone check dams (dam crest: 1 instance; downstream face: 9 instances). In the three instances of C and the two instances of D damages, multiple (2–4) defects with depths of 0.19–0.45 m were observed in a single inspection target.

L denotes the continuous flow of water through gaps inside the check dam (Figure 9G). Stone check dams are composed of

FIGURE 9 | Various deterioration types observed on stone check dams: **(A)** grasses and shrubs infiltrating the dam crest, **(B)** exposure of internal concrete due to joint spalling, **(C)** falling out caused by impact of bedload transport, **(D)** and **(E)** erosion of abutment slope and foundation; **(F)** vertical subsidence due to internal concrete outflow; **(G)** clear leakage and horizontal displacement of downstream face; **(H)** damage to the dam body due to the hydraulic force of flooding.

heterogeneous materials, and they are structurally less watertight than their concrete counterparts. Sixteen instances of *L* were found in the 12 stone check dams, and of these, 12 instances of leakages were observed together with foundation erosion, and a section of the damaged area had been washed downstream. In the seven instances of *L* that were Grade C or above, the filling concrete had flowed out and the internal porosity had increased, compromising the structural stability of the dam. Three instances of *VD* and *HD* were found in two inspection targets, and they were accompanied by *L* and *IC*, regardless of direction. One instance of *B* damage was confirmed, where the dam could not withstand the hydraulic force of flooding, and more than 70% of the structure had been washed away (**Figure 9H**).
