# Deep-Seated Deformation Mechanisms of Excavated Slope and Control Methods: A Case Study

Wu Y, Zhang Q, Ding X, Wang H,  
Huang S and Yin X (2022) Deep-  
Seated Deformation Mechanisms of  
Excavated Slope and Control  
Methods: A Case Study.  
Front. Earth Sci. 10:858542.  
doi: 10.3389/feart.2022.858542

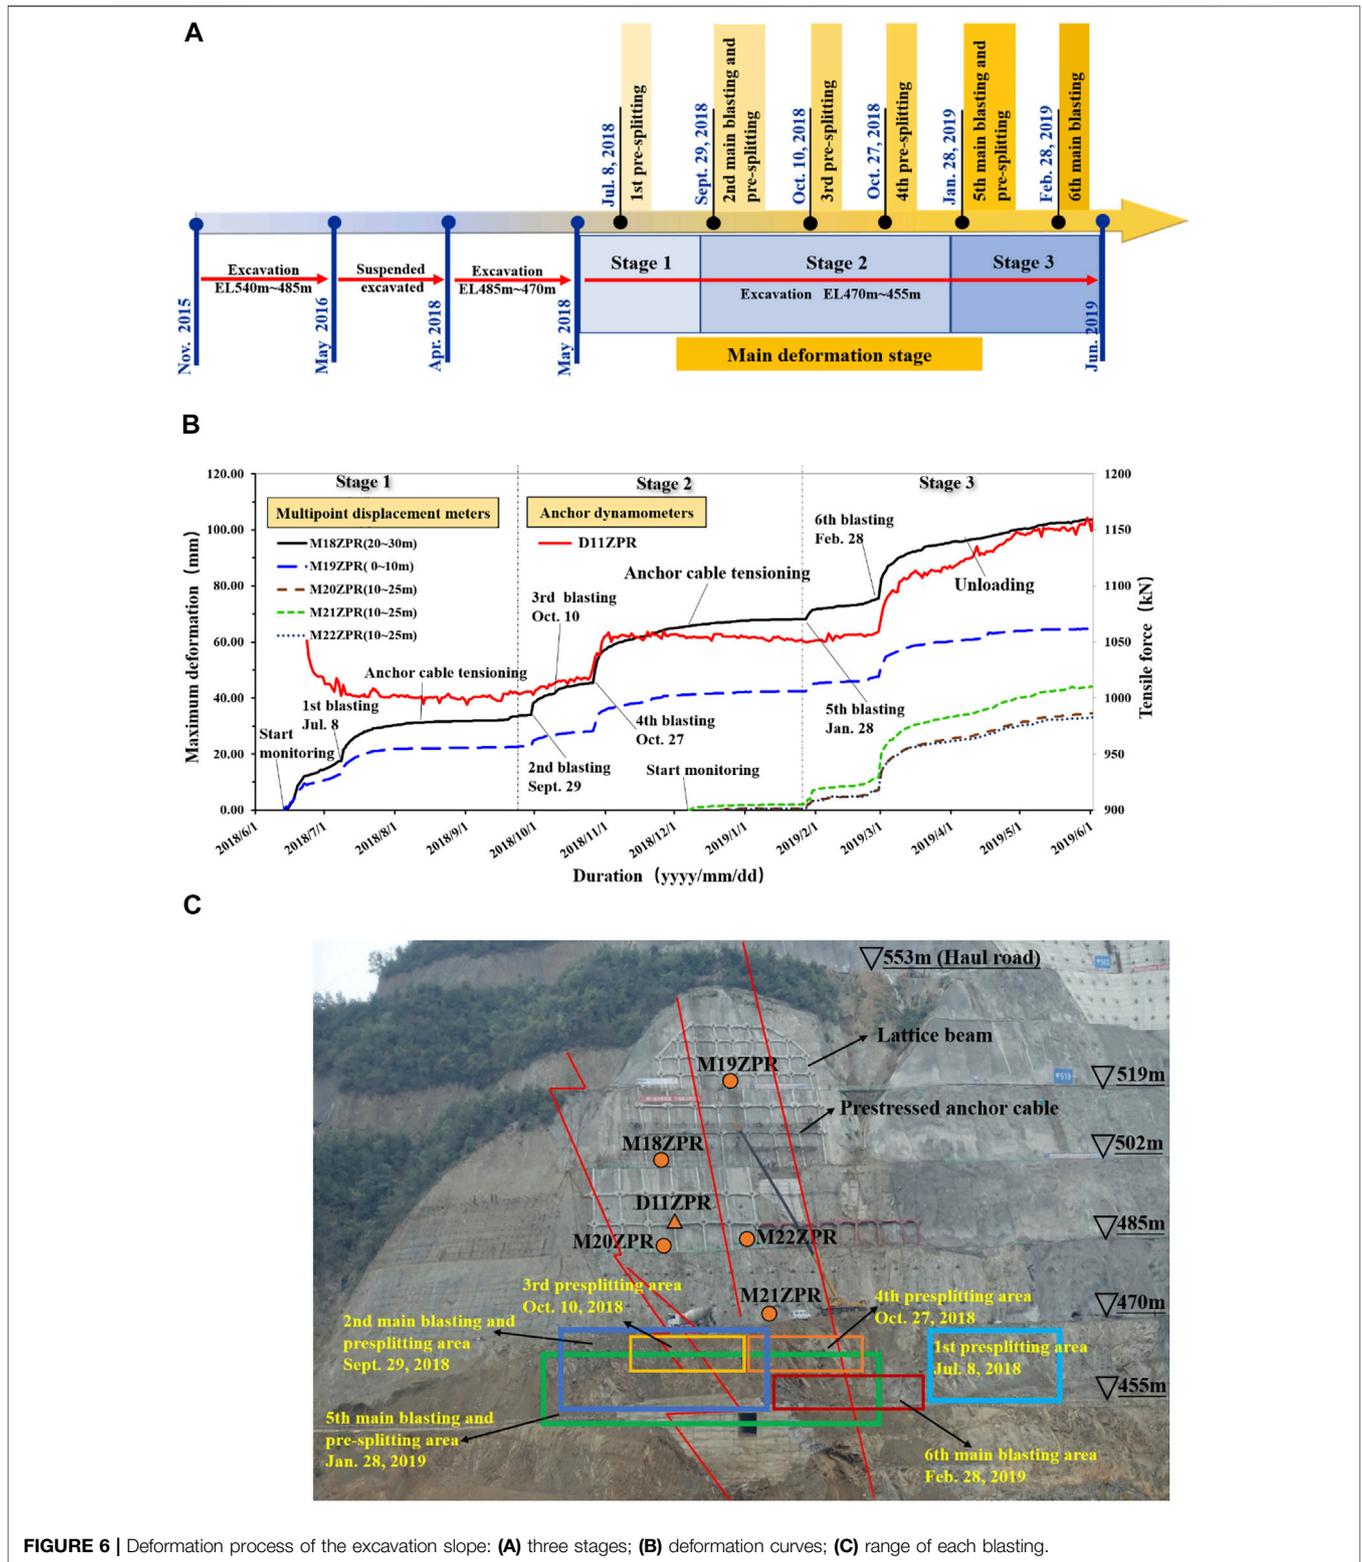
The main deformation process of the excavation slope was categorized into three stages (Figure 6A), and each stage included to the process of “excavation–deformation and damage–verification–reinforcement–deformation convergence.” Curves of the maximum deformation vs. time of multipoint displacement meters are shown in Figure 6B. The arrangement of the monitoring instruments, as well as the time and range of each blast, are shown in Figure 6C.

**FIGURE 6 |** Deformation process of the excavation slope: **(A)** three stages; **(B)** deformation curves; **(C)** range of each blasting.

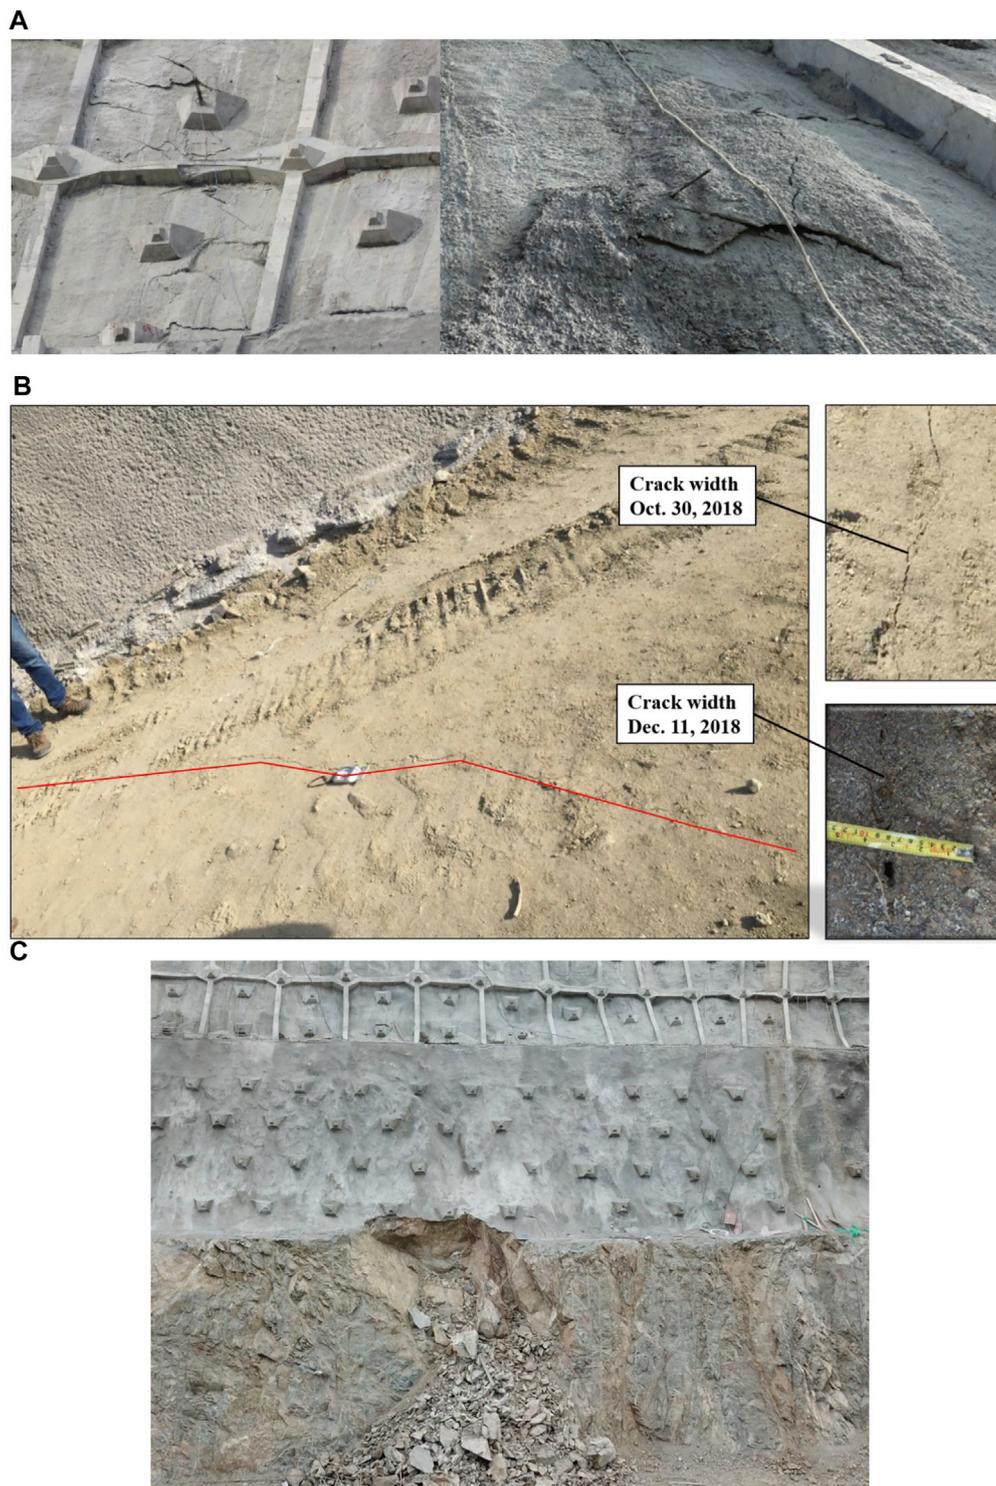
After excavation of the slope in the elevation range of 485–470 m, we found cracks on the inner side of the road at an elevation of 502 m, and three horizontal cracks appeared on the excavated face above an elevation of 519 m. On July 8, 2018, after the first presplitting blasting of the slope at the elevation range of 470–455 m, the shotcrete on the downstream side of the slope in the elevation range of 519–502 m showed a bulging phenomenon. In addition,

cracks also appeared in the anchor pier and lattice beam (Figure 7A).

**FIGURE 7** | Failure behaviors of the excavation slope: **(A)** stage 1; **(B)** stage 2; **(C)** stage 3.

On September 29, October 10, and October 27, 2018, the slope was excavated by blasting three times in the elevation range of 470–455 m. The measured values of M18ZPR and M19ZPR in each blasting also showed a step-like jump in growth with a large value. Obvious cracking occurred at the excavation face and along the rear edge of the slope (elevation 553 m), and the cracks tended to grow (**Figure 7B**).

From January 28 to February 28, 2019, the remaining part of the slope with an elevation range of 470–455 m was excavated by blasting. After blasting, one anchor pier cover at an elevation of 472 m appeared to be fractured, the transverse crack width of the slope with an elevation of 471 m increased significantly, and the shotcrete on the slope above an elevation 471 m showed a bulging phenomenon. On March 8, 2019, after rainfall, local collapse failure occurred along the slope below an elevation of 472 m and above fault fz39, with a volume of approximately 40 m<sup>3</sup> (**Figure 7C**).

like jump in growth. Then, the excavation was suspended, and additional support measures were considered to reinforce the slope. The reinforcing support measures featured the use of long prestressing cables that ran through the structural

Thereafter, the excavation was suspended again. Priority was given to the construction of prestressed cables. By the end of December 2018, the additional support measures (designed in the first stage) above 470 m were completed. The curves of deformation vs. time gradually converged again. By the end of January 2019, the deformation of the multipoint displacement meters M18ZPR (20–30 m) and M19ZPR (0–10 m) reached 51.9 and 30.83 mm, respectively. In addition, three sets of

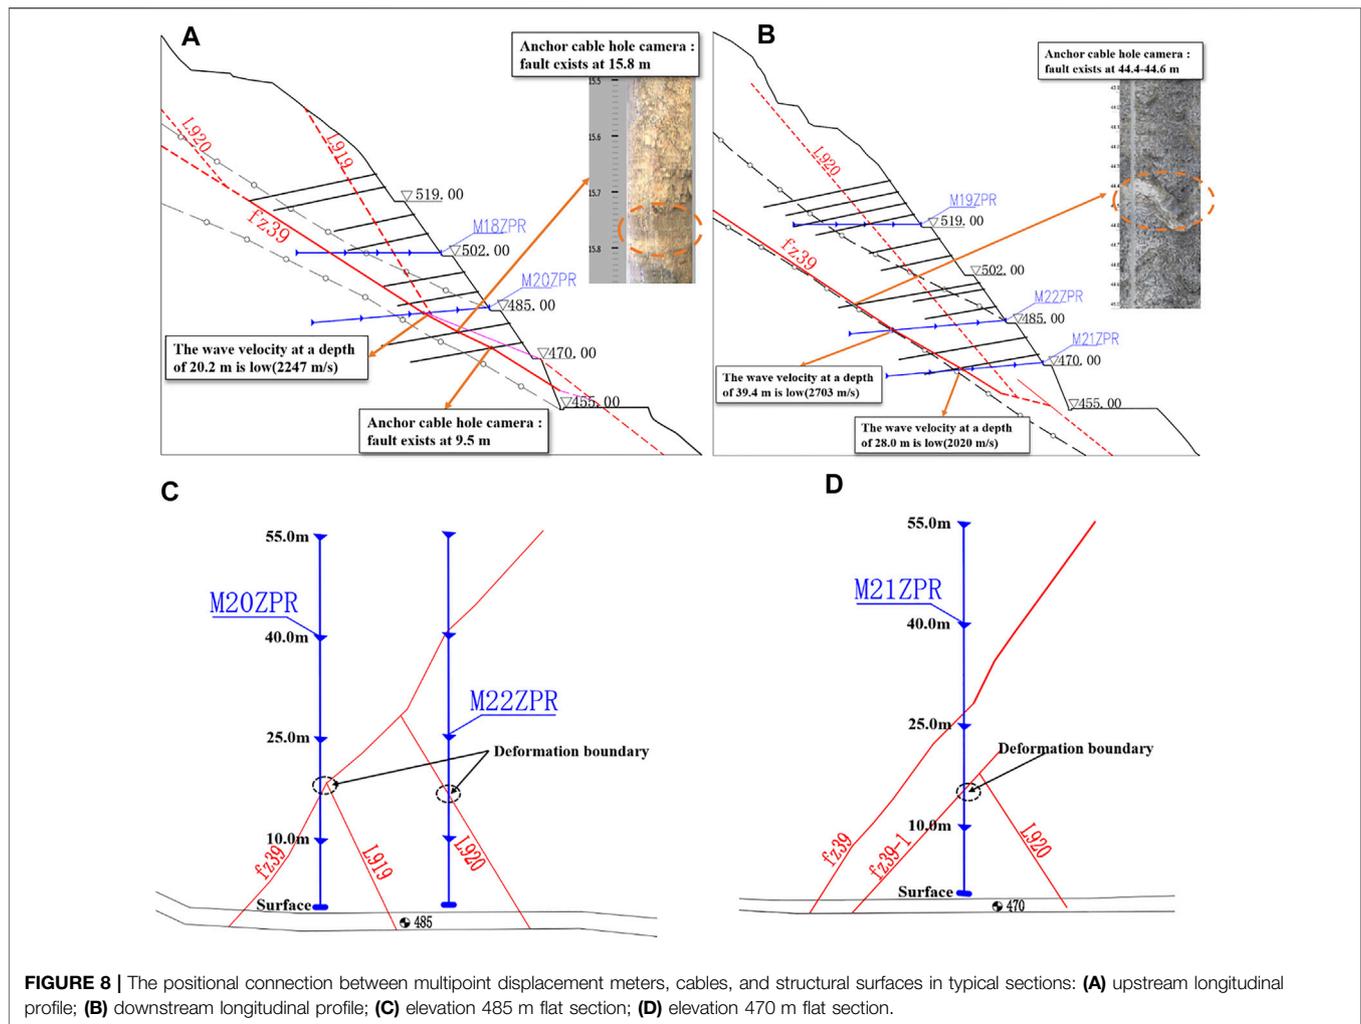
**FIGURE 8** | The positional connection between multipoint displacement meters, cables, and structural surfaces in typical sections: **(A)** upstream longitudinal profile; **(B)** downstream longitudinal profile; **(C)** elevation 485 m flat section; **(D)** elevation 470 m flat section.

The deep-seated deformation measured by the multipoint displacement meters occurred mainly in the hole-depth ranges of 20–30 m (M18ZPR), 0–10 m (M19ZPR), 10–25 m (M20ZPR), 10–25 m (M21ZPR), and 10–25 m (M22ZPR). These results were consistent with the inferred location of structural surfaces fz39 and L920 in the slope. This finding indicated that the deformation failure of the slope was controlled mainly by the structural surfaces fz39 and L920 and mainly occurred in the area within the intersection of structural surfaces fz39 and L920. The failure showed obvious block deformation behaviors, and the deformation of the structural surface accounted for a high proportion of the total deformation.

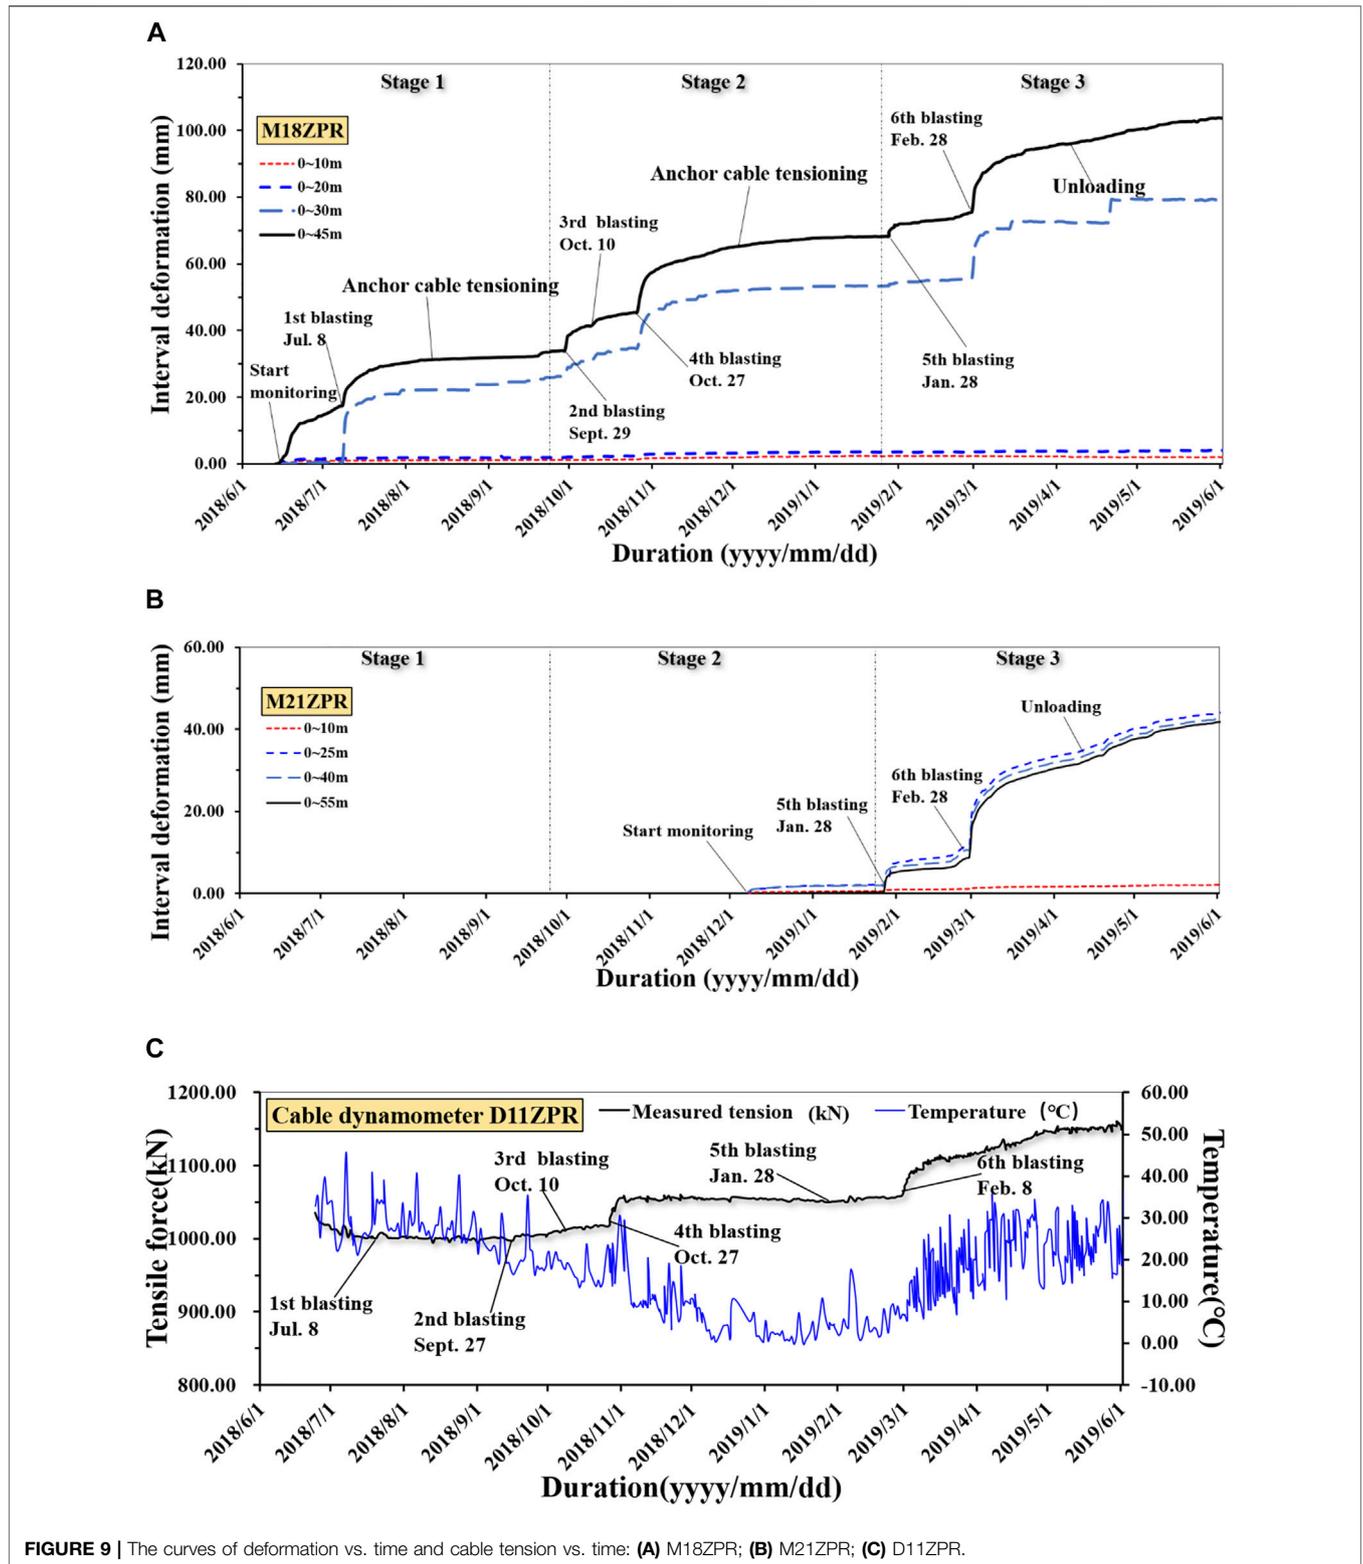
FIGURE 9 | The curves of deformation vs. time and cable tension vs. time: (A) M18ZPR; (B) M21ZPR; (C) D11ZPR.

The measured values of the multipoint displacement meters all showed step-like jump growth, and the jumping times were all related to the nearby blasting times. As of June 2019, the measured values were 104.84 mm (M18ZPR), 64.92 mm (M19ZPR), 36.57 mm (M20ZPR), 46.42 mm (M21ZPR), and 35.20 mm (M22ZPR). Although the overall deformation of the slope has not yet converged, the deformation rate has been decreasing gradually. Because M20ZPR, M21ZPR, and M22ZPR detected only the deformation caused by the partial excavation of the slope at the elevation range of 470–455 m, the total deformation was smaller than that measured by M18ZPR and M19ZPR, but the recent increments varied significantly.

The cable tension continued to change with the deformation of the slope. Since late October 2018, affected by blasting, the cable tension began to grow simultaneously along with the deformation. In particular, since the blasting on 28 February 2019, the cable tension growth significantly accelerated, and the measured jumping growth time and change law were consistent

with the deformation. As of June 2019, the measured value of D11ZPR in the lower part of the slope reached 114.3% of the cable locked value 1,000 kN.

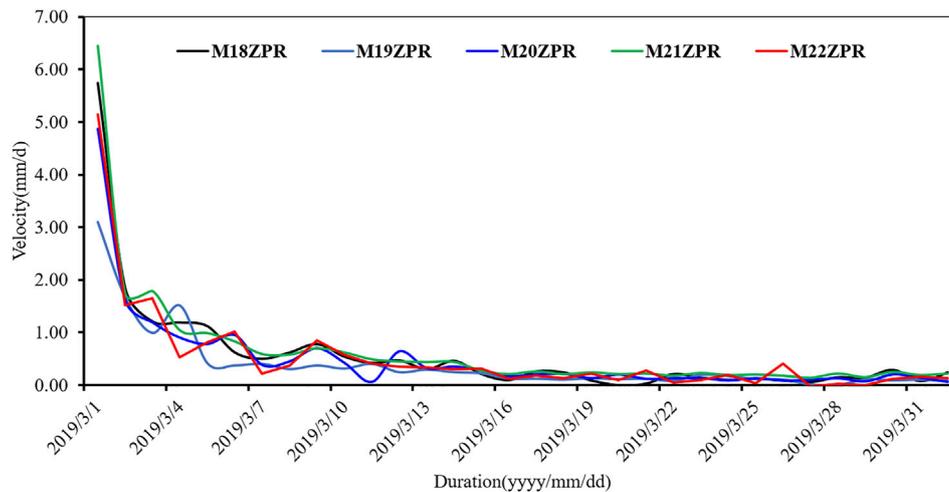
at the end of February 2019, the deformation rate was large in the first 3 days, and the maximum deformation rate of the orifice reached 5.74 mm/d (M18ZPR), 3.10 mm/d (M19ZPR), 4.87 mm/d (M20ZPR), 6.45 mm/d (M21ZPR), and 5.13 mm/d

**FIGURE 11** | Deformation rate after the sixth blasting.

(M22ZPR) (Figure 11). Then, the deformation rate gradually decreased. Certain fluctuations, however, did not fully converge, which indicated that the stress rebalancing adjustment time was long after blasting disturbances during slope excavation.
