Causes of Tunnel Diseases in a Karst Stratum and Remediation Measures: A Case Study

Shen Jiajia¹, Zhang Hu², Wan Li¹, Zhang Changan^{1*}, Shao Xing¹, Lin Zanquan² and Song Jie^{1*}

¹Shandong Provincial Communications Planning and Design Institute Group Co., Ltd., Jinan, China, ²School of Civil Engineering, Central South University, Changsha, China

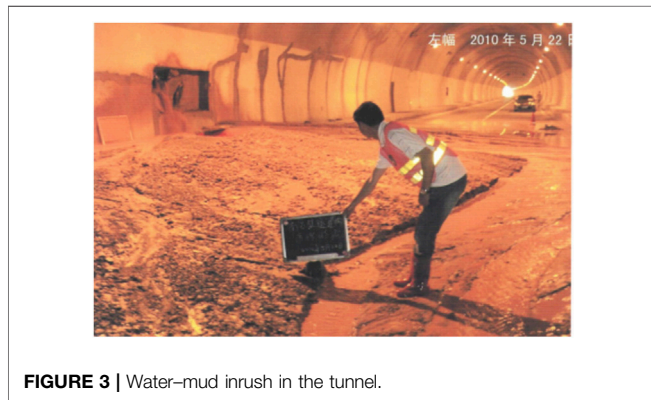
Structural diseases such as lining cracking, water leakage, and inverted arch uplift have occurred in the Nanshibi Tunnel since its opening in 2008. Even after treatment and maintenance, a large number of diseases occurred successively from 2010 to 2017, as shown in **Figures 3, 4**.

- (1) On 23 May 2008, local seepage was found during the acceptance of the main subgrade project of Nanshibi Tunnel. Very wide concrete cracks were seen in the interval ZK172 + 470 to +494, and the inverted arch was locally uplifted to 12 cm and accompanied by seepage containing limestone sediment and other substances.

- (2) Since 6 May 2010, this area received a large amount of rain continuously, and many karst collapses occurred on the surface. The secondary lining of the tunnel cracked, and the road surface was uplifted. Water gushing and mud inrush occurred at ZK172 + 464 to ZK172 + 520 and at ZK172 + 630 and YK172 + 627. Karst collapse and falling caves developed on the top of the cave.

- (5) Heavy rainfall occurred on the afternoon of 15 May 2015. Water and mud inrush occurred at the ZK172 + 520 section of the tunnel at noon on May 16, and sediment gushed from the cover plate of the left drainage ditch. The sediment covered the whole pavement, which was 26 m long and 8–10 cm thick with an area of about 200 m². The left maintenance road was tilted, and the maximum tilt height difference was 20 cm.

FIGURE 3 | Water-mud inrush in the tunnel.

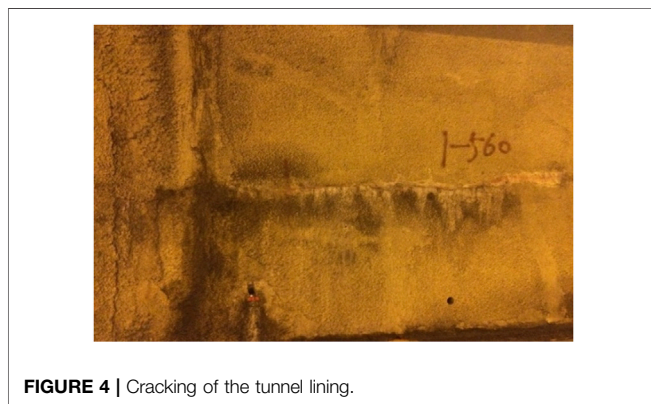
FIGURE 4 | Cracking of the tunnel lining.

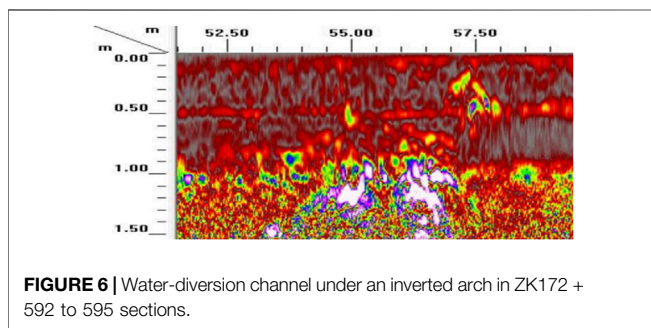
A comprehensive analysis of the geophysical prospecting results (e.g., the typical results shown in Figures 6, 7) reveals the following about the karst and water-diversion channel of Nanshibi Tunnel:

- (1) The surrounding rock of the ZK172 + 438 to ZK172 + 657 section of the left tunnel and YK172 + 345 to YK172 + 570 section of the right tunnel is relatively broken, with developed karst fissures. The local rock mass is broken and water-rich, and the karst caves are concentrated in this area. The spatial distribution of the fracture zone, tunnel sidewall, and vault-fractured area is generally irregular.

- (2) The areas with relatively concentrated karst development are located in the YK172 + 468 to YK172 + 536 and YK172 + 590 to YK172 + 657 sections. Several karsts intersect with the left and right lines of the tunnel and gradually develop from the left to the right line of the tunnel to the lower depth.

- (3) Analysis of the water content of the fracture zone showed that the water content of the tunnel floor is higher than that of the sidewall, and the water content of the floor of the right tunnel is higher than that of the left tunnel. The water-bearing area of the surrounding rocks of the floor is less than 4 m from the road surface.

FIGURE 6 | Water-diversion channel under an inverted arch in ZK172 + 592 to 595 sections.

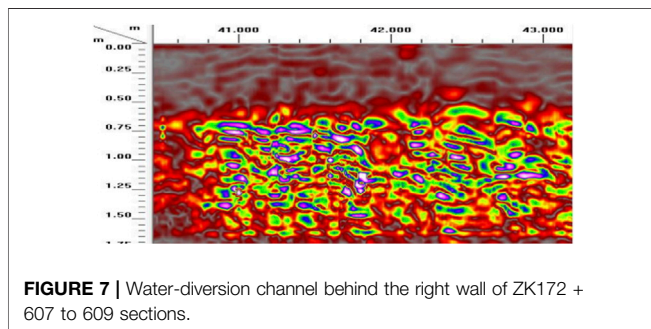
FIGURE 7 | Water-diversion channel behind the right wall of ZK172 + 607 to 609 sections.
