The Piping Failure Mechanism of a Loess Dam: The 2021 Dam Break of the Yang Village Reservoir in China

Keywords: loess, Yang village reservoir, piping failure, dam break, near-static liquefaction

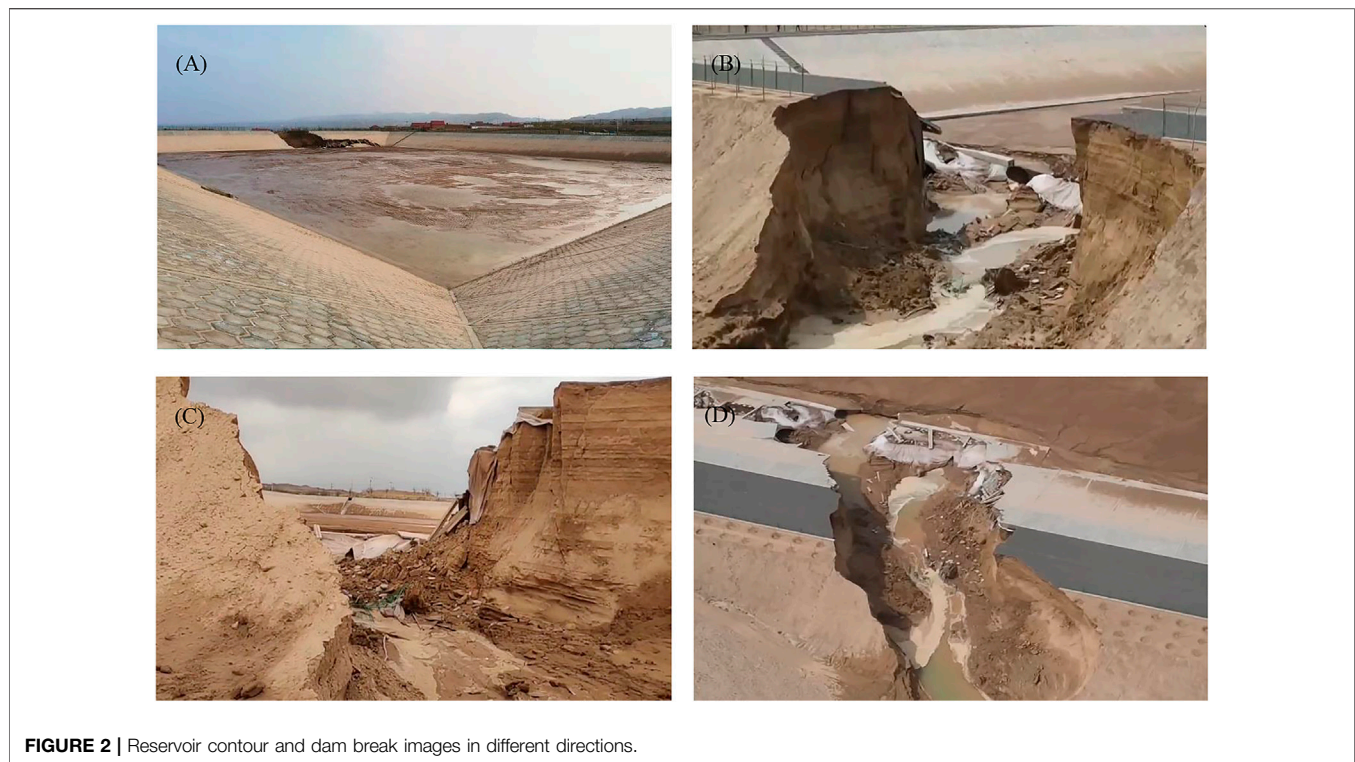
FIGURE 2 | Reservoir contour and dam break images in different directions.

Figure 2, **Figure 2A** shows the outline of the whole reservoir, and **Figures 2B–D** show the front, side, and top views of the dam break, respectively. The breach is on the south side of the dam

body, with a width of about 20 m. The sloped body on the south side of the dam body is shown in **Figure 3**, the slope length is 19 m, the inclination angle is 30 degrees, and the filling height of the dam body is 9.5 m. It can be seen from **Figures 2B,C** that the soil moisture content and layer thickness are well controlled during the construction of the dam bodies above the bottom of the breach. The damage of the dam body starts from the seepage at the bottom. It can be seen from **Figure 6** that the wave velocity at the bottom of the dam body is relatively small, corresponding to the same loess filling material, it can be considered that the compaction degree of the dam body bottom is relatively low. Therefore, under the action of the seepage force, the fine particles are gradually brought out of the dam body, and a piping channel is gradually formed at the bottom of the dam, which eventually leads to a complete dam failure. The dam breaks mainly caused nearly 0.67 km² of farmland to be flooded, but there were no casualties.

The reservoir is located in the hinterland of the Loess Plateau the west of Hongjian Mountain. The dam foundation is directly built on the thick loess stratum, which is the Q⁴ (according to the classification of stratigraphic age, the loess belongs to the sediments of Cenozoic, Quaternary, and Holocene) loess layer with a detectable depth of more than 10 m. The north and west of the reservoir depend on mountains, the south and east dams are filled with loess, and the location of the dam break is just in the dam filled in the south. As can be seen from **Figure 2C** that the

dam break started from the bottom of the dam, and there is no trace of water scouring in the middle and upper part of the dam body. The possible reason is that the compactness of the lower dam body is relatively low. After the geomembrane or geotextile blanket leakage, the water gradually infiltrates into the loess, forming a dominant channel of seepage in the dam body, resulting in the collapse of the whole dam body.

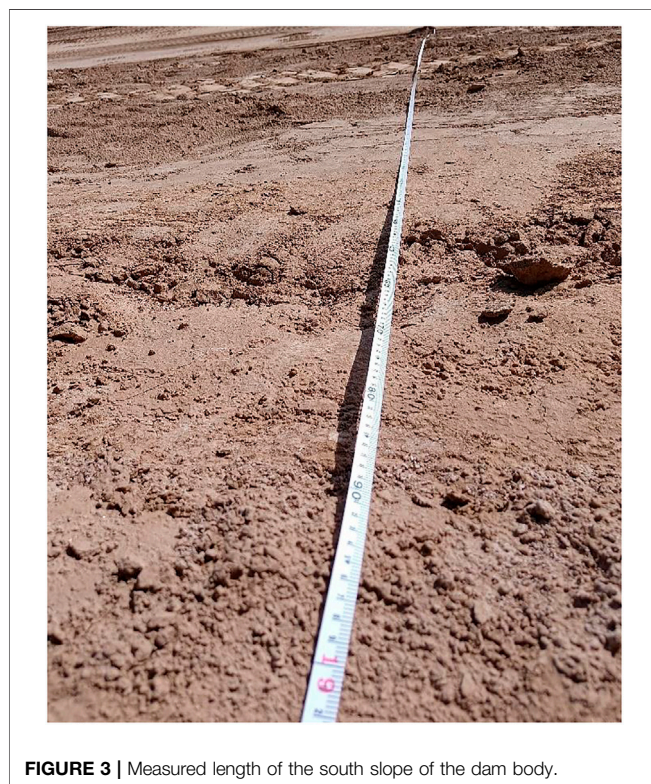
FIGURE 3 | Measured length of the south slope of the dam body.

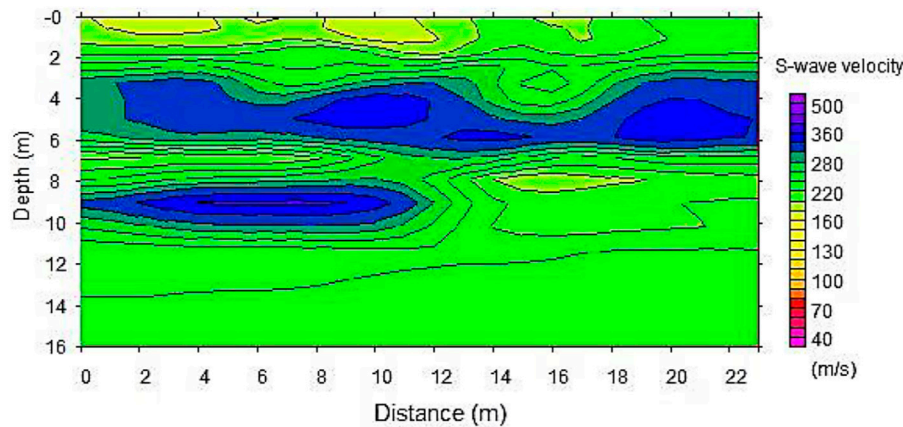
wave velocity, and the shear wave velocity of soil is an important index to evaluate the strength of rock and soil, which is common knowledge. Therefore, if we carry out continuous exploration with the transient Rayleigh wave method along the strike of the earth dam, we can draw the Rayleigh wave velocity profile of the dam body by using the dispersion curve to evaluate the quality of the earth dam. **Figure 6** shows the shear wave velocity distribution on a typical longitudinal profile of the dam body. From **Figure 6**, we can find that the soil density at the dam foundation is still relatively low. In general, there is a good statistical relationship between shear wave velocity and density, for example, the experiments showed that the relationship between shear wave speed and void ratio can be expressed as follows: $V_s = 69(2.973 - e)^{5.5} \rho_s^{-0.5}$, where V_s , e , and ρ_s represent shear wave speed, void ratio, and soil particle density, respectively (Wang et al., 2021b).

FIGURE 6 | Contour of spacing, depth, and wave velocity on longitudinal section.

- 1) The compactness of the dam bottom and the dam body should be checked layer by layer to ensure that the compactness is above 95%.
- 2) It is ensured that the dam bottom and body are free of unevenness, thorn particles, hard debris, etc.
- 3) The laying of HDPE should extend from the lowest part to the high position, do not pull too tight, to reduce the damage caused by the drag of the bentonite blanket on the foundation.

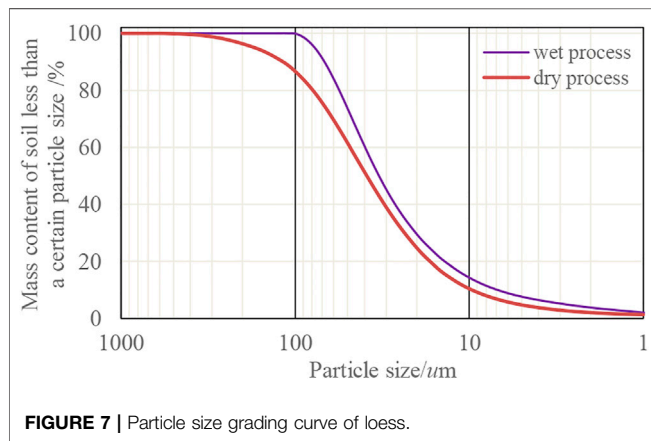
The particle size grading curve of dam filling loess is measured by the dry and wet methods, respectively. **Figure 7** shows the particle size grading curve of dam filling of the Yang village reservoir. It can be seen from **Figure 7** that the mass of particles with a particle size of 5~75 μm accounts for 88% of the total mass, and the plasticity index is less than 10. Therefore, the loess filling the dam body is typical silt. The non-uniformity coefficient $C_u = 5.9$ and curvature coefficient $C_c = 1.9$ of loess belong to well-graded soil, but the clay content (e.g., in silt, the part with particle size less than 0.005 mm is generally called clay.) is less than 10%. Although the gradation of loess is good, the particle size range is relatively narrow. Studies have found that liquefaction usually occurs when the clay content in silt (including loess) is less than 10% (Ministry of Housing and Urban-Rural Construction of PRC, 2016). There are also kinds of literature showing that saturated loess with a clay content of less than 12% or 15% has liquefaction behavior (Dong and Xia, 2016; He et al., 2020). The infiltration and liquefaction characteristics of loess provide favorable conditions for the occurrence of piping.

FIGURE 7 | Particle size grading curve of loess.

The coupled filter design method for loess is used in the Yang village dam, where the particle size distribution (PSD) of loess (Figure 7) is chosen as an example to verify the proposed method. The process of the proposed method is divided into two steps. First, the possible filter design band curves are designed using the Zhang et al. method (Figure 9). Second, determine the compaction and dispersive condition by choosing a possible filter in the design band curves (Figure 10). Figure 9, possible filter material chosen band intuitively displayed in Figure 9, we can choose one filter PSD for further compaction and dispersion verification. Finally, the chosen possible filter PSD in Figure 8 works well when its compaction exceeds 50% (relative density greater than 50%). Figure 10. The above-mentioned analysis shows that the proposed filter design method for loess can work

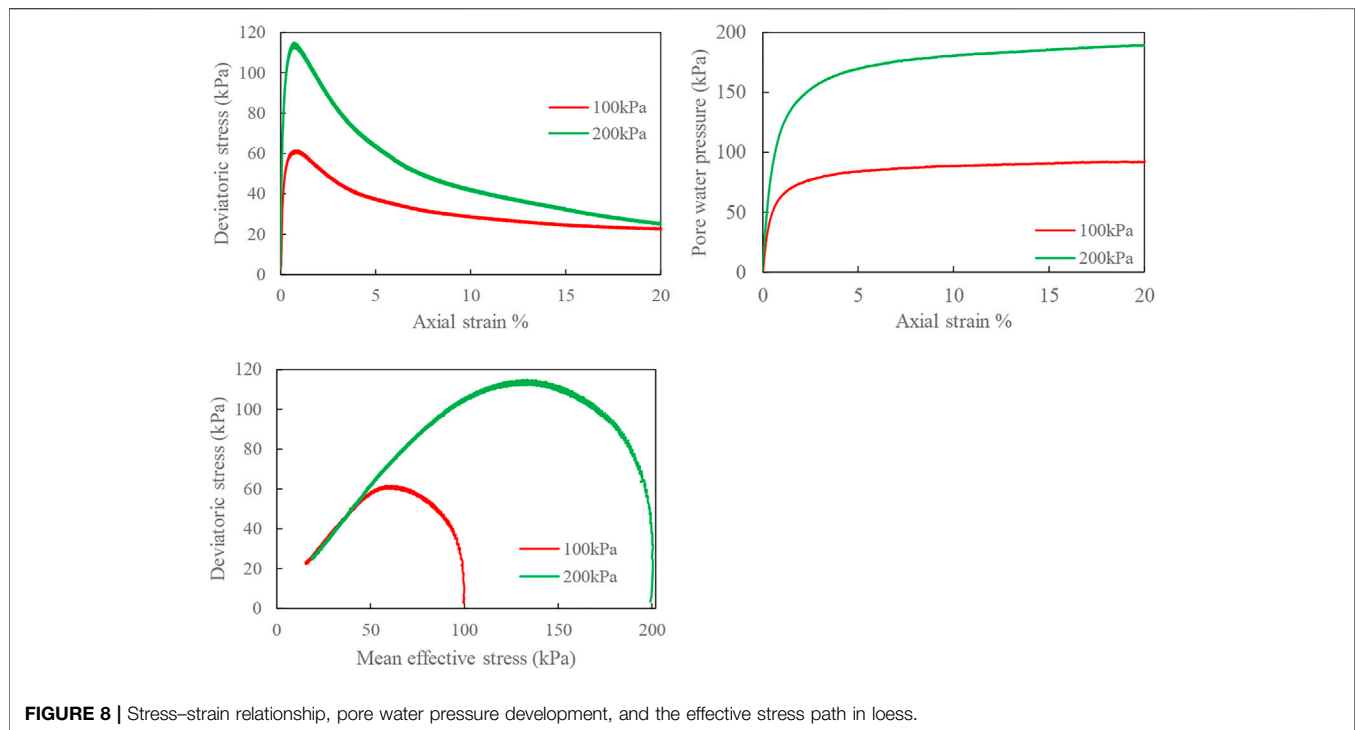
insufficient residual strength. The soil shows characteristics similar to fluid. **Figure 8A** is approximately consistent with the concept of static liquefaction; when the loess is saturated, the upper soil body has a loading effect on the lower soil body, and the lower saturated loess soon reaches its peak strength. When the excess pore water pressure does not increase and is almost equal to the confining pressure, the shear strength of the loess gradually decreases to the residual strength to achieve static liquefaction. These results are consistent with the Loess test results of sale mountain (Zhang et al., 2021d). Therefore, it is vital to evaluate the mechanical properties of the filled loess of the Yang village reservoir dam.

It can be seen from **Figure 8A** that the deviatoric stress peaks when the strain is minimal, and the corresponding peaks at 100 and 200 kPa are 61 and 114 kPa, respectively, and shear strength is relatively low. With the increase in the shear strain, the deviatoric stress decreases continuously from the peak value, and when the strain is significant, the deviatoric stress gradually tends to be around 25 kPa. According to the experiment, it can be seen that the residual strength of loess is deficient, showing the phenomenon of static liquefaction. The loess quickly breaks down undersaturation and deviatoric stress, further illustrating the anti-seepage arrangement's

importance. It can be seen from **Figure 8B** that the development of excess static pore water pressure develops very fast at minor strains, and the development of pore water pressure begins to slow down when the strain is 3%, and finally, develops to 92 and 189 kPa. The pore water pressure and the ratios of confining pressure reached 92 and 94.5%, respectively, which were almost equal to the confining pressure, and the effective stress was already very low. From **Figure 8C**, it can be found that the effective stress path of loess has been moving towards the stress origin along with the critical state line CSL after reaching the peak value, which also reflects the same static liquefaction trend as **Figure 8A**.

FIGURE 8 | Stress–strain relationship, pore water pressure development, and the effective stress path in loess.
