CITATION
Yang H, Xing B, He J, Jiang H and
Cheng Q (2022), The formation
mechanism and failure mode of a talus
slope induced by rockfalls in Nayong
County, Southwest China.
Front. Earth Sci. 10:973528.
doi: 10.3389/feart.2022.973528

The formation mechanism and failure mode of a talus slope induced by rockfalls in Nayong County, Southwest China

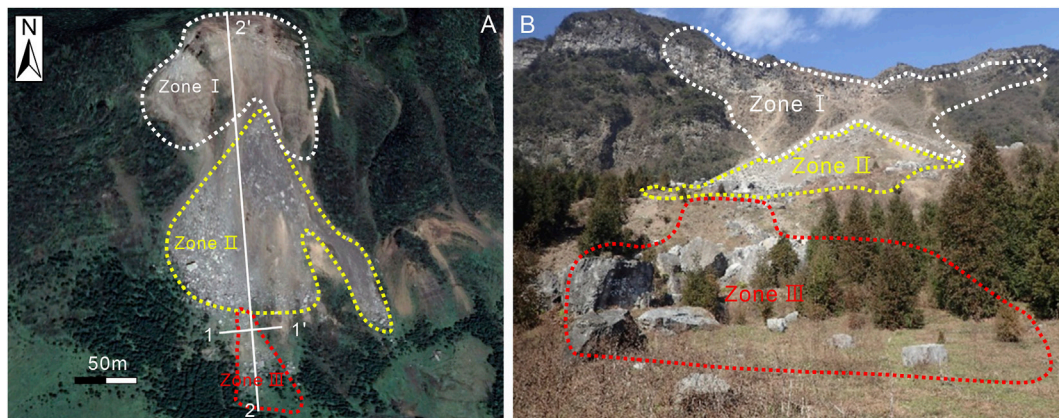
FIGURE 5
Overall features of the rockfall-dominated talus slope: (A) plane view (image source: Google Earth) and (B) front view.

The general morphology of this rockfall-dominated talus slope is fan-shaped in the plane. It is about 400 m long from north to south and 240 m wide from east to west. The orientation of the collapse direction is south-forward. Based on its morphology and material composition, this outcrop–talus system can be divided into the outcrop area (Zone I), talus slope (Zone II), and failure area (Zone III) (Figure 5).

Zone I is located at a cliff with a height of 50 m (Figure 5A). The bedrock at the lower cliff is gray–green, medium-thick siltstone interbedded with thin mudstone. The bedrock at the upper cliff is gray–green, medium-thick, fine sandstone interbedded with marl. The stratum inclines into the slope. The rock mass is cut into blocks of different sizes by joints.

Zone II is below the outcrop area. The height of the talus slope is about 120 m. The width of dispersion was about 180 m from west to east (Figure 5B). The slope angle is about 40° in the middle and upper parts. Gradually, the slope angle is reduced to 10° in the lower part. A platform is connected to the toe of the talus slope. The cone is mainly composed of gravel and residual soil with certain sorting properties. It presents fine debris at the top of the slope cone and boulders on the platform.

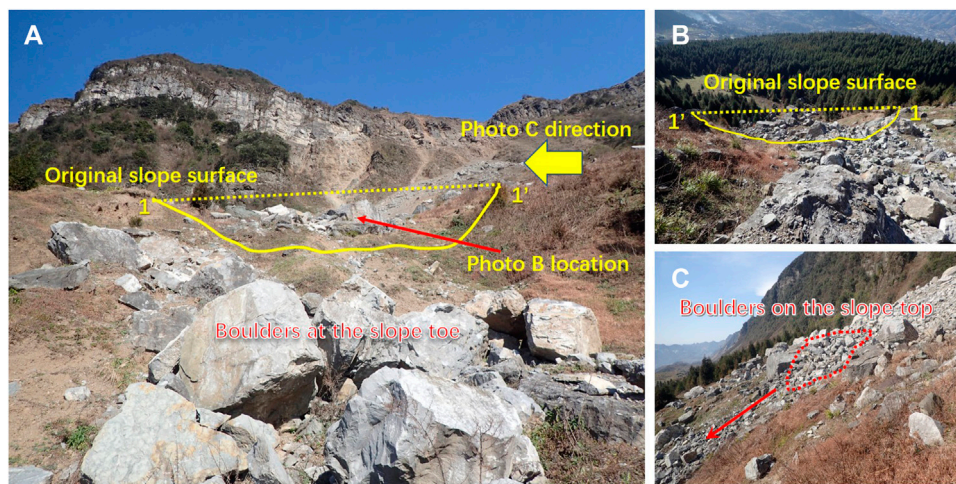
FIGURE 6

Detailed geomorphic features and boulder distribution of the failure area (Zone III). (A) overview of failure area, (B) boulders in the landslide trough, and (C) boulders on the slope top.

The failure area (Zone III) is below the platform of the talus slope (Figure 5) with a southern sliding direction. Figure 6 shows the detailed geomorphic features of the collapse area. The photo

in Figure 6A was taken at the slope toe. The dotted line area represents the original slope surface before slope failure. Then, there is a landslide trough with an average depth of 3 m after the slope failure. The width of the sliding body was about 15 m. The length of the sliding mass was about 100 m. The western boundary of the landslide shows a steep slope with a slope angle of 55° and a height of 2 m, while the eastern boundary presents a steep shape. A large volume of boulders can be seen deposited at the slope toe. In Figure 6B, taken from the slope top to the slope toe along the sliding direction, it is evident that boulders were distributed in the landslide. Figure 6C indicates the western orientation at the slope top, where there are a few large boulders (delineated by the red dotted line). Those missing large boulders are situated in the landslide trough and at the toe of the slope in Figure 6A.

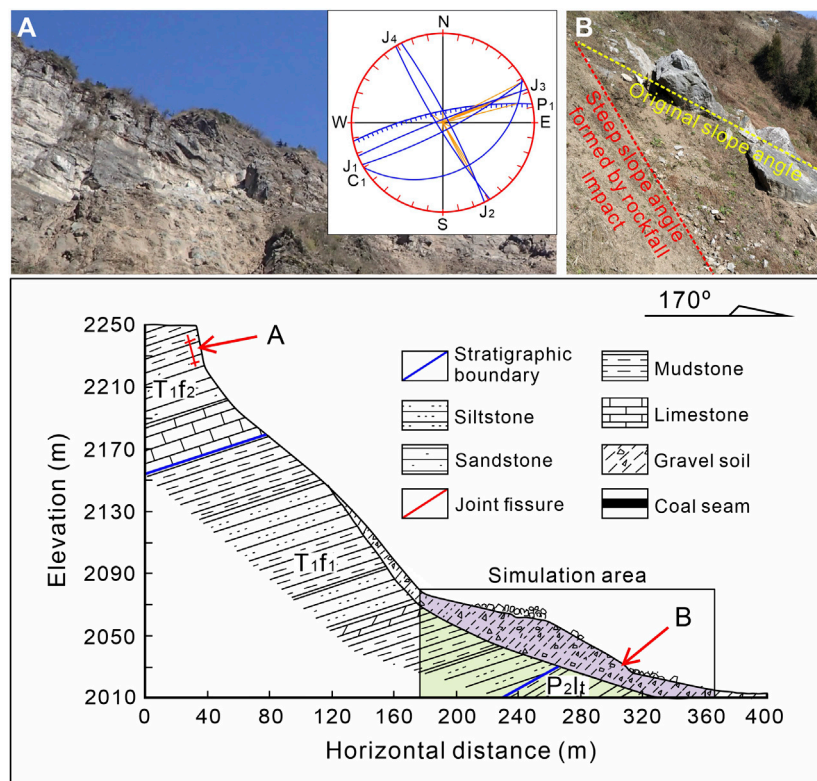
FIGURE 7 Profile section 2-2' of this rockfall-dominant talus slope. (A) source area and (B) slope toe cutting by rockfall impact.

Due to differential weathering, there is a cavity below the unstable rock mass in the source area (Figure 7A). The stereographic projection analysis of rock mass in the source area of collapse was carried out using the occurrence data (Table 1) of the rock strata and joints obtained from the investigation. The rock layer has been cut into blocks by J_1 , J_2 , J_3 , and J_4 joints. The intersecting lines of J_2 and P_1 and of J_4 and P_1 , which are the main controlling structural planes, tend toward the outside of the slope, and their inclination is less than the slope angle. The intersection lines of the other combinations tend toward the inside of the slope. Thus, although the rock mass in the source area is relatively fragmented, the whole rock mass is in a stable state, and only some boulders close to the slope are unstable. In extreme cases, such as earthquakes and torrential rain, fractures may expand the trend, and the dangerous rock mass may slide and collapse downward.

Differential weathering appeared on the outcrop (Figure 7A), and regional tectonics, such as the Baiyanjiao syncline and the Jijia anticline, controlled the development of joints and fissures on the slope. Due to the long-term geological action, cracks in the rock mass were gradually connected and enlarged to separate the slope surface rock mass from the bedrock. At the same time, weathering, dissolution, and surface water infiltration along the fissure also cause the fissure to expand further and gradually extend downward to form a complete fissure.

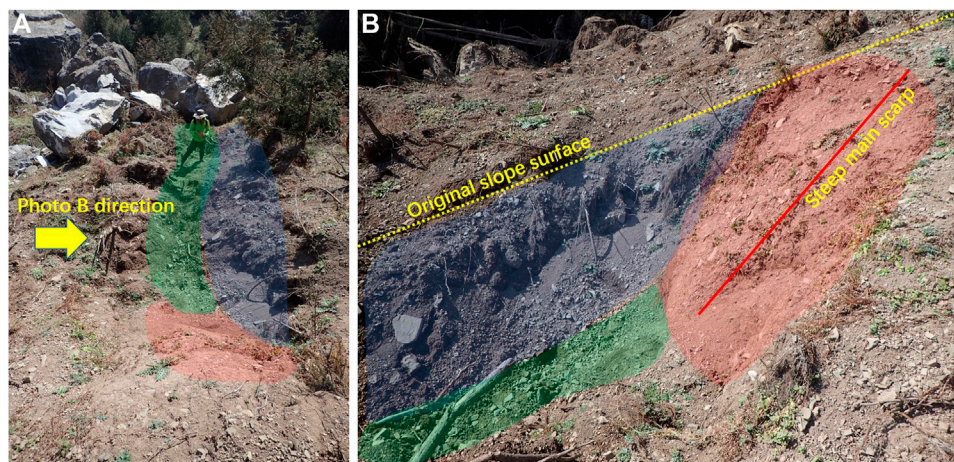
FIGURE 8
Slope toe cutting by rockfall impact: (A) view toward slope toe and (B) side view.

Figure 8 shows the ground traces located near the slope toe of the collapse area after the rockfall impact. The green zone indicates a long trench created by the boulder scraping action, the blue zone highlights the sidewall of the long trench, and the red zone shows a steep main scarp near the ground traces. It is evident that the geometry of the slope changed after the rockfall impact, so it may be concluded that frequent rockfall events induce toe cutting, which contributes to slope instability.

includes the contact, impact, and rebound stages. After the last stage, the rolling boulder remains as a trace on the slope and functions as a toe cutting (Figure 8). According to the numerical simulation analysis, toe cutting has a great influence on slope stability.

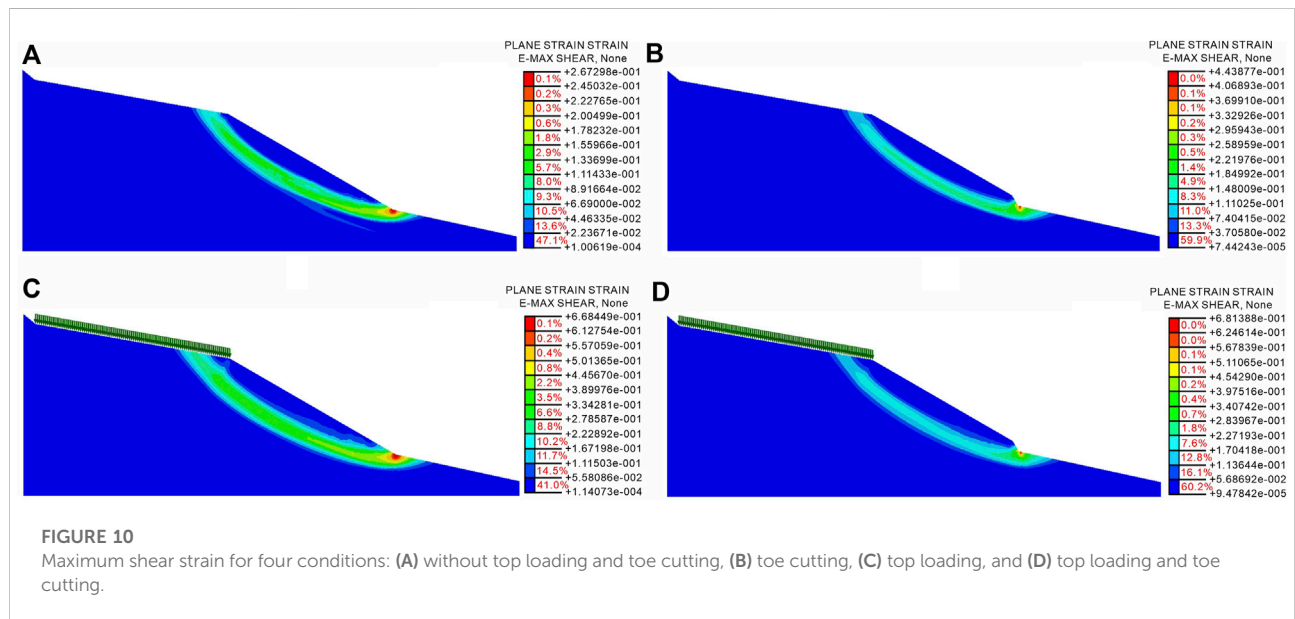
The numerical simulation results show that the maximum plastic deformation is concentrated at the toe of the slope for four simulation conditions (Figure 10). The safety factors of the slopes under conditions A, B, C, and D were 1.11, 1.06, 1.10, and 1.04, respectively. Theoretically, the slope is stable. However, in engineering practice, to make sure the slope has enough of a safety reserve, it is generally considered that the slope with a safety factor of $F_s = 1.1–1.5$ is stable. Therefore, the slopes in these four states are near the critical state of instability. The safety factor of the slope for the top loading condition was 0.01 smaller than that for the non-top loading and non-toe cutting conditions. The results indicate that boulders loading on the top of the slope has some influence on the stability of the slope, but that effect is not significant. The safety factor of slope for toe cutting condition

was 0.05 smaller than that for the non-top loading and non-toe cutting conditions. Here, the results indicate that the rockfall impact at the toe of the slope has a significant influence on the stability of the slope. The effect of toe cutting on slope stability was greater than that of top loading. The safety factor of the slope under the combined action of top loading and toe cutting was 0.07 smaller than for the non-top loading and non-toe cutting conditions. This result indicates that the slope becomes more unstable under the combined action of rockfalls.

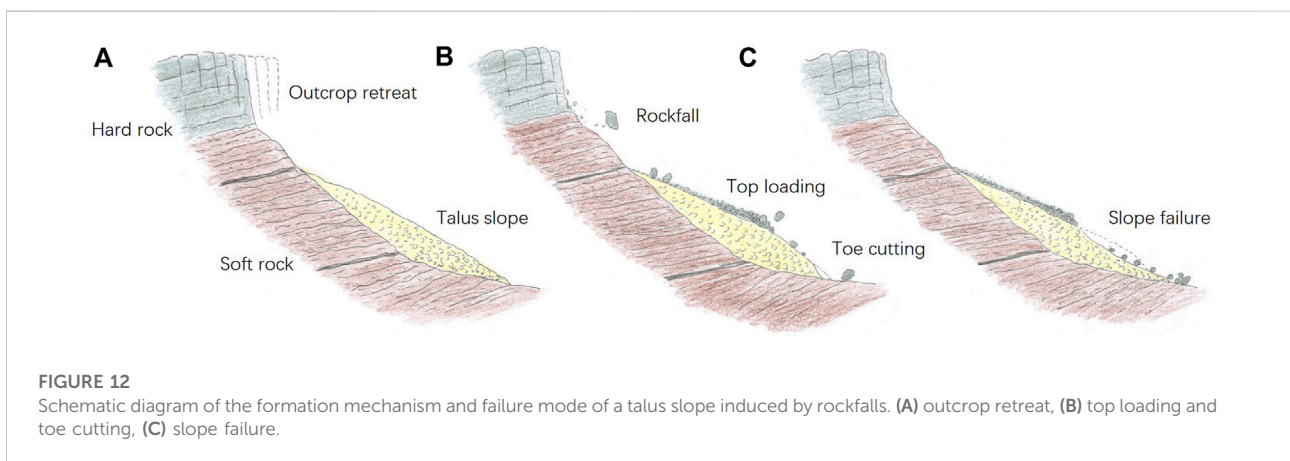
The failure mode of the talus slope induced by rockfalls at this study site is illustrated in Figure 12. The regional tectonic activities control the development of rock joints and fissures. The lithology—hard upper and soft lower at the outcrop—leads to differential weathering. External factors, such as goaf deformation and rainfall, aggravate the development of rock fissures. Frequently, the boulders detach, and these fragments cause the outcrop to retreat, along with the progressive development of talus deposits (Figure 12A). The boulders deposit on the platform in the middle section of the talus slope, which then serves as top loading for the slope mechanical system (Figure 12B). During the boulder-ground interaction of a rolling boulder with a high jump, the rockfall impact functions as a form of toe cutting to change the geometry of the talus slope. The mechanical balance of the slope changes at the same time, which causes a decrease in the antisliding force of the slope. Finally, on this talus slope, slope failure occurred due to the combined effect of top loading and toe cutting (Figure 12C). It is therefore evident that the prevention and mitigation efforts in this region should pay close attention to the role of rockfall impact in the geodisaster chain that affects talus slopes, while also considering the more commonly understood rockfall trajectory.

chain. Therefore, the prevention and mitigation efforts in this region should pay close attention to the role of rockfall impact in the specific geodisaster chains that affect talus slopes, while also considering the more commonly understood rockfall trajectory.
