Gureli Netto L, Singha K, Moreira CA, Gandolfo OCB and Albarelli DSNA (2023), Investigation of fractured rock beneath a uranium-tailing storage dam through UAV digital photogrammetry and seismic refraction tomography. *Front. Earth Sci.* 11:1281076. doi: 10.3389/feart.2023.1281076

# Investigation of fractured rock beneath a uranium-tailing storage dam through UAV digital photogrammetry and seismic refraction tomography

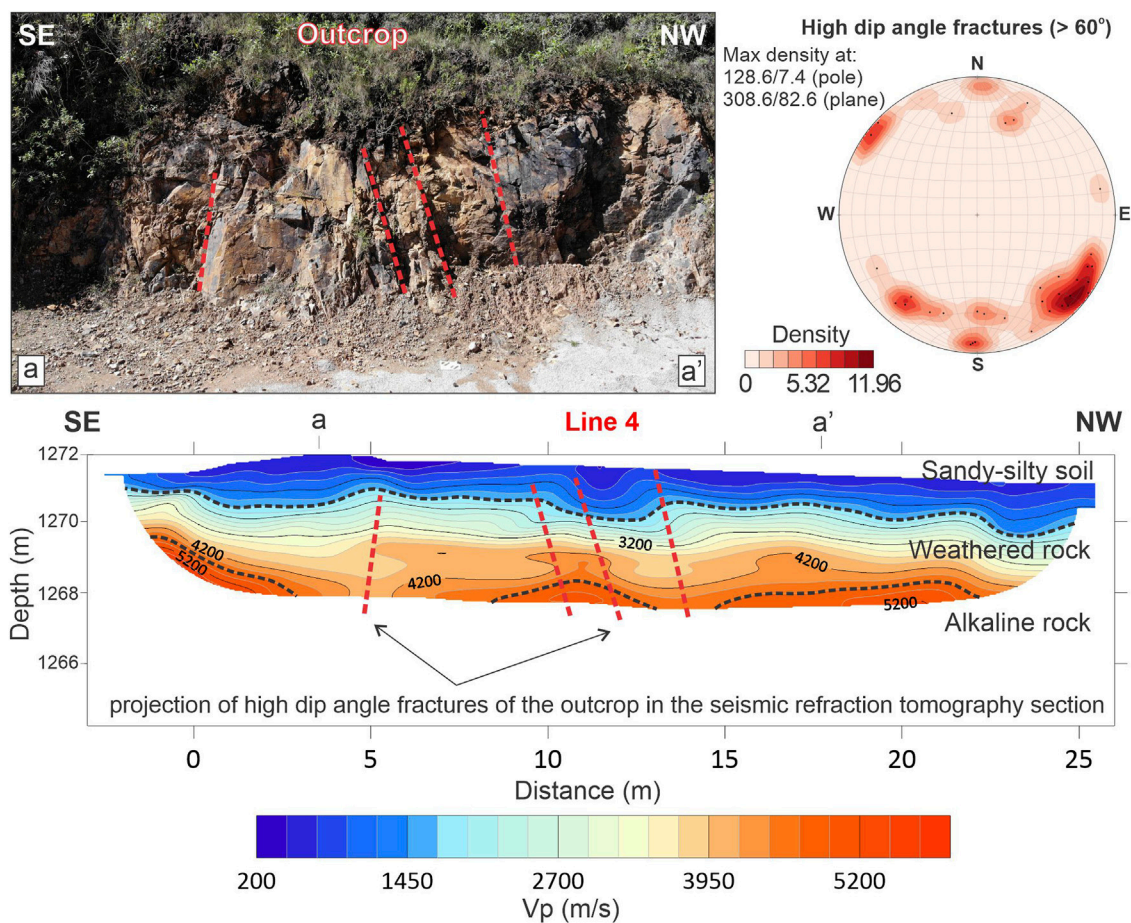
**FIGURE 6**  
Structural survey and seismic refraction in the outcrop of rock mass from Line 4. Fractures with high dip angle in the outcrop are traced in red.

The bedrock fracture strike measurements were fundamental to interpreting the seismic refraction tomography (SRT). The SRT performed on the outcrop near the foot of the dam shows three Vp layers (Figure 6). The most superficial layer, with Vp values up to

1,700 m/s, is consistent with the typical soil found in drillings carried out in the area (marked by the dashed black line in Figure 6). The soil layer is about a meter thick. Under the soil layer, higher values of Vp are observed that vary between 2,700 m/s and 5,400 m/s and are consistent with the values of rock masses (Capizzi and Martorana, 2014; Tomás et al., 2018). The historical geological mapping in the mining area (mine pit and pre-installation of the dam) indicated the presence of rock at 1,271 m. Different degrees of alteration were mapped in this mine pit area and resulted in different rock quality designations (Instituto de Pesquisas Tecnológicas – IPT, 1977; Fraenkel et al., 1985). The main factor related to the different degrees of alteration was the variations of the degrees of fracturing. Fracturing facilitates the flow of water in the rock and thus alteration and variation in the seismic velocity values. Results of the seismic refraction tomography showed variations of Vp values precisely at the depths associated with the presence of weathered rock (Figure 6).

The seismic results obtained in the outcrop area were compared with the visual fractures observed in the field. The position of fractures in outcrop matched vertical seismic anomalies in the SRT section (a-a'; Figure 6). The layer with Vp values of 3,950 m/s, interpreted as weathered rock in the study and supported by geological drillings carried out in the area, showed

an increase in thickness close to the position of the fractures (Figure 6). This result suggests that fractures may facilitate the percolation of water inside the rock, and that alteration of the rock by chemical weathering results in decreased seismic wave velocity values. In dams that store radioisotopes, as is the case of the present study, mapping fractures via seismic helps us to map preferential pathway and thus possible contamination. Although it is not

- (2) The seismic results obtained in the rock mass outcrop near the foot of the dam (Line 4) showed vertical, linear anomalies consistent with the positioning of the high dip-angle fracture family, although it was not sensitive variations from the family of low-angle fractures. However, in one of the lines made on the dam's berm (Line 1), the dip angle of the seismic stratum was consistent with the direction and angle of dip of the bedrock in the study region. The visualization of fracturing of the foundation rock mass may help in the identification of leaks. This information is crucial for decision-making in environmental monitoring and recovery projects.

possible to confirm the percolation of contaminants with geophysics alone, the identification of the different degrees of fracturing of the rock may help in siting groundwater monitoring wells where geochemical tests to explore leakage scenarios could be conducted.

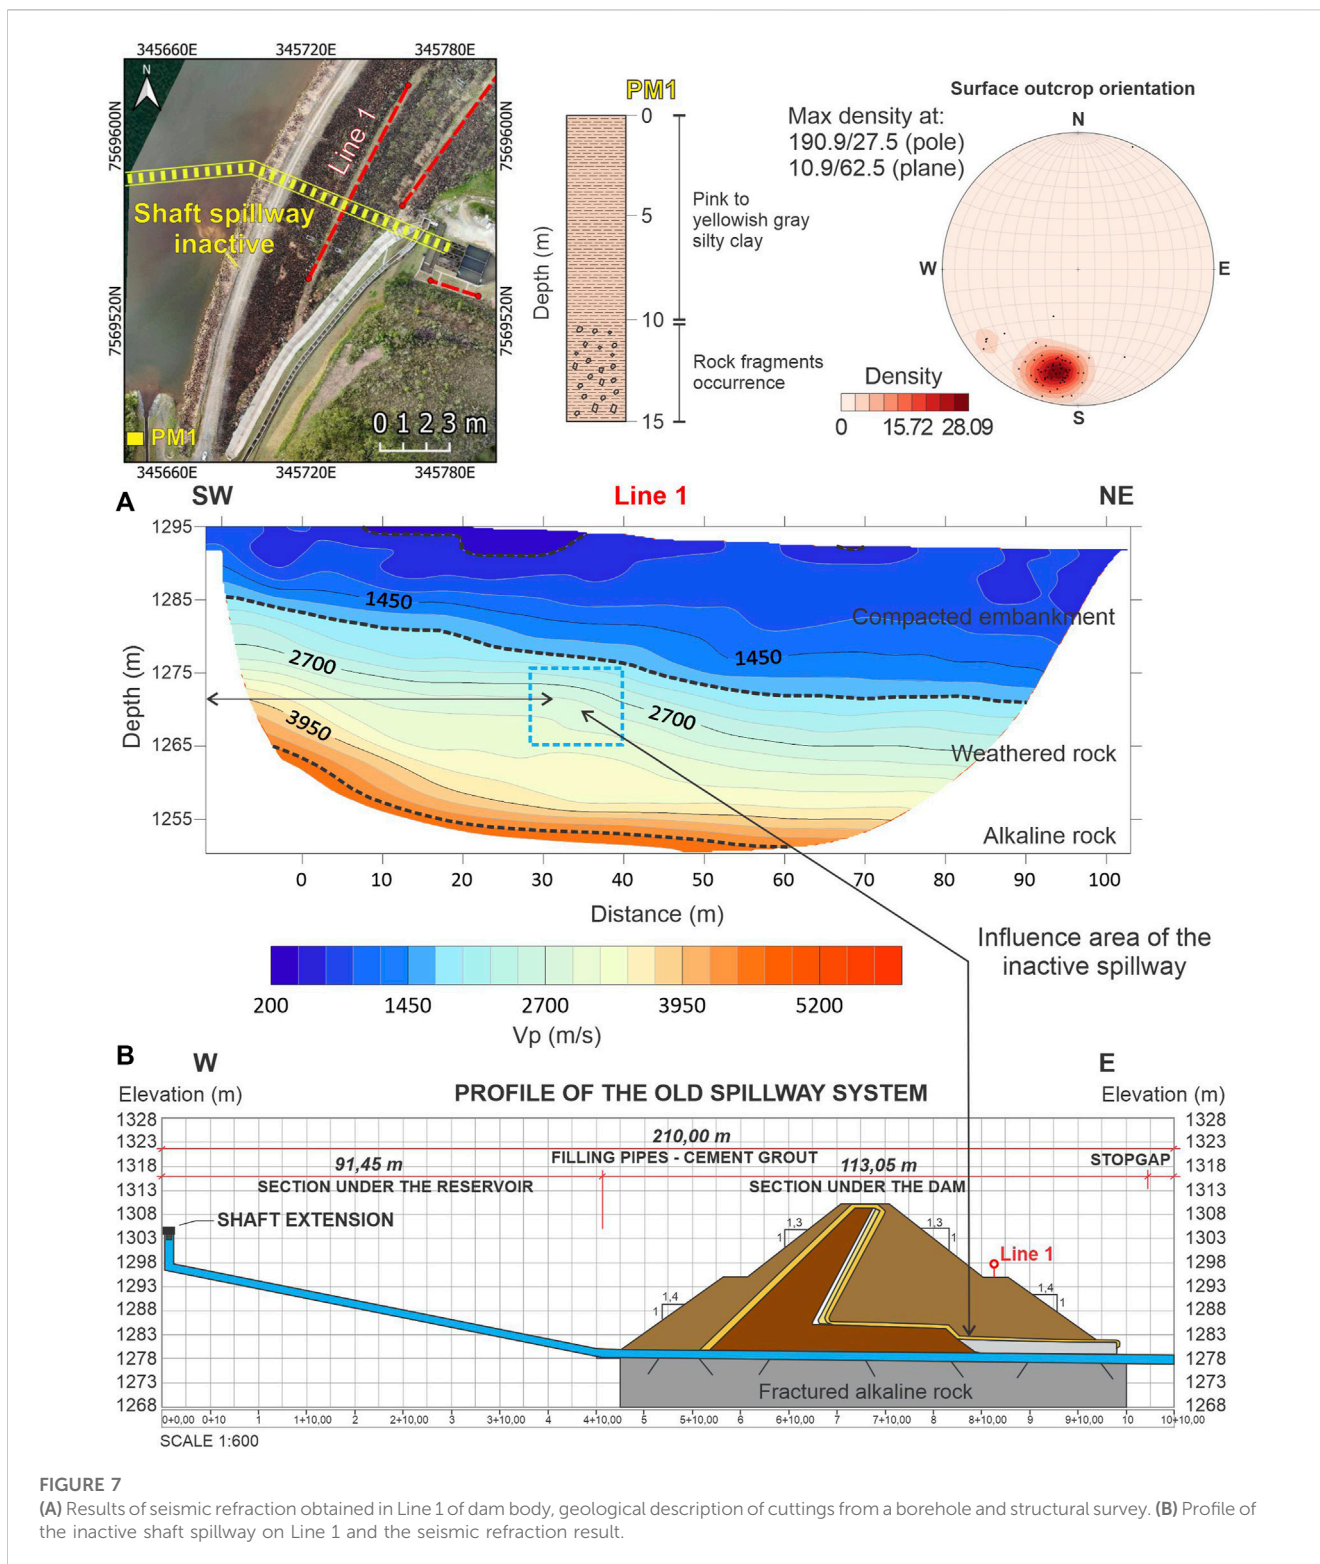
**FIGURE 7** (A) Results of seismic refraction obtained in Line 1 of dam body, geological description of cuttings from a borehole and structural survey. (B) Profile of the inactive shaft spillway on Line 1 and the seismic refraction result.

An anomalous response was identified in Line 1 between the distances of 30 m and 35 m in the seismic refraction tomography section (rectangle in blue in [Figure 7A](#)). The seismic layer at this location widened and curved. After the 40 m position in the seismic refraction tomography section, the strata returned to horizontal. Through the historical record of the operational and maintenance activities carried out on the dam, it was observed that at this point the old spillway, currently deactivated, crossed the section horizontally and in depth ([Figure 7B](#)). Identification of the presence and positioning of a hydraulic structure within the body or foundation of dams through non-invasive methodologies is desirable in dam maintenance studies. The deterioration process of internal structures, such as gates and valves, as well as the presence of erosion in the foundation, can compromise the stability of the dam. The lack of maintenance of the hydraulic structure can lead to leaks, infiltrations, and slides, triggering dam failure and jeopardizing adjacent communities and environmental resources. The hydraulic structure was filled with cement, so the elastic differences between the cement and rock were sufficient to cause variations in the seismic velocity. In civil engineering, soil and rock-concrete interfaces are generally considered potentially vulnerable zones. Deformation and failure can easily appear at these interfaces, progress under various loads, and induce engineering safety risks such as shear failure and risk of structure slippage ([Jiang et al., 2021](#)).

The seismic response related to the presence of the hydraulic structure at this depth showed that the acquisition was capable of identifying small changes in the composition of the material inside the dam associated with the elastic changes of the different materials. The section with the quantity of seismic rays in Line 1 exhibited an anomalous behavior similar to the behavior of Line 3 ([Supplementary Figure S8](#)), which will be presented next. In both cases, hydraulic elements (inactive spillway) and geological elements (boulders) were identified at these depths and influenced the behavior of seismic waves in the medium. This behavior was not observed in the results of Line 2, for example, which did not show

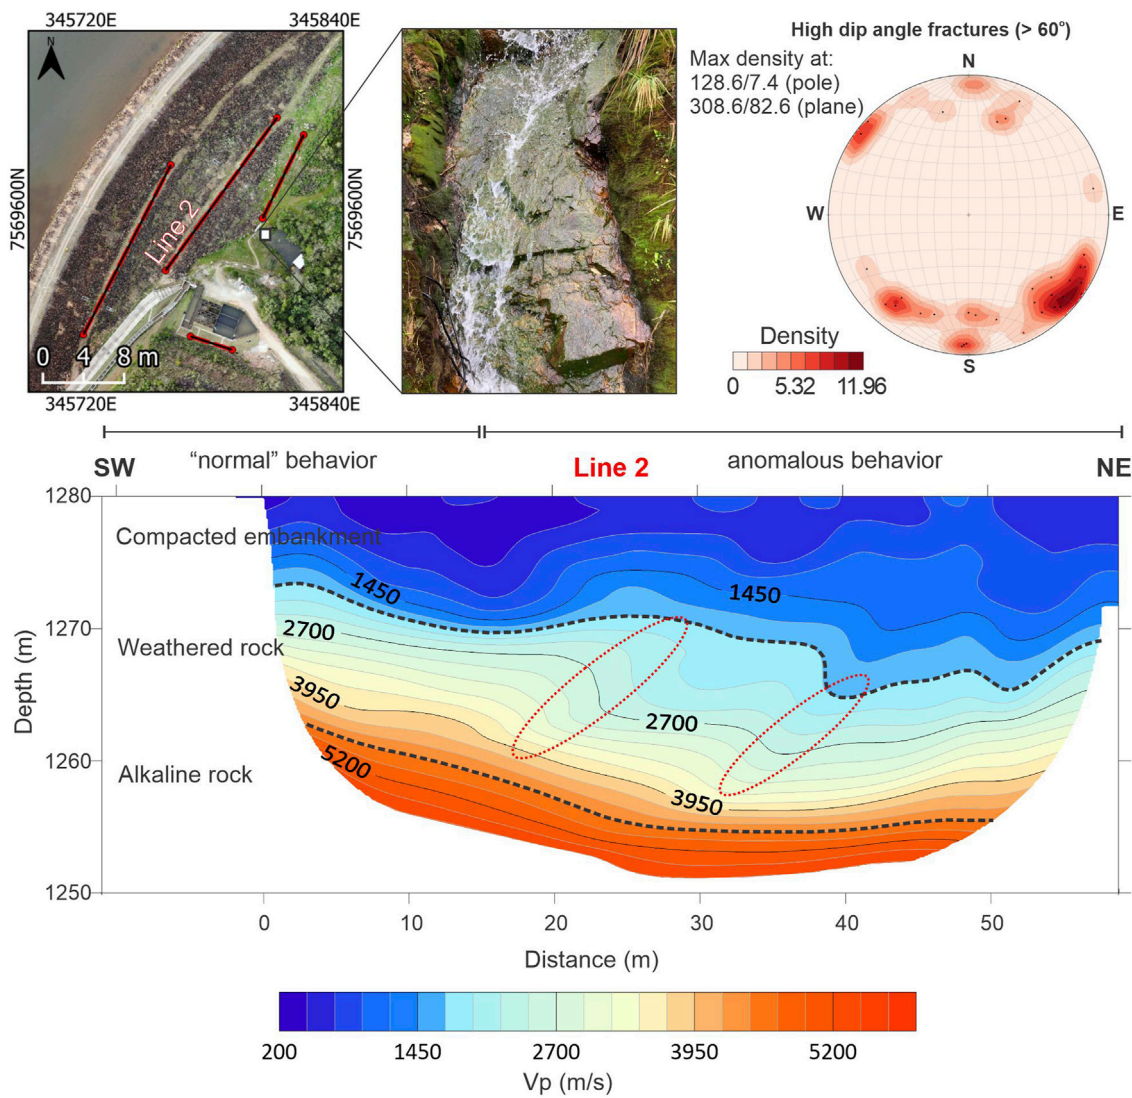
Line 2, carried out on the lowest berm (2<sup>a</sup> berm; [Figure 1A](#)) and close to the rock mass, also showed results consistent with the typical section of the dam ([Figure 8](#)). Between the distances of 0-15 m, the SRT section shows a horizontal seismic layer with no large variations in the  $V_p$  values and values consistent with weathered rock. At distances of 20 m and 35 m, according to the section of the dam, a 4-m thick saturated-sand filter was installed to release water at a depth of 9 m. This horizontal structure is composed of sand and observed in the SRT. Seismic strata with  $V_p$  values close to 1,450 m/s and 1,700 m/s showed increased thickness at this depth ([Figure 8](#)).

It was not possible to state that the observed seismic anomalies are related only to the presence of the saturated filter or physical changes in the material of the contact zone between the dam body and the rock foundation, such as compaction deficiencies. The vertical seismic anomalies observed in line 2 did not have the same pattern as the anomalies interpreted in the seismic refraction tomography section of the outcrop. The seismic response with values greater than 5,200 m/s from the elevation of 1,260 m, interpreted as alkaline rock, did not show vertical anomalies as were seen in the results observed in the seismic tests of the outcrop. Regardless, the identification of altered areas in the contact between the body and the foundation of the dam that may compromise the physical integrity of the structure are important in monitoring of the dam at this interface (compacted soil and rock foundation), which is important for the stability of the structure.

**FIGURE 8**  
 Results obtained in Line 2 of the dam body with anomalous behavior highlighted in red.

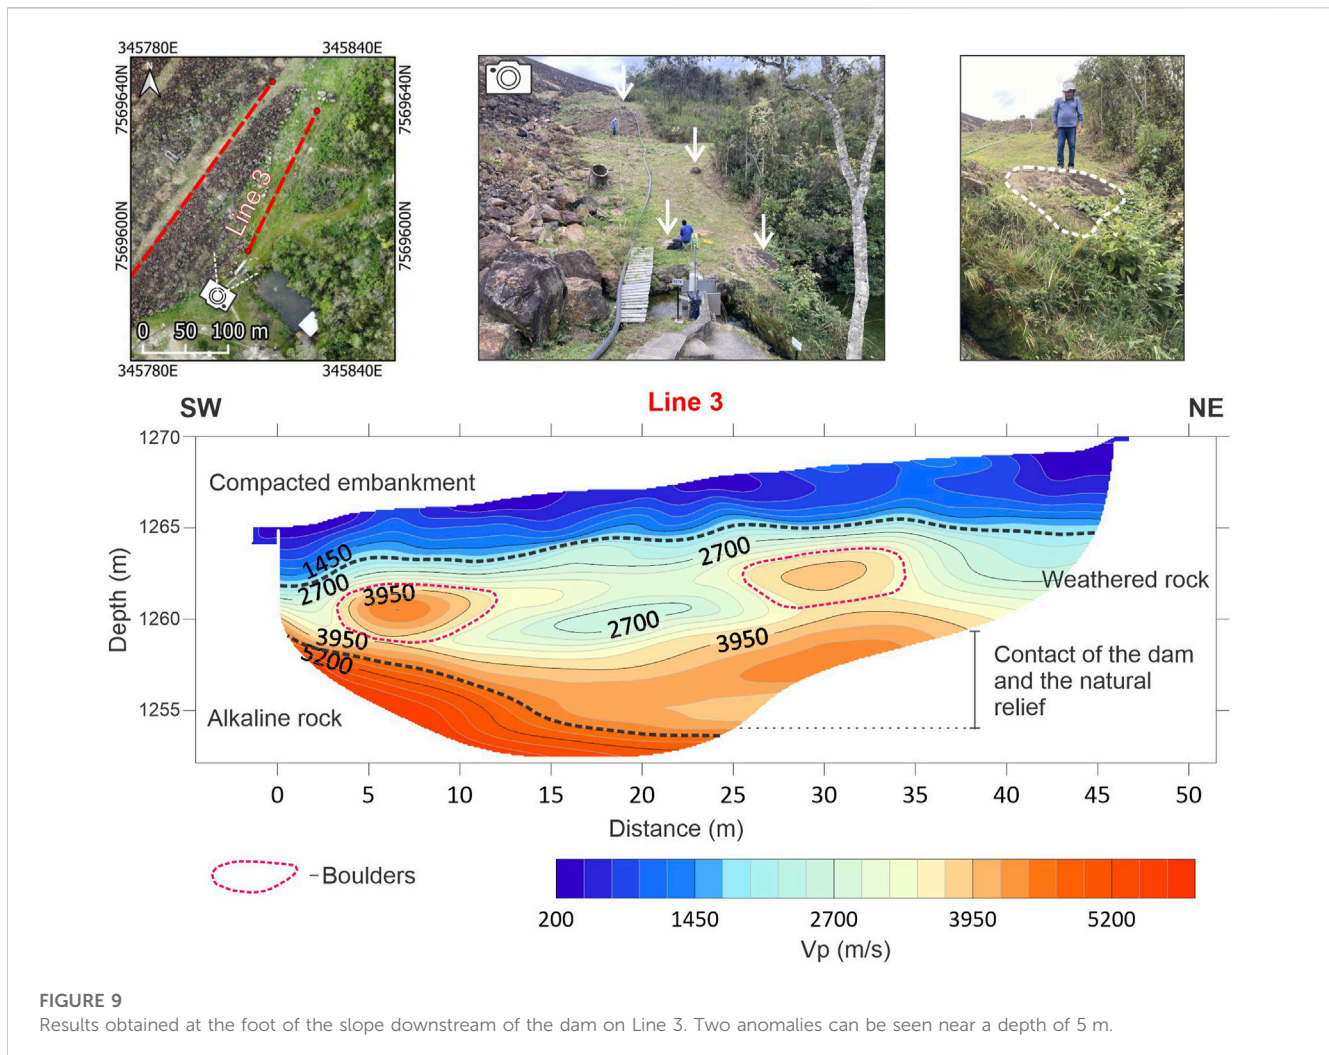
The acquisition line located at the foot of the downstream slope (Line 3; [Figure 1A](#)) was carried out in an area with a thin layer of soil. Among all the acquisition lines performed, Line 3 is the closest to the alkaline rock. During data acquisition, the presence of rock blocks of different dimensions between the foot of the dam and the natural relief (left abutment) was observed (white arrows in [Figure 9](#)), and these rock blocks were identified in the SRT near an elevation of 1,260 m with  $V_p$  values between 3,250 m/s and 3,950 m/s ([Figure 9](#)).

The presence of rock blocks near the rock mass of the dam foundation is not desirable in dam engineering projects; they are considered defective materials in the rock massif. In the present study, the rock blocks are arranged between the compacted soil layer and weathered rock, and may influence the compaction of the material and act as a facilitating agent in the development of preferential water flow paths. The layer with Vp values of 3,950 m/s, consistent with weathered rock, showed an increase in thickness in the contact of the dam and the natural relief (Figure 9), which might suggest possible saturation, water flow, or material alteration.
