Jenkins SF, McSporran A, Wilson TM,
Stewart C, Leonard G, Cevuard S and
Garaebiti E (2024) Tephra fall impacts to
buildings: the 2017–2018 Manaro Voui
eruption, Vanuatu.

Tephra fall impacts to buildings: the 2017–2018 Manaro Voui eruption, Vanuatu

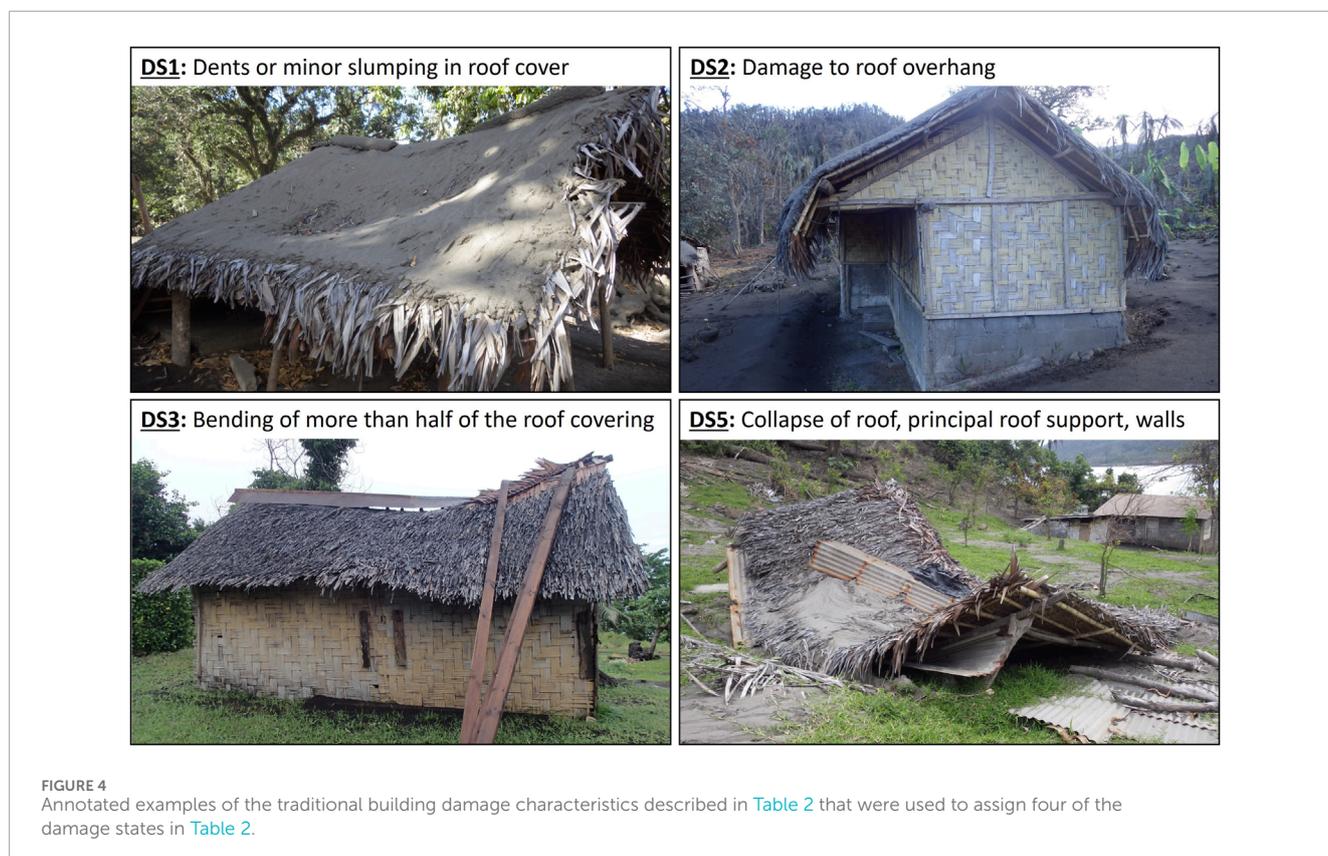
Tephra fall damage, or lack of damage, visible from field observations and photographs was recorded and a damage state allocated for each building (Table 2; Figure 4). Each building was assigned a binned tephra fall thickness based upon the isopachs developed for the March/April and July 2018 tephra fall phases (Figure 3). Photographs from the first field visit, undertaken between 9 and 34 days after the damaging tephra falls of the March/April phase, showed that many building roofs across the island had already been, or were in the process of, being cleared of tephra. We have therefore assumed that any tephra that accumulated on a roof during the March/April 2018 tephra falls was removed (by people, wind and/or rain) before the July 2018 tephra falls. Thus, building damage was associated with a tephra fall thickness from *either* the March/April or the July falls, rather than an accumulation of the two or only the July 2018 falls. This has the effect of being conservative, in that the individual phase, rather than cumulated multi-phase, tephra thickness is recorded.

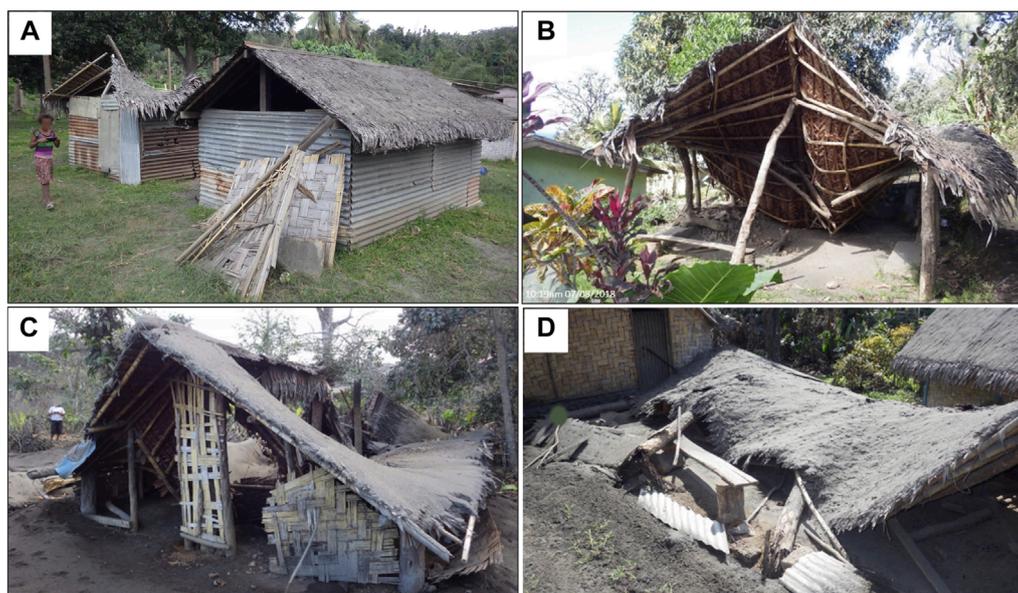
FIGURE 9

For hybrid and non-traditional buildings with corrugated sheet metal roofs (X2, X2, Nt, Nb, Nc), the level of damage sustained differed according to the condition and likely age of the roof and roof support. Figure 9A shows a hybrid building of non-traditional walls with traditional roof (X1); the building on the left has sustained collapse of the primary apex roof beam, while the building on the right remains intact. Both buildings were constructed at the same time and subjected to the same tephra thickness (~47 mm), with the only difference being that the collapsed building was constructed with a bamboo apex roof beam and the intact building with squared

1. Failure of the vertical load-bearing props supporting the edge or apex line of the roof (Figure 9B);
2. Failure of the primary horizontal apex roof beam (purlin: Figure 9C);
3. Detachment or failure of the principal rafters (running downslope from the primary apex roof beam: Figure 9D).

(A) Two hybrid buildings subjected to ~47 mm tephra fall show full (left) and no (right) roof collapse as a result of different materials used for the primary apex roof beam; and complete collapse of traditional (Ts) buildings, where (B) the vertical load-bearing props (tree trunks) have snapped at their base (tephra thickness ~55 mm); (C) the primary apex roof beam has broken but the vertical load-bearing props remain intact (tephra thickness ~53 mm); (D) where the vertical load-bearing props and apex beam remain intact (in the front section of the building), but the principal rafters are detached and damaged (tephra thickness ~134 mm). All photos: S.F. Jenkins.

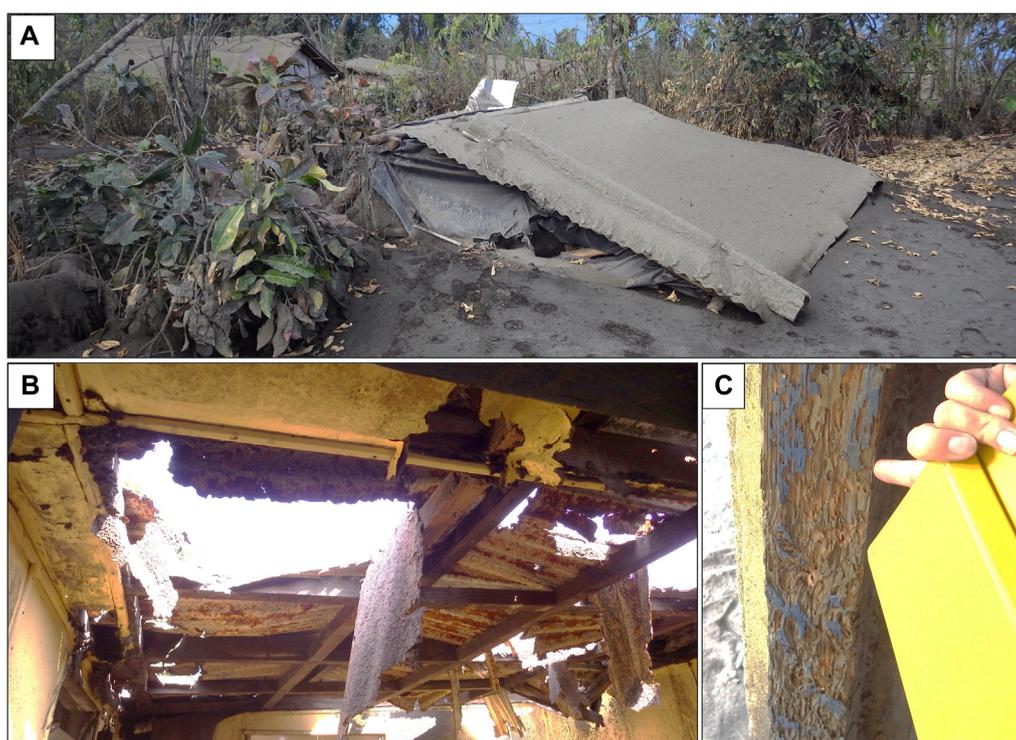
FIGURE 10

Good condition sheet metal roofs showing no corrosion exhibited collapse of the roof and/or support structure (Figure 10A) with destabilisation of the walls. For poor condition and corroded

sheet metal roofs, failure was typically through the roof covering, with the roof support structure remaining intact (Figure 10B). This has implications for the repair costs of such buildings in areas where tephra thicknesses are large enough to cause failure of good condition metal sheet roofs: more vulnerable poor condition metal sheet coverings will fail, preventing further tephra loading on the roof structure, while a good condition metal sheet covering may transfer all load to the roof support, which is more costly to repair than the roof covering alone in the event of failure. Conversely, a good condition metal sheet roof, which can be more difficult and costly to source than local timber, may be reusable. We observed at least one example of termite damage in the vertical load-bearing timber props of a non-traditional building (Figure 10C), which potentially would have exacerbated damage had the roof covering not been in very poor condition (resulting in failure of the roof covering).

Non-traditional buildings exhibiting (A) complete collapse (DS5) of the vertical load-bearing props with a good condition metal sheet roof covering (tephra thickness: ~134 mm); (B) a heavily corroded sheet metal roof resulting in DS3 damage (tephra thickness ~30 mm); and (C) termite damage to the vertical load-bearing prop.

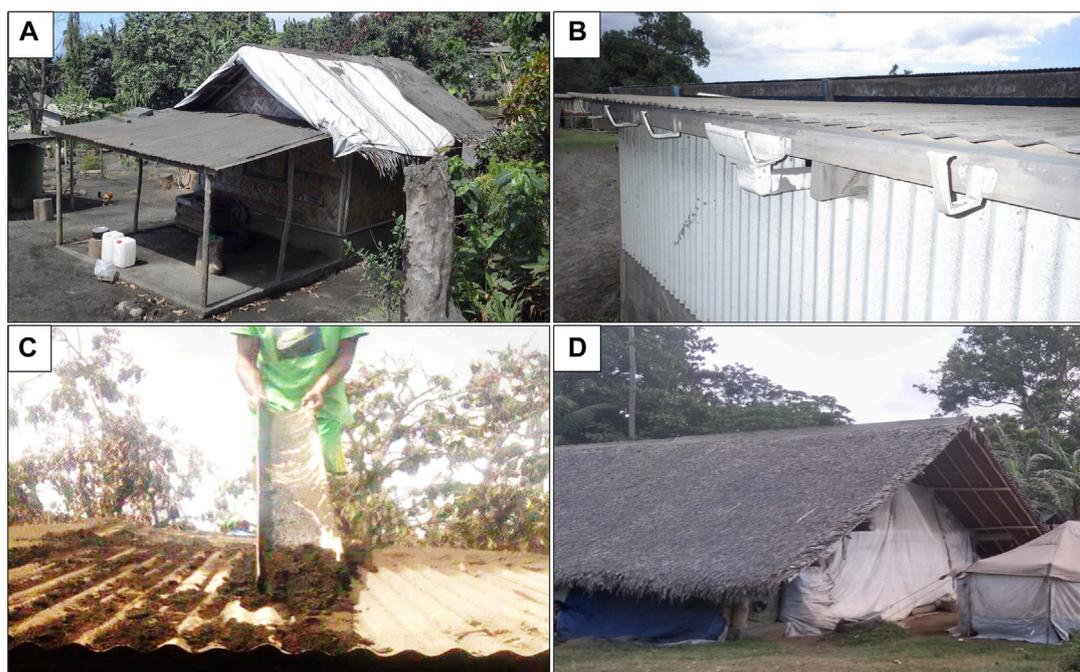
Of the 589 buildings surveyed on Ambae, 58 had gutters, with a further 35 showing evidence of having had gutters removed (Figure 11B) (93 total). The pre-emptive removal of guttering can prevent both damage to the gutter from overloading, as tephra is washed off the roof, and the contamination of water supplies. Rainwater tanks are the primary water source for Ambae residents, with many tanks fed by gutters.

FIGURE 11
Mitigation strategies employed by residents on Ambae to limit the impact of tephra falls on buildings: **(A)** successful use of a tarpaulin over part of a roof in south Ambae in shedding tephra; **(B)** Pre-emptive removal of guttering to prevent gutter damage and/or contamination of water supply; **(C)** Length of guttering used to clear tephra off roofs on Ambae; **(D)** Covering of large openings on traditional buildings in order to limit tephra contamination of the interior.

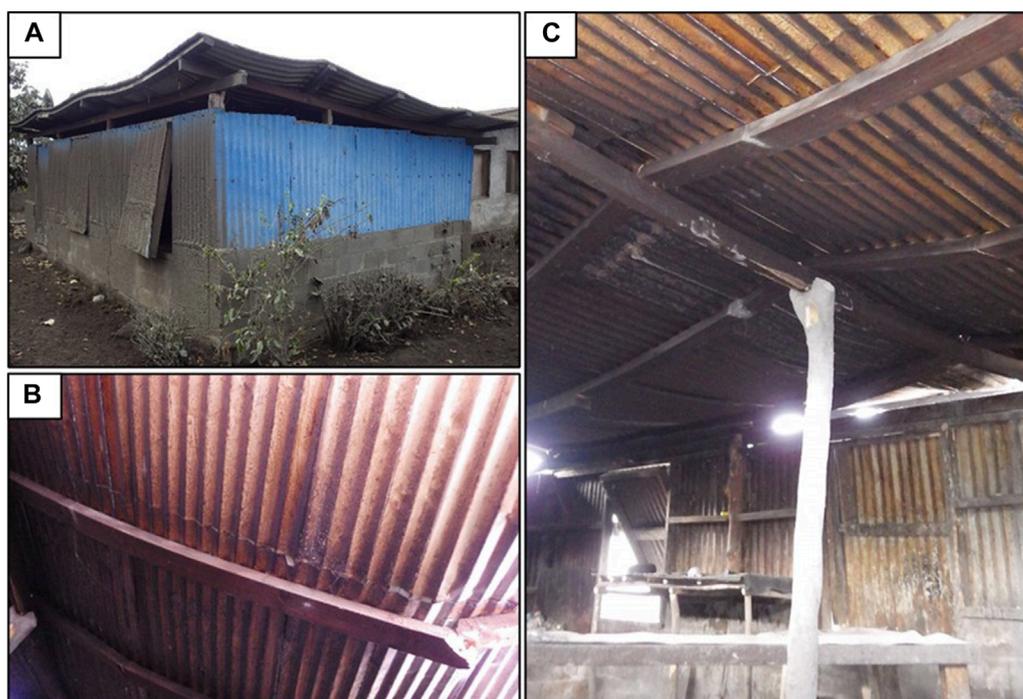
FIGURE 12

We observed floor “propping” poles that provided additional support to the primary beams (Figure 12) in two buildings in our survey. Conversations with one of the building owners confirmed that poles were placed to reinforce the primary beam and roof frame under tephra loading. Such poles increase the tephra loading that a roof can withstand: Figure 12 shows a hybrid building (Xw) that was exposed to ~125 mm of tephra during the July 2018 tephra falls. The building suffered extensive bending of the corrugated sheet metal roof cover and snapping of the supporting purlins/rafters, and yet the roof structure did not collapse, presumably because of the pole propping the roof from the floor in the centre of the building providing additional support. The potential benefit of temporarily propping or bracing roofs to increase their tephra load bearing capacity has been previously considered by Spence et al. (2005). These studies assumed that with carefully installed props the weakest building types could more than double their load bearing capacity, and accordingly, modelling the use of such props led to

Hybrid building exposed to ~125 mm of tephra during the July 2018 eruption phase: (A) exterior of the building with visible bending in the corrugated metal sheet roof cover. (B) Snapped purlin/rafter and deformed roof covering. (C) Prop installed to reinforce the roof support structure along with extensive bending in the roof cover and purlins/rafters.
