CITATION
Liu X, Lü X, Shao Y, Chen C, Liu G, Li Y, Li M,
Wu X and Chen Y (2024), Monitoring and
disaster prevention of high and steep
sandstone slopes along highways under
construction.
Front. Earth Sci. 12:1444592.
doi: 10.3389/feart.2024.1444592

Monitoring and disaster prevention of high and steep sandstone slopes along highways under construction

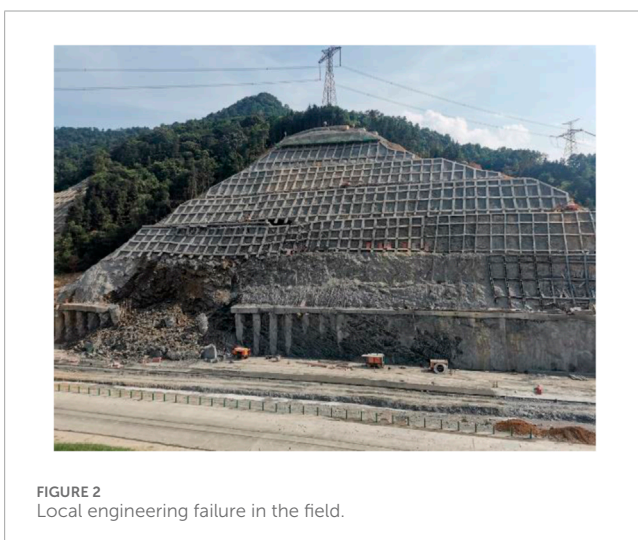
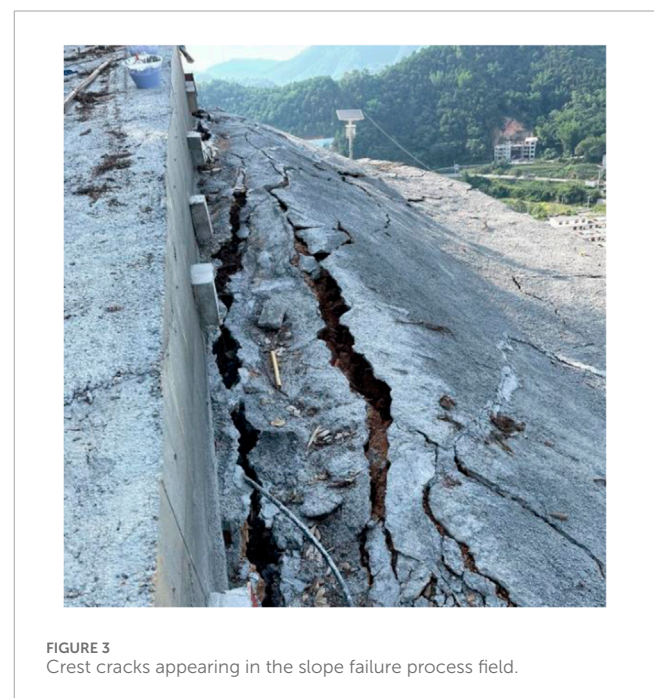
On 14 June 2021, the deformation rates of the deep displacement inclinometer boreholes, namely, 2-CX1, 2-CX2, and 2-CX3 in the main monitoring section of the slope increased to 12.84 mm/d, 14.80 mm/d, and 19.60 mm/d respectively. After that, the slope entered the high-speed deformation stage, and the tangent angle of the deep accumulated displacement-time curve reached 83°, triggering the critical-sliding. The maximum accumulated deformation of the slope reached 51 mm from 21:00 on June 17 to 15:00 on June 18. As to the maximum deformation period, the converted daily rate was 144 mm/d. The slope continued deformation until 15:50 on June 19, and local failure occurred on the slope surface during the first to second grade. The damage and crest cracks are shown in Figure 2 and Figure 3.
