Yao K, Wang Y, Fan S, Wan J, Wu H and  
Cao Y (2022), Fault mechanisms and  
diagnosis methods for typical load  
mutation problems of turbo-  
generator sets.

# Fault mechanisms and diagnosis methods for typical load mutation problems of turbo-generator sets

Since flexible peak shaving has been implemented in a growing number of high-power turbo-generator sets in the power grid owing to increasing demand, the load control performance of steam turbines directly affects the safety and efficiency of the unit operation. Load-following issues, especially load mutation, weaken the frequency control performance of the unit and cause load fluctuation faults, threatening power grid safety and stability. However, the definition, classification, characterization, generation mechanism, and diagnostic methods for load mutation problems have not been systematically researched. Based on the operational data of various turbo-generator set cases, this study systematically assessed three typical load mutation problems; namely, the common fault of unreasonable parameter settings of the control system as well as new-found faults in the actuator hardware and electrical interference. Subsequently, th

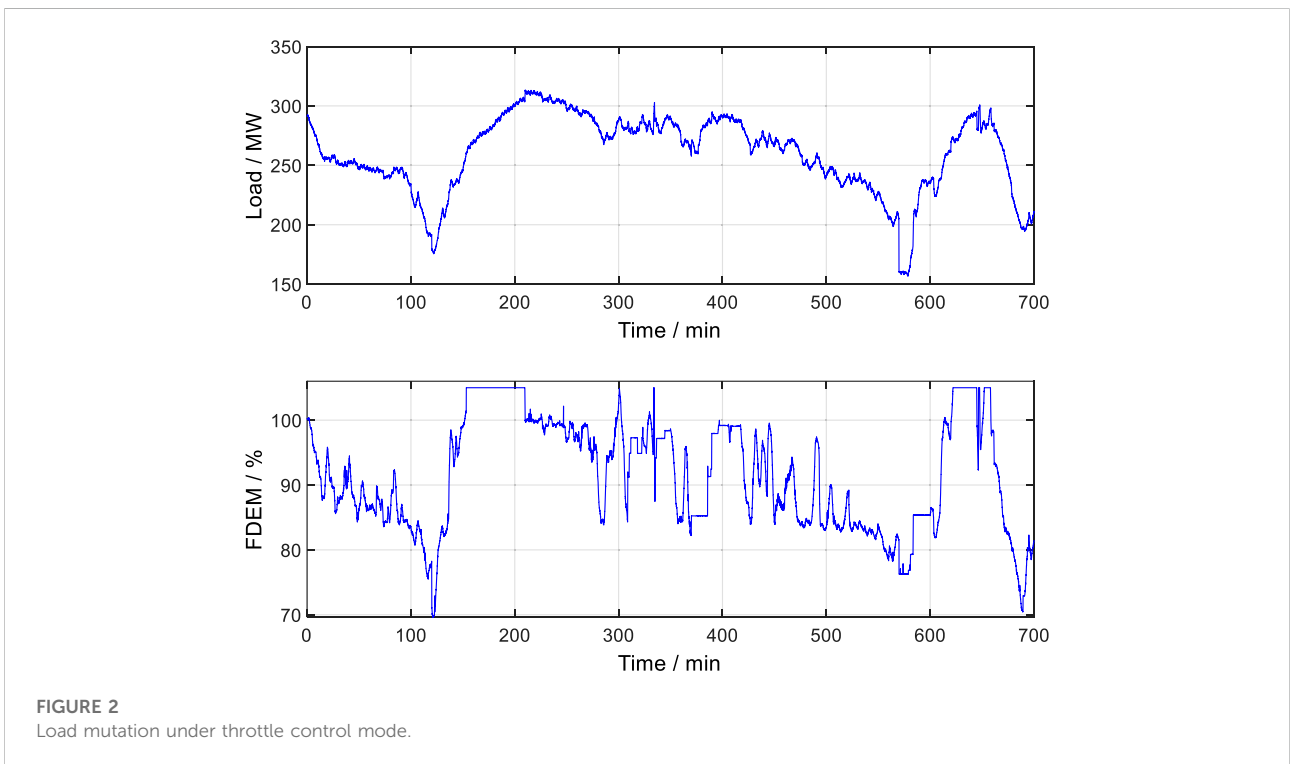
**FIGURE 2** Load mutation under throttle control mode.

The fault case is a subcritical 330 MW heating unit. It has a load mutation problem while operating in a partial FDEM range under the throttle control mode. Figure 2 shows the change curve of the actual load and FDEM. Unlike the load oscillation phenomenon, the load mutation cannot be directly seen in Figure 2. However, when operating in such fault conditions, the unit cannot successfully run under AGC. As shown in Figure 3, the unit has a nonlinear flow characteristic curve in the FDEM range of 78%–86%. The curve slopes of the three FDEM ranges [70%, 78%], [78%, 86%], and [86%–100%], differ significantly, with an approximately four-fold slope difference between the second and third FDEM ranges in this figure, which means the load variation corresponding to a unit FDEM is four times that of other load ranges.

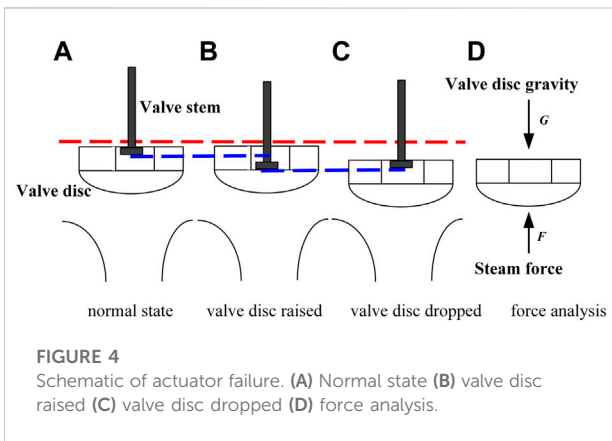
**FIGURE 4**  
Schematic of actuator failure. (A) Normal state (B) valve disc raised (C) valve disc dropped (D) force analysis.

As a direct actuator in the load control process, changes in the valve lift and disc position of the GV can adjust its flow area, resulting in alterations in the steam admission of the steam turbine, thereby changing the unit load. Wear of the connecting parts of the GV, such as the yoke bushing, can cause the connecting parts of the valve disc to trip and loosen (or even fall off), resulting in a load mutation. Figure 4 shows a schematic diagram for such a fault. The positions of the GV in normal and trouble-free states are shown in Figure 4B. A lack of tight connection between the valve stem and valve disc causes an invalid valve lift when this unit is moving. As shown in Figure 4A, the valve stem rises while the position of the valve disc remains unchanged. Figure 4D shows that the valve disc assembly is subjected to a weight  $G$  (downward) and a steam flow force  $F$  (upward) during valve adjustment. When the main steam pressure changes to an appropriate value, the steam force  $F$  acting on the valve disc will be less than the weight  $G$  of the valve disc assembly. The valve disc will then drop to the position instantly, as shown in Figure 4C. This effect is equivalent to the sudden closing of the GV, resulting in a sudden pressure drop, eventually leading to load mutation. This hardware failure is closely related to the valve structure and unit type. Different unit capacities are accompanied by different valve structures (unequal  $G$ ). Moreover, the unit types, such as subcritical and supercritical, have different steam pressure operating ranges; thus, the steam force  $F$  will change similarly. Therefore, further analysis of the hardware failure of units with different capacities is required.

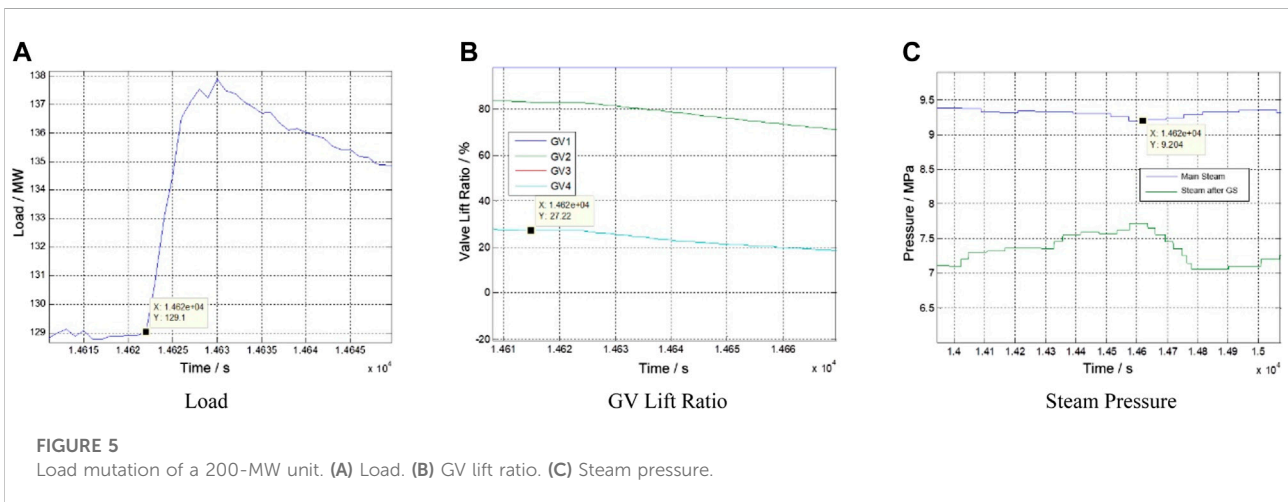
**FIGURE 5**  
Load mutation of a 200-MW unit. (A) Load. (B) GV lift ratio. (C) Steam pressure.

The conventional characterization of a GV hardware failure in a 200 MW unit is load mutation. Figure 5 shows the problem characterization of this hardware failure. In Figure 5A, the load suddenly increases by 8.5 MW, from 129 to 137.5 MW. The GV in Figure 5B shows no instantaneous action during this time. Figure 5C shows that the main steam pressure and the pressure after the GV fluctuate in the corresponding time periods. This occurs because the valve disc is held up by the steam flow force

and changes the steam pressure when the unit has a GV hardware failure, causing a sudden load change.

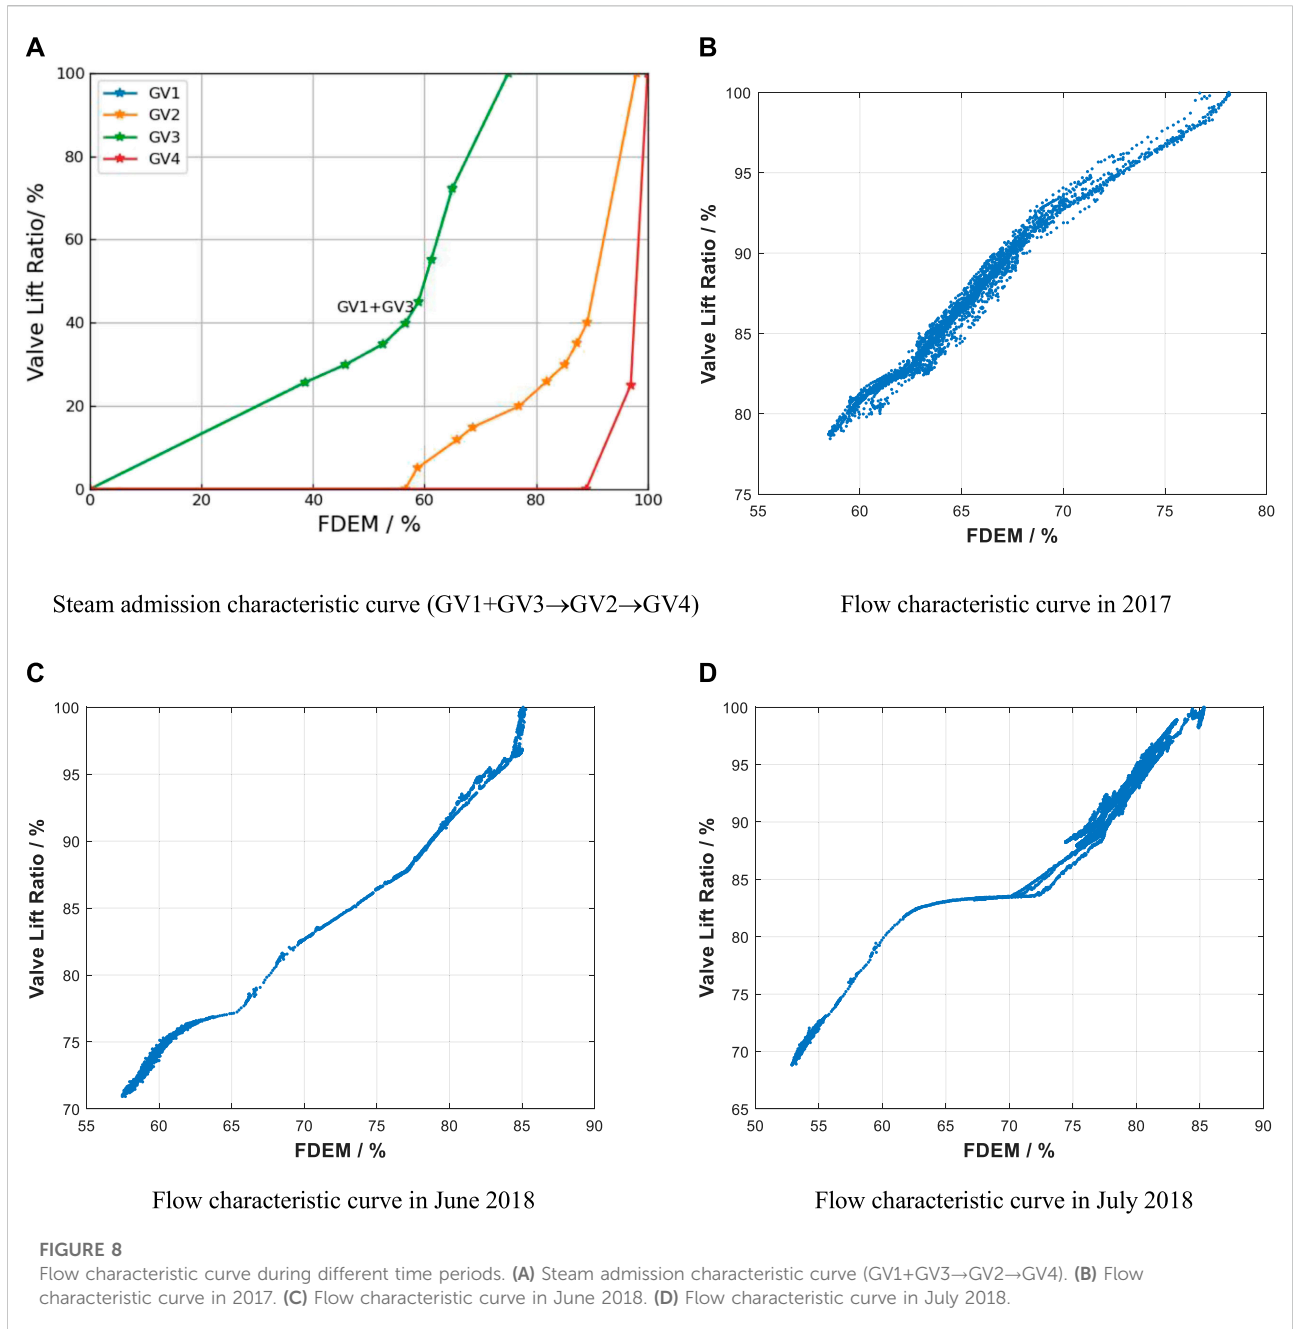
**FIGURE 8**

Flow characteristic curve during different time periods. (A) Steam admission characteristic curve (GV1+GV3→GV2→GV4). (B) Flow characteristic curve in 2017. (C) Flow characteristic curve in June 2018. (D) Flow characteristic curve in July 2018.

Figure 8B shows the flow characteristic curve for the designed steam admission characteristic curve, with reasonable linearity. Compared to Figure 8C, the FDEM

leveled off at 62%–65% in June 2018. However, this flattened curve area increased to 62%–71% after 1 month, increasing 6% of the total interval (Figure 8D). Within the gap length, the valve stem had an invalid valve lift, which prevented changes in valve opening and inlet steam flow; thus, the flow characteristic curve in this area is flat. Over time, the degree of wear deepens, the invalid valve lift increases continuously, and the no-flow interval gradually expands. Consequently, the steam flow force cannot overcome the disc weight and the valve disc shows a falling state. The steam flow into the steam turbine remains steady while the valve disc does not show transient rising or falling during load regulation. Therefore, a hardware looseness fault in a 600 MW unit will not show a load mutation fault. Therefore, whether the hardware looseness fault in a 600 MW unit will cause load mutation failure should fully consider the GV structure.

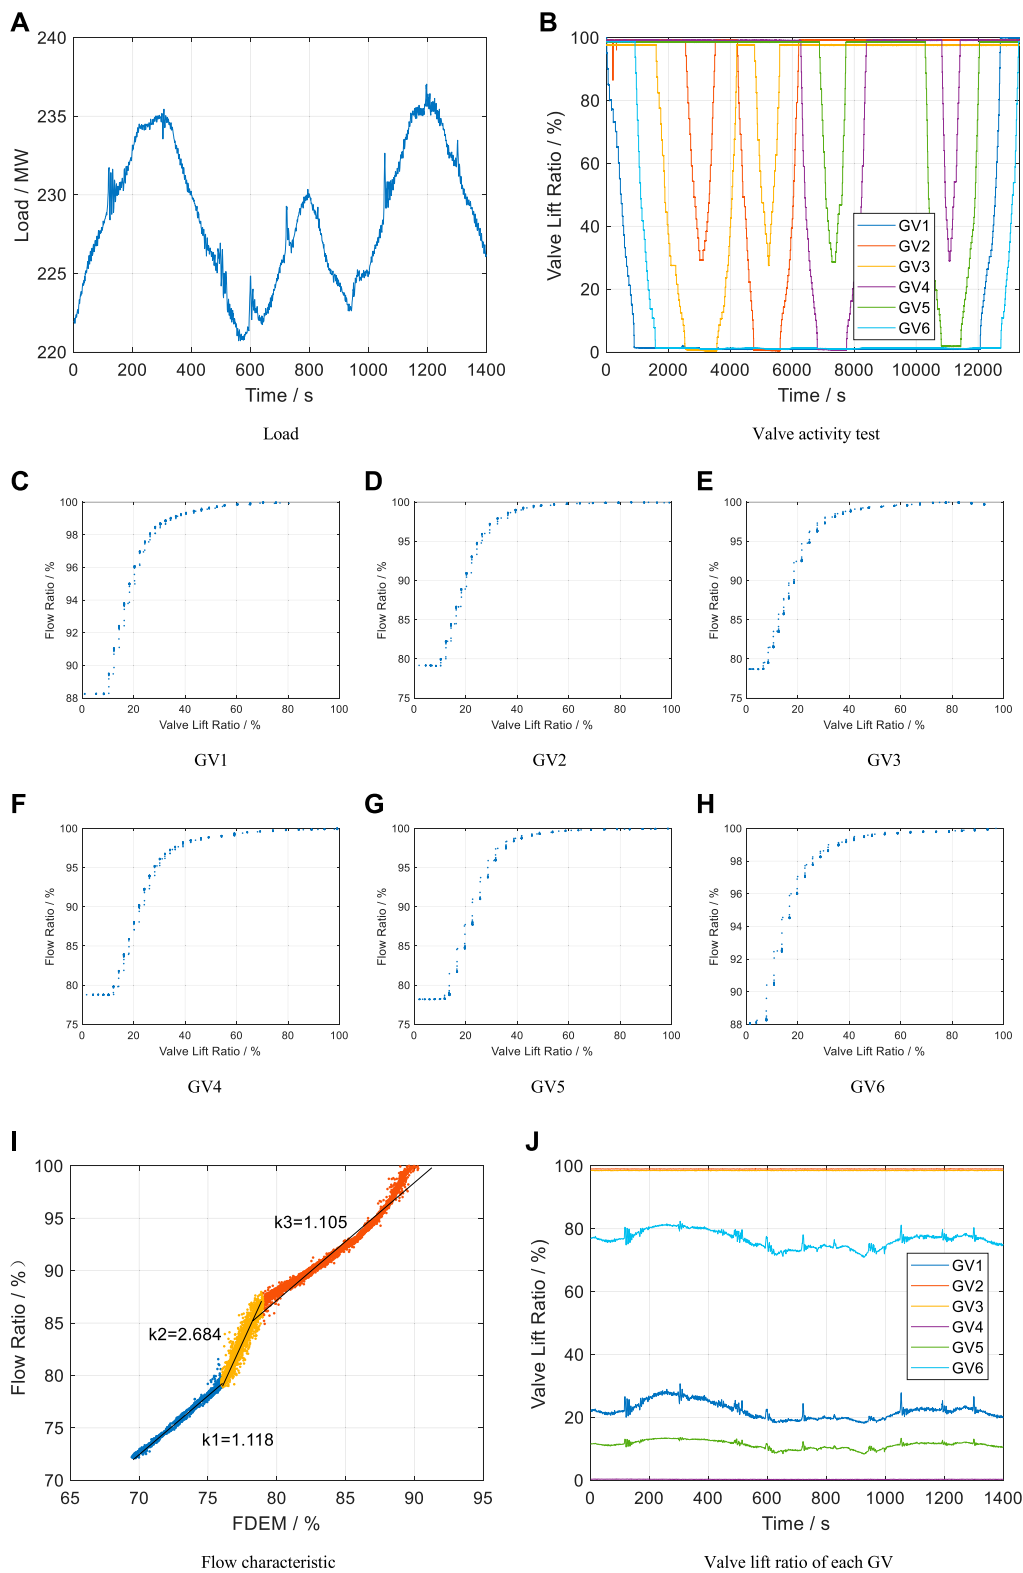
**FIGURE 19**  
 6 GV activity test. (A) Load. (B) Valve activity test. (C) GV1. (D) GV2. (E) GV3. (F) GV4. (G) GV5. (H) GV6. (I) Flow characteristics. (J) Valve lift ratio for each GV.

This case is a 300 MW unit equipped with six GVs. Load mutation was observed during its operation. As shown in Figure 19A, the load mutation reached a maximum of 4.5 MW. The fault diagnosis was carried out according to the above method. The detailed test process is shown in Figure 19B. According to the GV activity test data, the flow characteristic curves of each GV were obtained, as shown in Figures 19C–H. This fault was not an actuator failure because the curve for each GV is reasonable. Figure 19I, the steam admission characteristic curve according to the historical data in the throttle control mode, shows strong nonlinearity. The curve slope of FDEM in

the 76%–79% range is about 2.5 times that of other ranges. Thus, this load mutation failure was caused by poor unit flow characteristics. Figure 19J shows the valve lift of each GV corresponding to Figure 19A, in which the valve lift frequently changes due to the unit flow characteristics, which in turn causes unit load oscillation.
