Study on the Mechanism of Failure in the LiF–NaF–KF Molten-Salt-Purifying Processing System

The failure of LiF–NaF–KF molten salt processing engineering was investigated. The results indicate that the failure is related to the blockage of pipes. The mechanism of blockage was studied systemically. The results reveal that the blockage of pipes was attributed to corrosion. UNS ⁰²²N01 alloy vessel was corroded in molten salt to form KNiF₃ and K₂NiF₄. The corrosion products were reduced by H₂ to form metallic Ni, which is the precipitant in salt. The transfer of precipitant in terminal salt was stopped by incomplete root penetration, which results in one pipe blocked at the welded joint. The corrosion products were reduced by H₂ to form metallic Ni and deposited on the inner surface of H₂ gas outlet, which resulted in another blocked pipe.

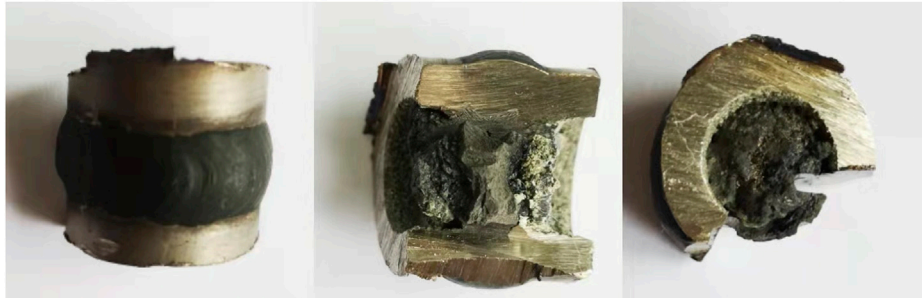
Figure 1 shows a real picture of the welded joint of the pipe bellow adaptor in vessel 03 where molten fluoride salt was processed with HF/ H_2 , showing that this pipe is almost completely blocked. **Figure 2A** is the cross-sectional SEM image of the blocked pipe. The EDS elemental mapping image in **Figure 2A** shows that the blockage is composed of dense depositions and cracks. The elemental mapping images in **Figures 2B–I** indicate that the blockage is composed of the elements Ni, Cr, Mo, F, K, Na, C, and O, which is different from molten FLiNaK salt. The XRD pattern in **Figure 3** reveals that the blockage is composed of KNiF₃, Ni, K₂NaNiF₆, Na₅Al₃F₁₄, LiF, K₂NiF₄, Na₂Mo₃O₆, and Cr₉Mo₂₁Ni₂₀ phases. KNiF₃, Ni, and K₂NaNiF₆ are the main components of the blockage, where Ni should be from Ni vessel. Ni-containing fluorides should be corrosion products of Ni vessel induced by impurities in molten FLiNaK salt. KNiF₃, K₂NiF₄, and K₂NaNiF₆ should be complexes of NiF₂ with KF and NaF. The binary diagrams of NiF₂ with alkali fluorides reveal that NiF₂ can react with LiF, NaF, and KF to form (Li_{1-x}Ni_x)F, NaNiF₃, K₂NiF₄, and KNiF₃ (Ocadiz-Flores et al., 2018). The results of the XRD pattern in **Figure 3** indicate that there are KNiF₃, K₂NaNiF₆, and K₂NiF₄ phases in the blockage. Lack of (Li_{1-x}Ni_x)F and Li₂NiF₄ in the blockage should be attributed to the smaller ionic radius of Li⁺ than K⁺ and Na⁺ because the alkali cation with a smaller ionic radius is closer to the F⁻ surrounding the

FIGURE 1 | Picture of the blockage at the welded joint of the pipe (inner diameter: 10 mm) bellow adaptor in vessel 03.

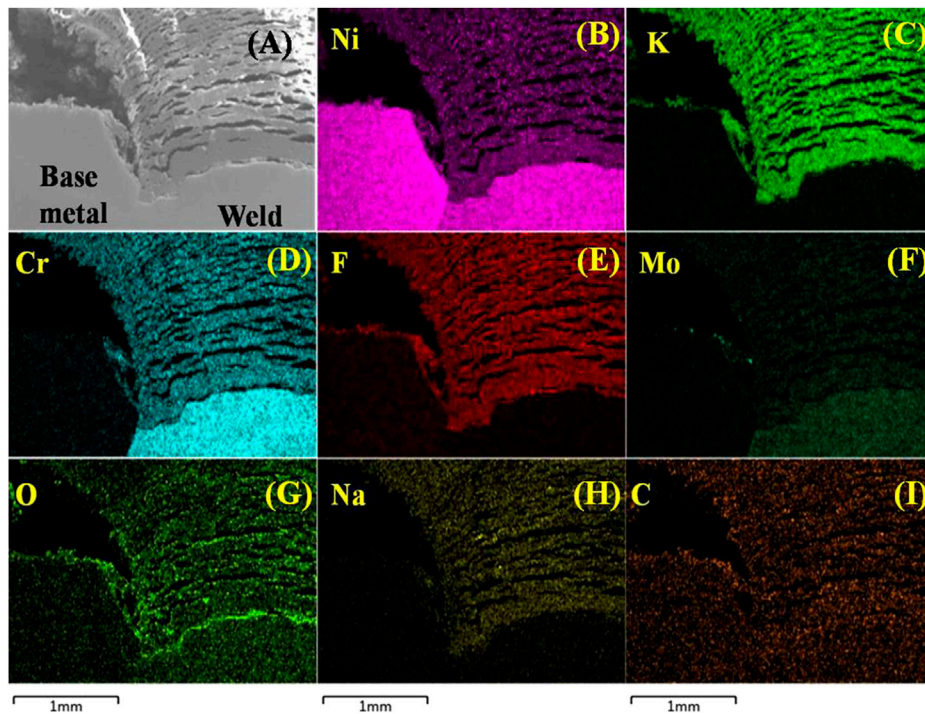
FIGURE 2 | (A) Cross-sectional SEM image. (B–I) EDS elemental mapping image of the blockage at the welded joint of the pipe bellow adaptor in vessel 03.

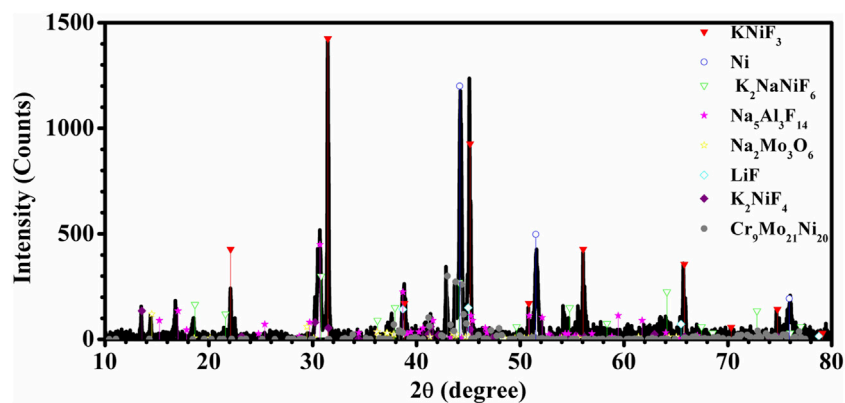
FIGURE 3 | XRD pattern of the blockage at the welded joint of the pipe bellow adaptor in vessel 03.

Ni^{2+} to form a weakened complex (Ocadiz-Flores et al., 2018). KNiF_3 , K_2NaNiF_6 , and K_2NiF_4 in the blockage should be complexes of the corrosion product of Ni with KF and NaF. The KF– NiF_2 phase diagram reveals that NiF_2 firstly reacts with KF to form K_2NiF_4 and then forms KNiF_3 with the increase in the concentration of NiF_2 above 33 mol% (Ocadiz-Flores et al., 2018). The XRD pattern in **Figure 3** shows that KNiF_3 is the main Ni-containing fluoride. The existence of KNiF_3 indicates that there should be a large amount of NiF_2 in the terminal salt during transportation between different vessels. The saturation concentration of NiF_2 in the FLiNaK salt at 550°C is only 0.42 wt% (Jardan et al., 1956). The amount of NiF_2 in molten FLiNaK salt which is more than the saturation concentration can result in the turbidity of molten salt (Jardan et al., 1956). In addition, the melting points of KNiF_3 , K_2NiF_4 , and NaNiF_3 (Ocadiz-Flores et al., 2018) are higher than the processing temperature (i.e., 580°C). Therefore, the extra KNiF_3 , K_2NiF_4 , and NaNiF_3 in the terminal salt should be in the form of precipitants. The Ni-containing fluorides can be reduced by H_2 to form metallic Ni, which is also in the form of a precipitant.

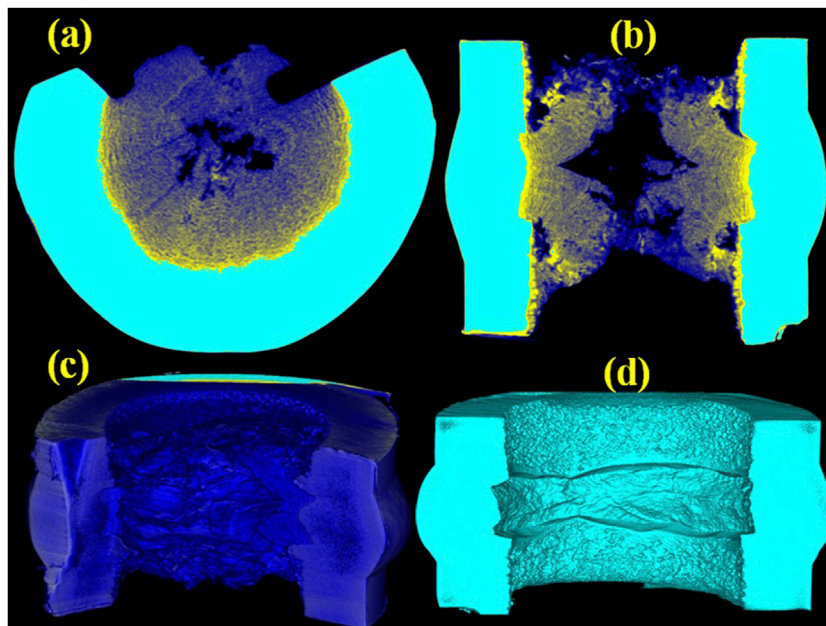
FIGURE 4 | (A) Sagittal (yz) slice, **(B)** frontal (xz) slice, **(C)** 3D CT images of the blocked pipe bellow adaptor in vessel 03, and **(D)** 3D CT images of the blocked pipe after removing the blockage and salt that adhered to the surface of the pipe.

of pipes in the FLiNaK processing system. The 2D CT images in **Figures 4A,B** show that there is a layer-like structure in the blockage. The layered structure is consistent with the SEM image in **Figure 2A**. It appears that the alternate layers of depositions and cracks are like a layered structure. The alternate layers of depositions and cracks should be related to the periodic transportation of molten salt between different vessels. The 3D CT image in **Figure 4C** shows that the welded pipe is almost fully blocked at the inner of the weld. Therefore, the mixed H_2/HF sparging gas cannot come into the vessel, and molten salt cannot be transferred between the different vessels. To unveil the puzzle, the blockage and the salt that adhered to the blocked pipe were removed by using image processing, and the result is shown in **Figure 4D**. It can be clearly seen that there is a welding defect at the backside of the weld. It is a typical incomplete root penetration which is a failure of the weld metal to penetrate into the root of a joint (Hughes and Matthews, 2009; Mandal and Mandal, 2017). It is worth noting that this defect occurs at all the backside for the half-girth weld. The incomplete root penetration defect can stop the transfer of precipitants in the terminal salt and then deposit on the welding defect area to result in the blocked pipe. **Figure 5** shows the internal structure of another welding pipe above the adaptor in vessel 02 which was scanned by 3D CT as well. It is noteworthy that the internal surface of the girth weld is very smooth, and no welding defects and depositions were found on the inner surface of the pipe. A comparison of **Figure 4** and **Figure 5** indicates that the incomplete root penetration defect plays an important role in the blockage of the pipe. Thus, this kind of welding defect should be avoided in molten salt purification processing system and MSRs.

Several reasons can be usually ascribed to the incomplete root penetration defect (Hughes and Matthews, 2009; Mandal and Mandal, 2017). The first one is low welding current, which normally results in shallow penetration. The second one is the unreasonable design of the welding groove and gap, such as thick root face and narrow or too wide root gap, which results in the root being hard to penetrate. The third one is poor surface cleaning before welding or fast heat dissipation rate. A better solution to prevent the incomplete root penetration defect is employing a higher welding current and reasonable welding preparation. There should be filters in the molten salt processing system to remove the precipitants.

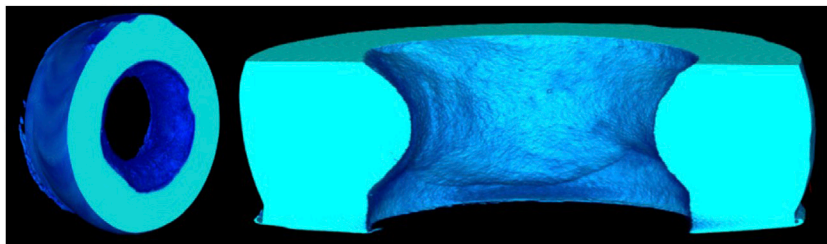
FIGURE 5 | 3D CT images of the blocked pipe above the adaptor in vessel 02.

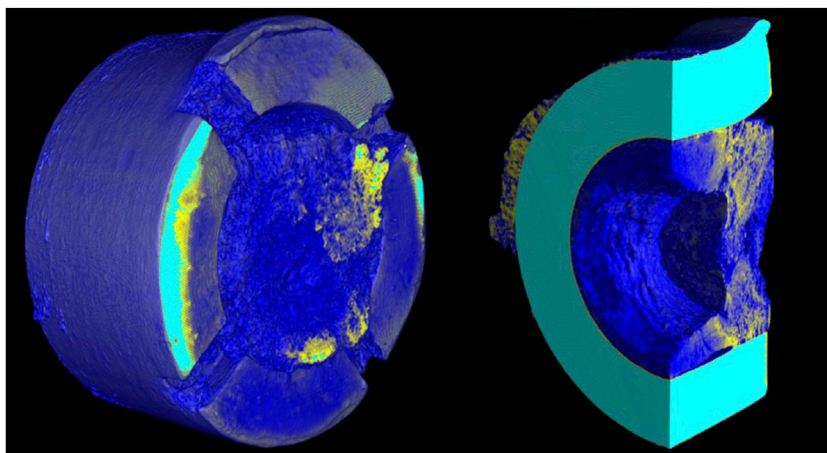
FIGURE 6 | 3D CT images of the blocked pipe which was immersed in vessel 04.

Figure 6 is a 3D CT image of the pipe which is immersed in salt in vessel 04, with the end of the pipe shown to be completely blocked. Therefore, the H_2 sparging gas cannot come into the vessel to purify the molten fluoride salt, and the molten fluoride salt cannot be transferred between vessels. The origin of the blockage in the pipe immersed in salt in

The results shown above indicate that the blockage located at the end of the pipe immersed in salt in vessel 04 is mainly related to the reduction of Ni²⁺ by H₂. Therefore, this kind of blockage should be avoided by decreasing the concentration of Ni²⁺ in salt and the amount of Ni²⁺-containing precipitants. The ratio of H₂ and HF in the sparging gas should be controlled, and residual HF in molten salt should be removed by sparging with anhydrous helium to decrease the corrosion of the Ni vessel and then decrease the amount of Ni²⁺-containing corrosion products. Meanwhile, filters should be added in the processing system to remove Ni-containing precipitants from the molten salt.

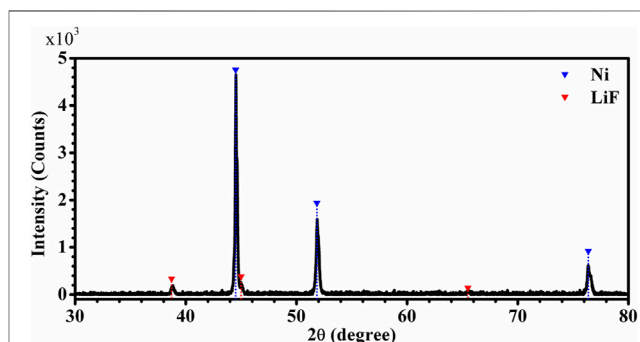
FIGURE 7 | XRD pattern of the blockage in the pipe immersed in vessel 04.

in molten FLiNaK salt and transfer the molten salt between vessels. The pipe in vessel 04 was for H₂ to remove metallic ions in the molten FLiNaK salt. The vessels and pipes in the processing system are composed of metallic Ni. Impurities in raw fluoride salts and residual HF in molten salt can result in the corrosion of the Ni vessel to form NiF₂. The results in **Figure 3** indicate that NiF₂ can react with KF and NaF to form K₂NiF₄, KNiF₃, and K₂NaNiF₆. Ni-containing impurities in molten FLiNaK salt can affect the corrosion of nickel-based alloy by the following reaction: Ni²⁺ + Cr ⇌ Cr²⁺ + Ni (Briggs, 1964; Pavlík et al., 2015). Therefore, Ni²⁺ in molten fluoride salts should be removed by processing. It is known that H₂ can reduce Ni²⁺ into metallic Ni. Therefore, the molten salt transferred into vessel 04 was purged with H₂ to remove residual Ni²⁺ in it. The XRD pattern in **Figure 7** shows that the blockage is mainly composed of metallic Ni, indicating that the blockage was induced by the deposition of Ni that was reduced by H₂ in the molten salt.

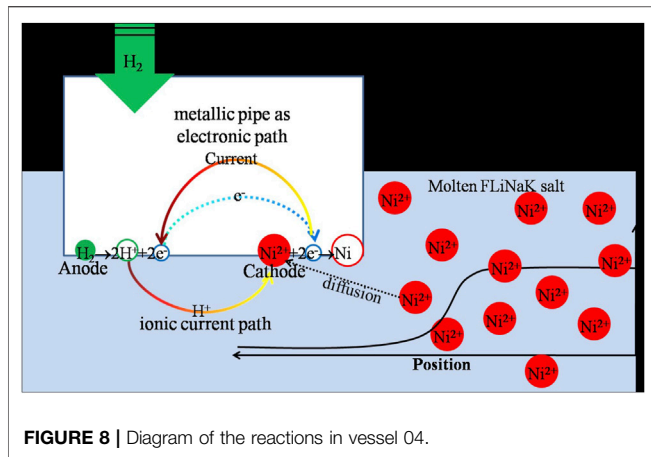
Figure 8 is a diagram of the reactions in vessel 04. The salt in vessel 04 was processed with H₂ by reaction 1). H₂ and Ni²⁺ in the molten FLiNaK salt make up an electrochemical corrosion cell, where H₂ at the end of the pipe in vessel 04 can be referred to as the anode and Ni²⁺ in the salt can be referred to as the cathode. The oxidation of H₂ generates electrons [reaction (2)], while the reduction of Ni²⁺ consumes electrons [reaction (3)]. The metallic outlet pipe provides an electronic path for the movement of electrons from the anode to the cathode. The flow of current is from the cathode to the anode, which is opposite from the flow of electrons. Then, the current flows from the anode to the cathode by the movement of positively charged ions in the molten FLiNaK salt. At the H₂ gas outlet, Ni²⁺ is reduced by H₂ to form metallic Ni and deposited on the surface of the pipe. Ni²⁺ at the H₂ gas outlet is consumed to form a concentration gradient of Ni²⁺ in the molten FLiNaK salt, which then results in the diffusion of Ni²⁺ in the molten FLiNaK salt towards the H₂ gas outlet. As time goes on, Ni²⁺ in the molten FLiNaK salt will be removed little by little, and the deposition of metallic Ni results in the mouth of H₂ gas outlet becoming narrower and narrower until the pipe is finally blocked.
