Xie Y, Zhao J, Wang J and Wei H (2022),
Microstructure degradation of service-
exposed turbine blades made of
directionally solidified DZ125 superalloy.
Front. Mater. 9:973119.
doi: 10.3389/fmats.2022.973119

Microstructure degradation of service-exposed turbine blades made of directionally solidified DZ125 superalloy

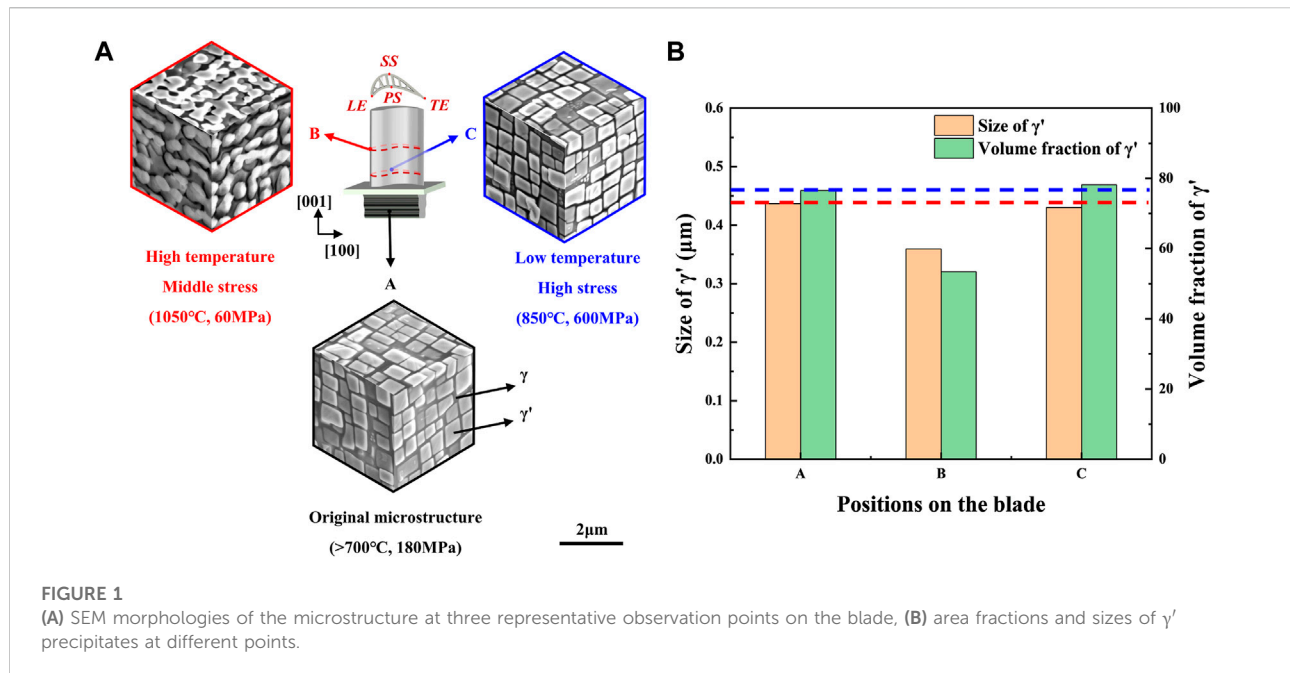
FIGURE 1
(A) SEM morphologies of the microstructure at three representative observation points on the blade, (B) area fractions and sizes of γ' precipitates at different points.

Figure 1A). During service, the temperature of point A was very low due to the cooling gas, and the microstructure barely changed, so it can be used as a reference point. Point B was directly impacted by high temperature gas, and because of the blade structure, the stress at this position was low, so points B was in high temperature and low stress during service. Point C was in a low temperature and high stress environment, which was the result of the coupling effect of high centrifugal force and film cooling. The temperatures and stresses during service at these three positions have distinct characteristics, therefore, these three points can be selected as typical observation positions to study the degradation of microstructures on the blade. With reference to the data in the literature (Wen et al., 2010; Chen et al., 2016), the approximate comparable levels of temperatures and stresses at points A, B, and C are shown in Figure 1A.

Figure 1 illustrates the morphologies of the γ' precipitates and the statistics of the characteristic parameters at the typical points. In Figure 1A, the morphologies of γ' precipitates at different positions are presented. It can be found that γ' precipitates at point A maintains with almost perfect cubic structure. At point B, γ' precipitates have obviously rafted. When observing along the direction of $\langle 100 \rangle$ (i.e. direction vertical to centrifugal force), γ' precipitates are obviously interconnected and evolves into a strip or plate in some positions with the rafting direction is perpendicular to

the $\langle 001 \rangle$ direction. There are also some regions where γ' precipitates are not completely connected to the surrounding precipitates, yet the cubic shape is also degraded to a spherical shape. In the direction of $\langle 001 \rangle$ (i.e. direction perpendicular to centrifugal force), the initial cubic γ' precipitates have evolved into spherical shape and the adjacent spherical γ' precipitates tend to connect with each other in both the $\langle 010 \rangle$ and $\langle 100 \rangle$ directions. In contrast, the precipitates at point C remain in a good cubic structure without rafting, and there is nearly no difference in the morphologies of γ' precipitates with point A. [Figure 1B](#) shows the statistical results of the volume fraction and size of the precipitates at these three positions. Comparing the characteristic parameters of the precipitates at these three positions, it can be found that the parameters at points A and C are similar, while there are considerable gap between point B and the other two positions, where the size of the precipitates decreases by about $0.1 \mu\text{m}$ compared to position A (or C) and the volume fraction decreases by about 30%. This indicates that the temperature has a dominating role in the rafting of the γ' precipitates.

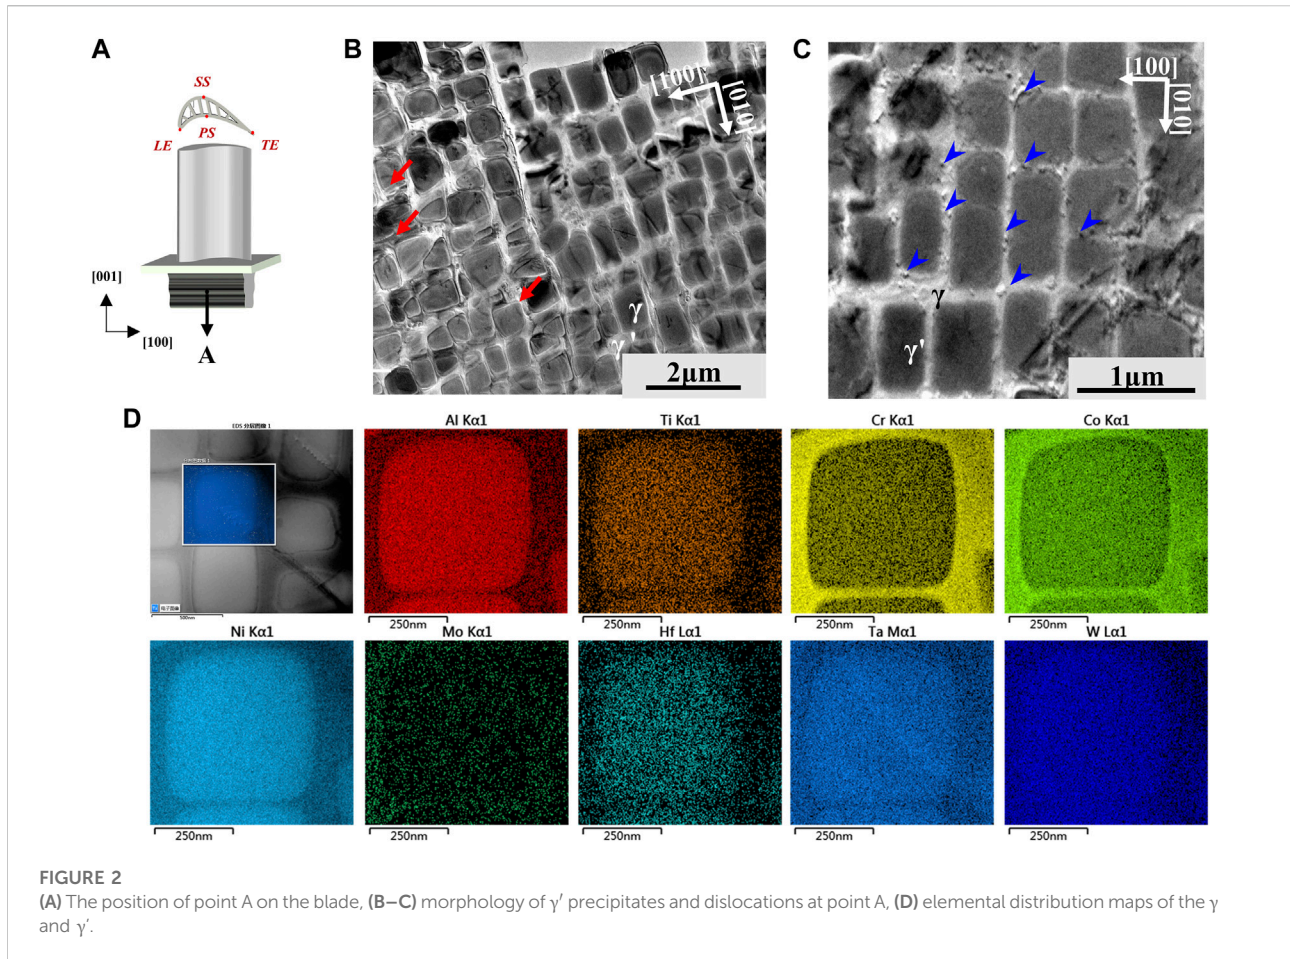
[Figure 2](#) shows TEM morphology of the precipitates and dislocations at point A with the position given in [Figure 2A](#). [Figure 2B](#) shows a TEM image of a low magnification. It can be found that the γ' precipitates maintain a good cubic structure, and at some positions can observe triangular precipitates (as indicated by the red arrows), which is probably due to the destruction of the complete cubic γ' precipitates during the process of preparation of the sample and the γ' cube is sheared along the slope leaving only a corner, so that only a triangle can be seen when observed under the TEM. [Figure 2C](#) shows the morphology of the sample observed at high magnification, revealing the presence of many short mismatch dislocations in the matrix phase (as shown by the blue arrows), which are mainly caused by the mismatch between the lattices of the two phases. Similar to that of the SEM, the γ' precipitates at point A of the blade is not degraded, and only the mismatch dislocations formed during the heat treatment process exist, indicating that the mortise is essentially damage-free during service and satisfies the demand as a reference. In addition, the distribution of elements in DZ125 alloy is shown in [Figure 2D](#), with Ni, Al, Ti, Hf, Ta, and W mainly enriched in the γ' precipitates, while Cr, Co, and Mo are mainly enriched in the γ matrix.

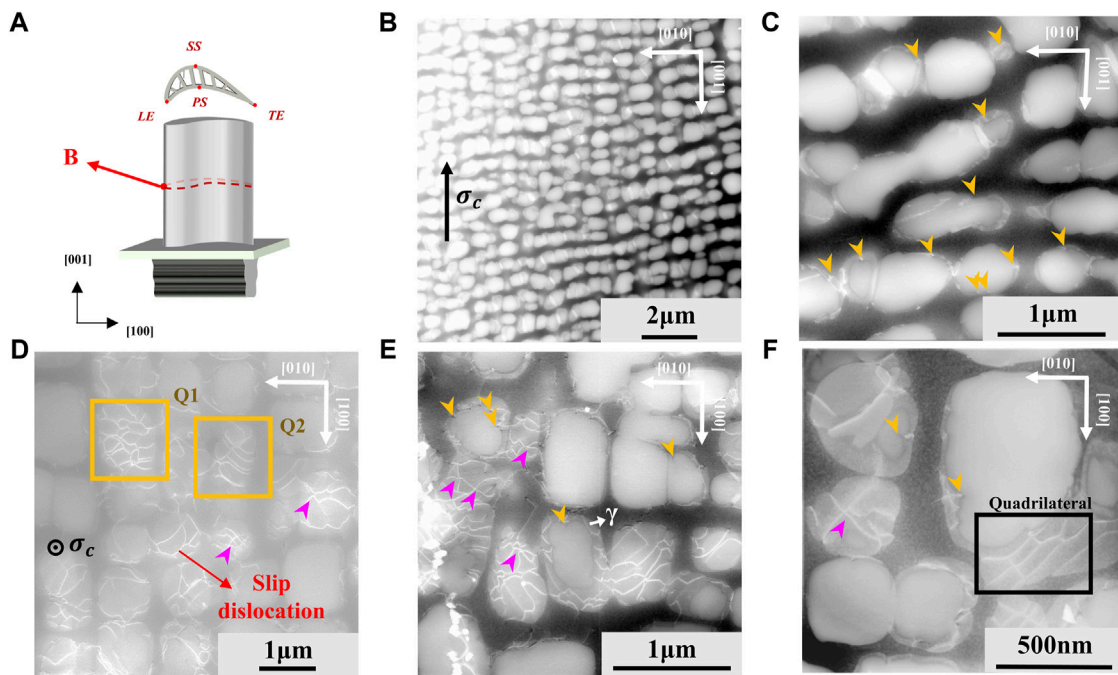
Point B on the blade is in a high temperature and low stress during service, and obvious rafting has occurred at point B according to the SEM image. To further analyze the dislocation behavior on the blade, it is necessary to investigate the microstructure at the nanoscale. STEM morphologies of dislocations at point B are given in [Figure 3](#) with [Figure 3A](#) shows the position of point B on the blade. It can be seen in [Figure 3B](#) that the γ' precipitates at point B have a distinct feature of rafting with the rafting direction perpendicular to the direction of centrifugal force (the direction of centrifugal force has been marked with black arrows in [Figure 3B](#)), and the original cubic structure has become ellipsoidal and connected, which is consistent with that observed in the SEM. It can be further noticed (as shown in [Figure 3C](#)) that no dislocations cut into the

γ' precipitates while there are only few dislocations in the γ matrix. Instead of a perfect phase-interface, the interface of the γ' precipitates is extruded with some grooves by dislocations, which is shown as a short white line in the figure (as indicated by the orange arrow in Figure 3C). This may be due to the stress field caused by dislocations that affect the diffusion process of the elements (Mehrer, 1996; Ardell and Prikhodko, 2003), thereby pegging the migration of the two-phases interface and forming a groove structure at the interface. Similar phenomena are found in Figures 3D,E, both marked with orange arrows. Figures 3D,E gives the morphologies of dislocations at point B when observed along the [001] direction (i.e., parallel to the centrifugal force). As shown in Figure 3D, the surfaces of the γ' precipitates are covered with a number of slip dislocations, which are only present on the surface of the γ' precipitates rather than extending into the γ -matrix channel. It is indicated that the dislocations observed in Figure 3C are all located near the phase interface near the matrix phase. The dislocations in the area selected by the orange box in Figure 3D (Q1 and Q2) can be found to be interdigitated and have a tendency to form a dislocation network, while the other dislocations are chaotic, probably due to the complex stress state during service or the low level of heavy elements in the

FIGURE 3 Microstructures at point B (A) the position of point B on the blade, (B) morphologies of rafted γ' precipitates and (C) dislocations observed at $\langle 100 \rangle$ direction, (D–F) morphologies of γ' precipitates and behavior of dislocations observed at $\langle 001 \rangle$ direction.

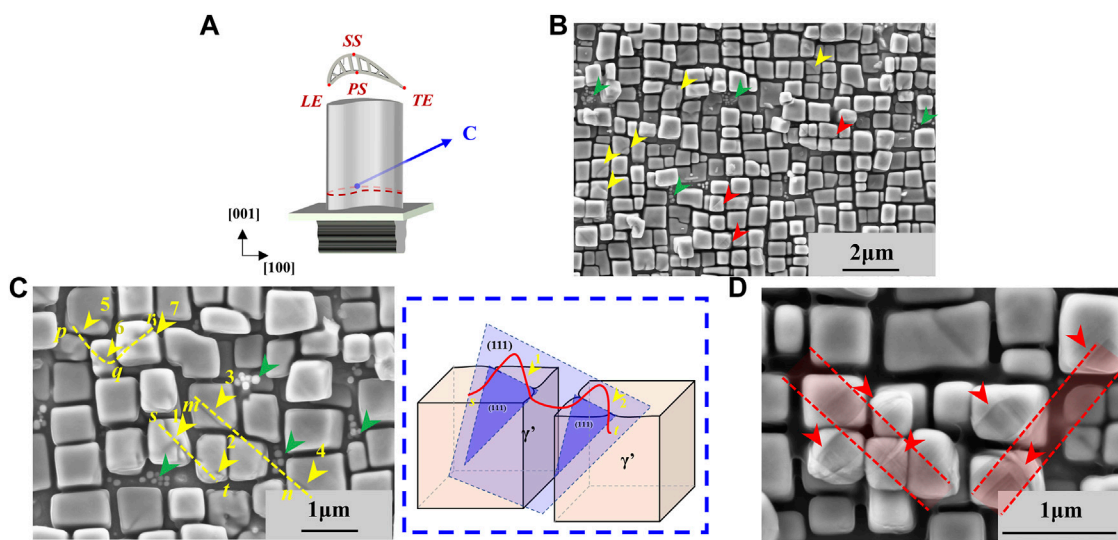
FIGURE 4 SEM morphologies of defects at point C of the blade: (A) the position of point C on the blade, (B) various defects on the surface of the γ' precipitates at point C, (C) dislocations cut into the γ' precipitates and a schematic diagram of dislocation behavior, (D) other feature on the surface of the γ' precipitates.

direction of 001 (as indicated by the red arrow in the Figure 4B), can be observed on the surface of the γ' precipitates. An enlarged image of the γ' precipitates cut by the dislocations is given in Figure 4C, where it is noticeable that the dislocations affect the migration of the phase interface and it is possible to cut more than one γ' precipitates by the same dislocation. It can be found in Figure 4C that the dislocations in the same field of view have different behaviors, such as the dislocation *s-t*, which only left a groove near the edge of the γ' precipitates, instead of leaving continuous cutting traces on the surface of the γ' precipitates. This may be due to the continuous cross-slip of dislocations in the (111) plane, as shown in the schematic diagram on the right side of Figure 4C (Agudo Jácome et al., 2014). In contrast, the traces 3 and 4 indicate that the dislocation left complete cut traces on the surface of the γ' precipitates, and these two sites may be

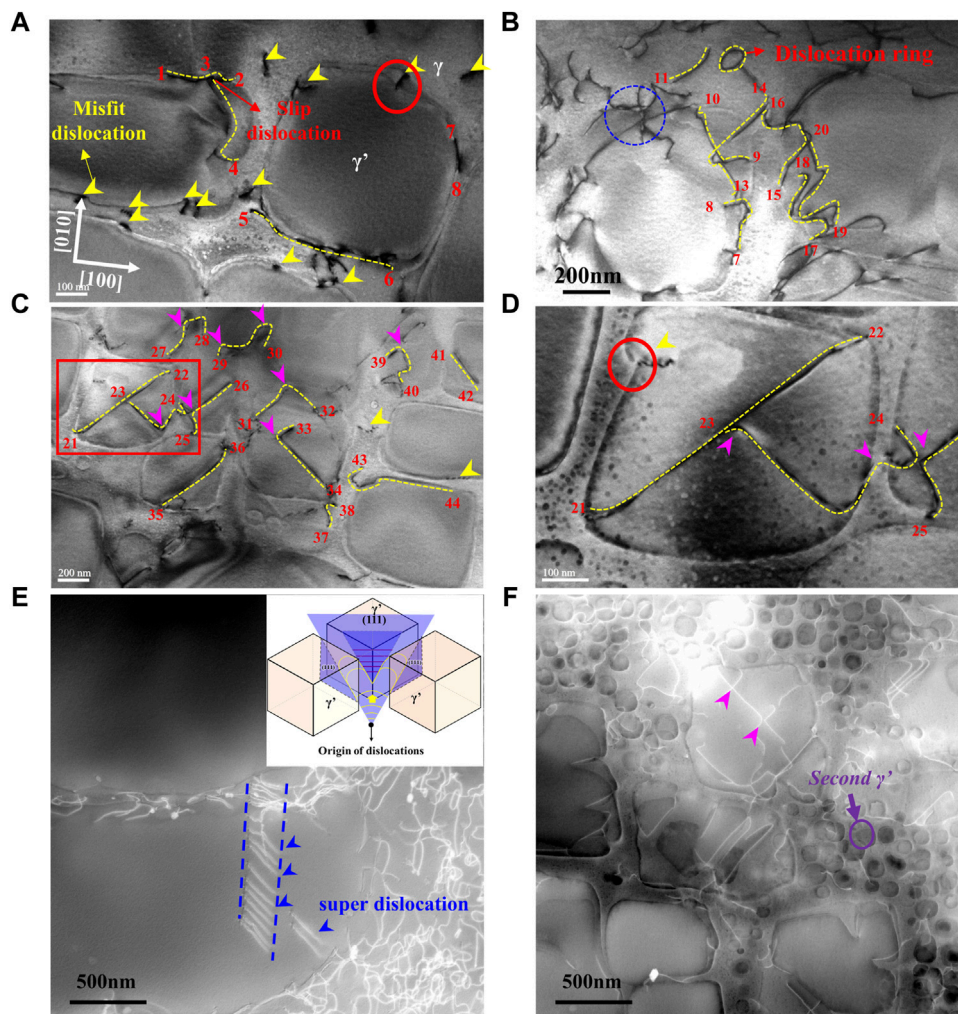
FIGURE 5 Dislocation morphologies at point C of the blade (A–D) TEM morphologies, (E–F) STEM morphologies.

The morphologies of dislocations at point C of the blade are given in Figure 5. Some typical types of dislocations are given in Figures 5A–D. Among them, the short dislocations indicated by yellow arrows in Figure 5A are mismatch dislocations, which are caused by lattice mismatch stress and have existed in the original heat treatment state of the material, and can also be observed at point A. The irregular dislocations line drawn with yellow dashed lines are slip dislocations, which are the main type of dislocations to form a dislocation network. Both of these dislocations are $\frac{a}{2}\langle 011 \rangle$ dislocations located in the γ matrix. The dislocation pegging interface can be found in the red circle in the Figure 5A, where both mismatch dislocations and slip dislocations have pegging effects on the interface. The patterns of some typical slip dislocations are given in Figure 5B and Figure 5C, however, differences exist in the behavior of the slip dislocations at these two positions. The slip dislocations in Figure 5B are more disorganized and tangled as shown in the blue dashed circles, while the dislocations in Figure 5C are mostly oriented at an angle of 45° to the $\langle 001 \rangle$ direction. This can be explained by the different stress fields at the two positions. In Figure 5D, a magnified view of the red box in Figure 5C is given, and it

can be pointed out that there is an obvious effect that dislocation pegging the phase interface at the position marked by the red circle. As a result, the interface is divided into two parts and the bottom part cannot be further pushed forward with the dislocation pinning, otherwise the upper part of the interface is obviously out of focus, which is probably due to the different migration driving force at the boundary and corner of the interface (Tsukada et al., 2017; Wang et al., 2019). STEM images of the dislocations are presented in Figure 5E. Between the blue dashed lines is a row of $\frac{a}{2}\langle 011 \rangle$ dislocations, and to the right of this row, there is a pair of super dislocations with anti-phase domains between these two dislocations. The formation mechanism of these dislocations is shown in the inset at the top right corner of Figure 5E. There may be a dislocation source (Wang et al., 2015), which constantly generates new dislocations in response to the stress, near the γ' precipitates and when an accumulated number of dislocations is sufficient, the stress field generated by the blocked dislocations will push the former dislocations to cut into the γ' precipitates and then generate a dislocation row. In addition, it is also worth noting that there are quite a few secondary γ' precipitates observed in Figure 5F. These secondary γ' precipitates are mainly observed near the eutectic region, indicating that this position may have experienced high temperatures during the service. The secondary γ' precipitates can as well be observed at the position indicated by the green arrow in Figure 4.

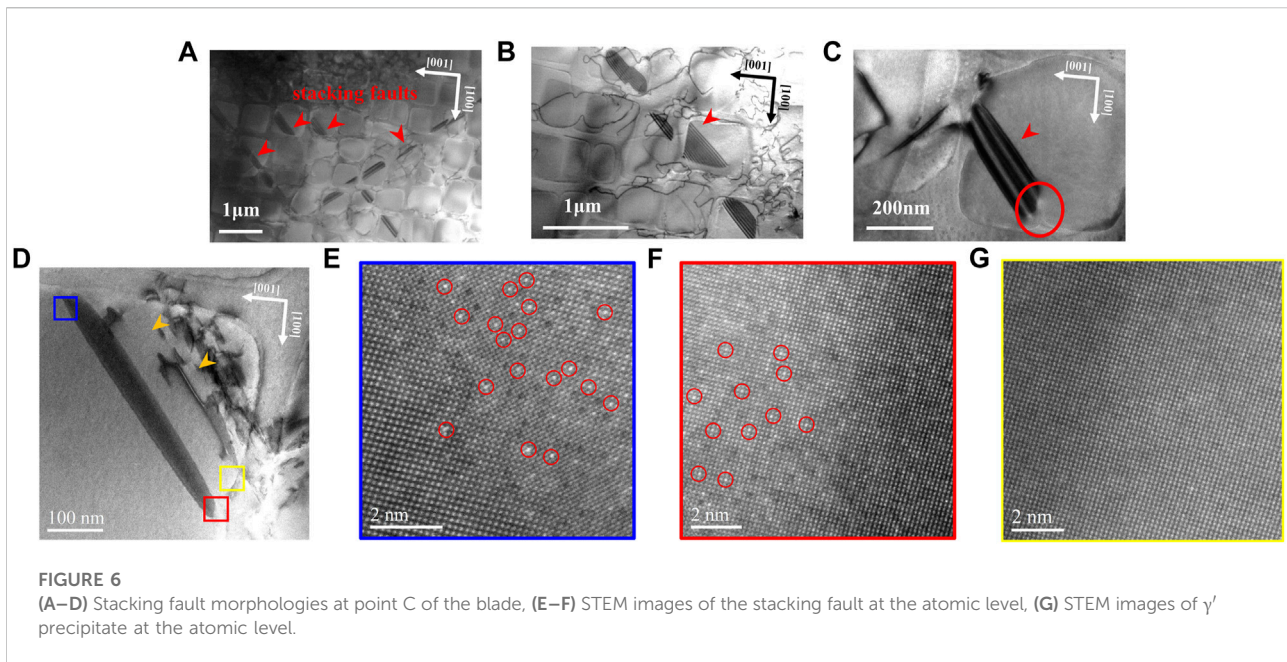
The morphologies of the stacking faults at point C of the blade is given in Figure 6. In Figure 6A, the stacking faults are captured at a low magnification, and it can be observed that there are at least four stacking faults traversing several γ' precipitates in this region, and these stacking faults are intersecting with each other. In Figure 6B is a magnified view of the stacking faults, it can be found that the stacking faults are a set of light and dark parallel lines observed from the $\langle 010 \rangle$ direction. Figure 6C shows the stacking fault in a single γ' precipitate. The position which is marked by the red box indicates that the end of the stacking faults drags the interface of the two-phase, and the other end also has a similar effect but not obvious. The effect of stacking faults on the migration of the interface is essentially the effect of stacking faults on diffusion. To understanding the interaction between stacking faults and elements better, Figures 6D–F gives the atomic level STEM images at both ends of the stacking fault. Since STEM image is a mass-thickness contrast image, the larger the atomic number is, the brighter the atomic image is. It is evident from the Figure 6E and Figure 6F that there is a large number of heavy elements enriched in the stacking fault, which is also observed similarly in the work by Wu et al. (Wu et al., 2020), and the enrichment of elements may lead to a change in the chemical potential near the stacking faults, resulting in the effects of the stacking faults on the diffusion near the interface of the two phases. The atomic images at the two-phase interface are provided in Figure 6G, and it can be seen that there is no significant enrichment of heavy elements in either the γ' precipitates or the γ matrix, which is only present near the stacking faults. Moreover, the enrichment of heavy elements near the stacking faults can also explain the traces left by the stacking faults observed in Figure 4D, where the elements in the stacking faults differ from the surrounding precipitates, leading to different degrees of etching and thus to the morphology of the stacking faults observed under SEM.
