# Fatigue fracture failure analysis of guide valve based on welding defects

Chenyang Du\*, Chang Liu, Xiaowei Li\*, Jianyu Lu, Jun Yuan and  
Baolin Liu

Pressure Vessel Business Unit, China Special Equipment Inspection and Research Institute, Beijing, China

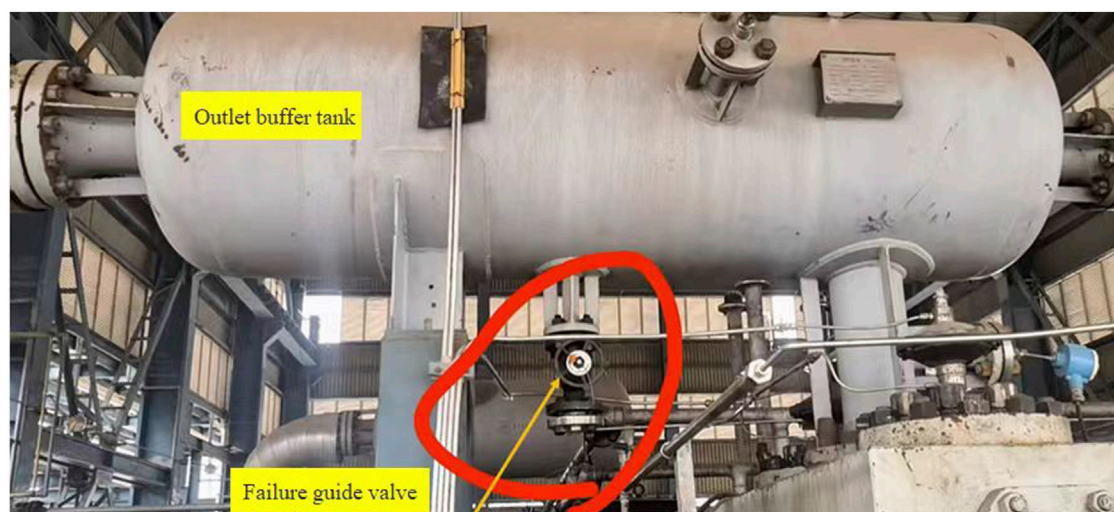
**FIGURE 1**  
Leak location site conditions.

In January 2023, a petrochemical company experienced the sudden detachment of the guide valve located at the bottom of the primary outlet buffer tank (Figure 1) of reciprocating compressor C101B in the diesel hydrogenation unit. This incident resulted in hydrogen leakage from the tank. The outlet buffer tank, positioned at the exhaust end of the compressor, is a type of pressure vessel that primarily dampens pipeline pressure fluctuations arising from compressor operation. Due to its proximity to the compressor and exposure to its vibrations, the outlet buffer tank is subject to fatigue operating conditions. Figure 1 illustrates the layout of the outlet buffer tank, and the failed guide valve is indicated by the red circle in the image.

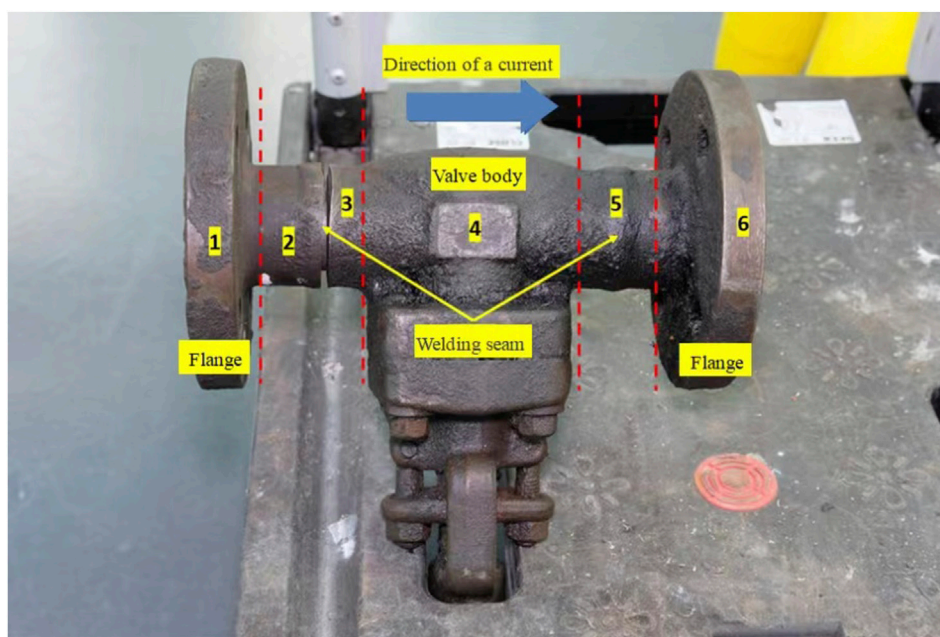
The overall macro image of the guide valve that has failed is given in Figure 2. The fracture of the shower valve is visible, located at the welding seam between the left valve and the flange. The internal medium flows from the left side to the right side of the shower valve, as indicated by the blue arrow in the figure. Consequently, the fracture occurred at the upstream position. To determine the cause of the guide valve fracture, the failed components were subjected to macro-fracture observation, micro-fracture analysis, metallographic examination, hardness testing, and material analysis. The test results were carefully analyzed, and conclusions were drawn. This failure analysis aims to identify the cause of the failure and provide appropriate suggestions and measures to prevent similar accidents in the future, thereby reducing operational risks associated with the equipment.

**FIGURE 2**  
Segmentation of a failed sample.

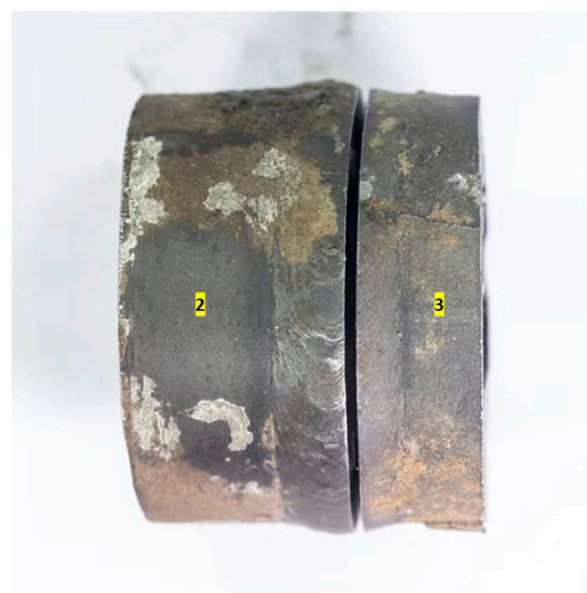
**FIGURE 3**  
Macroscopic appearance of the surface at the failure location.

Upon sectioning the sample containing the fracture, additional macroscopic observation was conducted, and the surface morphology of the fracture is depicted in Figure 3. The surface morphology of the fracture reveals that the entire fracture occurred

within the weld, with the crack tending toward the valve body within the weld region. The fracture surface exhibits a smooth and even crack without any branching. The presence of the weld seam is evident on the surface, while the valve body side and flange side appear smooth, devoid of any corrosion pits.

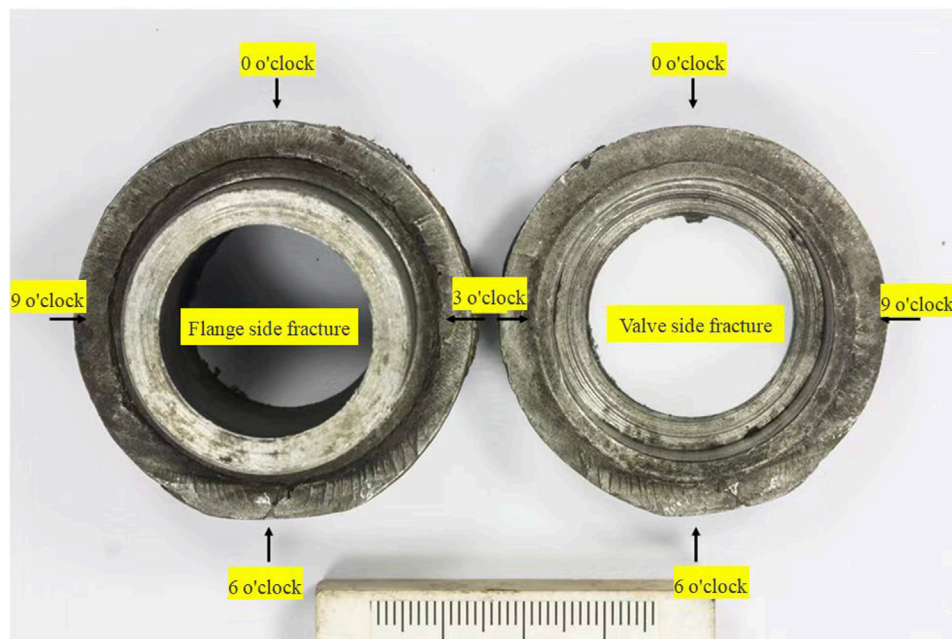
**FIGURE 4**  
Macroscopic appearance of the fracture.

the valve operating rod were designated as 0 o'clock, as depicted in Figure 4. The fracture was examined using a low-magnification stereomicroscope (Stemi 508, ZEISS, Germany). Fracture at 0 o'clock reveals a smooth and flat fracture surface at this location, exhibiting characteristics consistent with fatigue crack propagation. The fracture morphology at 6 o'clock shows many fatigue steps and radial stripes diverging from the inside of the fracture surface to the outside. These features primarily arise from the stress changes that occur as the fatigue crack extends to this point, leading to the expansion of the fatigue crack and the formation of multiple fatigue steps, visually represented as multiple radial stripes. This macroscopic appearance corresponds to the typical features of a fatigue crack source area.

As can be seen from the fracture on the left side of Figure 4, the divergent radial stripes are mainly concentrated in the directions from 4 o'clock to 7 o'clock and from 11 o'clock to 2 o'clock on the figure, and it can be inferred that the fracture originated from multi-source fatigue cracking at these two places, and then extended to the whole valve fracture. The diameter of the valve is 50mm, so it can be calculated that the crack length from 4 o'clock to 7 o'clock is about 39.27mm, and the crack length from 11 o'clock to 2 o'clock is about 39.27 mm.

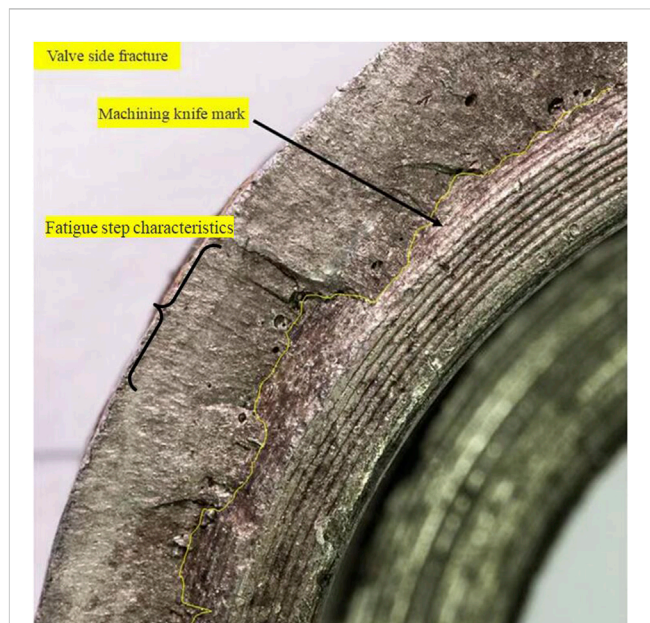
Based on the overall macro-morphology of the fracture, the suspected point of fracture initiation appears to be approximately at the 2 o'clock position. A closer examination of this area is presented in Figure 5. The image reveals machining tool marks on the surface of the valve body, indicating the presence of these marks from when the welding groove was machined. Furthermore, it is evident from the figure that the welding groove at this particular position did not fuse properly. Additionally, numerous fatigue steps were identified on the fracture surface, suggesting that the fatigue crack originated from the inner wall and propagated toward the outer wall. The depth of the unfused defect in the weld measures approximately 3.7 mm.

**FIGURE 5**  
Macroscopic view of cracking location.

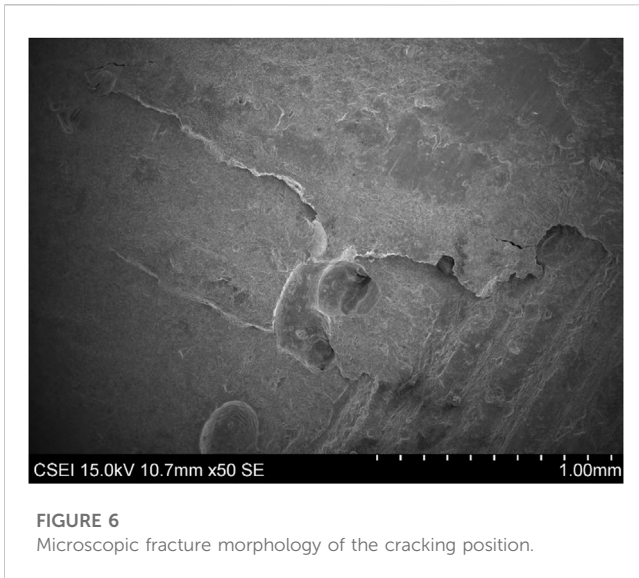
The crack initiation position depicted in Figure 5 was examined using a scanning electron microscope (EVO 10/AZteLiveOne30, ZEISS, Germany). The observations from this examination are presented in Figure 6. Figure 6 displays a micro-fracture where fatigue steps are visible, extending from right to left.

**FIGURE 6**  
Microscopic fracture morphology of the cracking position.

Additionally, at the lower right position, multiple parallel stripe features are evident, which correspond to the machining tool marks left during sample processing. In the figure, the enlarged fracture surface appears smooth, without the presence of any other cracks.

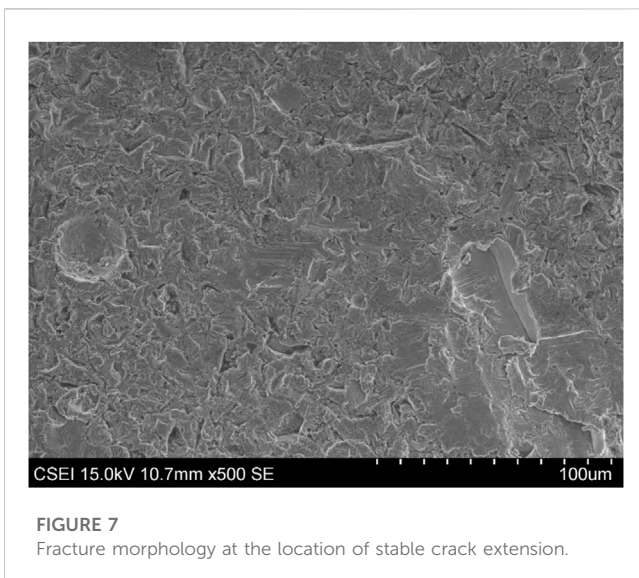
**FIGURE 7**  
Fracture morphology at the location of stable crack extension.

A closer examination of the crack propagation position is illustrated in Figure 7. In the figures, it is apparent that the surface morphology of the fracture surface at the crack propagation position is smooth and devoid of any discernible grain characteristics. In Figure 7, the local fracture surface exhibits signs of contact with other objects.

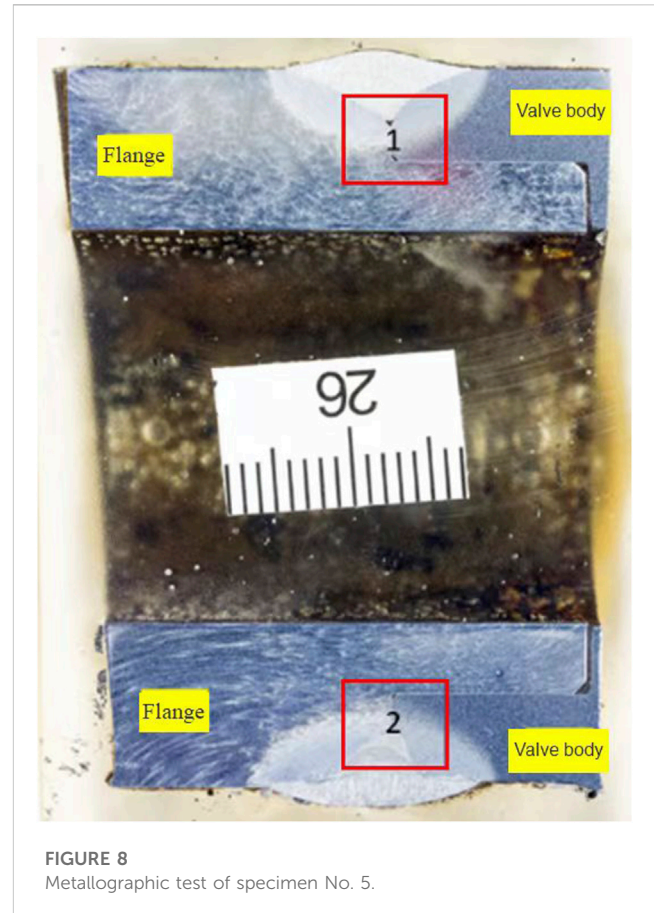
**FIGURE 8**  
Metallographic test of specimen No. 5.

were performed using the AXIO Imager A2 m metallographic microscope (ZEISS, Germany). Figure 8 illustrates the location of the metallographic examination on sample No.5. Two key positions, namely, position 1 (at 0 o'clock) and position 2 (at 6 o'clock), were selected for observation. The metallographic photograph of position 1 is presented in Figure 9. It is evident from the figure that this position corresponds to a weld, specifically the weld joining the flange and the valve body. However, the root of this weld does not form a complete connection between the flange and the valve body, indicating a lack of penetration in the weld. The fusion line between the valve body and the weld was further magnified, revealing unfused defects along the fusion line between the weld and the valve body, consistent with the morphology shown in Figure 5 of the macro photograph of the fracture. It can be observed that there are also unfused defects on the flange side, although the length of these defects is smaller compared to those on the valve body side.

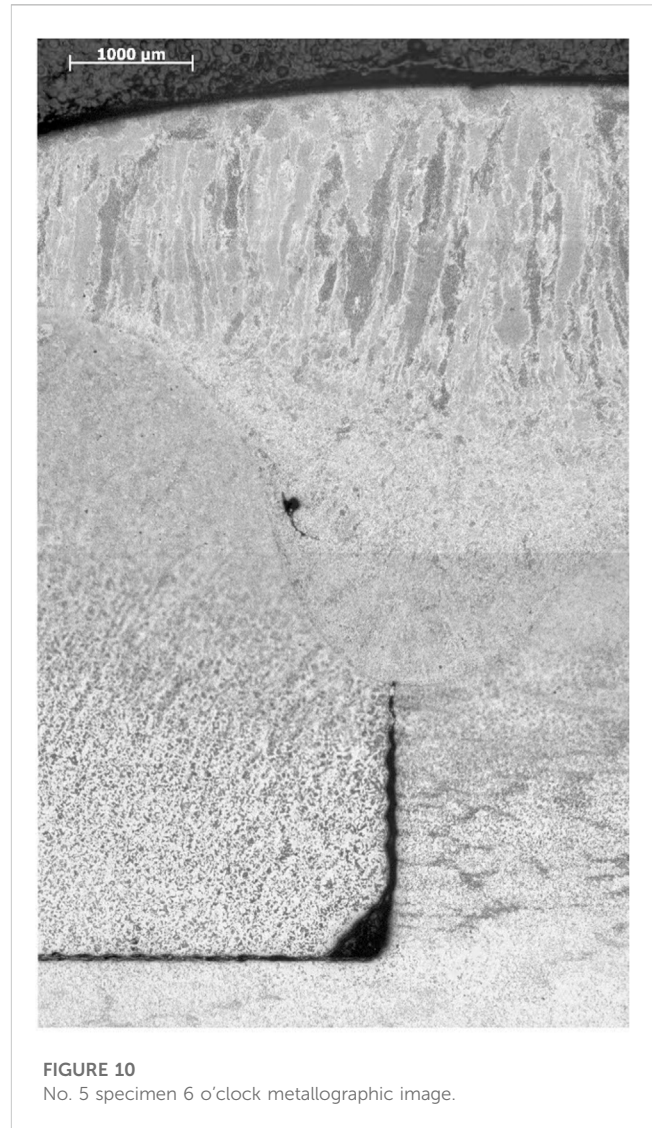
Figure 10 displays the metallographic image of position 2. From the macroscopic morphology, it is evident that this position corresponds to the welding arc-closing and arc-starting point. Consequently, multiple welding features are visible, along with unfused interlayer characteristics within the weld. By zooming in on the region between the valve body and the flange, it becomes apparent that a lack of penetration defect is present. Moreover, this lack of penetration defect exhibits the characteristic of extending toward the weld position.

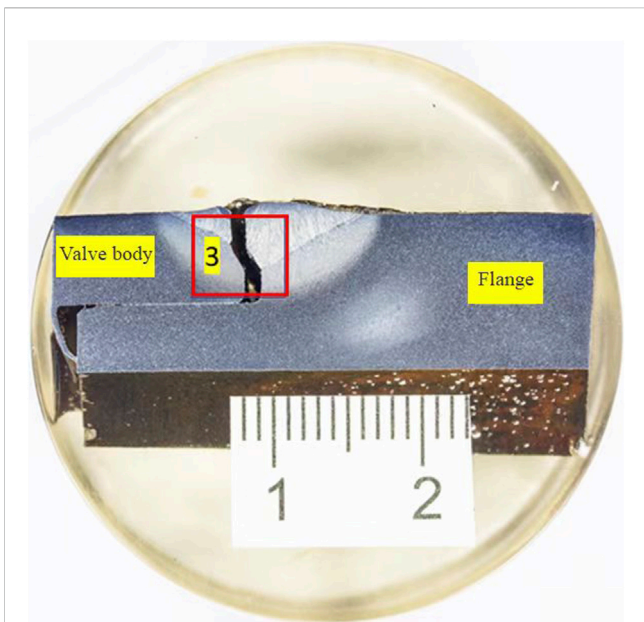
The cracked fracture was reassembled, and a metallographic examination of the cross-section was conducted. Figure 11 presents

**FIGURE 11**  
Cross-sectional metallography of the cracking point.

the metallographic specimen of the section at the crack initiation point. Key area 3 was selected for magnified observation, as shown in Figure 12. The figure reveals the presence of an unfused groove defect on the flange side within this area. The crack propagates from the unfused groove defect toward the outer wall, following a straight

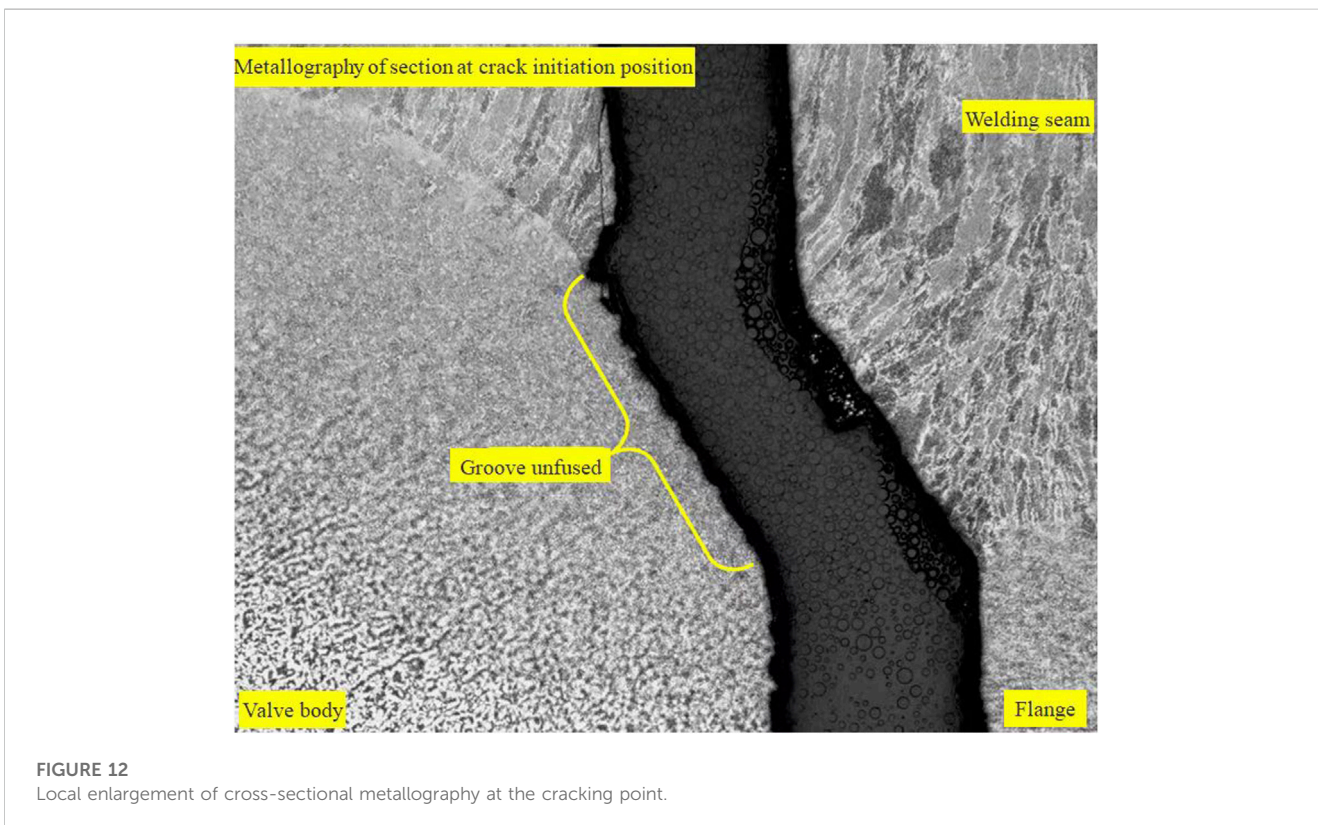
**FIGURE 12**  
Local enlargement of cross-sectional metallography at the cracking point.

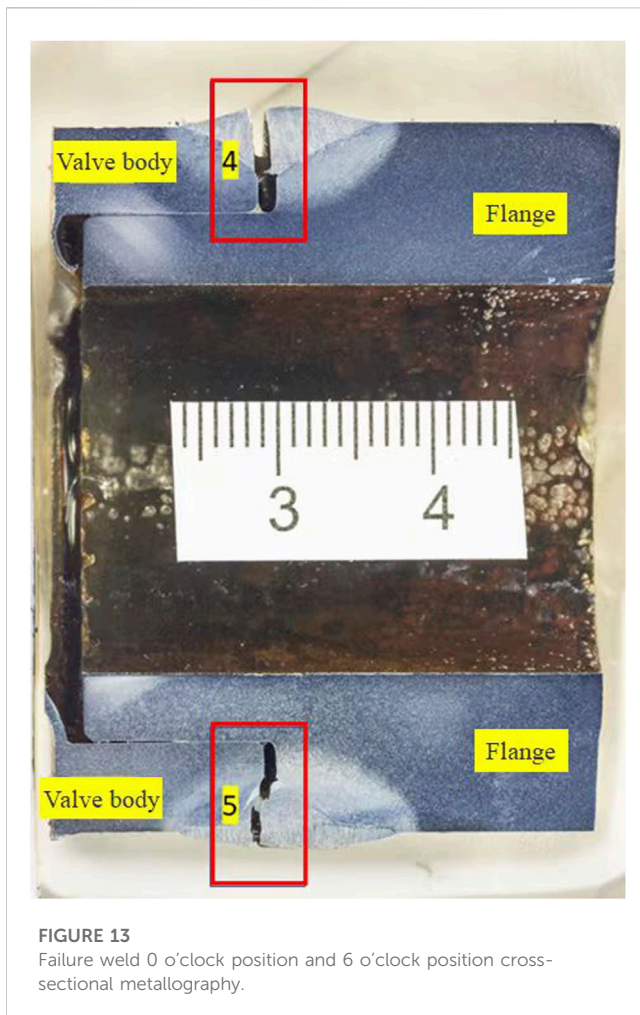
path without any bifurcation. Cross-section metallography was performed at the 0 o'clock and 6 o'clock positions of the failed weld. Figure 13 illustrates the sampling positions. A partial enlargement at the 0 o'clock position is depicted in Figure 14. It can be observed that only one weld is utilized in this area, exhibiting an incomplete penetration defect on the inner side of the weld. The crack, overall, is flat, straight, and devoid of any bifurcation or secondary cracks. From the figure, it is apparent that a lack of penetration defect is also present in the weld. Furthermore, there is a lack of fusion defect in the groove on the valve body side. The characteristics of the crack align with the fatigue characteristics of multi-point initiation from the inner wall position.
