Study of the damage characteristics and corrosion mechanism of tunnel lining in a sulfate environment

Xinrong Liu, Yang Zhuang, Xiaohan Zhou*, Ninghui Liang*, Jinwang Mao and Hai Chen

School of Civil Engineering, Chongqing University, Chongqing, China

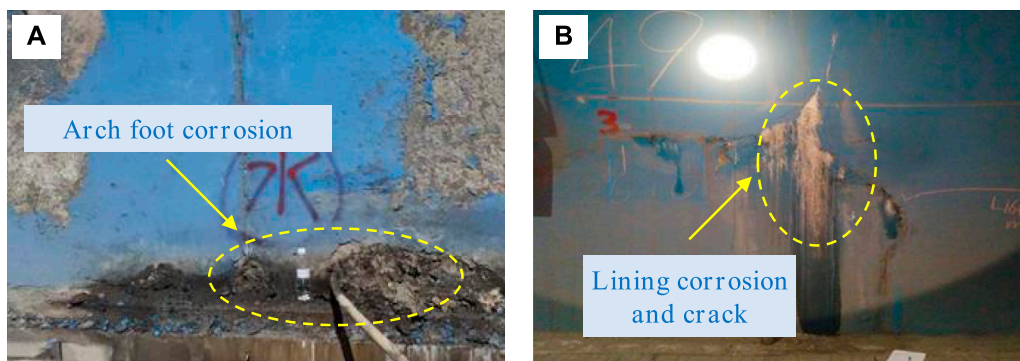
As shown in Figure 2, there were 15 leakage points on the right opening and 23 leakage points on the left opening of the tunnel. The leakage mainly occurred at the arch foot of the tunnel, as shown in Figure 3A, then at the arch waist, and occasionally occurred at the vault. Additionally, the leakage was not isolated but usually occurred with cracks and corrosion in the lining, as shown in Figure 3B. Furthermore, no freezing phenomena were observed during the coldest months.

FIGURE 3
Typical tunnel leakage phenomena at the arch foot (A) and lining cracks (B).

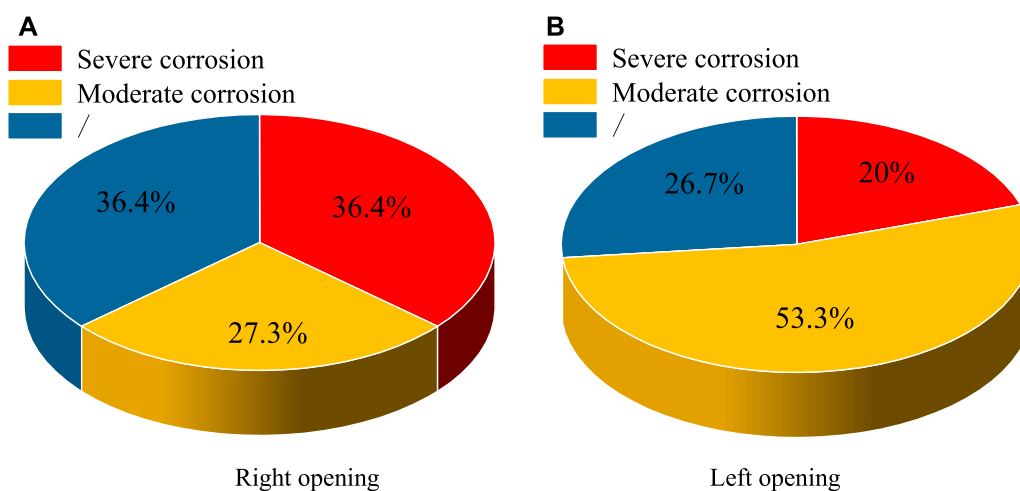
A certain amount of water leakage was collected and analyzed in the left and right openings where the leakage was serious and could be easily sampled. The results showed that the leakage water mainly contained sulfate ions; the concentration of sulfate ions in most of the leakage water was greater than 200 mg/L and the highest was 1,410 mg/L. According to the Code for Durability Design of Concrete Structures in Highway Engineering (JTG T3310-2019), the environmental levels of water in the chemical corrosion environment were divided, and the results are shown in Figure 4. Most of the leakage points in this tunnel were moderately corroded,

but in certain places, the degree of corrosion even reached a serious level.

FIGURE 4
Corrosion degree of water leakage in the right opening (A) and left opening (B).

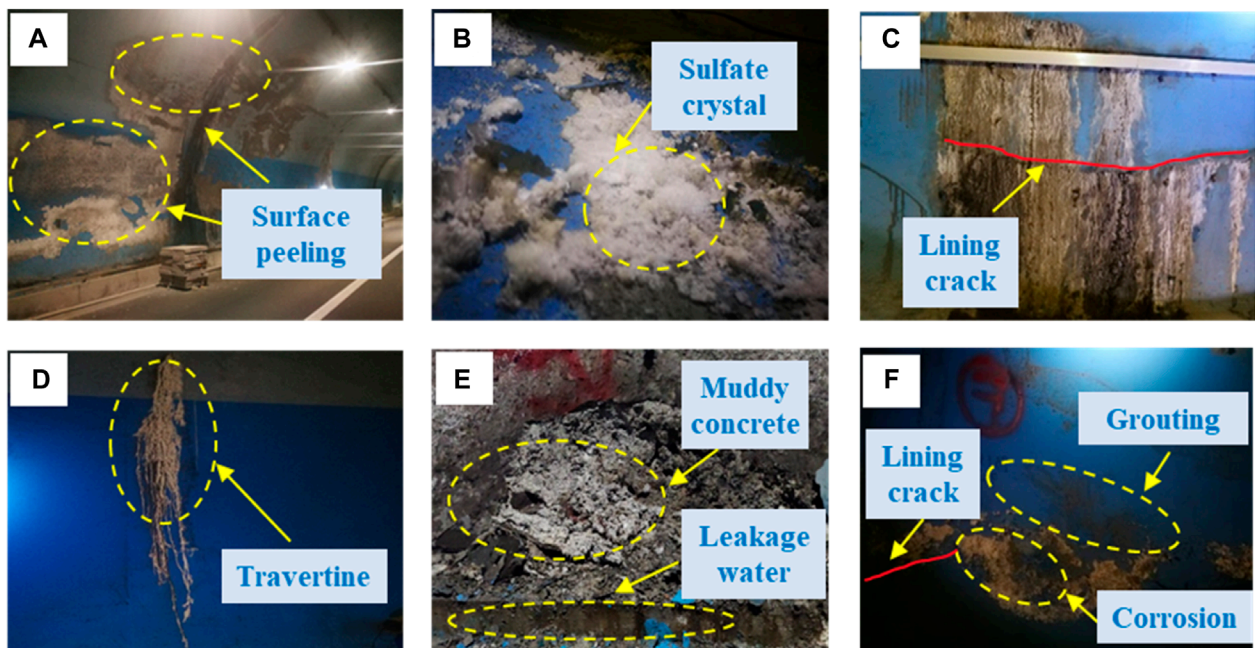
Based on the investigation of the corrosion section of the tunnel, it was found that the corrosion areas were mainly concentrated at the arch foot and waist of the Z1 and Z2 sections of the left opening. This may be because the drainage system of these sections of the tunnel was blocked and corrosive groundwater accumulated in the site, converting the site to a long-term contact site, resulting in lining corrosion.

The corrosion phenomenon is shown in Figure 5. The lining surface, which had a certain strength, was dry and peeled off in large areas, as shown in Figure 5A. Soft white crystals that could be easily removed were present on some parts of the corroded lining surfaces, as shown in Figure 5B. Additionally, the corrosion was deeper in the area of the cracks as shown in Figure 5C. Travertine that was hard and difficult to remove was present in some parts of the cracks, as shown in Figure 5D. Some areas of the arch foot lining were immersed in leakage water, appearing muddy and completely losing their strength, and could be easily observed, as shown in Figure 5E. Cracks and lining corrosion reappeared in some grouting repair sites, as shown in Figure 5F.

FIGURE 5 Corrosion of the tunnel lining: (A) surface peeling; (B) sulfate crystal; (C) lining crack corrosion; (D) travertine; (E) muddy concrete; (F) grouting repair site corrosion.

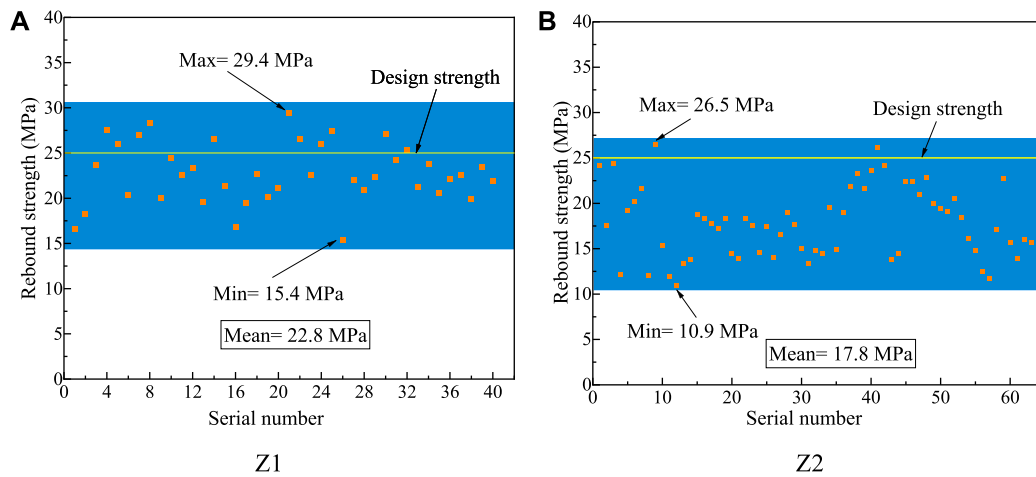
reached or exceeded the design value in terms of strength. The maximum value was 29.4 MPa; this may be due to the initial stage of sulfate corrosion and carbonation, which made the reaction products fill the pores of the concrete, thereby reducing the porosity, and increasing the density and strength. The lowest strength was only 10.9 MPa, which was lower than the design value.

FIGURE 7
Rebound strength of the corroded lining at Z1 (A) and Z2 (B).

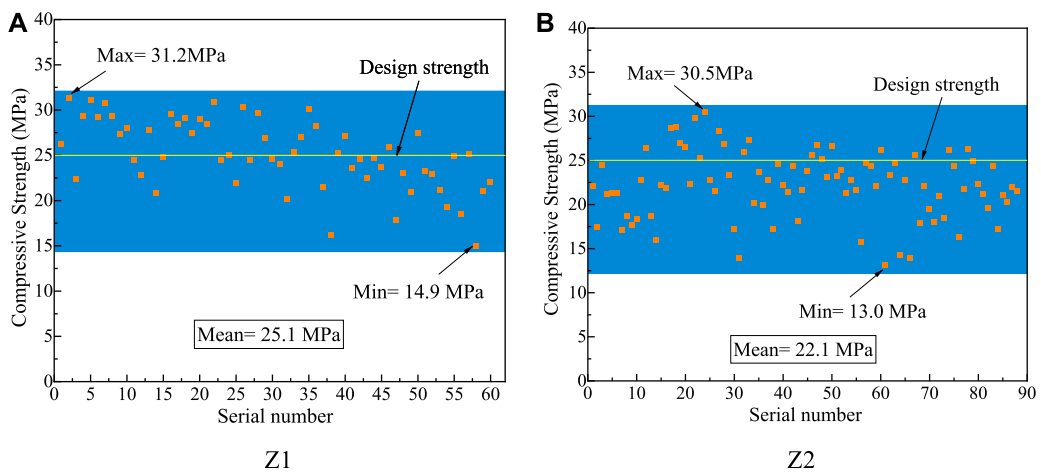
The average strength of Z1 was 25.12 MPa, 50% of which met or exceeded the design standard, and the maximum strength was 31.2 MPa. The reason for this phenomenon may be that part of the core sample came from the lining surface, which had not been corroded, and due to carbonization, the compressive strength increased. However, the lowest strength was only 14.9 MPa, which only reached 59.6% of the designed strength, indicating that the deterioration of the lining was not uniform, and this would lead to stress concentration.

The average strength of Z2 was 22.1 MPa, and only 21.6% reached the design strength, with a maximum value of 30.5 MPa and a minimum value of 13.0 MPa. This indicated that the lining corrosion of Z2 was more serious than that of Z1. After the lining was corroded, the lining material deteriorated seriously, and the lowest strength was only 52% of the designed strength. The safety factor of the structure was greatly reduced, and there were hidden risks that compromised operation safety.

FIGURE 9
Core strength of the corroded lining at Z1 (A) and Z2 (B).

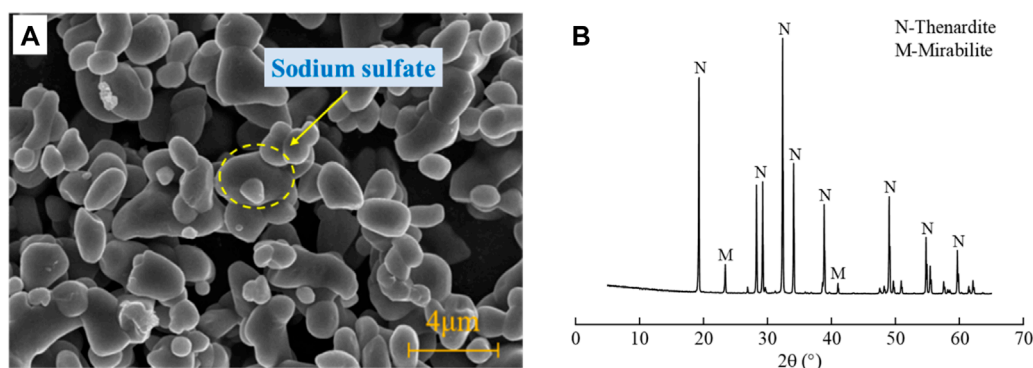
FIGURE 10
Microstructure (A) and XRD pattern (B) of the soft white crystals.

Figure 10 shows the results of SEM and XRD analysis of the white crystals. It can be observed that the white crystals were mainly sodium sulfate crystals, and their microscopic morphology is shown in Figure 10A, with a diameter of 0.2–2 μm. According to the XRD pattern (Figure 10B), the white crystals were mainly a mixture of thenardite (Na₂SO₄) and mirabilite (Na₂SO₄·10H₂O), and the thenardite content was higher.

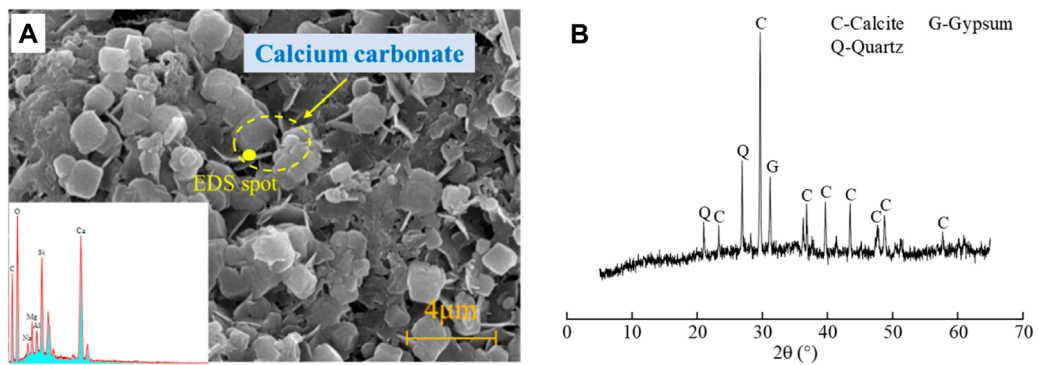
FIGURE 11
Microstructure, EDS analysis (A), and XRD pattern (B) of travertine.

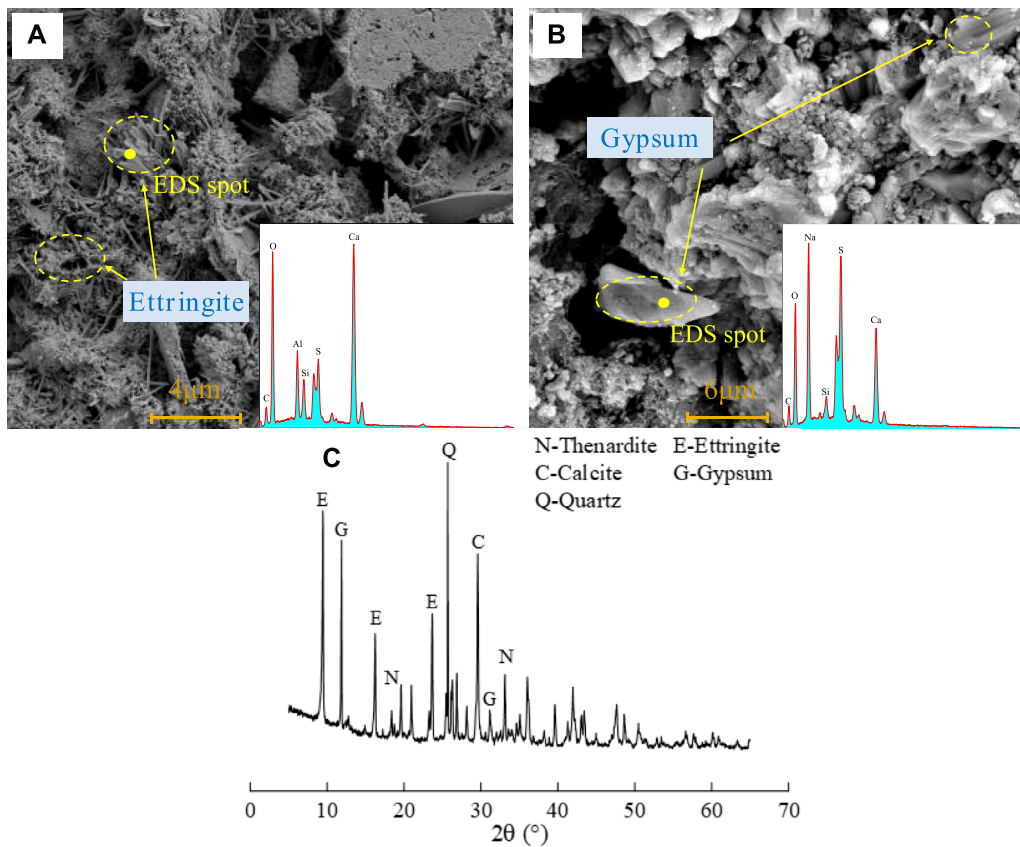
The results of SEM, EDS, and XRD of corroded lining concrete of strength are shown in Figure 12. As can be observed in Figures 12A, B, needle-rod and massive crystals were produced in the lining concrete corroded by sulfate. EDS analysis revealed that the elements Ca, Al, S, O, C, and Si were present in the needle-rod crystals, while the elements Ca, S, O, and Na were present in the massive crystals. XRD revealed that the needle-rod crystals were ettringite, whereas the massive crystals were gypsum. After sulfate had corroded the concrete, common corrosion products such as ettringite and gypsum were produced, demonstrating that conventional chemical corrosion occurred in the tunnel lining.

FIGURE 12
Microstructure, EDS analysis (A,B), and XRD pattern (C) of the corroded lining concrete of strength.

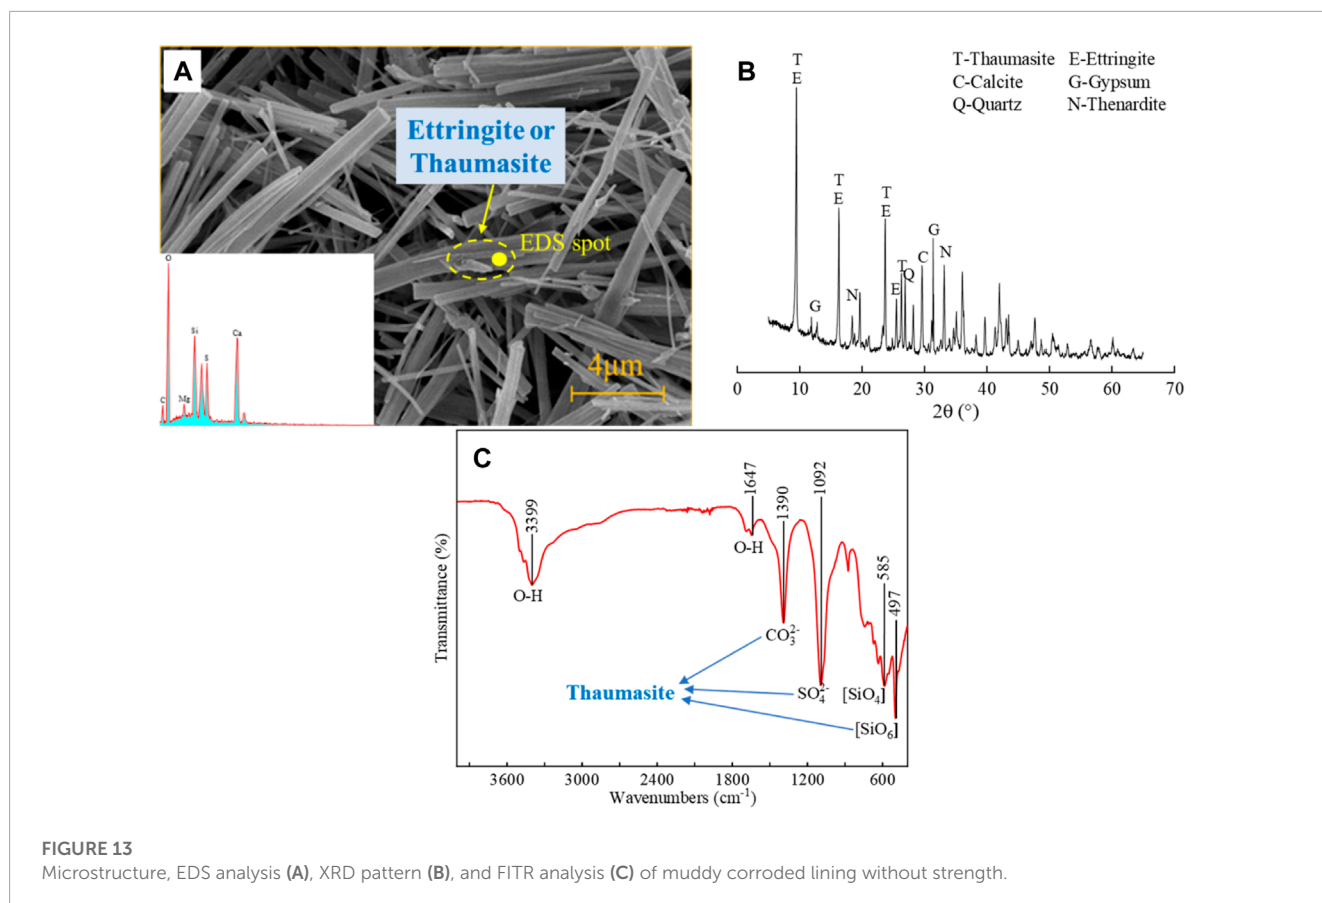
To further determine the muddy corrosion products, the residual powder samples were analyzed by FTIR. The FTIR spectra are shown in Figure 13C, and the wavenumber of important infrared absorption bands refers to the available data (Ma et al., 2019). The results showed that there was a C-O stretching vibration at approximately $1,400\text{ cm}^{-1}$, indicating the presence of CO_3^{2-} . In addition, there was a S-O stretching vibration at approximately $1,100\text{ cm}^{-1}$,

indicating the presence of SO_4^{2-} . Moreover, a peak was detected at 497 cm^{-1} ; this peak was related to the existence of an SiO_6 bond. Octahedral silicon is a rare coordination state for mineral silicates. Therefore, the existence of this peak indicated the presence of thaumasite or solid solution containing thaumasite. Second, no peak was found at approximately 850 cm^{-1} , indicating the absence of AlO_6 . The results of FTIR showed that the composition of the muddy lining concrete was mainly

FIGURE 13 Microstructure, EDS analysis (A), XRD pattern (B), and FITR analysis (C) of muddy corroded lining without strength.

thaumasite. Therefore, a relatively rare sulfate corrosion occurred in the tunnel.
