Franzoni E and Pizzigatti C (2024), Onsite and laboratory assessment of repair mortars for reinforced concrete floor slabs in heritage buildings.

Onsite and laboratory assessment of repair mortars for reinforced concrete floor slabs in heritage buildings

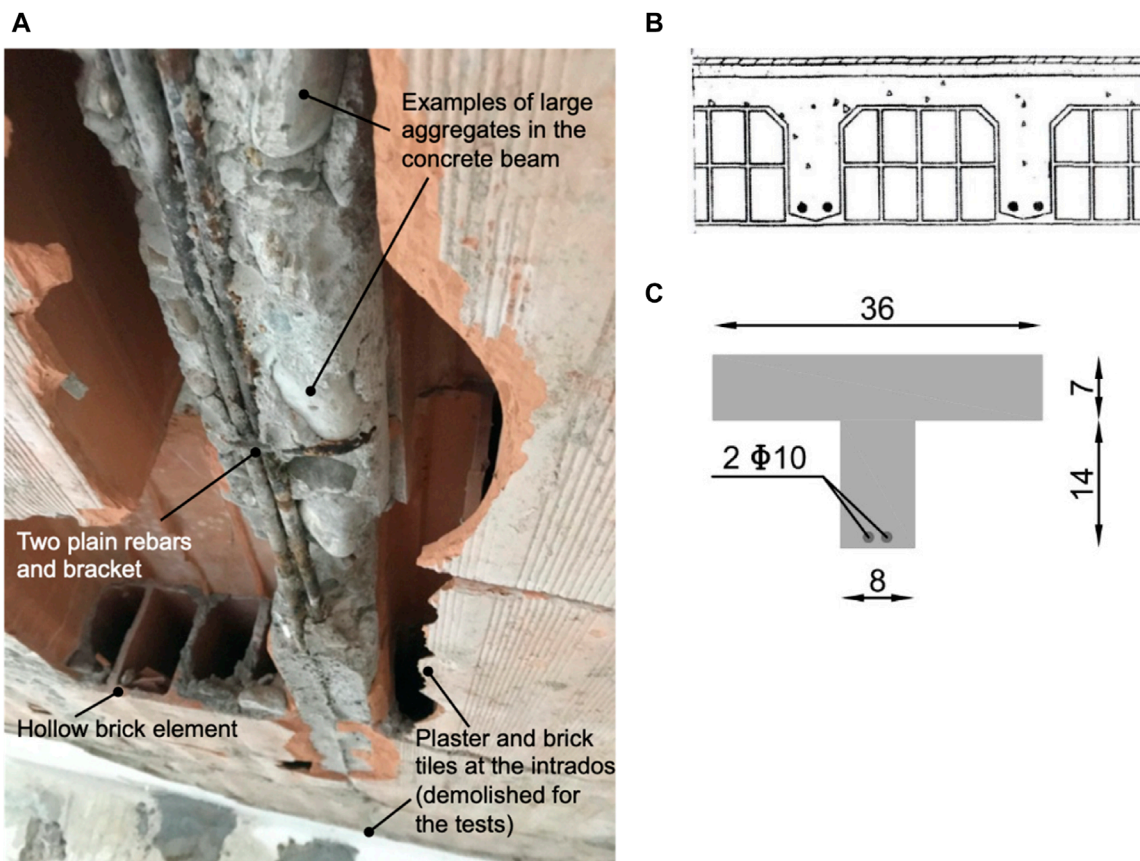
FIGURE 2
(A) Detail of a beam after the demolition of the layers underneath: it is possible to see the large size of the gravel and the irregular position of the longitudinal steel bars; (B) sketch of the reinforced concrete and hollow tiles mixed floor; (C) size of the reinforced concrete beams (sizes in cm, diameter of the rebars in mm).

layers of thin hollow brick and plaster were demolished and four reinforced concrete ribs (beams) were entirely exposed (Figure 2A). These beams were characterized by exceptionally large aggregates (size up to 8 cm, Figure 2A), totally unfitting to the cross section of the beam, which is 8 cm large. In fact, visible gaps and voids were observed in the beams, confirming that casting the fresh concrete into the formworks was difficult. Likely, at the age of construction the provincial workers were not familiar with concrete yet. At the bottom of each beam, two plain rebars having diameter 10 mm were present (Figures 2B, C). These rebars were placed in a very inaccurate way, i.e., not symmetrically and directly on the formworks, resulting in an almost nonexistent concrete cover. Rust was observed over the rebars' surface.

Given the low quality of concrete and the presence of rust over the steel reinforcement, it was decided to clean the rebars and apply repair mortar at the intrados, reprofiling the beams without any change of size, as requested by the authorities. The application of additional strengthening solutions at the beams' intrados, such as fiber-reinforced composites, will be evaluated in the future, after the modelling of the seismic behaviour of the building. Three different repair mortars were tested, in the beams A, B and C, respectively (Figure 3). Each beam was ideally divided into three parts having length 80 cm (parts I-III), which were subjected to different treatments:

- In Part I, concrete was removed all around the reinforcing bars, and rust was manually cleaned by steel brush (Figure 3B). Then, the original profile of the beam was recreated by applying a repair mortar.
- In Part II, concrete was removed only in the cover part, i.e., below the steel rebars, and rust was manually cleaned by steel brush only from the exposed surface of the bars (Figure 3B). This condition was investigated to mimic what could happen in practice, if a less radical demolition is carried out. Then, the original profile of the beam was recreated by applying a repair mortar.
- Part III was left without any mortar application, for reference.

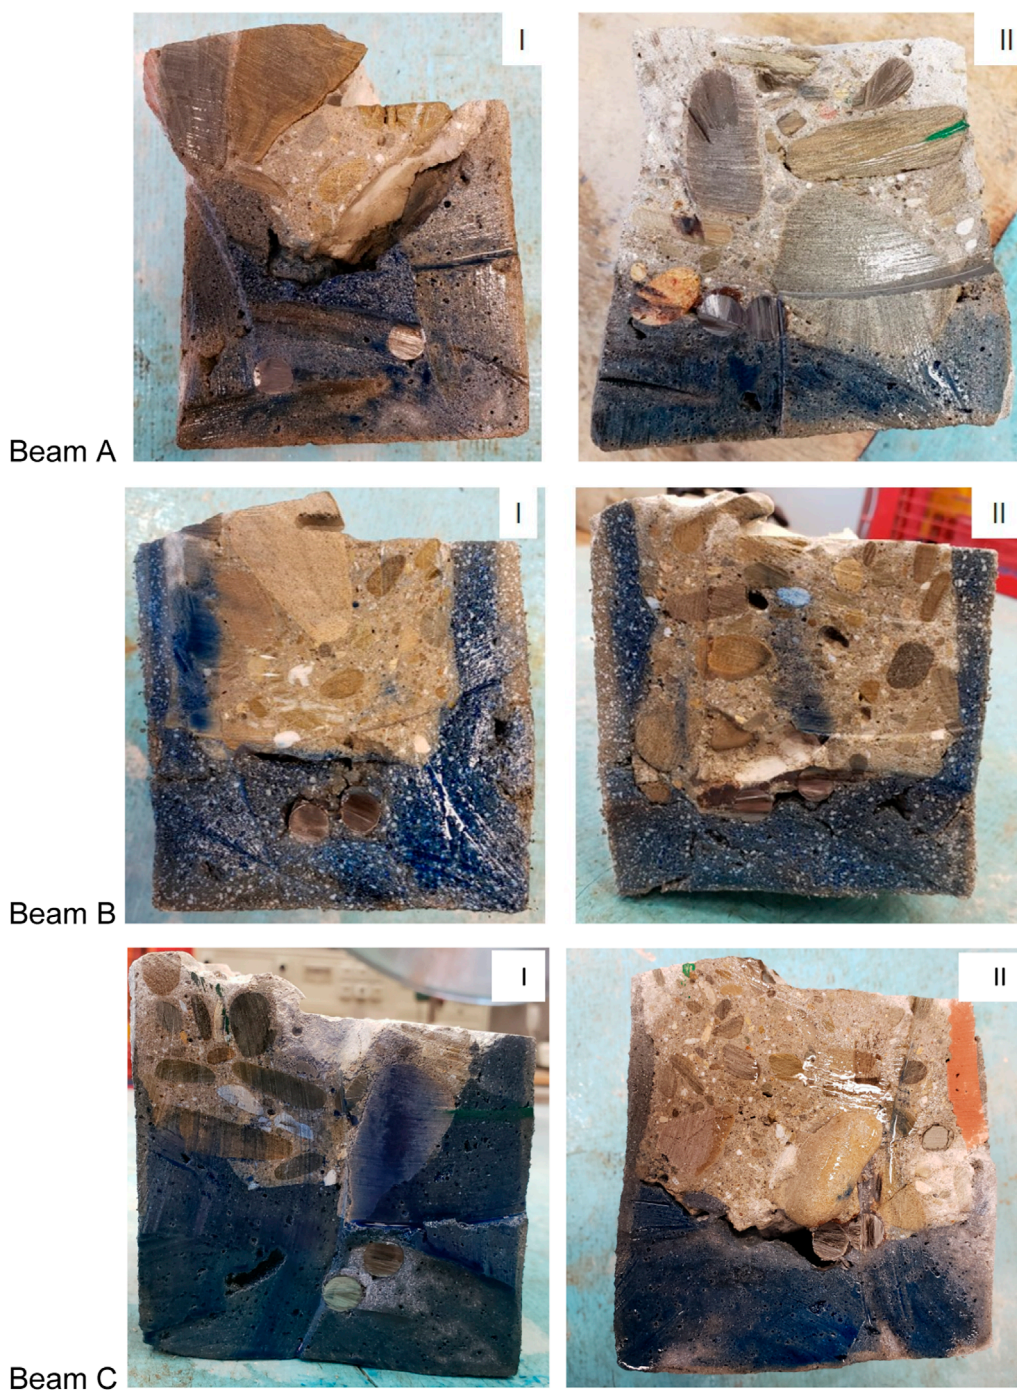
FIGURE 7 Colorimetric tests performed by thymolphthalein on the cross sections of beams (A–C) (some circular blue traces on the concrete are due to the powder of repair mortars spread by the angle grinder during the cut).

The colorimetric test by thymolphthalein (Figure 7) highlighted that the original concrete was entirely carbonated, while all the repair mortars were highly alkaline, as expected. The pH values measured in the positions of Figure 5 are reported in Table 1. The two set of measurements taken after 24 and 48 h in water (see Section 2.2.1) were basically identical, hence the pH values reported in Table 1 are their average. The original concrete exhibited an average pH equal to 9.5, while the new mortars resulted quite similar each other and with an average pH of 12.4. It is difficult to say if some re-alkalization of the original concrete occurred as a consequence of the application of the new products, because the pH of concrete close to the interface (sampling position 2 in Figure 5) was in some cases

unaltered and in some cases slightly higher, so drawing conclusive remarks was not possible. However, even when improved, the pH or the original concrete adjacent to the repair mortars only reached values equal to 10.6, 11.8, and 10.1 (in parts I of beams A, B and C, respectively), so not enough for protection conditions.

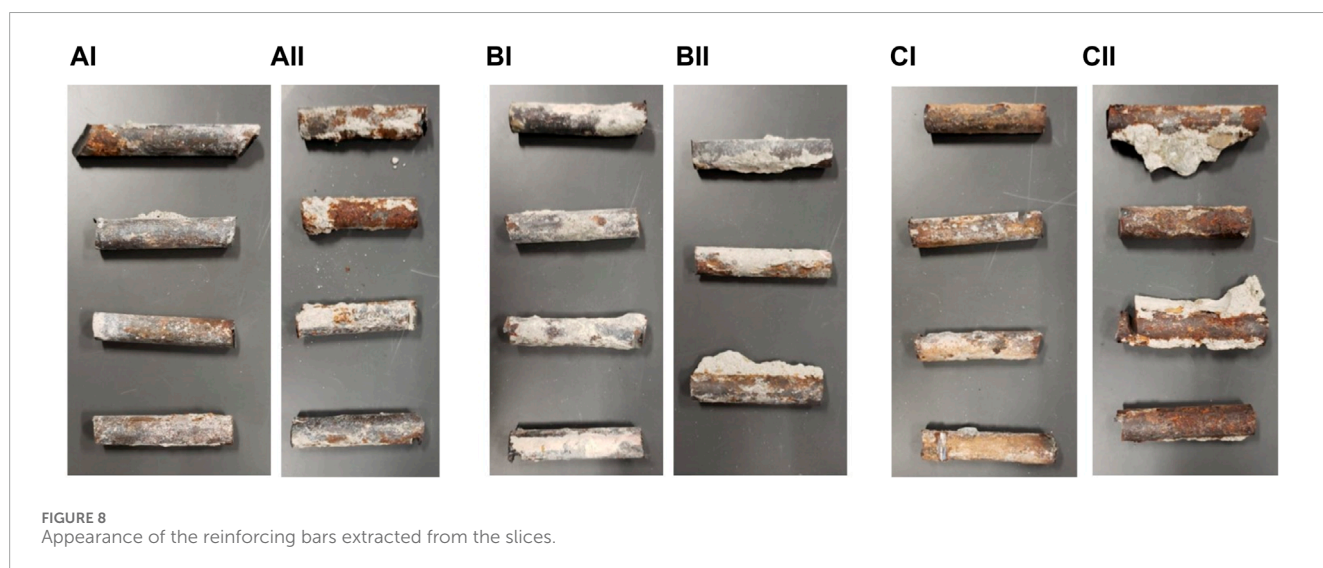
The appearance of the reinforcing bars extracted from the slices of the beams is shown in Figure 8. Although the photos provide no insight into the corrosion depth, they show at a glance how rust is present almost everywhere, despite the cleaning of the rebars before the application of the repair products, thus steel brushing was not effective enough in removing the corrosion products. This observation is consistent with the data of the corrosion potential described above. The shiny patina in A I is due to the corrosion inhibitor, while the white layer covering the reinforcement in B I is due to the passivating paste. In C I, the light brown color of the steel is likely due to some mixing between the rust powder and the repair mortar.

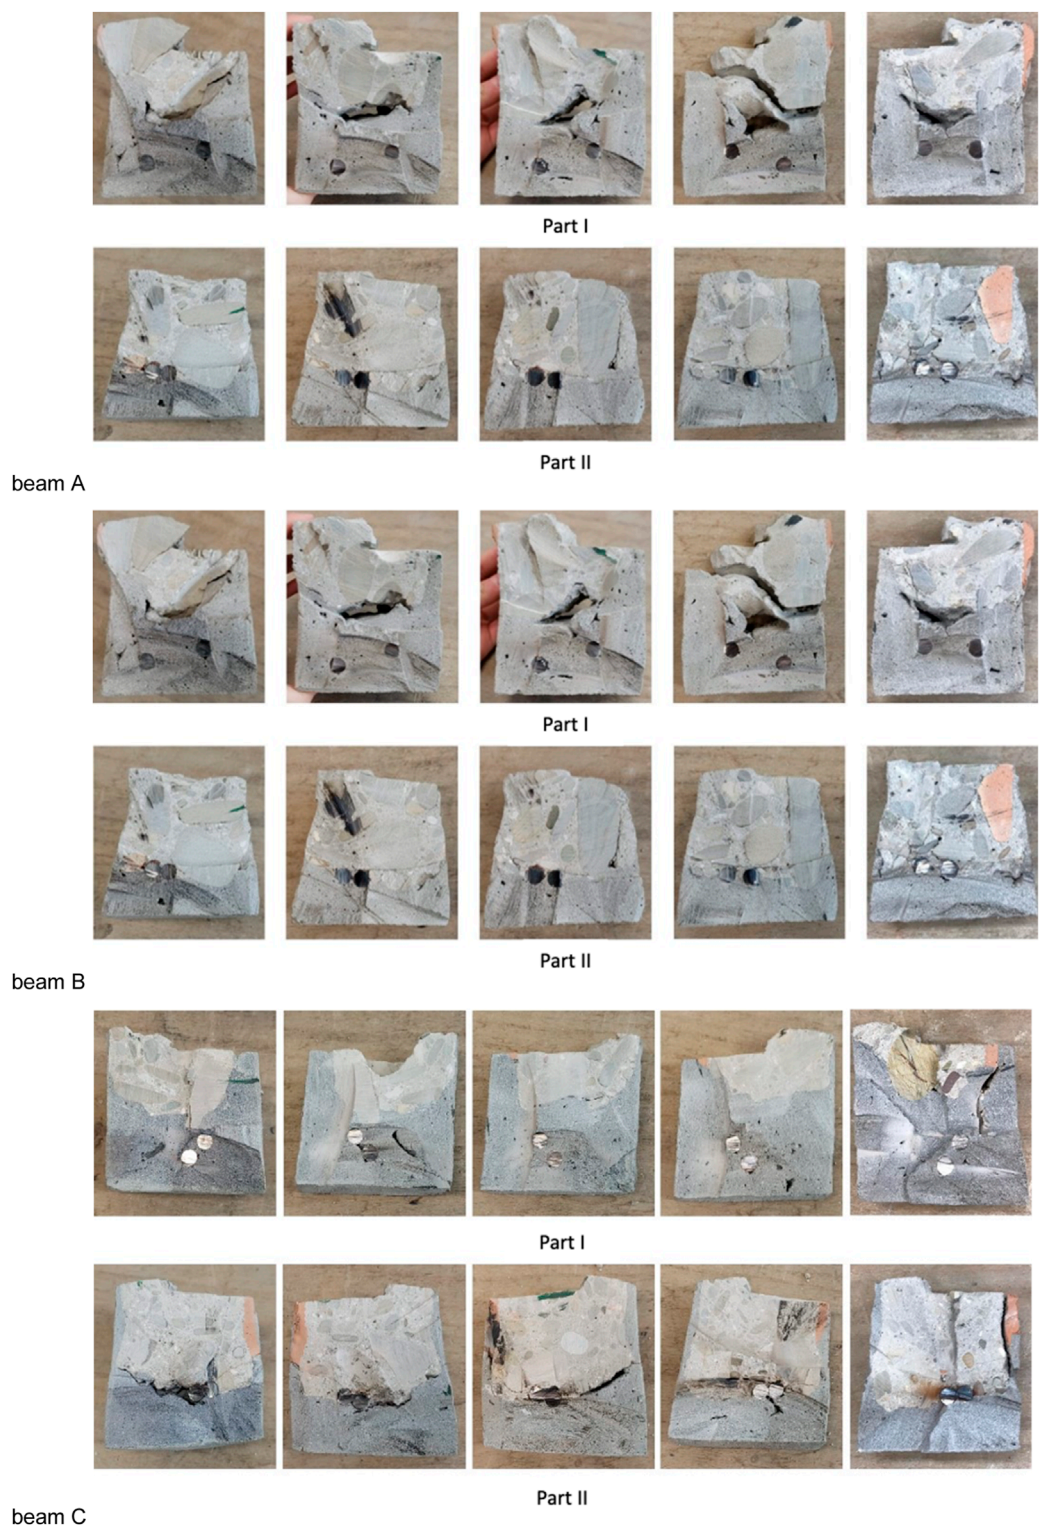
FIGURE 10
Appearance of the cross section of the slices.

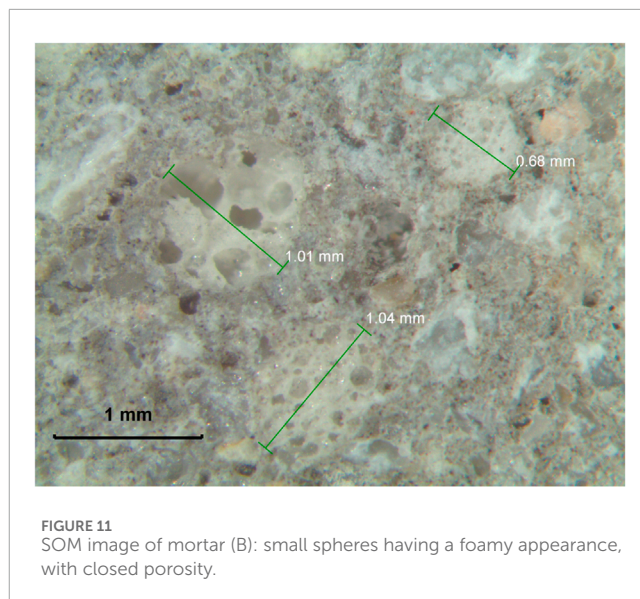
FIGURE 11
SOM image of mortar (B): small spheres having a foamy appearance, with closed porosity.

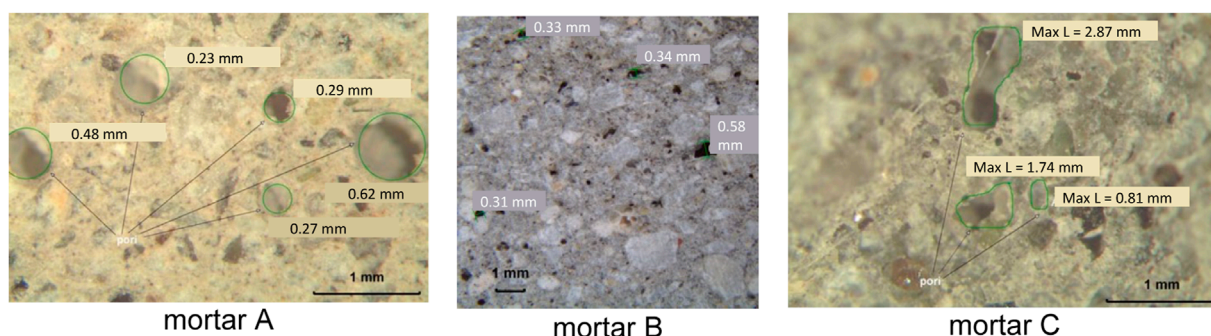
FIGURE 13 Air voids in mortars (A–C), observed by SOM.
