Operational and structural diagnosis of sewerage and drainage networks in Côte d'Ivoire, West Africa

In Cote d'Ivoire, the failure of urban sewage systems is a crucial problem for the drainage of wastewater and rainwater. This failure is due to many factors and therefore, calls for diagnostic studies. The present study aimed at analyzing these networks in order to identify the different factors that contribute to the operational and structural degradation in selected sewerage and drainage networks in Abidjan, Cote d'Ivoire. The method used in the study involved semi-structured interviews, video camera inspection and socio-environmental field surveys (geographical survey and household survey), followed by descriptive statistics. The results revealed that many structural, environmental and behavioral practice contribute to the progressive degradation of urban sewage systems. These factors are essentially those that prevent the normal flow of wastewater in the pipes such as the illegal dumping of solid waste, the unauthorized connection of wastewater networks, unsustainable urban agricultural practices, as well as the high concentration of vegetation on both sides of the network and

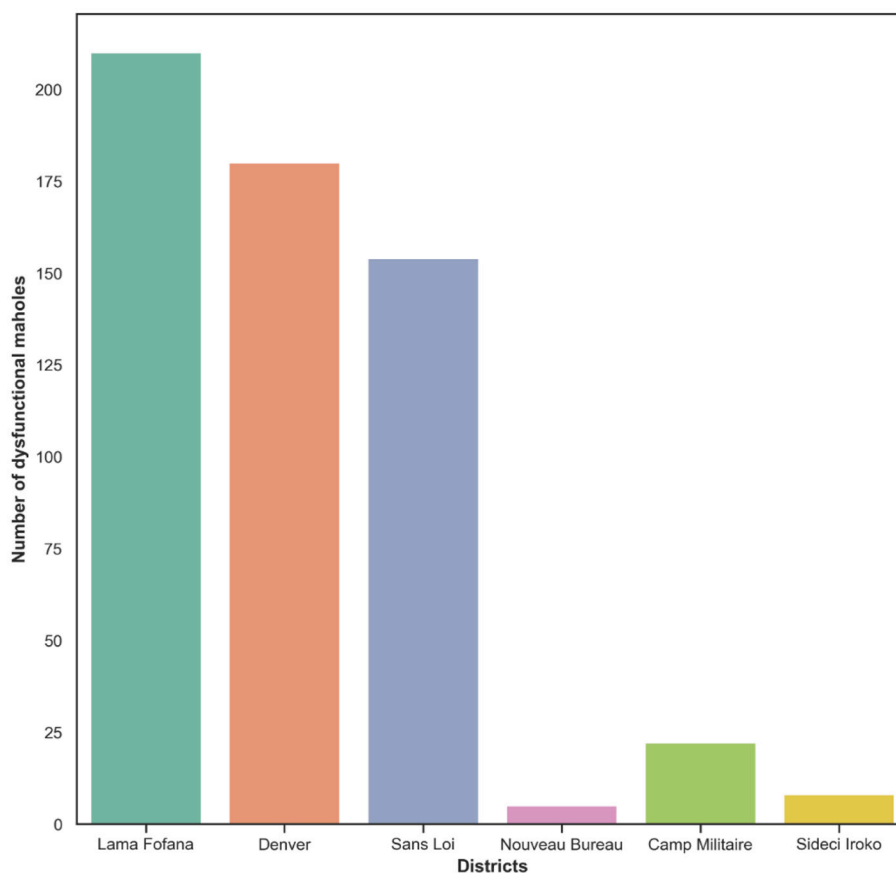
FIGURE 5
Distribution of failed manholes along the sewer system.

Ultimately, this situation worsens and sewer backups or odors from the sewer are observed in the different neighborhoods in the area. In total, 210 backflow manholes were detected in Lama Fofana representing 34.25% of the backflow manholes observed along with the system, 180 in Denver representing 26.4%, 154 in Sans Loi representing 25.12% of the backflow manholes, 5 in Nouveau Bureau representing 0.9%, 56 in Camp Militaire representing 9.15% and 8 in Sideci Iroko representing 1.40%. Figure 5 presents the number of manholes along the sewer network.

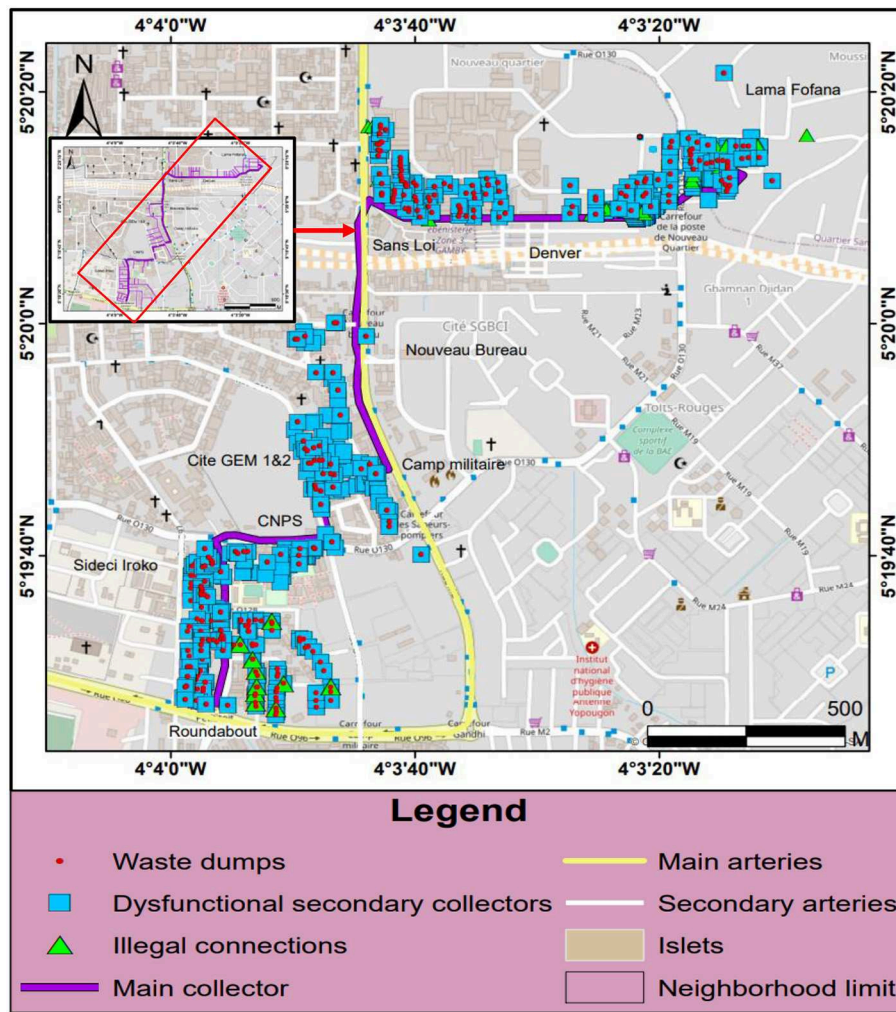
FIGURE 7 Spatial distribution of the different anthropogenic degradation factors along 21/22 collector.

In the first part of the 21/22 collector, the geographical survey identified a total of 136 garbage dumps. These deposits represent 59.11% of the total waste observed in this area. Supplementary Figure 5 shows some of the waste found at the dysfunctional manholes in Lama Fofana, Denver, and Sans Loi districts. This waste is generally composed of tree slices, old mattresses, and municipal solid waste resulting from poorly planned urbanization. These deposits are almost entirely located on sewer manholes. Since most of the manholes are dysfunctional. The waste eventually find their way into the network, creating blockages and backflow. The water can no longer circulate and leave the network. Thus, one can observe the stagnation of wastewater favoring the development of anopheles lava which puts the health of residents at risk. This situation was observed throughout this area. The

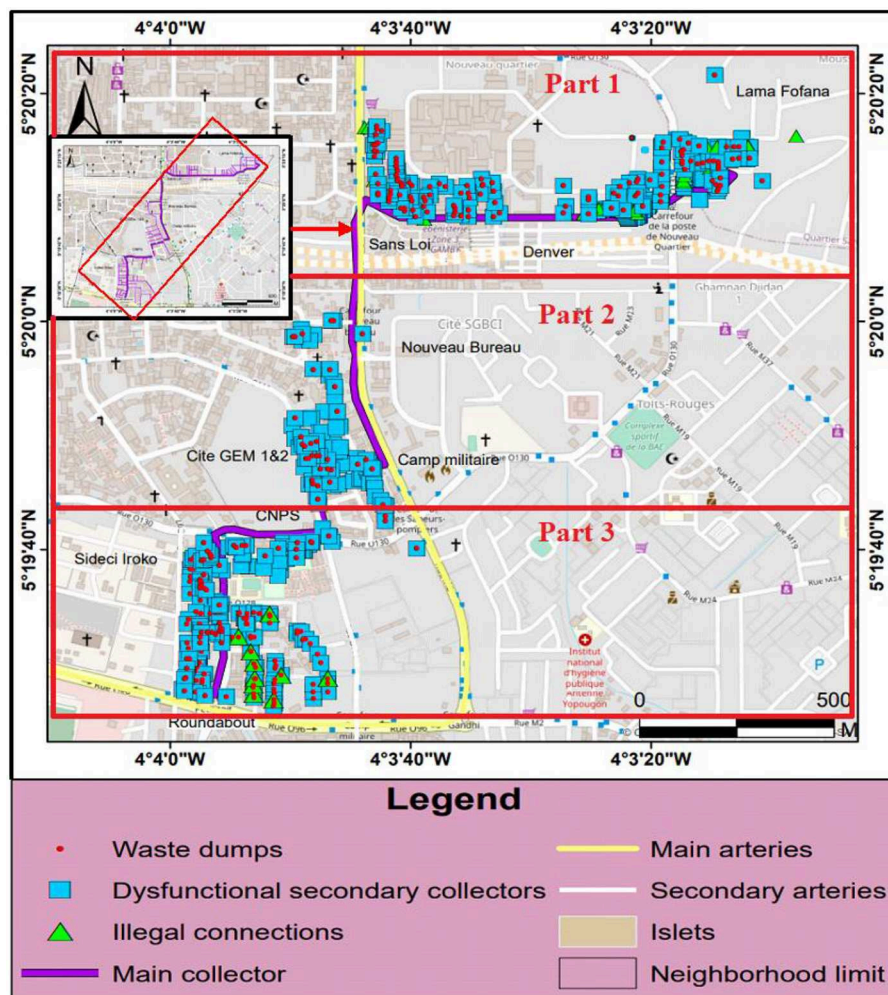
FIGURE 8 Spatial distribution of anthropogenic failure factors in each part of the 21/22 collector.

proportion of waste observed in this first part was as follows: 70 deposits in Lama Fofana, 25 deposits in Denver, and 41 deposits in Sans Loi. Figure 8, Part 1 presents the spatial distribution of anthropogenic factors of dysfunction in the first part.

Militaire market at the end of the GEM3 housing estate. The second branch was in front of the Nankoko pharmacy. The failures factors in this section are presented in Figure 8 part 2.

As for the anarchic and defective connections of waste water evacuation in the last part, 31 anarchic connections (i.e., 12.39%) were listed on both sides of the main collector. These connections were practically implemented by the residents in precarious conditions. This practice hurts the network, leading to serious problems of dysfunction in the area. The diameters of these connections vary from 40 mm to 120 mm. The malfunctioning of the network in this area was much more evident on the side of the Lycée Saint Francois and at the level of Saint Francois Roundabout. The spatial distribution of anthropogenic malfunction factors in the third area are presented in Figure 8 part 3.

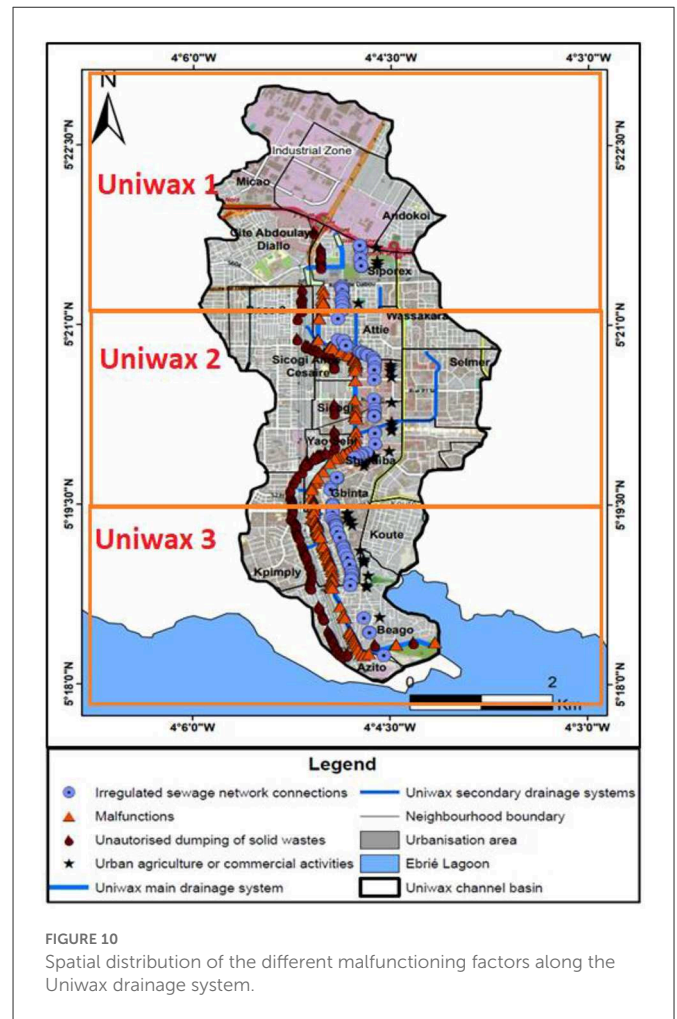
FIGURE 10 Spatial distribution of the different malfunctioning factors along the Uniwax drainage system.

Thirty one malfunctioning problems were observed in the different districts located in UNIWAX 1. These problems represent 16.40% of the malfunctioning problems. The network was clogged with sand and solid waste in its major parts in Cité Abdoulaye Diallo up to the level of Lycée Technique. At the level of Banco 2, just after the Banco 2 Bridge, several areas of obstructions were identified in the canal, thus highlighting the total dysfunction of the channel. The channel was either exposed or broken (3.5%), cracked (2.6%), broken (5.9%), or blocked (4.4%). The network in this areas was in an advanced state of degradation and was not developed. This situation led to poor drainage of rain water, causing the rise of water

In UNIWAX 2, a total of 76 structural dysfunction problems were identified, i.e., 40.21% of the dysfunction problems along the canal. The most important were in Sicogi Aimé Césaire, Yaosehi, and Gbinta. Also, the geographical survey identified several obstruction zones on the canal (42.10% of the canal was totally blocked by illegal waste deposits). As for other structural problems, 27.63% of the system was bare, the most critical being in Sicogi Aimé Césaire and Yaosehi (see Supplementary Figure 9); 14.49% of the network was broken and 15.78% was affected by erosion and landslides. Also, in the Gbinta district, the dysfunction was materialized by a progressive widening of the canal due to the phenomenon of erosion and landslides.

With regard to the question related to the structural problems of the drainage system in UNIWAX 3; 82 problems were identified representing 43.39% of the structural malfunctions along the network. These problems were considered to be those that prevent the system from functioning properly in the 3 neighborhoods located in the latter area. All these problems observed in the channel were due to the fact that either the canal was blocked (61.84%), broken and
