Chang S-H, Lin K-Y and Yu C-C (2025) Case Report: A minimally disruptive technique for the management of frozen leads. *Front. Cardiovasc. Med.* 12:1518177. doi: 10.3389/fcvm.2025.1518177

# Case Report: A minimally disruptive technique for the management of frozen leads

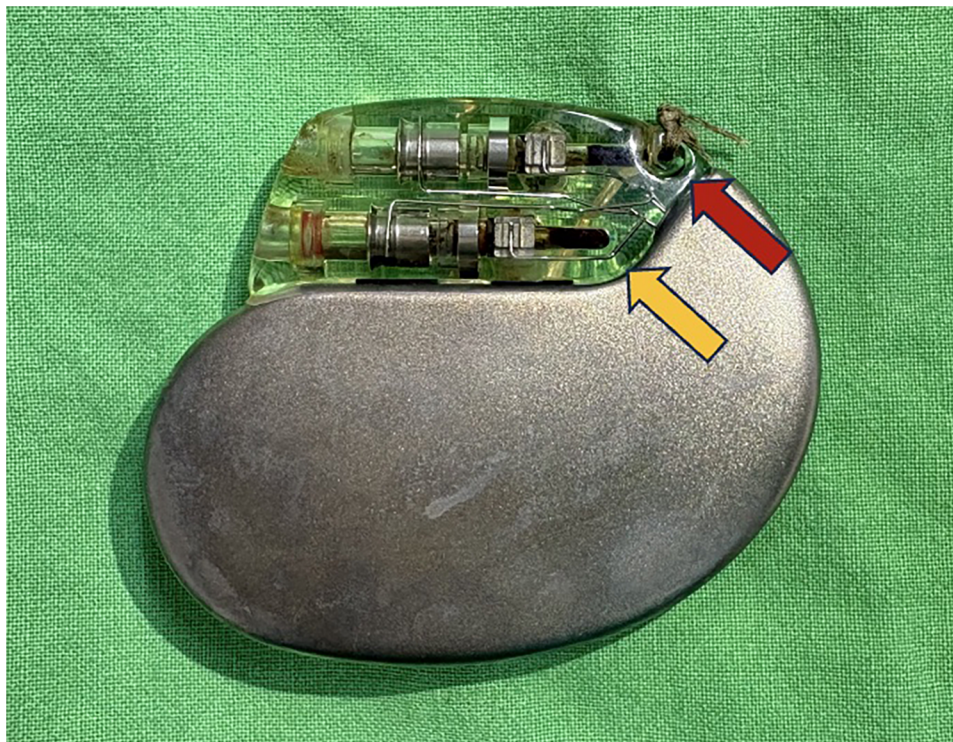
In the operating room, following a skin incision and dissection of the surrounding tissue and capsule, the old pulse generator was successfully extracted. Upon inspection, an unusual dark brown discoloration was noted in both pin ports (Figure 1). While the RV lead was easily unscrewed, difficulty was encountered with the RA lead. The screwdriver was unable to properly engage the set screw through the silicone plug, the mechanism of which was unclear. Despite attempts to manipulate the screw from various angles and cleaning the hexagonal socket with fine tweezers and a needle, the screw remained inaccessible.

FIGURE 1  
The dark brown discoloration of the RA (red arrow) and RV (yellow arrow) pin ports.

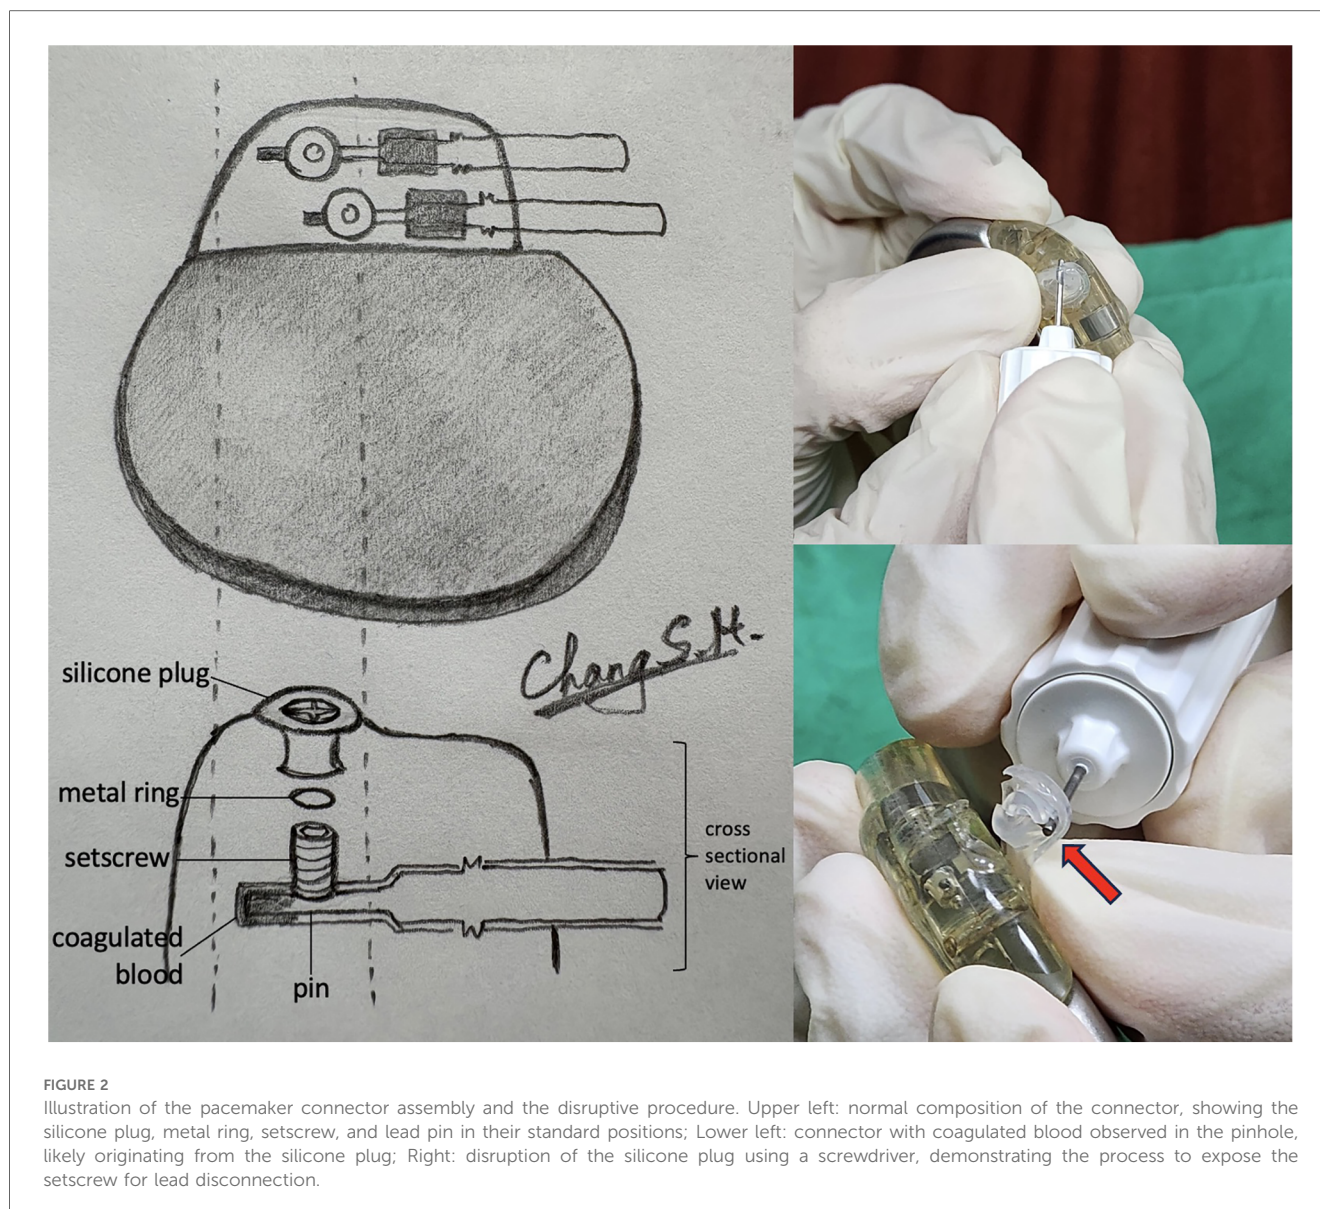
**FIGURE 2** Illustration of the pacemaker connector assembly and the disruptive procedure. Upper left: normal composition of the connector, showing the silicone plug, metal ring, setscrew, and lead pin in their standard positions; Lower left: connector with coagulated blood observed in the pinhole, likely originating from the silicone plug; Right: disruption of the silicone plug using a screwdriver, demonstrating the process to expose the setscrew for lead disconnection.

with a surgical drape prior to disrupting these parts for preventing any components loss. An illustration of the normal position of silicone plug, metal ring, setscrew, pin with coagulated blood, and the disruption procedure were provided in Figure 2. After disrupting the silicone plug, a small metal ring was exposed. Once the metal ring was removed, direct visualization of the hexagonal socket was achieved. Additional cleaning with a 22-gauge needle allowed the screwdriver to securely engage the socket, and the RA lead was successfully unscrewed (Figure 3). Upon testing, the parameters of both leads were within normal limits, with the RA lead impedance reduced to 1,175 ohms.

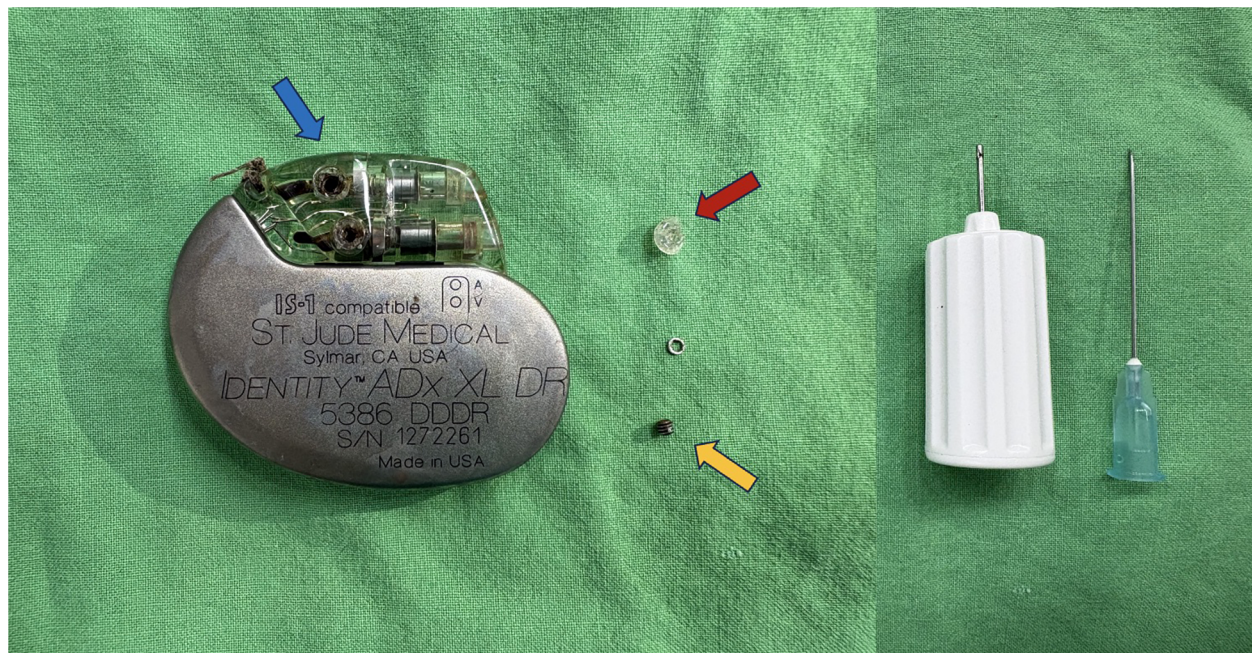
FIGURE 3

setscrew damage has been reported as the most common cause of “frozen lead” (3), we emphasize the importance of identifying the root cause by removing the silicone plug. In our case, some blood clots had accumulated at the head of the setscrew, deforming it and preventing proper engagement of the screwdriver. Furthermore, blood clots were also observed on the pins of both leads, which we believe contributed to the rising RA lead impedance. This was further supported by the normalization of RA impedance after we removed the clotted blood from the pin. Hybrid system with lead-generator incompatibility is another possibility to consider when sporadic impedance spikes was observed (8). To our knowledge, this is the first reported case highlighting this mechanism, and our simple technique of removing silicone plug and metal ring over the setscrew can be an effective routine first step in managing this issue.

The blue arrow showed the original position of the setscrew (yellow arrow) and silicone plug (red arrow). We used a screw driver and a 22-gauge needle (right side of the figure) for removing the silicone plug and cleaned up the hexagon head of the setscrew head.

In our case, we used a screwdriver and tweezers to remove the silicone plug and metal ring covering the setscrew, which allowed us to better understand the mechanism of the “frozen lead”. Although
