Seismic vulnerability assessment of old churches in the twin cities of Bhubaneswar and Cuttack using the macroelemental approach

Historic buildings are the cultural and traditional identity of a country. However, these buildings are vulnerable to earthquakes because of their aged structure, poor maintenance, and inadequate structural health monitoring. Therefore, seismic vulnerability assessment is a critical aspect in the restoration and retrofitting of heritage buildings. In this study, a comprehensive survey was performed to collect the data of old and historic church buildings in and around the twin cities of Bhubaneswar and Cuttack in Odisha for evaluating the performance of these structures against seismic activity. The macroelemental method for seismic vulnerability assessment was used to calculate the seismic vulnerability index of church buildings. The probable damage was estimated based on the obtained values of the mean damage grade according to the EMS-98 scale and were compared with the grade of damageability acquired using the rapid visual screening method for Indian conditions. Damage probability matrices were constructed to determine the probabilistic future damage

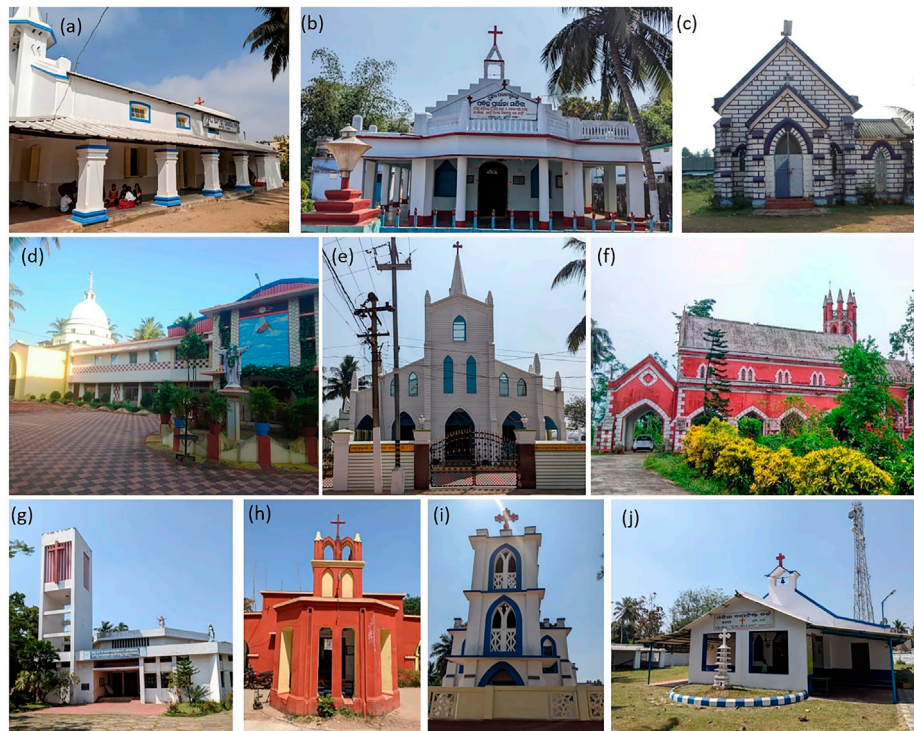
FIGURE 2

(A) Pipili Baptist Church, Pipili (B) Ashraya Pur, Jamkouli (C) St. John Church, Jatni (D) St. Vincent Pro's Cathedral, Bhubaneswar (E) Bahilipada Church, Barakuda (F) Church of Epiphany, Cuttack (G) Our Lady of Most Holy Rosary Cathedral, Cuttack (H) Mount House Church of God, Cuttack (I) Sacred Heart Church, Jatni (J) Oriya Baptist Church, Jatni.

Church of Epiphany (Figure 2F) constructed in the year 1826, is one of the oldest churches in Cuttack city. This historical building is a masonry structure with timber truss roof and a built-in madras terrace roofing style. The structure replicates ancient

Sacred Heart Church (Figure 2I) is one of the old churches in Jatni, Odisha. The church is a masonry structure with madras terrace style roofing and is more than 50 years old. A cruciform structure can be observed in the plan view. The roof is strengthened by the addition of steel beams in the transverse direction. Buttresses are present on the exterior of the structure. Arch structures can be observed on the sides of the building. Based on the possible damage mechanisms, the vulnerability index (v_{ki}) was obtained to be 0.528. Even though the building is

Bahilipada Church (Figure 2E) is a 100-year-old cruciform-shaped church in Barakuda, Odisha, and is similar to many cathedrals and historical churches. The church has undergone renovations, and a new reinforced concrete building was constructed to address vulnerability concerns. Based on the possible damage mechanisms, the vulnerability index (v_{ki}) was 0.35. The damage index (i_d) was obtained to be 0.05, and the damage level (D_k) of the whole structure is 0. According to the Arya method (Arya, 2011), the building can be classified as C+, that is, the MR-RCF of ordinary design without earthquake or wind resistant design with unreinforced masonry infill.

St. Vincent's Pro Cathedral (Figure 2D) is one of the oldest churches in Bhubaneswar, Odisha. The cathedral was opened to

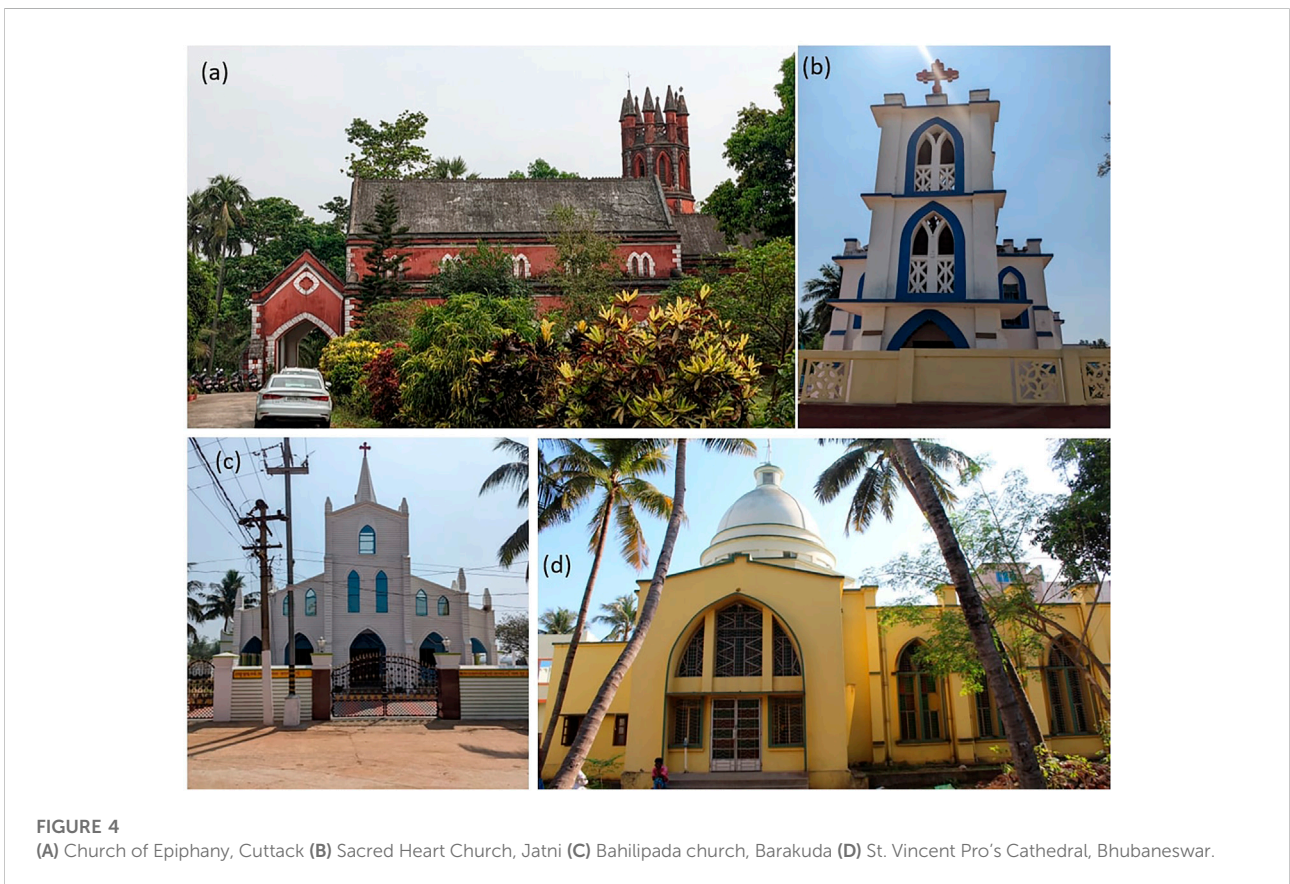
Among the surveyed churches, seismic vulnerability analysis was performed on four buildings, including two masonry and two reinforced concrete buildings (Figure 4). The analysis involves the identification of macroelements in each building, assigning the values of v_{ki} and v_{kp} , calculation of the weights of the possible damage mechanisms by AHP followed by the calculation of seismic vulnerability index and estimation of the damage grade. Possible representations of collapse mechanisms in the analyzed churches are displayed in Figure 5.

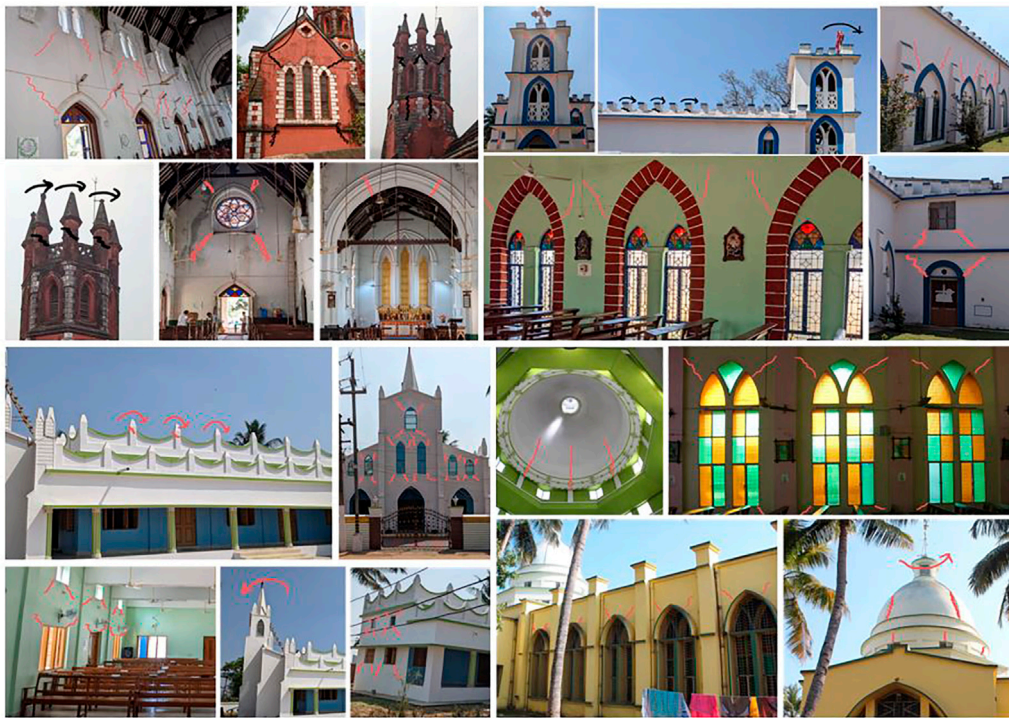
FIGURE 5
Possible collapse mechanisms in the analyzed churches.

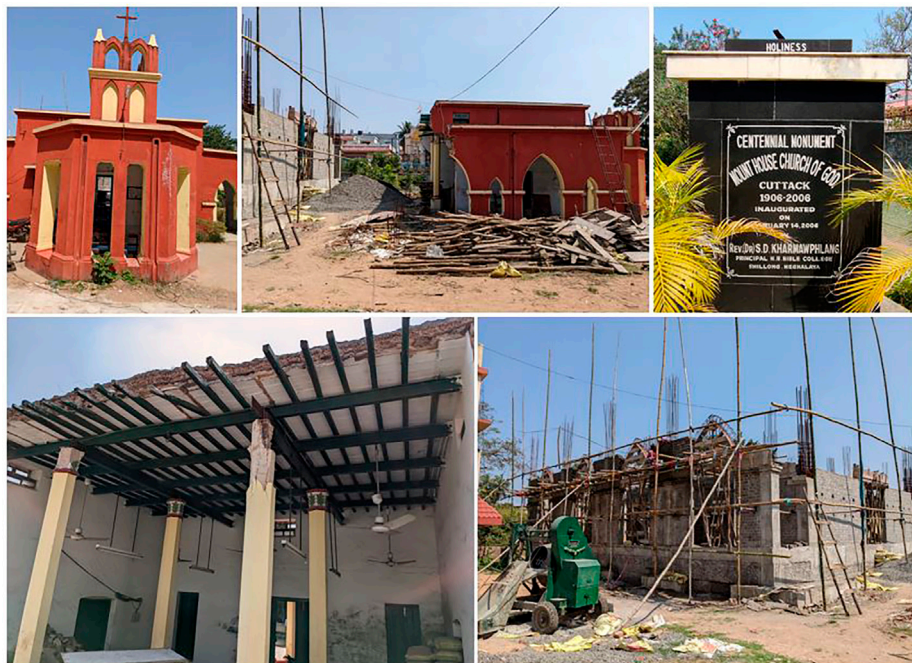
FIGURE 6
Mount House Church of God, Cuttack.

vulnerability of the existing masonry structure. The new building was a reinforced concrete structure, which was constructed to look like the original church building while at the same time providing seismic resistance that was not present in the old masonry structure. Cracks were observed on the walls and some roof elements of the half-demolished structure. The structure is a reinforced concrete structure with confined masonry. The confined masonry type of construction is known to exhibit superior earthquake resistant properties compared with conventional RC structures. Therefore, the method can be adopted to overcome the seismic vulnerability problems.

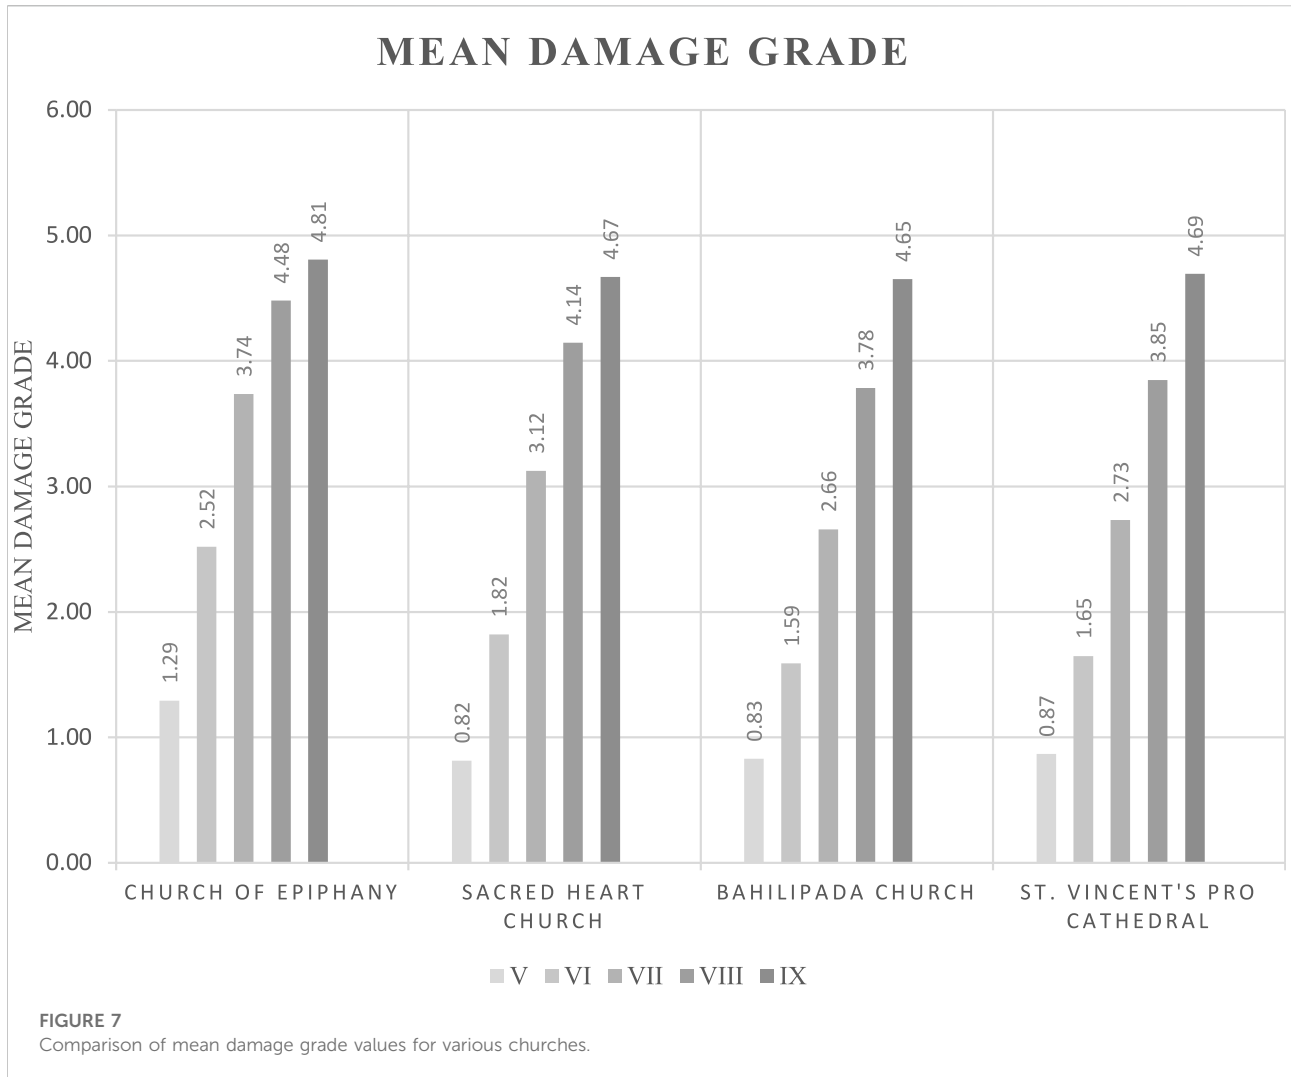
The mean damage grades according to the macroseismic method for the four churches at earthquakes of various intensities are displayed in Figure 7. The damage level of all buildings varied from negligible for an intensity of V to very heavy damage for an intensity of IX. However, higher values of damage grade were observed for the Church of Epiphany, Cuttack, than those for other churches because of its higher vulnerability index. The damage grades were lower than with the RVS method for Indian conditions. For an intensity of VII on the MSK scale, the Church of Epiphany has a damage grade of 3.73, which represents a possibility of heavy to very heavy damage according to EMS-98. A moderate grade of damageability was estimated according to the RVS method for the same intensity of earthquake. The

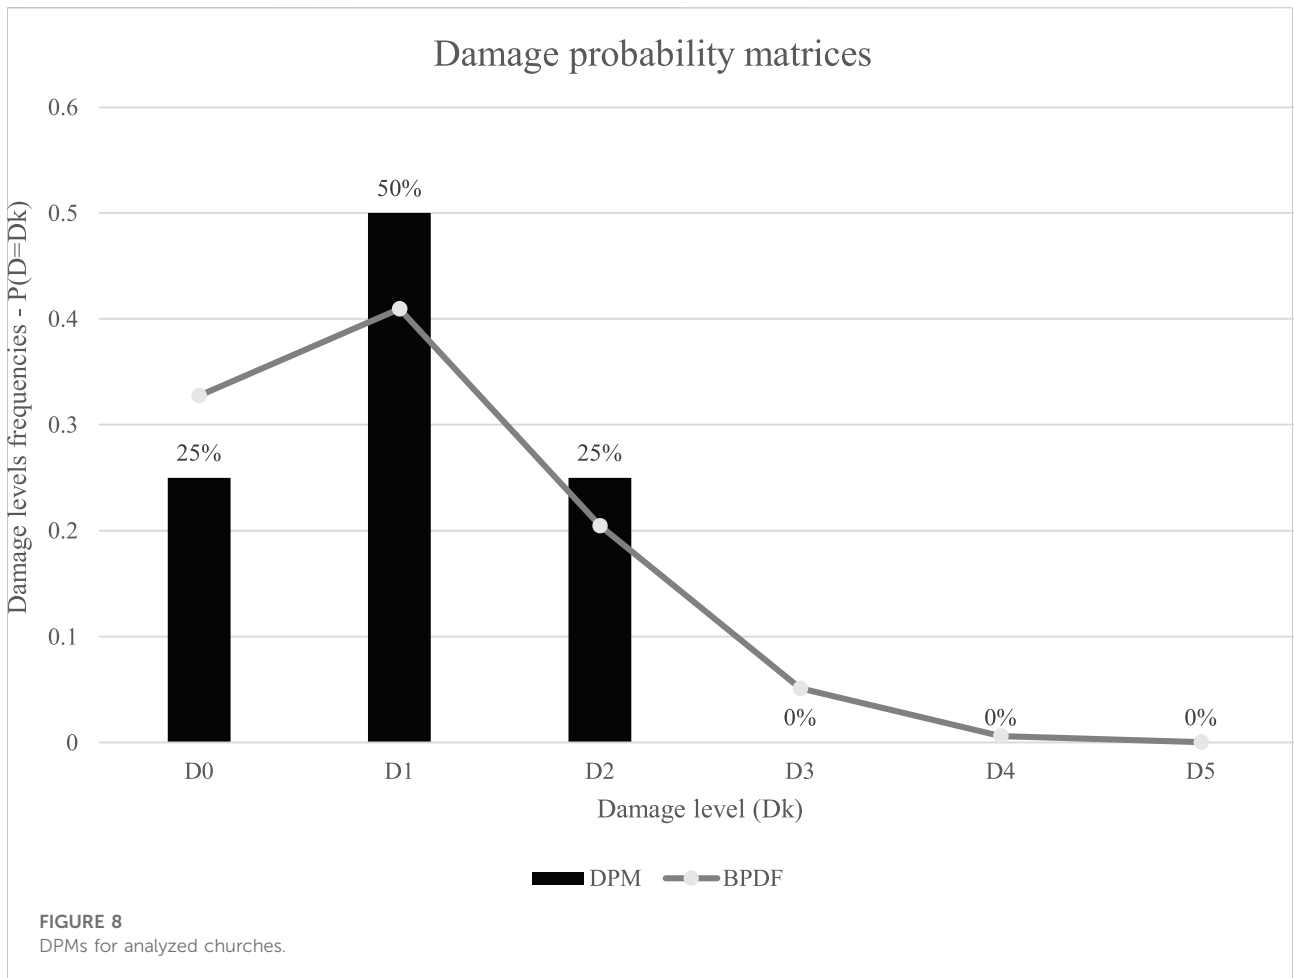
The damage probability matrices based on the current damage state are displayed in [Figure 8](#). DPMs revealed that the St. Vincent Pro's Cathedral and Sacred Heart Church have 41% probability of D1 level (negligible-slight) damage, while the Church of Epiphany had 20.50% probability of D2 level (moderate) damage in case of an earthquake of V–VI (MSK) intensity.
