# Full Scale Reinforced Concrete Beam-Column Joints Strengthened with Steel Reinforced Polymer Systems

This paper presents the results of an experimental campaign performed at the Laboratory of Materials and Structural Testing of the University of Salerno (Italy) in order to investigate the seismic performance of reinforced concrete (RC) beam-column joints strengthened with steel reinforced polymer (SRP) systems. With the aim to represent typical façade frames' beam-column subassemblies found in existing RC buildings, specimens were provided with two short beam stubs orthogonal to the main beam and were designed with inadequate seismic details. Five members were strengthened by using two different SRP layouts while the remaining ones were used as benchmarks. Once damaged, two specimens were also repaired, retrofitted with SRP, and subjected to cyclic test again. The results of cyclic tests performed on SRP strengthened joints are examined through a comparison with the outcomes of the previous experimental program including companion specimens not provided with transverse beam stubs and strengthened by carbon fiber-reinforced polymer (CFRP) systems. In particular, both qualitative

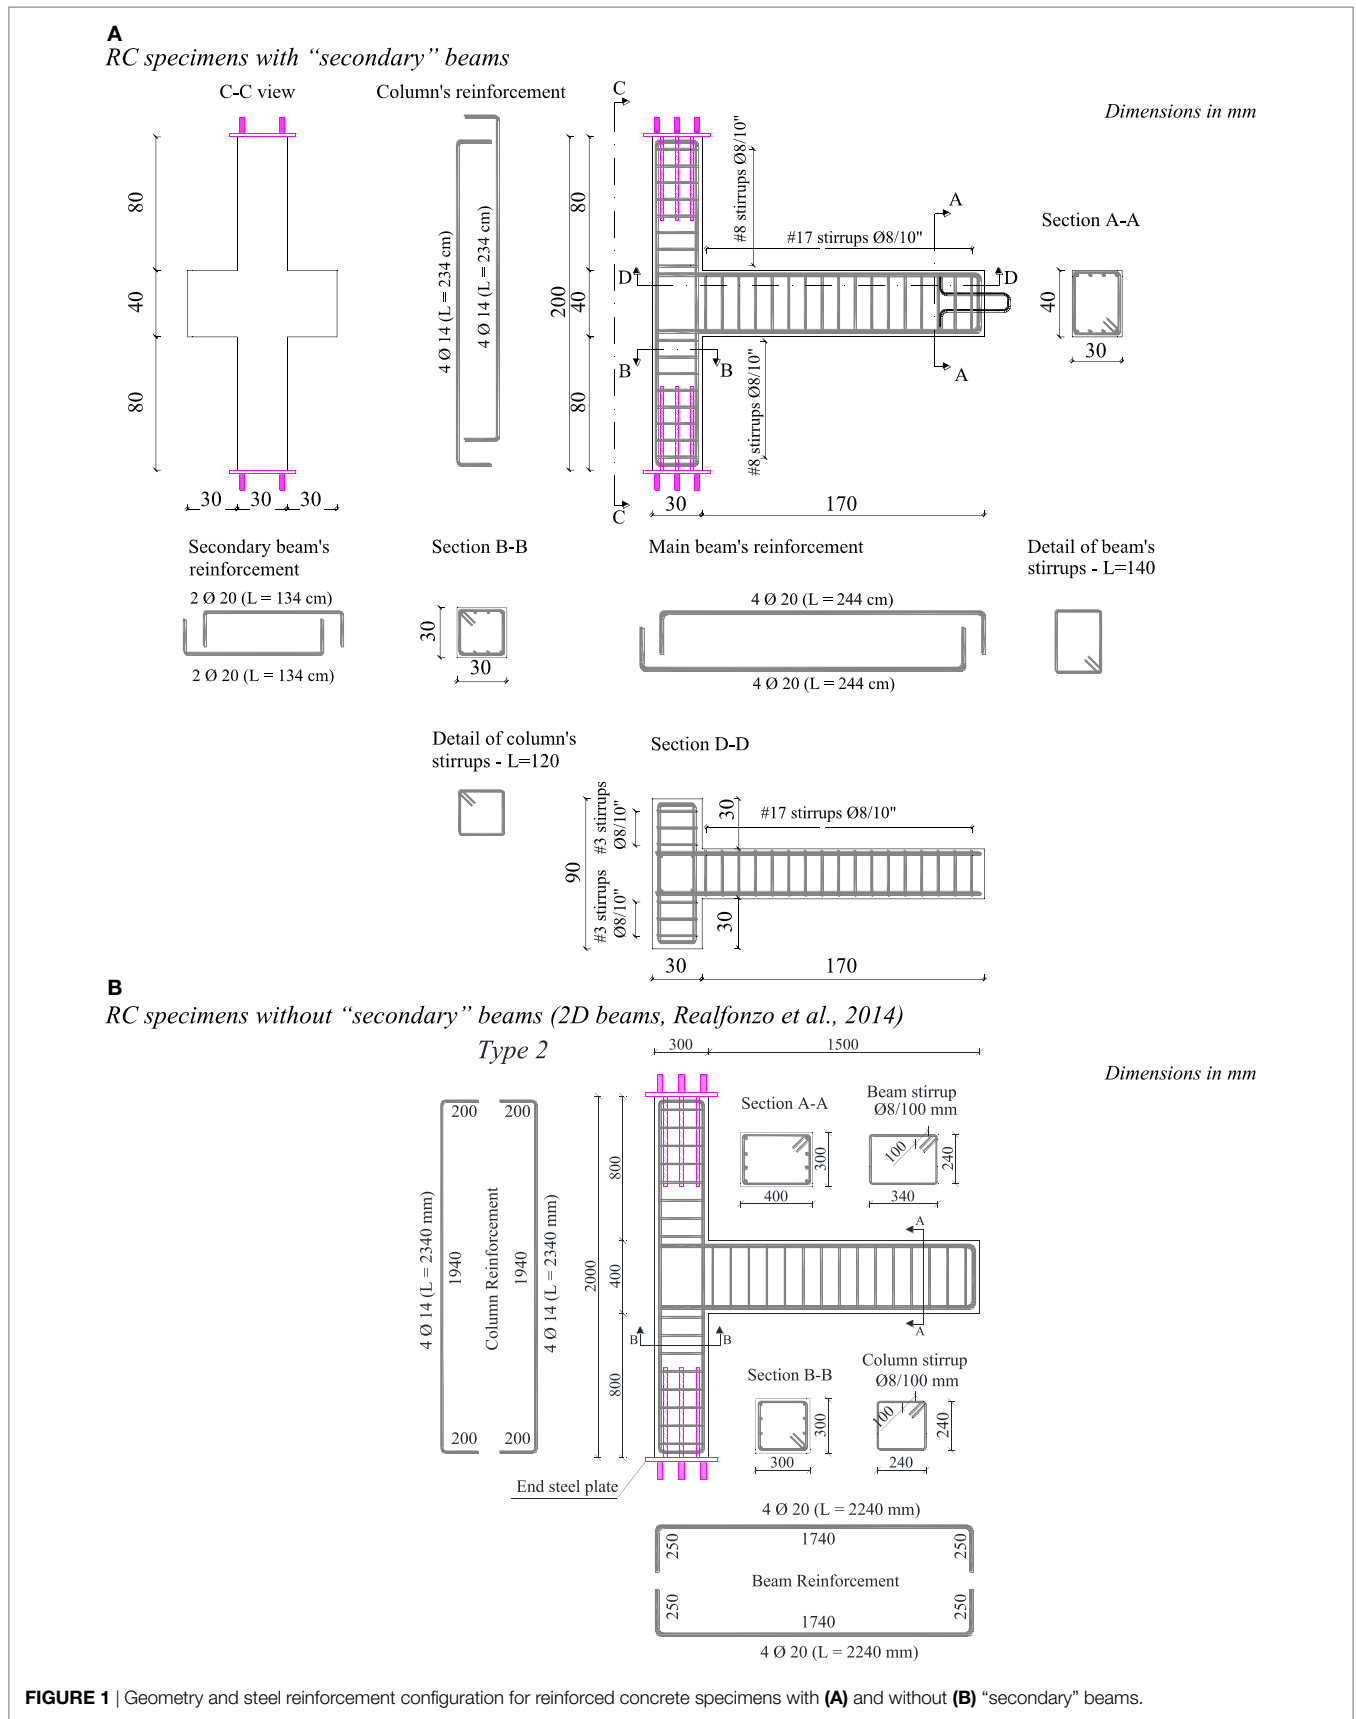
**FIGURE 1** | Geometry and steel reinforcement configuration for reinforced concrete specimens with **(A)** and without **(B)** "secondary" beams.

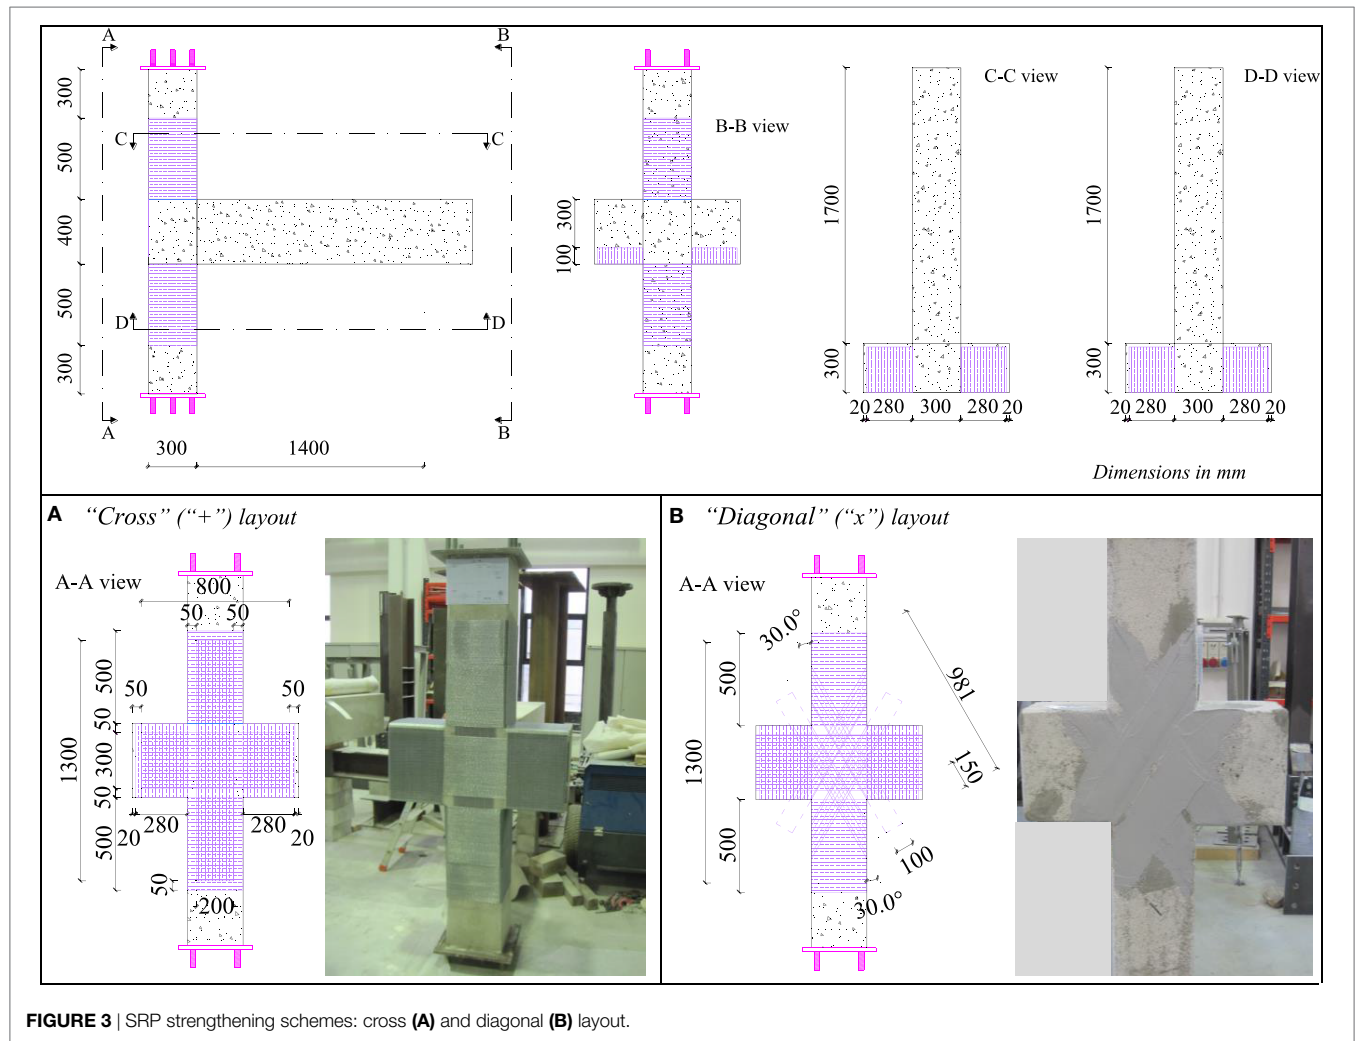
**FIGURE 3** | SRP strengthening schemes: cross (A) and diagonal (B) layout.

In the “+” upgrading of the joint panel (**Figure 3A**), a 1,300 mm long and 200 mm wide SRP strip was applied to the column and restrained by the external SRP wrapping, while another sheet was applied to the two secondary beams and restrained by two U-shape strips simulating the presence of a beams’ shear strengthening. It is worth highlighting that the “cross” pattern was also considered for retrofitting the above mentioned two specimens that, after being tested and damaged, were repaired by using a thixotropic mineral mortar, retrofitted with SRP and subjected to cyclic test again.

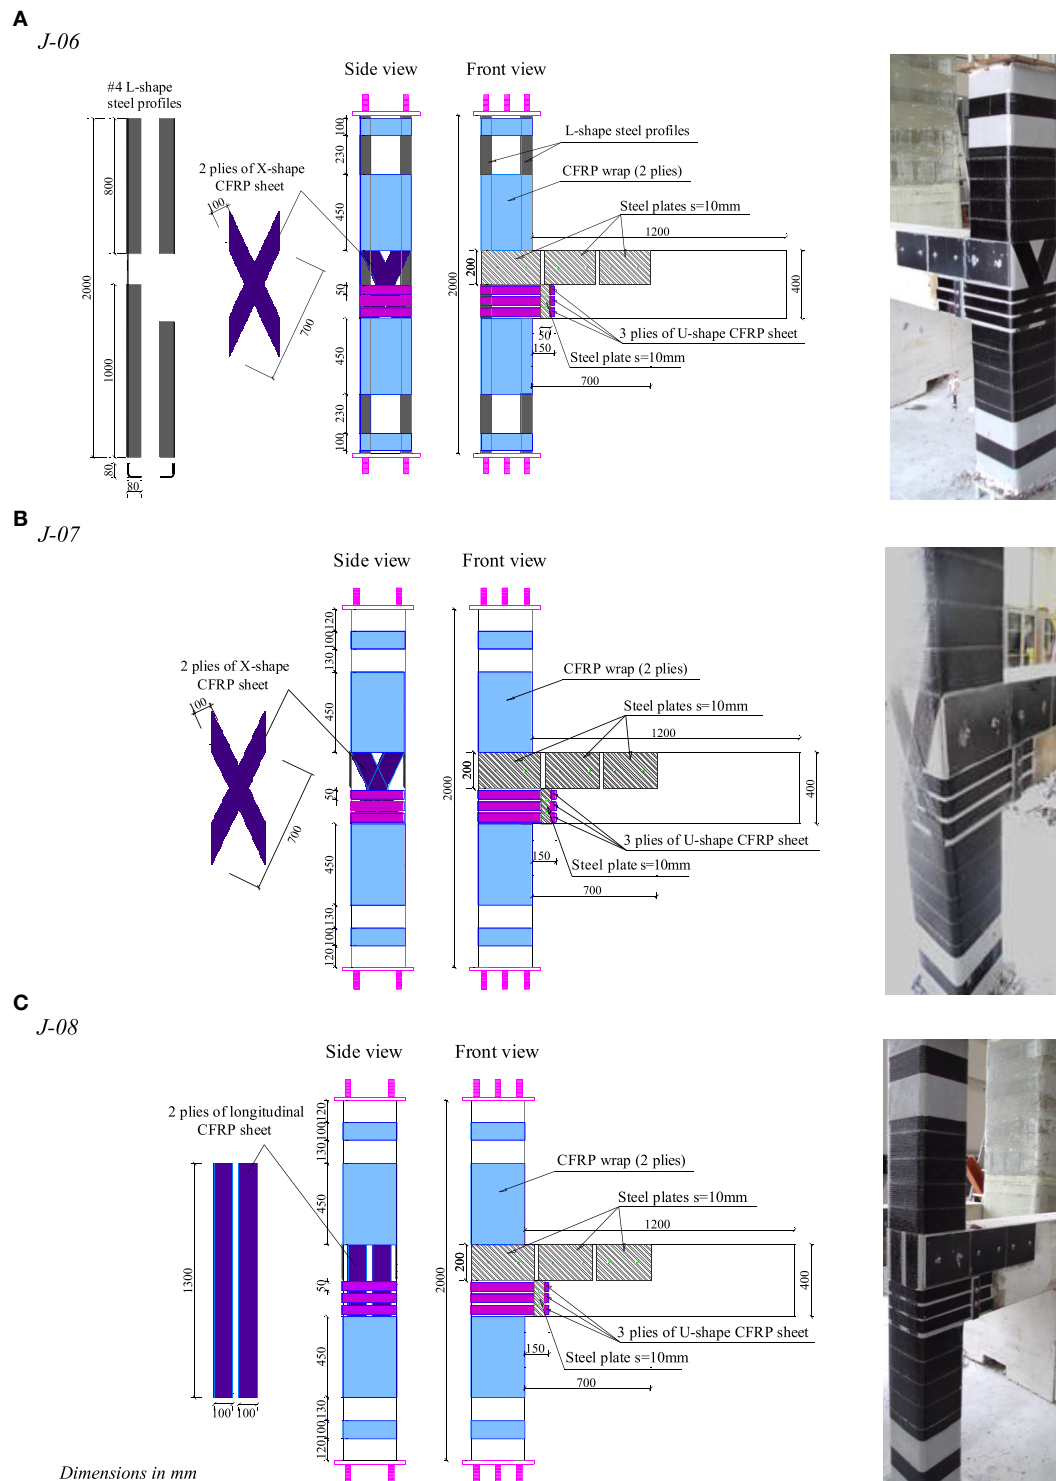
**FIGURE 4** | Carbon fiber reinforced polymer (CFRP) strengthening schemes: specimens J-06 (A), J-07 (B), and J-08 (C).

In the strengthening scheme considered for the joint “J-06” (**Figure 4A**), the column upgrading is similar to that already considered by the authors in previous experimental investigations (Realfonzo and Napoli, 2009, 2012; Napoli and Realfonzo, 2015); it entailed four longitudinal cold bent steel profiles placed along the member corners before applying the external continuous wrapping made of two CFRP layers. The profiles were always glued to the concrete substrate by means of an epoxy adhesive and consisted of 80 mm × 80 mm × 6 mm equal leg angles made of structural steel S235. These were continuous on the exterior face of the joint and discontinuous on the interior one, thus providing the joint panel with a better confinement.

In the strengthening schemes considered for the joints “J-07” and “J-08” (Figures 4B,C, respectively), instead, the CFRP confinement of the columns was not coupled with the arrangement of steel profiles.

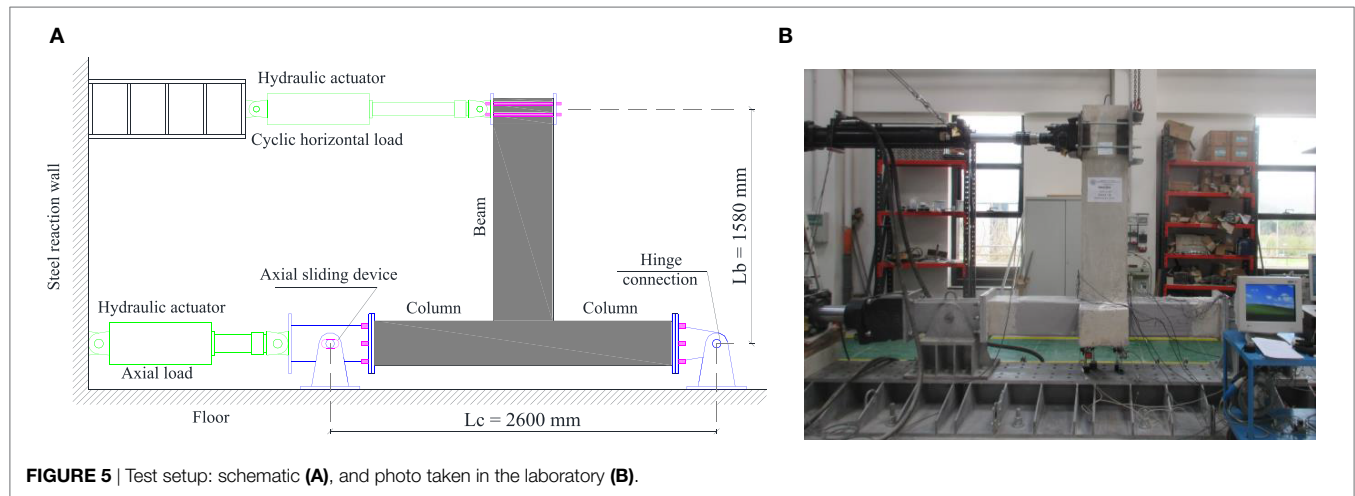
**FIGURE 5** | Test setup: schematic (A), and photo taken in the laboratory (B).

The horizontal force was cyclically applied in displacement control at the main beam through a 250 kN MTS hydraulic actuator, mounted at 1,430 mm from the beam base and fixed to a reaction steel frame. An increment of the imposed horizontal

displacement every three cycles was considered in order to evaluate the strength and stiffness degradation at repeated lateral load reversals. The increment of the displacement amplitude was given as fraction of the estimated beam yield displacement,

$\Delta y$  ( $\approx 14$  mm); two different displacement rates were considered during the tests: 0.2 mm/s before the achievement of  $\Delta y$  and 1 mm/s after  $\Delta y$ .

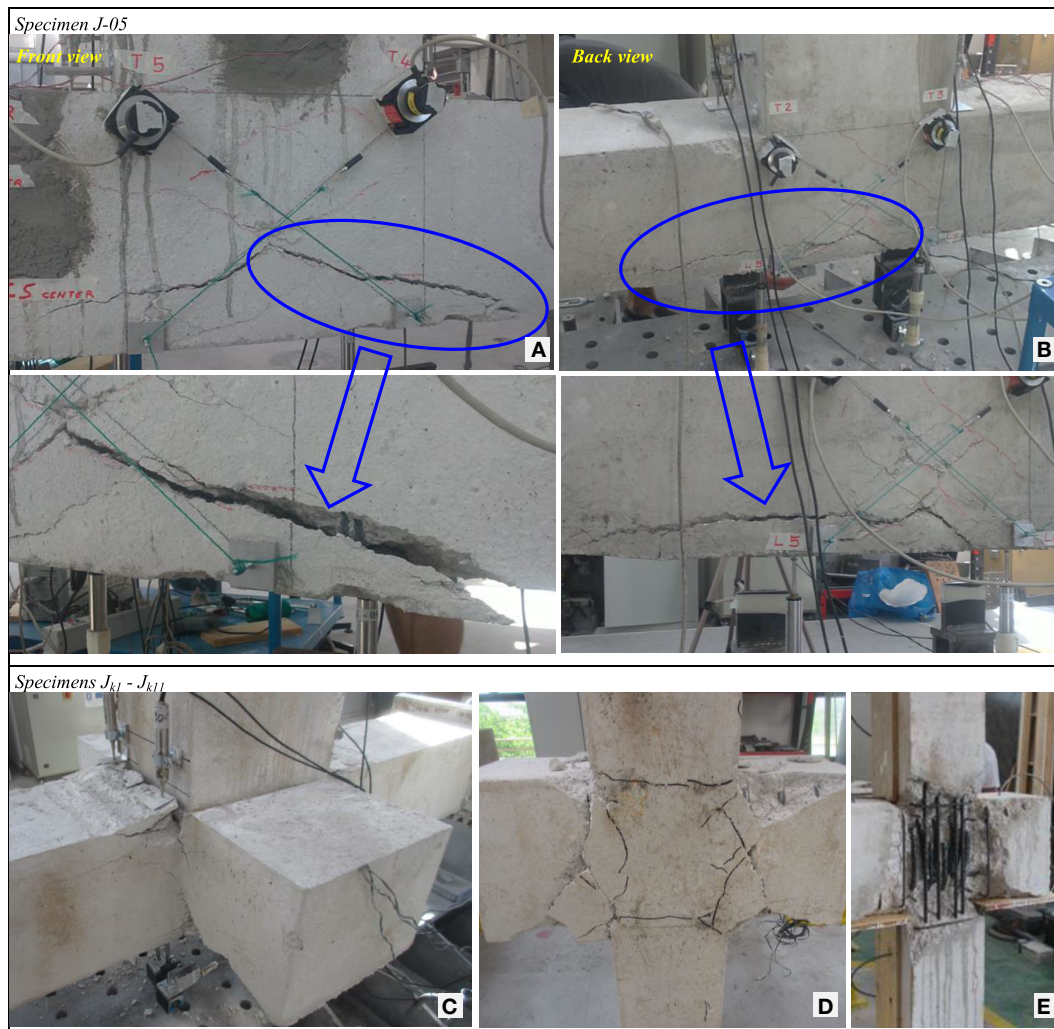
**FIGURE 6** | Crack pattern and failure for control specimens: J-05 (A,B);  $J_{k1}$  and  $J_{k11}$  (C-E).

**Figure 6** shows the comparison between the crack pattern and failure mode experienced by the unstrengthened specimen “ $J-05$ ” and those of the counterparts “ $J_{K1}$ ” and “ $J_{K11}$ ,” thus showing the influence of the confinement effect provided by the secondary beams on the type of observed damage.

In particular, **Figures 6A,B** depict the crack pattern of the unconfined joint “ $J-05$ ” (Realfonzo et al., 2014). The shear cracks on the joint panel are clearly noted, as well as the removal of a significant portion of concrete on the outer side, caused by the push-in/pull-out action of the beam’s longitudinal steel rebars. Additionally, even though non-visible in the Figure, slight signs of column’s concrete crushing have been observed on the inner

Figures 6C–E show the damage experienced by the control members “ $J_{k1}$ ” and “ $J_{k11}$ ,” respectively. In this case, the introduction of the secondary beams had a non-negligible influence on the failure mode observed. Indeed, even though the joint panel experienced a severe damage (with incipient detachment of concrete portions on the secondary beams), this was lower than that shown by the counterpart “J-05.” Conversely, concrete spalling from the column member in the portion close to the main beam-column interface was observed mainly for the specimen  $J_{k1}$  (Figure 6C). Figure 6D allows for better observing the joint crack

pattern shown by the control specimens provided with secondary beams; by removing the outer portion of the concrete layer (see Figure 6E), signs of damage in the inner concrete core were noted.

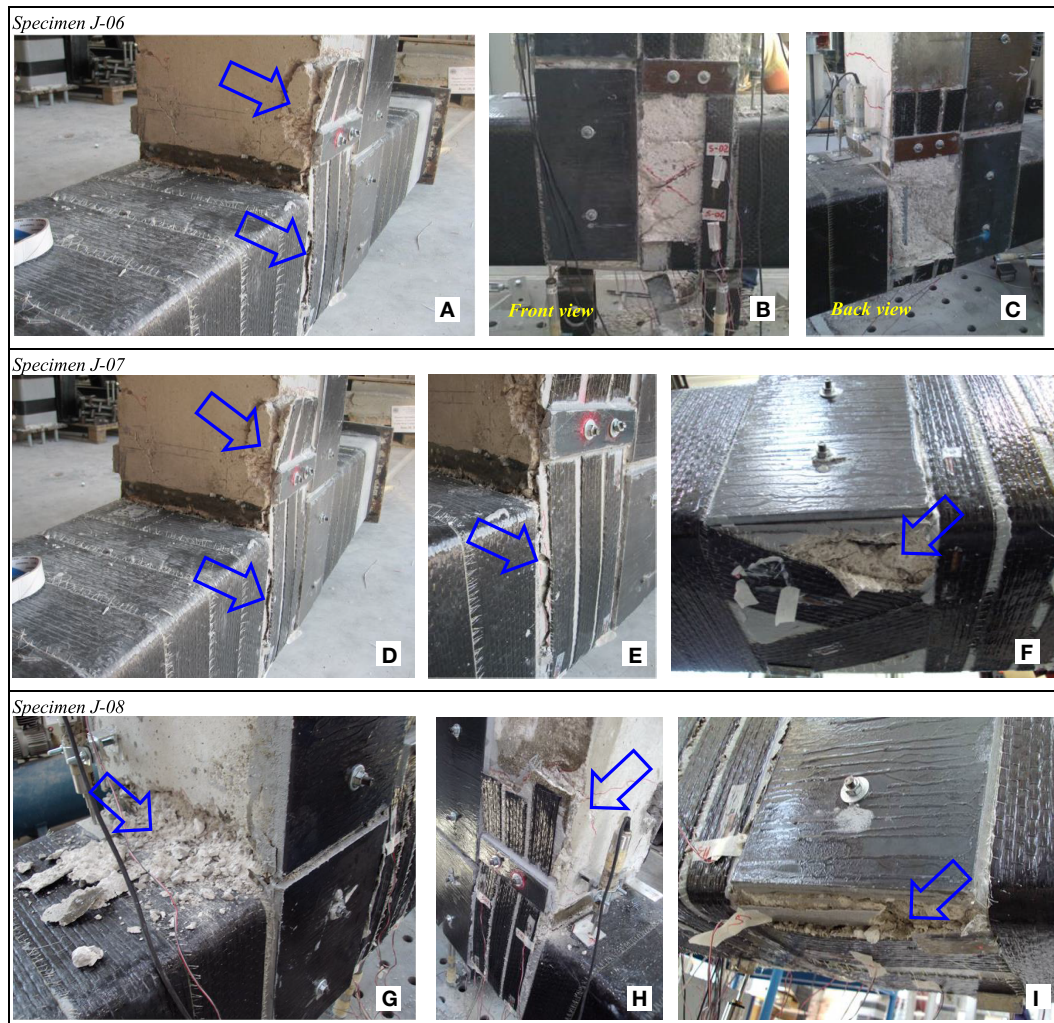
**FIGURE 7** | Crack pattern and failure for CFRP strengthened specimens: J-06 (A-C); J-07 (D-F); J-08 (G-I).

Figures 7 and 8 show the scenario of damage experienced by specimens strengthened with CFRP systems and SRP systems, respectively.

The CFRP strengthened specimens all exhibited the delamination of the external reinforcement which was delayed but not avoided by the use of mechanical steel anchors (Figures 7A,D,E,H). Of course, the occurrence of this phenomenon just above the anchorage steel plates was promoted by the opening of flexural cracks at the column-beam interface.

Figures 7B,C show the damage exhibited at the end of the test by the portions of the joint panel “J-06” “hidden” by the FRP: the typical diagonal cracks are clearly visible. For this member, it was also noted the beneficial contribution deriving by the arrangement of steel profiles on the joint’s exterior face which improved the out-of-plane stiffness. Indeed, in this case, the damage of the concrete cover caused by the push-in/pull-out action of the beam’s longitudinal steel rebars was strongly mitigated when compared with the damage observed for the specimens “J-07” and “J-08,” independently on the FRP layout (“x” or “vertical” pattern) used for the joint panel (see Figures 7E,I).

Furthermore, in all the performed tests, signs of damage were observed in the first 100 mm of the beam members, i.e., in the portion of concrete close to the column-beam interface. This phenomenon, mainly noted in the case of the specimen “J-08” (Figure 7G), was probably promoted by the local weakening induced with the installation of the mechanical anchors used for both steel plates and CFRP sheets.

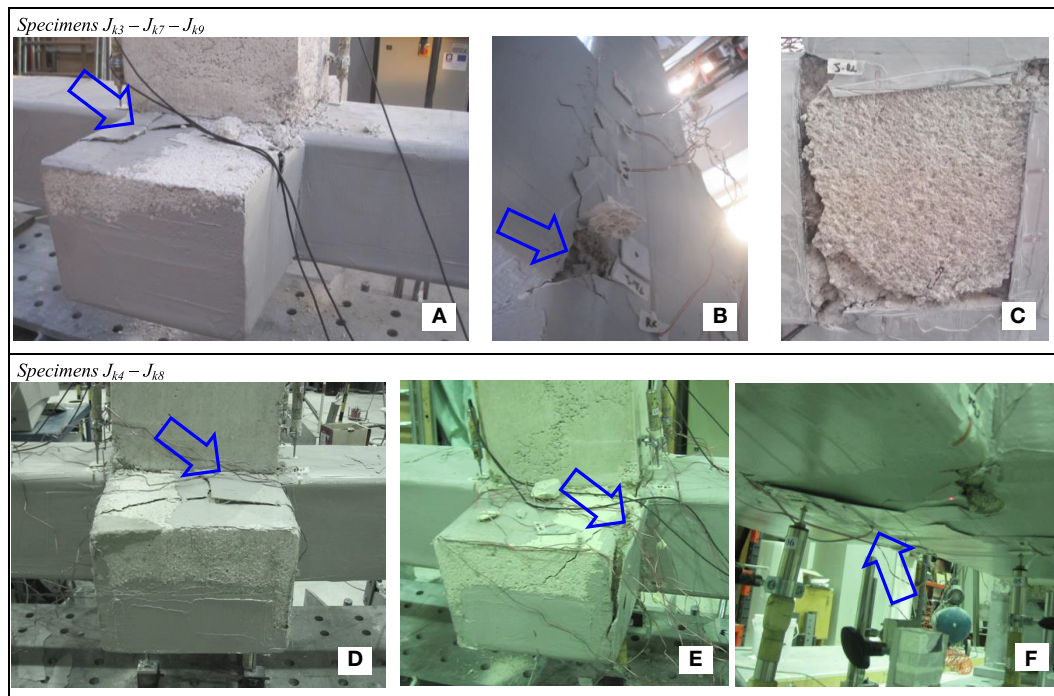
**FIGURE 8** | Crack pattern and failure for SRP strengthened specimens:  $J_{K3}$ ,  $J_{K7}$ , and  $J_{K9}$  (A-C);  $J_{K4}$  and  $J_{K8}$  (D-F).

In the case of SRP strengthened specimens, it is observed that, regardless of the considered layout (“cross” or “diagonal”), the SRP system preserved the column member from failure and strongly mitigated the damage exhibited by the joint panel up to high values of the imposed displacement (Figures 8B,F); conversely, the debonding of the “U” shape strip from the secondary beams (Figures 8A,D,E) and a progressive degradation of the concrete cover located at the main beam-column interface (Figure 8B), were noted. Also, during tests a large flexural crack, not clearly visible in the Figures, opened at the main beam base-section, thus implying that the use of the SRP strengthening systems contributed to moving the collapse from the joint panel toward the main beam (as desired in seismic areas); however, the failure of the beam was not achieved due to early occurrence of the loss of bond by main beam’s longitudinal steel reinforcement.

By removing the external strengthening (Figure 8C), it can be clearly noted the damage of the outer portion of the joint

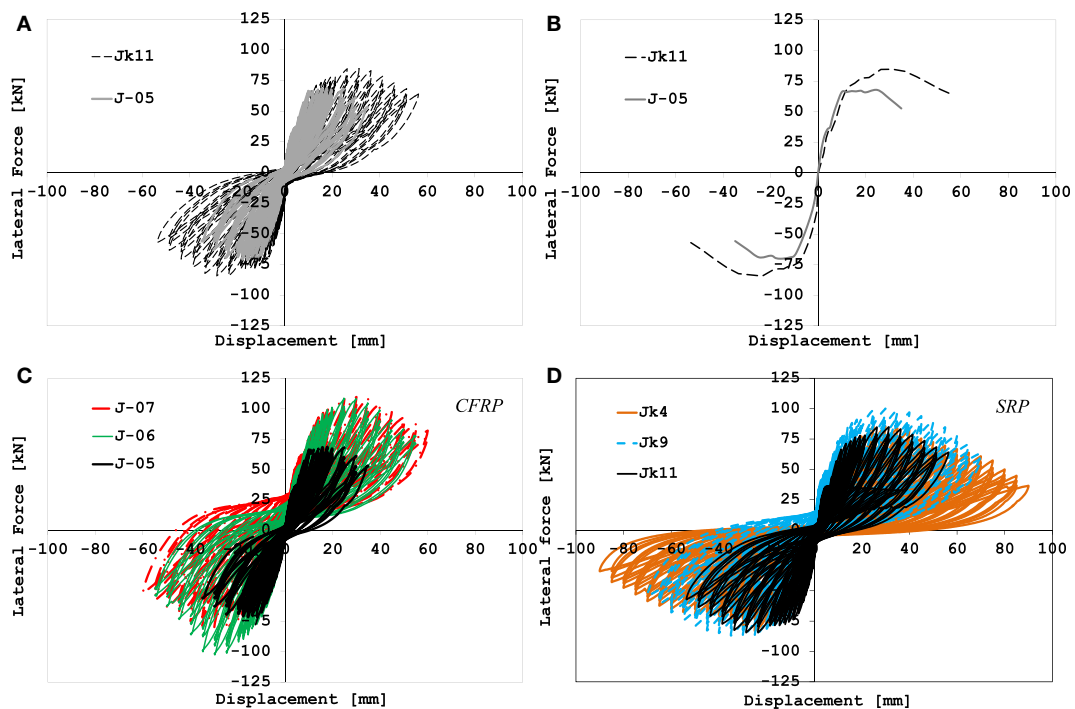
**FIGURE 9** | Load-displacement curves for: control specimens (A,B); CFRP strengthened specimens (C); SRP strengthened specimens (D).

strengthened specimens (Figure 9C) with the corresponding ones related to SRP strengthened members (Figure 9D). In particular, the experimental plots in Figure 9C refer to three representative beam-column subassemblies of the previous experimental

By looking at the plot in **Figure 9C**, it is noted that, as already mentioned earlier, the experimental curves highlight a rather non-symmetric behavior in terms of lateral force. Also, in the case of the strengthened specimens and under high values of the imposed displacement, the cycles exhibit a shift toward the forces' positive axis; this evidence is of course motivated by a non-uniform propagation of the crack pattern in the joint panel, being it partly confined by the steel plates simulating the presence of a floor slab.

Regardless of the use of steel profiles at the column corners, the comparisons highlight the effectiveness of the strengthening systems employed for the specimens “ $J-06$ ” and “ $J-07$ .” Having designed these specimens according to a “strong-column” scheme, the experimental results have confirmed that the CFRP external confinement is sufficient by itself to avoid the premature failure of the column.

By looking at the plot in **Figure 9D**, it seems that, at a first glance, the examined SRP strengthening solutions provided a good performance with respect to the unstrengthened member but rather reduced when compared to that experienced in the case of CFRP systems. Indeed, although a less degrading post-peak behavior is noted for the SRP strengthened specimens with respect to the control member (“ $J_{k11}$ ”) and confirmed by an appreciable increase of the deformation capacity (mainly when the “cross” pattern is employed), only a slight strength increase, sometimes over 10%, was observed (in this case specifically when the “cross” layout is used).

The seeming reduced performance of the SRP systems with respect to the control member was obtained because the full exploitation of the external strengthening was limited by the slip of the main beam's longitudinal reinforcement. This evidence was: (a) confirmed during the cyclic tests through the opening of only one large flexural crack at the beam-column interface, and (b) theoretically verified since, by applying an analytical model available in the literature (Fib Bulletin No. 72, 2014), the value of the lateral force corresponding to the slippage of the steel reinforcement is in agreement with the experimental results obtained in the case of SRP strengthened members.

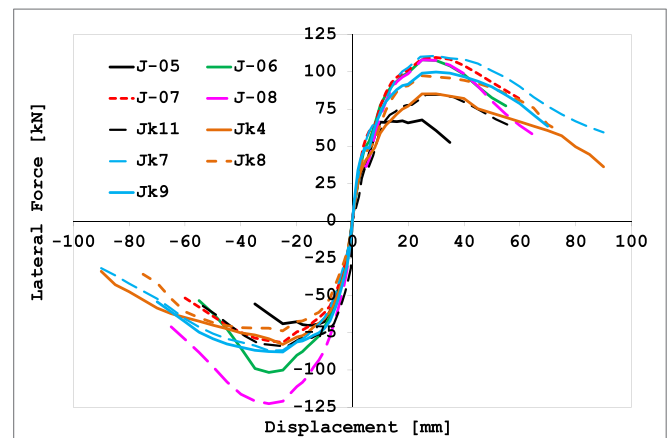
**FIGURE 10** | Load-displacement envelopes: comparison between SRP and CFRP strengthened specimens.

The overall performances obtained in the case of both CFRP and SRP strengthened specimens can be better compared by observing the  $F - \Delta$  monotonic envelopes in **Figure 10** and the values of the indices  $I_F$ ,  $I_{\Delta 85\%}$ , and  $I_{\Delta 75\%}$  reported in **Table 3**. These indices, giving an idea on the increases of strength and deformation capacity (at 15 and 25% strength decay) achievable

Conversely, looking at the post-peak branches of the  $F-\Delta$  curves it seems that the SRP strengthened specimens exhibited a less degrading behavior with respect to the case of CFRP strengthened members where the collapse is achieved as soon as the abrupt delamination of the CFRP strip anchored to the main beam occurred. However, the ductility increases over the member “J-05” at 15% (or 25%) strength decrease are still significant, approximately spanning between 30% (for the joint “J-06”) and 50% (for the joint “J-07”). In the case of the SRP systems, instead, the ductility increases are in the range 10–28%.

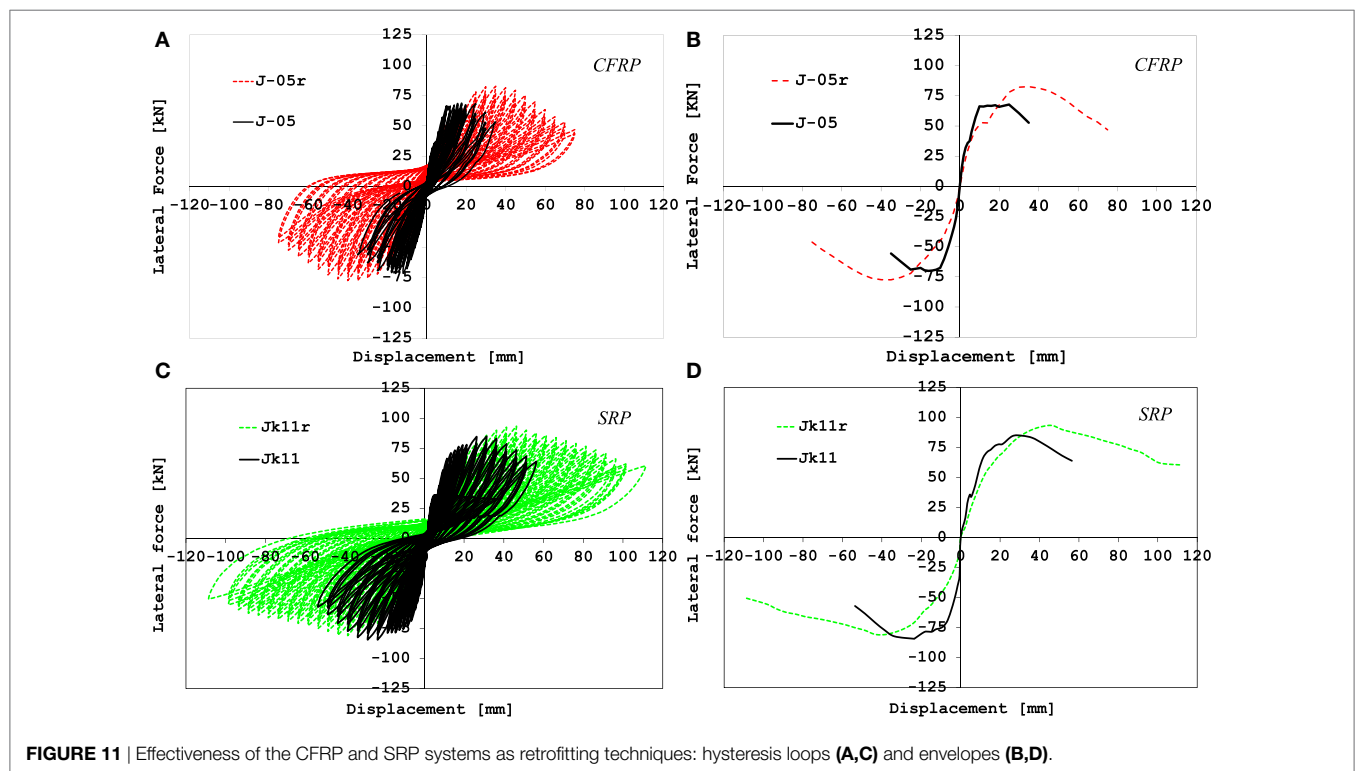
The effectiveness of using the considered CFRP system to retrofit repaired RC beam-column subassemblies is clearly visible in **Figures 11A,B** where comparisons in terms of  $F-\Delta$  cyclic curves and corresponding monotonic envelopes are shown for the specimens J-05 and J-05\_R.

The effectiveness of using the considered SRP system to retrofit repaired RC beam-column subassemblies is shown in **Figures 11C,D** where  $F-\Delta$  cyclic curves and corresponding monotonic envelopes are plotted for the specimens  $J_{k11}$  and  $J_{k11r}$ .

As expected, the  $F-\Delta$  response of the retrofitted member exhibits an initial stiffness lower than that of the corresponding member J-05. Conversely, the plots clearly highlight the beneficial effects produced by the employed strengthening systems not only in restoring but also in improving the performance of the “original” specimens mainly in terms of ductility. Indeed, as shown in **Table 2**, the specimen J-05\_R was capable of increasing the flexural strength and the deformation capacity at 15% strength decay of about 16 and 75%, respectively. In this case, the confinement

Also in this case, although the early stiffness was not restored, the specimen  $J_{k11r}$  exhibited the same strength performance of the counterpart  $J_{k11}$  and even higher deformation capacity at both 15 and 25% strength decay (the increases of lateral displacement over the specimen  $J_{k11}$  were approximately equal to 60 and 75%, respectively).

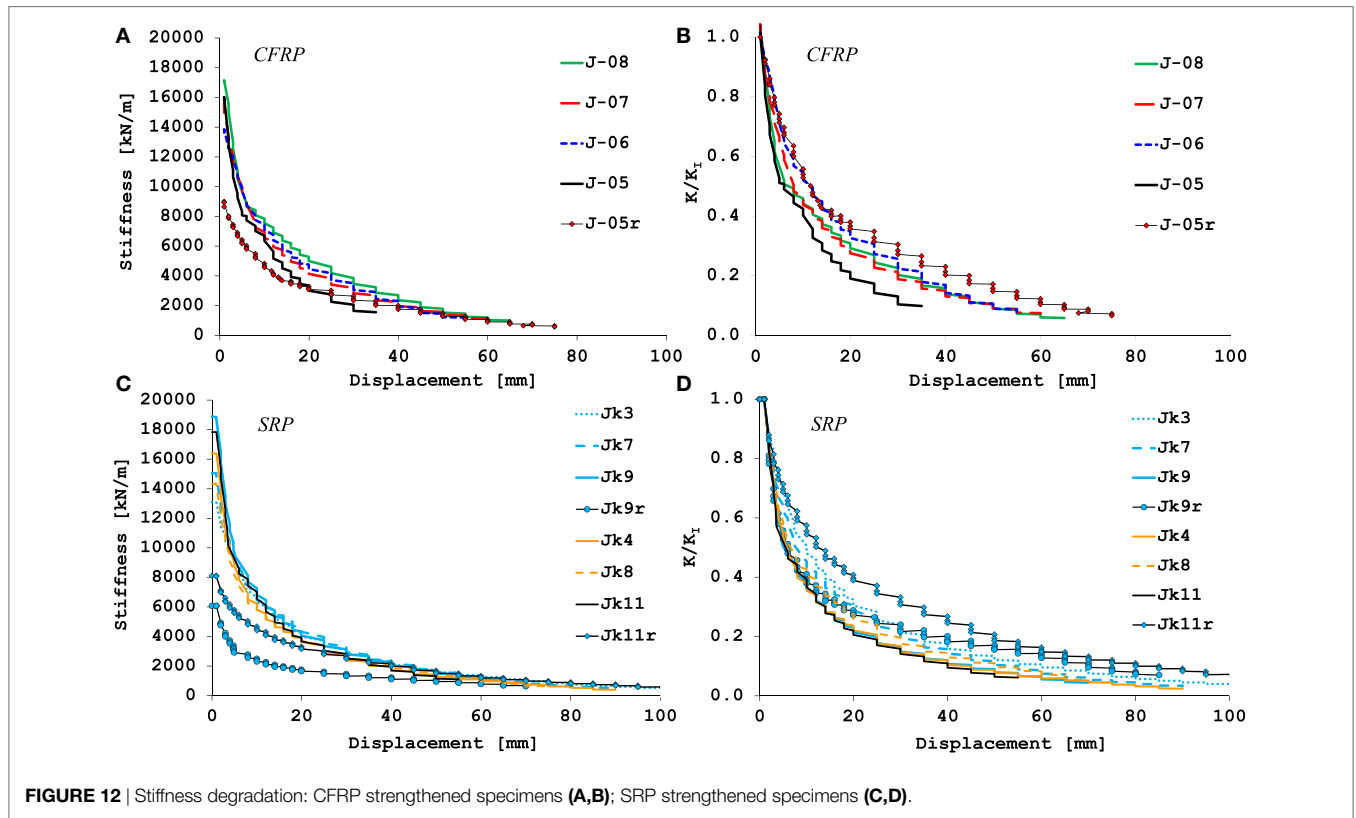
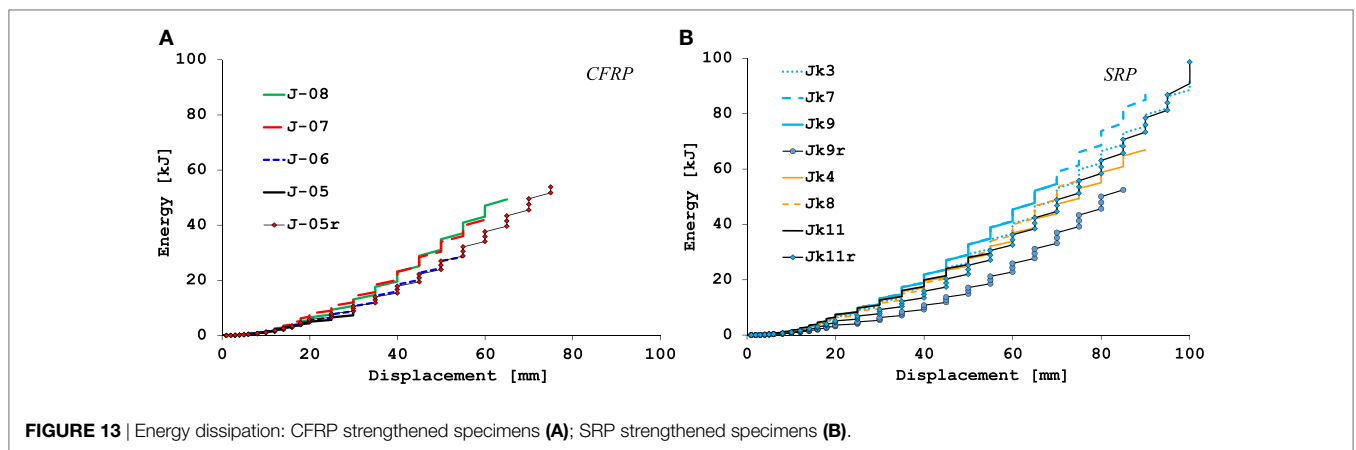
where  $F_{\max,i}^+$  and  $F_{\max,i}^-$  are the beam lateral forces in the push and pull directions whereas  $\Delta_i^+$  and  $\Delta_i^-$  the corresponding displacements. The stiffness of each cycle was then normalized with respect to the stiffness of the first cycle  $K_1$  and plotted in **Figures 12B,D**, thus providing a measure of the stiffness degradation.

In particular, the graphs in **Figures 12A,B** refer to specimens strengthened with CFRP systems whereas those in **Figures 12C,D** to members strengthened with SRPs.

the external strengthening does not imply a modification of the initial stiffness of the specimens (see, **Figure 12A**), the reference joint J-05 showed a faster stiffness degradation with the imposed displacement (see, **Figure 12B**). Among the CFRP strengthened specimens, it is noted that the joint J-06 exhibited a more gradual reduction of the stiffness thanks to the confinement effect provided by the continuous steel profiles which delayed the concrete spalling.

By focusing on the repaired joint J-05r, it is observed that, although the initial stiffness was about half of the  $K_I$  value estimated for the specimen J-05, the use of the CFRP strengthening system had a significant effect on the stiffness degradation which was strongly mitigated.

Tests performed on “3D” joints have highlighted that the initial stiffness has not remarkably changed in comparison to the previous tests nor the application of the SRP strengthening system has a relevant effect. At the same time, since the unstrengthened joints  $J_{k1}$  and  $J_{k11}$  already exhibited a better cyclic behavior with respect to the “2D” counterpart, the stiffness degradation of the SRP strengthened members is only slightly improved at a given imposed displacement. Of course, the SRP strengthened specimens are capable of undergoing higher displacement at conventional collapse (see, **Figures 12C,D**).
