Stehlik M, Zideluns J, Petite C, Allard V,
Minissale M, Moreau A, Lereu A,
Lemarchand F, Wagner F, Lumeau J and
Gallais L (2024), Investigation of laser-
induced contamination on dielectric thin
films in MHz sub-ps regime.
Adv. Opt. Technol. 12:1261267.
doi: 10.3389/aot.2023.1261267

Investigation of laser-induced contamination on dielectric thin films in MHz sub-ps regime

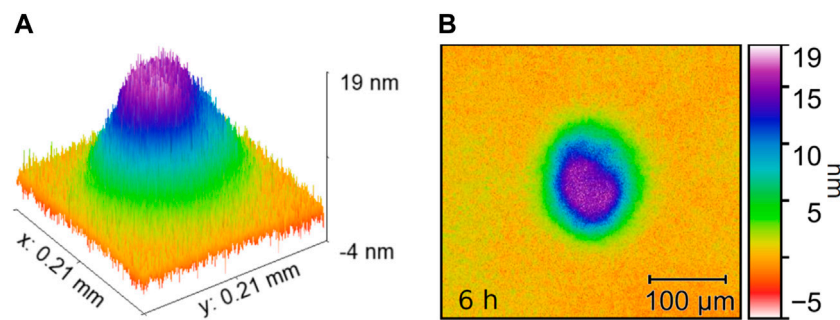
FIGURE 1

LIC deposit detected *ex-situ* by optical profilometry on SiO₂ layer of 450 nm thickness. (A): 3D surface topography; (B): 2D surface topography. Both images show the same LIC deposit obtained after 6 h of irradiation with 700-fs 515-nm 3-MHz laser emitting 35-W of mean power, 10-μJ pulse energy. The near Gaussian laser beam profile had a 1/e² diameter of 130 μm.

The thicknesses of contamination deposits were measured *ex-situ* by optical profilometry (Zygo NewView). Examples of deposits observed by this method are shown in Figure 1.

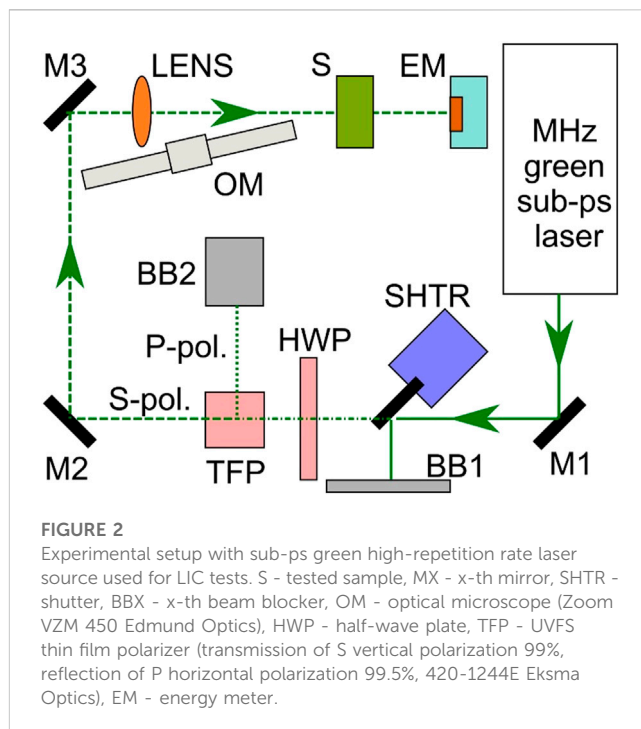
The average power of the laser was approximately 35 W, which corresponds to a pulse energy of 10 μJ . The laser pulses were reflected by three mirrors, as shown in the schematic drawing in Figure 2, and directed towards a fused silica planoconvex lens with a focal length of 20 cm.

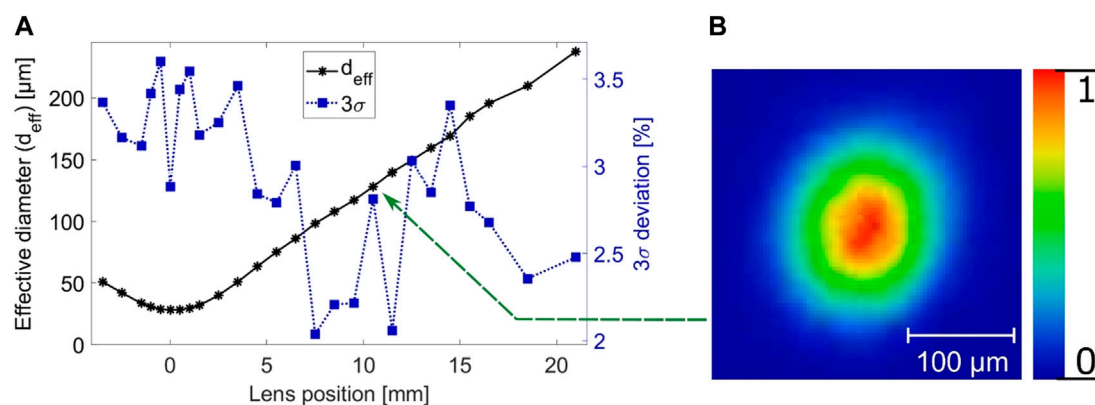
FIGURE 3

Beam profile of MHz sub-ps green laser measured with a sensor of 3.45 μm pixel length: (A) effective beam diameter (d_{eff}) and 3σ standard deviation of effective area as a function of lens position. The 0 position is at the focal plane; (B) beam profile corresponding approximately to the lens position used for LIC tests with effective beam diameter around 130 μm . For lens positions >0 , the CMOS sensor of the beam profiler is farther from the lens than the focal plane.

For each lens position, we recorded 100 frames. The effective beam areas were analyzed using the maximum exposure value detected on a single pixel, without using any averaging method. The dependence of the effective beam diameter on the lens position is shown in Figure 3, with the beam profile corresponding to the one used for the LIC tests. At the focal plane, the effective beam diameter was approximately 30 μm , whereas the diameter used for the LIC tests was around 130 μm . We found values of the 3 standard deviations of beam area reaching up to 3.5% (Figure 3A).

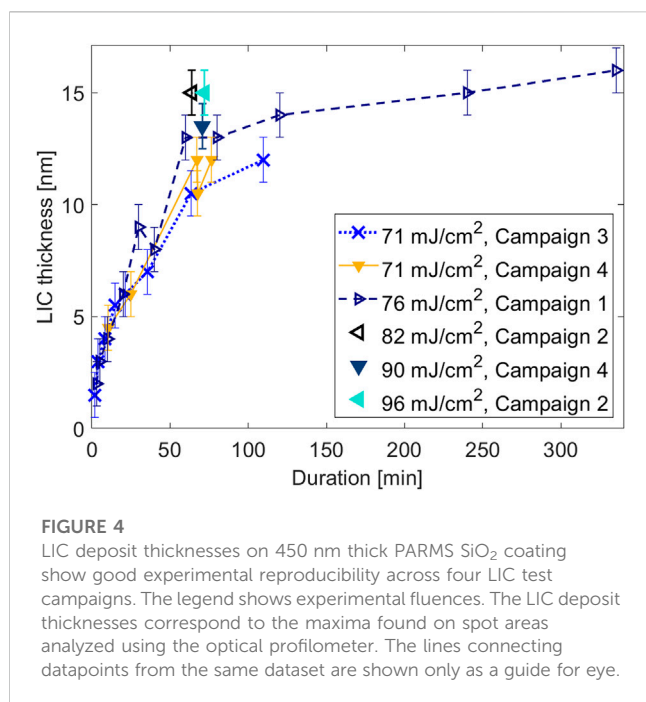
FIGURE 4

LIC deposit thicknesses on 450 nm thick PARMS SiO₂ coating show good experimental reproducibility across four LIC test campaigns. The legend shows experimental fluences. The LIC deposit thicknesses correspond to the maxima found on spot areas analyzed using the optical profilometer. The lines connecting datapoints from the same dataset are shown only as a guide for eye.

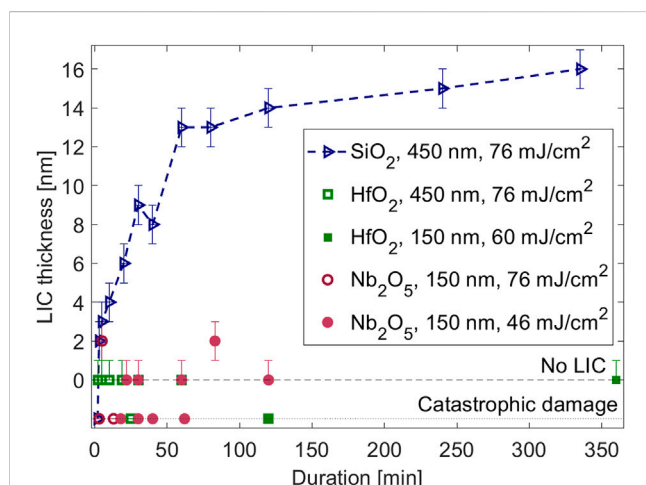
**FIGURE 5**

Effect of material on LIC dynamics. All results refer to samples deposited by magnetron sputtering and tested in the same LIC campaign. On some samples damage occurred during the exposition, and the LIC thickness was consequently not determined (referred to as a negative value on the graph). On the irradiated sites of HfO₂, we did not detect any contamination deposit. In the case of Nb₂O₅, the growth of contamination layers thicker than 2 nm was not possible, since the irradiation conditions were close to damage threshold at 3.3 MHz repetition rate. The dashed line connecting SiO₂ LIC thicknesses is shown only as a guide for eye.

Figure 5 presents the results obtained for three magnetron-sputtered coating materials, SiO₂, HfO₂, and Nb₂O₅, within the same LIC test campaign. At an experimental fluence of 76 mJ/cm², only SiO₂ coatings showed clear LIC deposits thicker than 2 nm. For HfO₂ samples, we either did not detect any surface modification or observed catastrophic damage. Even after 6 h of irradiation using a fluence of 60 mJ/cm², we did not observe any LIC deposit on 150 nm thick HfO₂. Nb₂O₅ was also challenging to study, as it is susceptible to damage under the conditions used. Nevertheless, we found 2 nm thick LIC deposits in two cases.

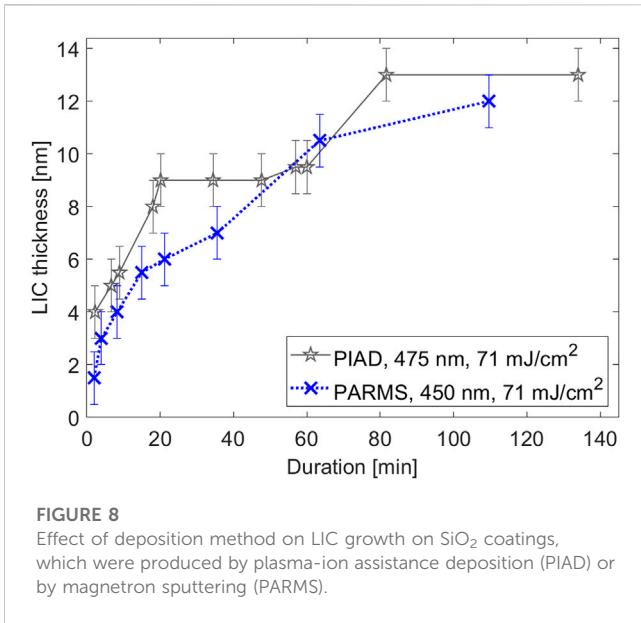
FIGURE 8 Effect of deposition method on LIC growth on SiO₂ coatings, which were produced by plasma-ion assistance deposition (PIAD) or by magnetron sputtering (PARMs).

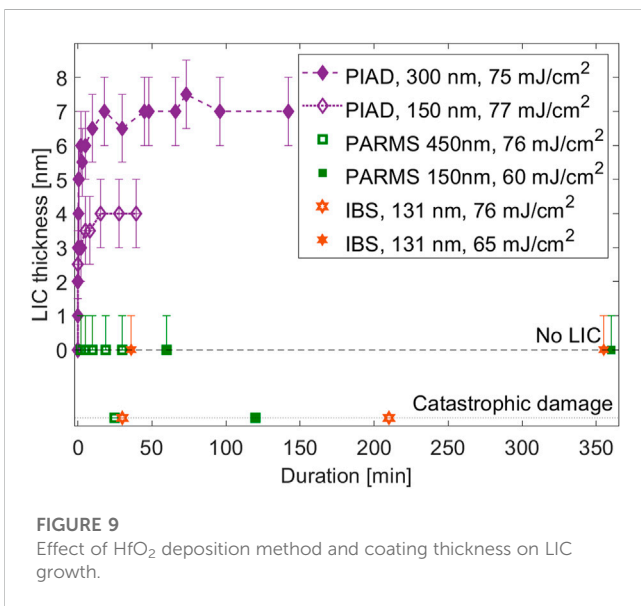
FIGURE 9 Effect of HfO₂ deposition method and coating thickness on LIC growth.

In the case of HfO₂, we compared the material responses to laser irradiation of PARMS, PIAD, and IBS deposited coatings, as shown in Figure 9. We found no LIC deposits on the irradiated spots of PARMS and IBS coated HfO₂ even after 6 h long tests. At the same time, we observed that these coatings are susceptible to catastrophic damage formation when irradiated at a fluence of 76 mJ/cm². In the case of PARMS HfO₂, a catastrophic damage was observed even at 60 mJ/cm². The only deposition method that allowed the observations of contamination growth dynamics on HfO₂ coating was the PIAD method.

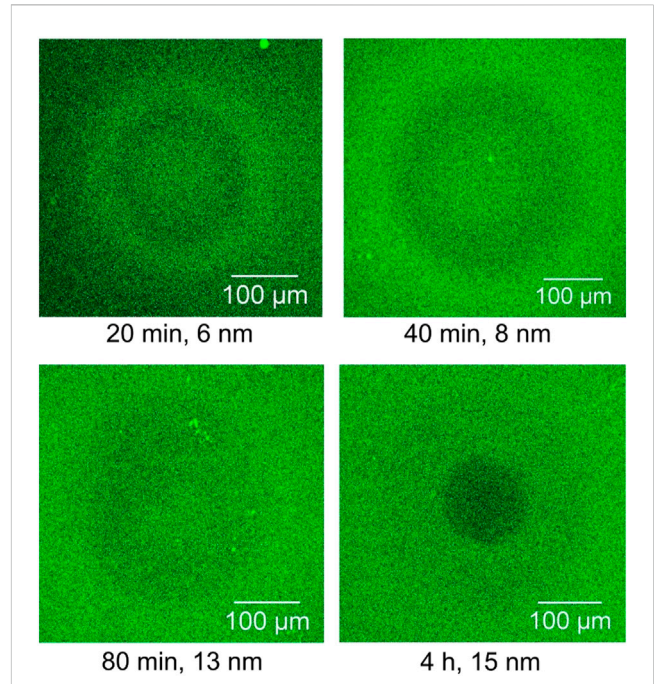
FIGURE 10 Spots on PARMs SiO₂ coating of 450 nm thickness observed by *ex-situ* confocal fluorescence microscope (Leica TCS SPE). Excitation wavelength was 405 nm. Images were captured using x10 objective magnification with the light spectrum ranging from 455 to 800 nm, with the same acquisition parameters. The labels below the images indicate the exposure duration and LIC deposit thickness determined by the optical profilometer. The fluence for exposition was 76 mJ/cm².

Figure 10 shows 2D images of spots on a 450 nm thick PARMs SiO₂ coating. The fluorescence images reveal spots that were tested for LIC growth by exposing them to green laser light for periods ranging from 20 min to 4 h.

The evolution of changes in the irradiated spot images suggests that the chemical nature of deposits is modified with irradiation time. Initially, we observed the growth of the deposited area up to 80 min, followed by a second transformation of the deposit that further reduced the fluorescence yield. Similar material transformations were reported for UV nanosecond pulses in a vacuum. (El Reaidy et al., 2018). However, the luminescence

A possible reason for the darker central region observed in the 4-h test could be that the contamination layer absorbed some of the fluorescent or excitation light. Another hypothesis is that the LIC deposit may act as an interferential layer. This effect was previously described in detail in by Wagner et al. (2020), who found that the effective refractive index of LIC deposits can be lower than that of the fused silica substrate due to its nanometric porosity. Such a layer exhibits slightly antireflective characteristics, which was observed during the early phase of the LIC deposit evolution.

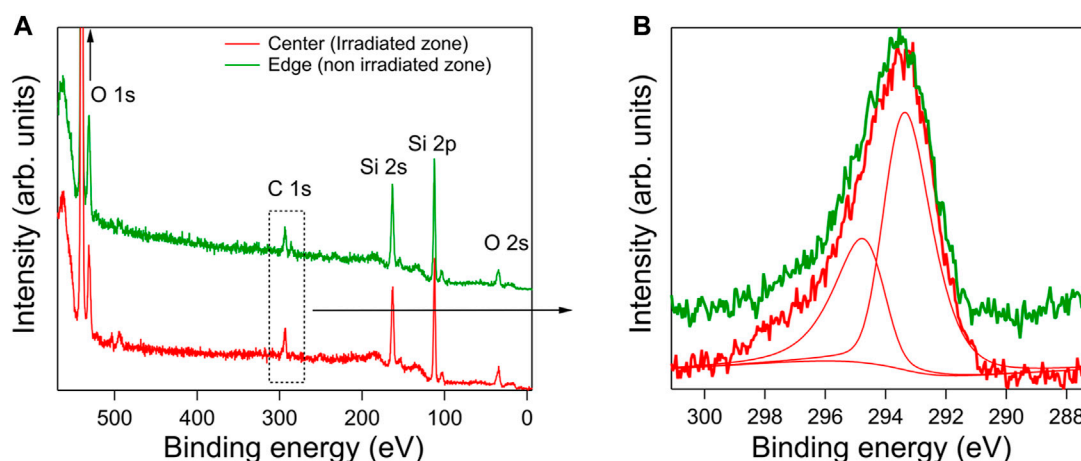
FIGURE 11

(A) Comparison of spectra between the two analyzed zones on SiO₂ sample: center part with array of LIC deposits (red) and edge of sample which was not irradiated by the laser. This XPS analysis revealed presence of Si, O, and C. The largest difference between the two analyzed zones, detailed in the inset for C, suggests that there may be carbon compounds characteristic to the LIC. (B) Zoom on the C 1s core level region.

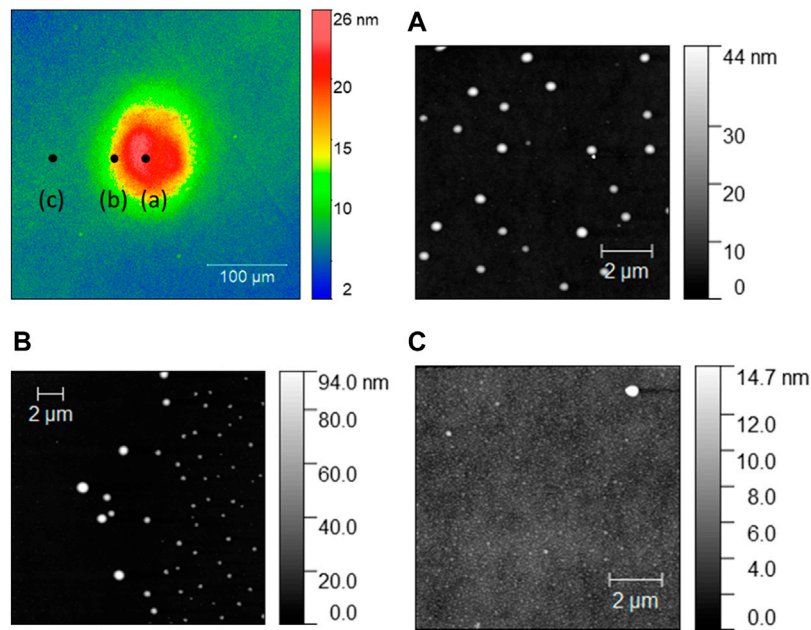
FIGURE 12 Optical Profilometry measurement of a LIC deposit on a 450 nm SiO₂ layer obtained after 4 h exposition to 76 mJ/cm². The different points correspond to the positions of the AFM measurements in 10 × 10 μm² area. (A) Center of the LIC deposit; (B) edge of the LIC deposit; (C) outside the laser illuminated area.

The AFM measurements reveal a particulate structure, that was not resolved with the optical profilometric measurement. We observed the formation of nanoparticles, resulting from the LIC deposit, in correlation with the deposit thickness measured by optical profilometry. From the topography images in Figure 12,

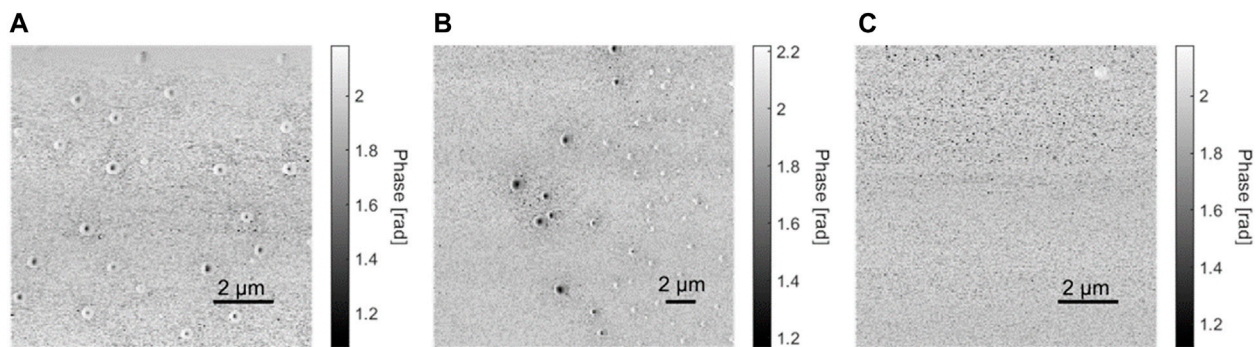
FIGURE 13 Mechanical Phase variation at (A) Center of the LIC deposit, (B) edge of LIC deposit and (C) outside the laser illuminated area.

Furthermore, working in tapping mode using AFM, we can also simultaneously record the mechanical phase of the microcantilever oscillations as in Figure 13 for the different area. A phase lag may be associated to a variation in the viscoelastic properties of the samples. At the center of LIC induced nanoparticles (Figures 13A, B), we observed a phase variation that is not seen over dust particles outside the LIC area (Figure 13C). This let us assumed that the LIC deposit induces some physical and/or chemical changes of the thin film during laser irradiation as mentioned in the introduction. Looking more specifically at the profiles across the LIC induced NP, we observed a larger and more important phase shift (≈0.5 rad) for the NP at the LIC edge that may be correlated to the size and shape of the NPs made on the topography images (Figure 12). This nanostructuration induced by LIC is certainly the cause of the observed changes on the optical profilometry measurements.

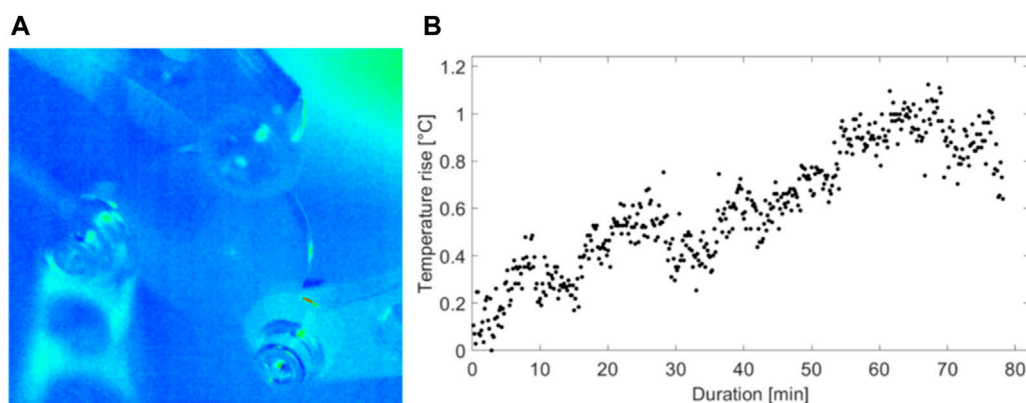
FIGURE 14

Evolution of temperature on 450 nm thick PARMs SiO₂ coating during the irradiation inducing LIC: **(A)** Photograph of irradiated sample captured by thermal camera during the experiment. The heated area is visible at the center of the sample but the temperature rise is less than 1°C compared to the mean temperature of the sample. **(B)** Temperature rise as a function of duration. Exposure time of the camera was 10 ms and the deposit covered a bit more than one pixel.

Experiments were conducted on a magnetron-sputtered 450 nm thick SiO₂ coating. The temperature evolution was recorded during 80 min long laser exposure at 3.3 MHz with a mean power of 35W and effective beam diameter of 130 μm. After the exposure, the spot was analyzed *ex-situ* via the optical profilometer and a LIC deposit thickness of around 12 nm was found. Results are reported in Figure 14.
