The 2015 Gorkha Nepal earthquake: insights from earthquake damage survey

Katsuichiro Goda^{1*}, Takashi Kiyota², Rama Mohan Pokhrel², Gabriele Chiaro², Toshihiko Katagiri², Keshab Sharma³ and Sean Wilkinson⁴

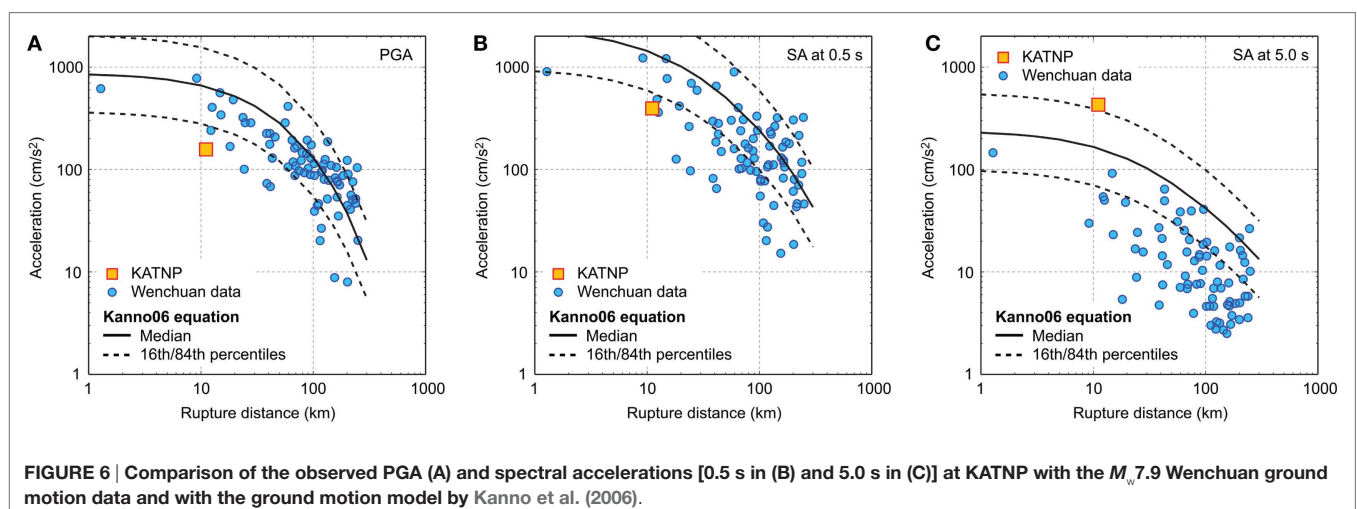
Figure 6 compares observed ground motions at KATNP (i.e., **Figure 5**) with the ground motion data from the M_w 7.9 Wenchuan earthquake as well as the Kanno06 model. The rupture distance for KATNP (=11.1 km) is calculated using the USGS finite-fault plane model (i.e., **Figure 2A**). For the Kanno06 model, 16th and

84th percentile curves are also shown to indicate a typical range of predicted ground motion variability. **Figure 6A** indicates that the observed PGA at KATNP is significantly smaller than the Wenchuan data in the similar distance range and the predicted PGA based on the Kanno06 equation (below the 16th percentile curve). The below-average trend of the observed ground motion intensity, in comparison with the Wenchuan data and the Kanno06 model, persists for spectral accelerations at vibration periods < 2.0 s (**Figure 6B**). These comparisons indicate that the level of short-period ground motion near KATNP during the 2015 mainshock was smaller than expected ground motion levels based on empirical data/models for similar scenarios. On the other hand, **Figure 6C** shows an opposite trend: the long-period spectral acceleration at KATNP is significantly greater than the counterparts based on the Wenchuan data and the Kanno06 model. The large spectral acceleration in the long vibration period range is attributed to the basin effects. It is also interesting to note that the recent ground motion prediction model, such as Boore et al. (2014), can take into account the basin effects using a depth-to-bedrock parameter [note: in **Figure 6**, the equation by Boore et al. (2014) is not considered because it is based on R_{jb}]. Using the empirical model by Boore et al. (2014), the expected site amplification due to the basin effects is a factor of two for vibration periods longer than 2.0 s; the observed long-period spectral acceleration can be better explained. Therefore, it is important to adopt advanced ground motion models that can account for major systematic components (e.g., faulting mechanism and basin amplification) in predicting ground motion intensity for future earthquakes.

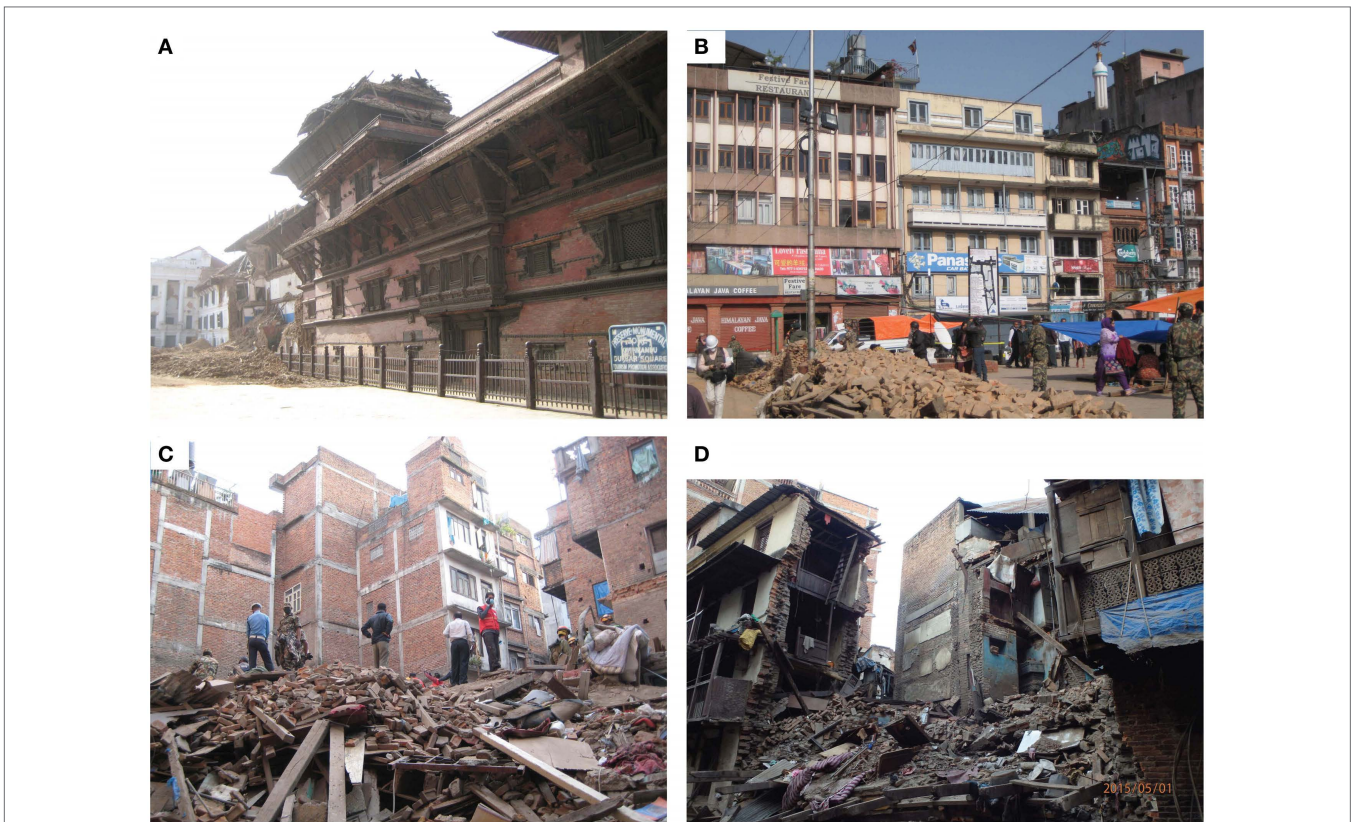
Many historical buildings in the Kathmandu Durbar Square (in front of the Old Royal Palace of the former Kathmandu Kingdom and is a UNESCO World Heritage site) were devastated (area 1 in **Figure 4**). **Figure 8A** shows the collapse of the Basantapur Tower. The complete destruction in the Durbar Square was in sharp contrast with undamaged buildings surrounding the Durbar Square (**Figure 8B**; several wall cracks can be found on these buildings;

however, the majority of the masonry buildings are structurally stable). This indicates that the ground shaking experienced in this area (note: this is relatively close to the KATNP station; see **Figure 4**) was sufficient to cause the collapses of the old historical buildings but was not to cause severe damage to the surrounding buildings. This observation was confirmed by walking through the Indra Chowk area (market squares near the Old Palace), where many old masonry buildings (three to six stories) were densely constructed. Nevertheless, there were several buildings that collapsed completely and some search and rescue activities were undertaken (**Figures 8C,D**).

FIGURE 8 | Damage in Kathmandu (area 1 in Figure 4). (A) Collapse of the Basantapur Tower in the Kathmandu Durbar Square. **(B)** Undamaged buildings opposite of the Basantapur Tower in the Kathmandu Durbar Square. **(C)** Collapse of four 5- or 6-story old masonry buildings. **(D)** Collapse of a 4-story masonry building.

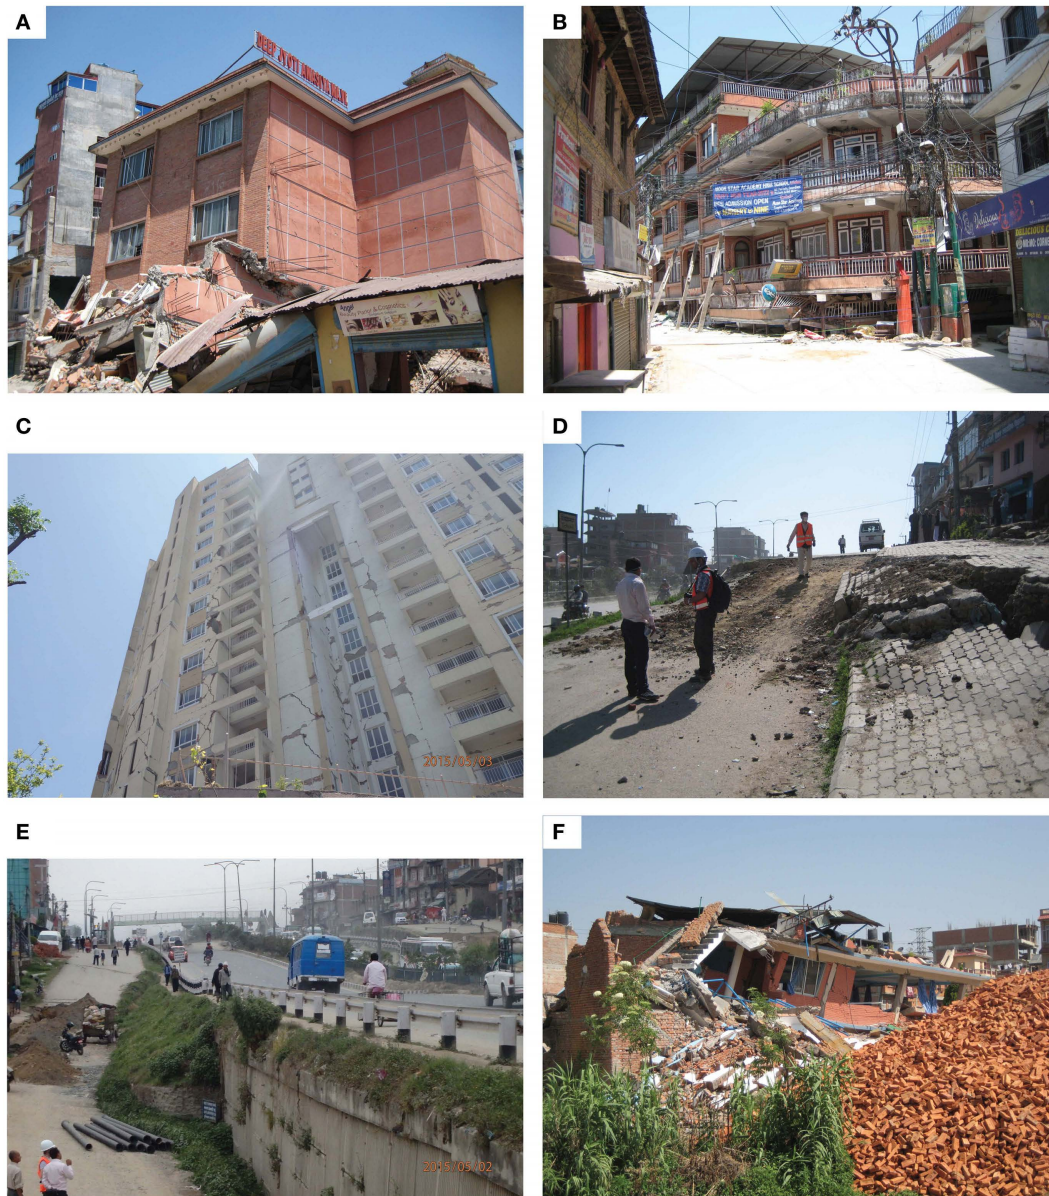
There were numerous building collapses in the north-west section of the Ring Road along the Bishnumati River (area 2 in **Figure 4**). According to the local geomorphological map, sites within about 300 m from the river are alluvial (Holocene) soil deposits, whereas sites farther east are Pleistocene soil deposits. Therefore, site amplification effects due to different soil conditions may be expected in this area. A walk-through survey was carried out to investigate the spatial distribution of collapsed and severely damaged buildings in this area. Out of

28 collapsed or severely damaged buildings, 19 buildings were in the alluvial deposit area (**Figure 9A**), whereas 9 buildings were in the Pleistocene deposit area but nearer to the boundary (**Figure 9B**). This qualitatively confirms the effects of local site conditions on the building damage and collapse.

In area 3, there was a 16-story high-rise apartment complex (Park View Horizon). The walls of this building suffered from many major cracks along its height (**Figure 9C**). Currently, the apartments are unfit for living and residents have evacuated. The causes of the major damage of the Horizon apartments (and similar high-rise buildings in Kathmandu) may be attributed to the long-period ground motions (**Figure 5**). In addition, local topological features may have contributed to extensive damage there (the complex is on a hill).

Along the Araniko Highway between Kathmandu and Bhaktapur (area 4 in **Figure 4**), a section of the highway (about 200 m in length) built upon embankments was damaged due to the ground settlement. The amount of settlements was about 0.5–2.0 m, depending on locations (**Figure 9D**). The central section of the highway was constructed using reinforced soil retaining wall and

gravity-type retaining wall (2–3 m high and 100 m wide). The retaining walls were structurally intact and suffered from minor cracks and outward deformation only, whereas the natural slopes at both ends of the highway embankments experienced noticeable settlements (Figure 9E). Several buildings along the highway were tilted due to the settlements. A pedestrian footbridge crossing the highway suffered from the differential settlement of foundation, resulting in a gap of 45 cm between the bridge girder and the stair steps.

In area 5 (Figure 4), minor liquefaction, which was evidenced by sand boils and did not cause any structural damage, was observed in a small open land near a canal. In the surveyed area, a church was collapsed due to the ground shaking (Figure 9F). According to local residents, the church building was standing after the M_w 7.8 mainshock but was collapsed due to the M_w 6.7 aftershock on the following day. The extent of structural damage before the M_w 6.7 aftershock is unknown. There were several houses that settled and tilted in this area. However, the degree of destruction in this area was minor.

FIGURE 9 | Damage in Kathmandu (areas 2–5 in Figure 4). (A) Collapsed building along the Bishnumati River (alluvial soil deposit area; area 2 in Figure 4). (B) Collapsed building (soft story collapse) near the Bishnumati River (boundary between alluvial and Pleistocene soil deposit areas; area 2 in

Figure 4). (C) Horizon apartment buildings (area 3 in Figure 4). (D) Settlement of the Araniko Highway (area 4 in Figure 4). (E) Damage to the Araniko Highway (area 4 in Figure 4). (F) Collapsed church in the Imadol area (area 5 in Figure 4).

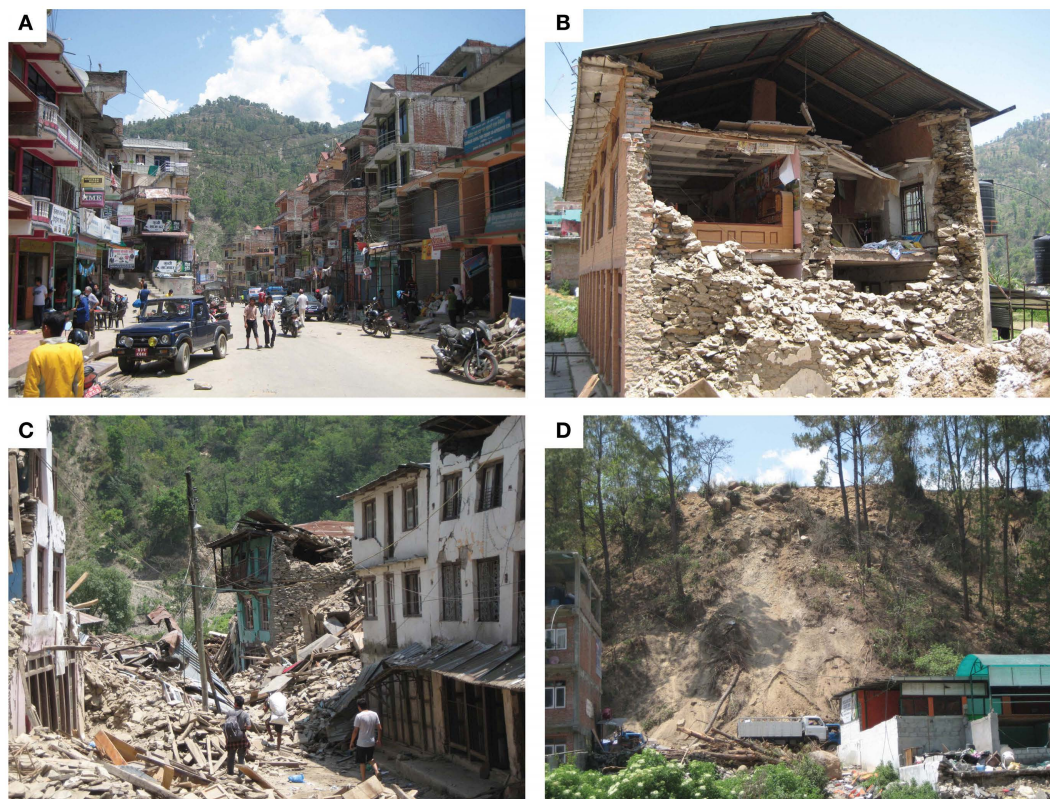
street of Melamchi was not completely destroyed (Figure 10A); most buildings looked undamaged based on their appearances, although several buildings were collapsed. On the other hand, buildings along a side street were devastated by the earthquakes (Figures 10B,C). The majority of the damaged buildings were made of brick and stone. Along the road, several sections of the slope suffered from shallow landslides (Figure 10D), their debris blocked the road at one time but was removed. There was a steel truss bridge with RC deck for vehicle crossing; the bridge was not damaged (inspected from backside). It has been reported that

FIGURE 10 | Damage in Melamchi (see Figure 3). (A) Main street in Melamchi. **(B)** Damaged stone masonry house. **(C)** Devastated street in Melamchi. **(D)** Shallow landslide along the main road.

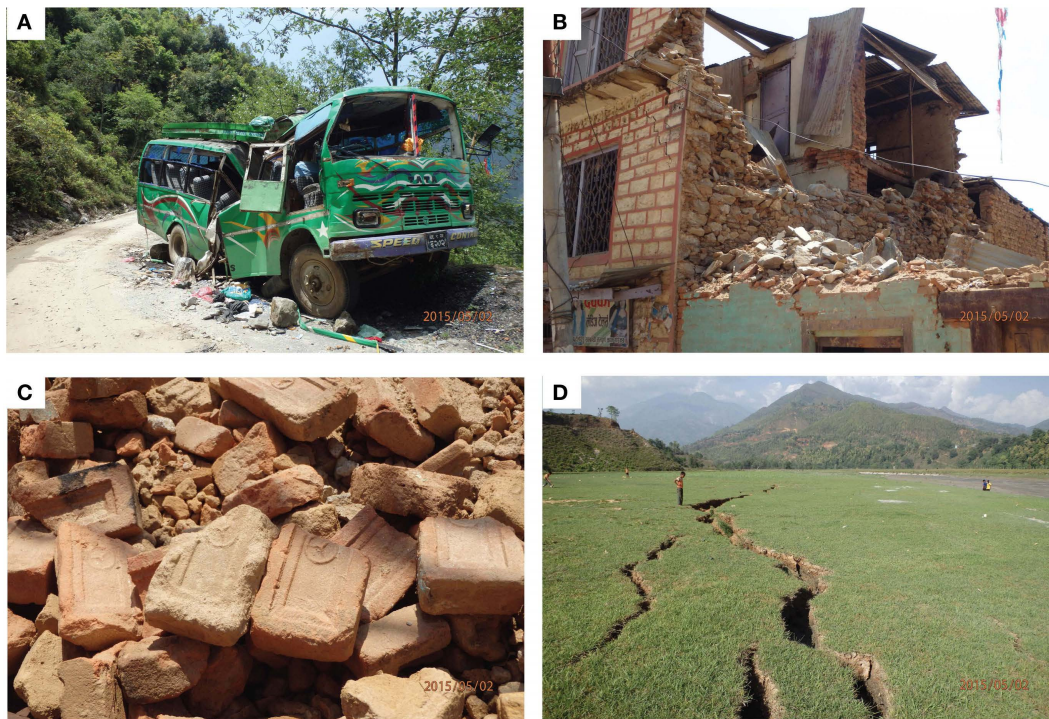
hydroelectric station. Trishuli was closer to the hypocenter of the M_w 7.8 mainshock, and thus severer damage, in comparison with Kathmandu, was expected. Along the way to Trishuli, earthquake damage in Ranipauwa (about 15 km north–west of Kathmandu) appeared relatively minor. Proceeding further north–west, earthquake damage to houses and landslides along the mountain slopes were observed more frequently. The rock fall, as secondary hazard, can be dangerous; a bus was hit by fallen boulder and several people were killed (**Figure 11A**). In Battar (about 25 km north–west of Kathmandu), a large number of brick/stone masonry buildings were collapsed (**Figure 11B**). The building materials of these damaged buildings were of poor quality; for example, two different types of the fragile bricks were used in one of the damaged houses (**Figure 11C**). According to local residents, many buildings were collapsed due to the 25 April M_w 6.6 aftershock, which occurred 30 min after the mainshock.

In Trishuli, there was an earth fill dam for hydroelectric power generation. The main body of the dam was the excavated and compacted soil. The height of the dam was 12 m (upstream side) and 20 m (downstream side), and the crest width was about 4 m. Due to the earthquake, there were cracks at upstream side of the dam and fissures on the crest. Moreover, liquefaction (as evidenced by silt boils) and lateral spreading (**Figure 11D**) occurred inside of the dam reservoir due to the earthquake. The operation of the power generation had been suspended since the

following day of the mainshock; at the time of the visit, no power was available in nearby villages. Overall, the earthquake damage to the Trishuli dam will not cause severe problems immediately. However, the extent of cracking along the dam axis may suggest a deterioration of the dam body, which may be accelerated into the dam failure by future earthquakes or penetration of rain water into the dam body through cracks. It is important to mention that in worst-case scenarios (note: this earthquake is not the extreme case in terms of ground shaking intensity), catastrophic dam failures could have been caused. As there are several major hydroelectric projects along the Trishuli River as well as in other major rivers in Nepal, ensuring dam safety against large earthquakes is important.

FIGURE 11 | Damage in Trishuli (see Figure 3). (A) Destroyed bus due to boulder fall. **(B)** Damaged brick masonry house in Battar. **(C)** Different types of bricks used in the damaged masonry house in Battar. **(D)** Ground fissures in the Trishuli dam reservoir.
