Damage Assessment on Buildings Following the 19th September 2017 Puebla, Mexico Earthquake

Samuel Roeslin^{1*}, Quincy T. M. Ma¹ and Hugón Juárez García²

Keywords: seismic damage assessment, 2017 Puebla earthquake, building damage, seismic assessment forms, Global Earthquake Model (GEM), European Macroseismic Scale EMS-98

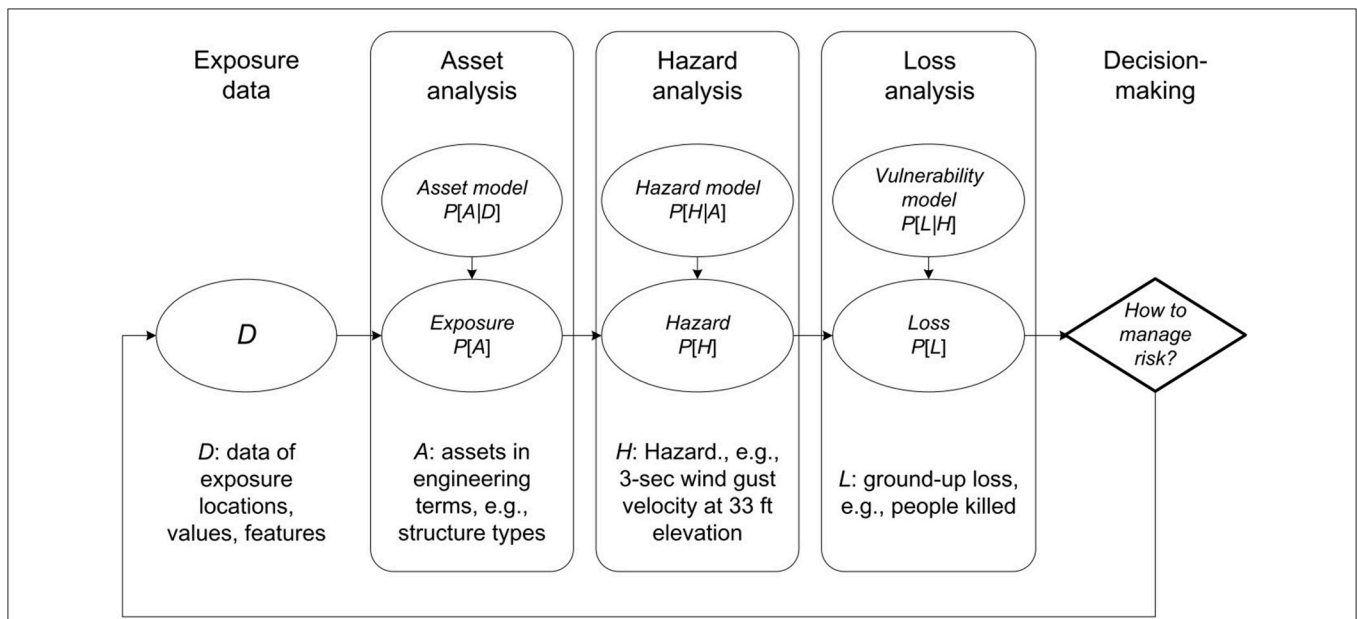
FIGURE 2 | An engineering approach to risk analysis (Porter, 2018).

Porter (2018) presents a concise summary of the engineering approach to risk analysis. A schematic overview is reproduced in **Figure 2**. Informed decision making requires understanding of asset characteristics and the site-specific potential hazards. This approach to risk analysis aligns with the Pacific Earthquake Engineering Research Center (PEER) Performance-Based Earthquake Engineering (PBEE) methodology.

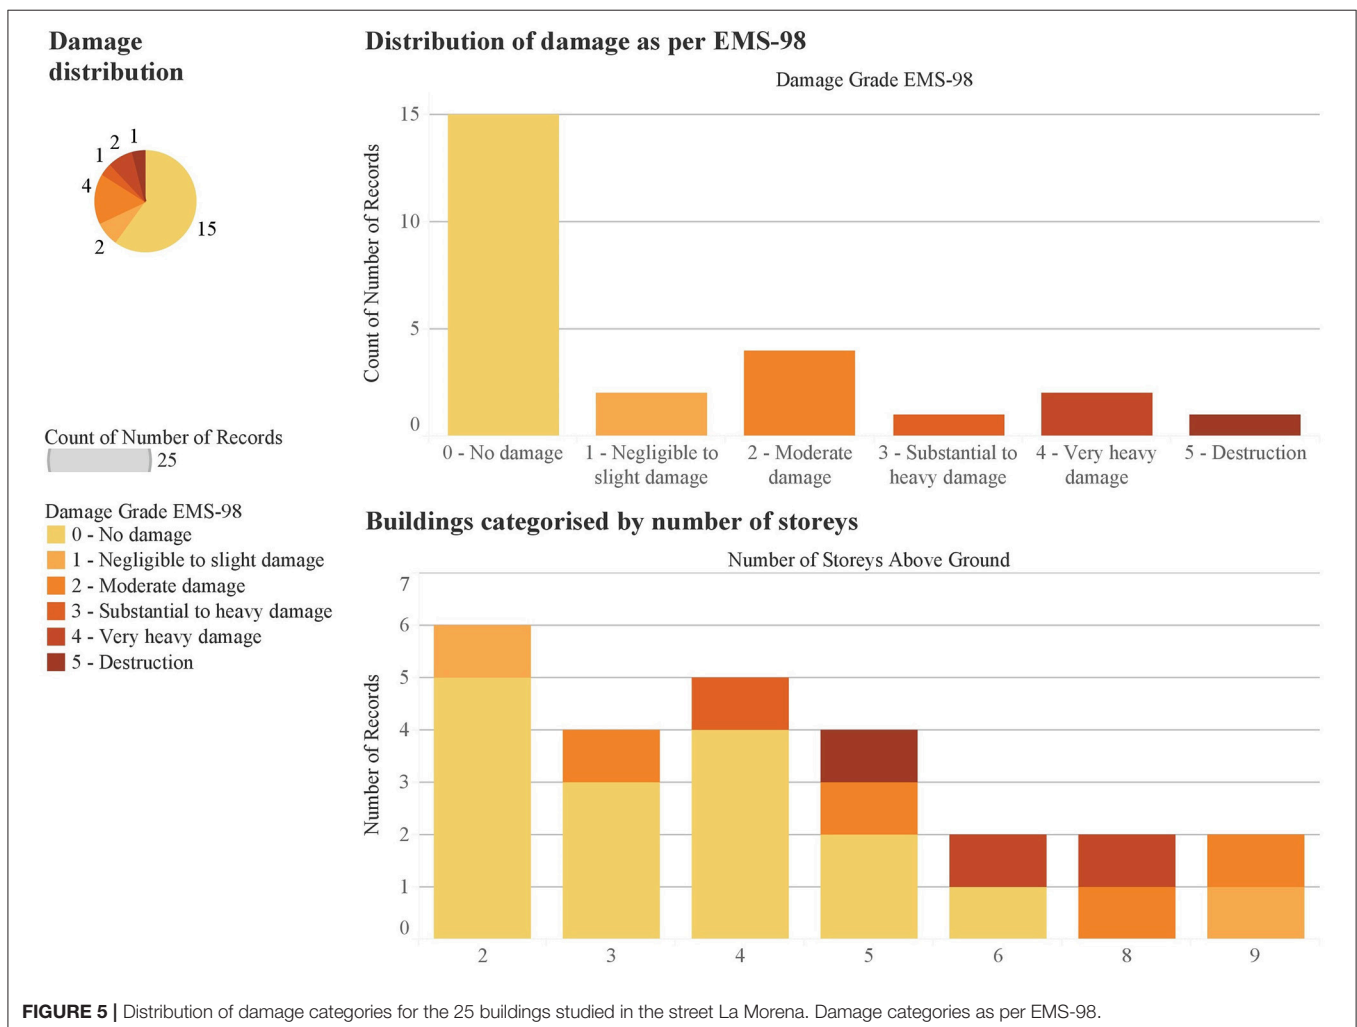
FIGURE 5 | Distribution of damage categories for the 25 buildings studied in the street La Morena. Damage categories as per EMS-98.

Figure 5 shows the overall distribution of damage grade of the assessed buildings, and the distribution as separated by number of storeys. Out of the 25 buildings assessed, 15 suffered no damage, 10 experienced at least slight damage, and 1 building collapsed. The damage scale followed EMS-98, and a consistent color code was used for all graphs in this paper. The color code ranged from beige for buildings with no damage to dark red for collapsed buildings.

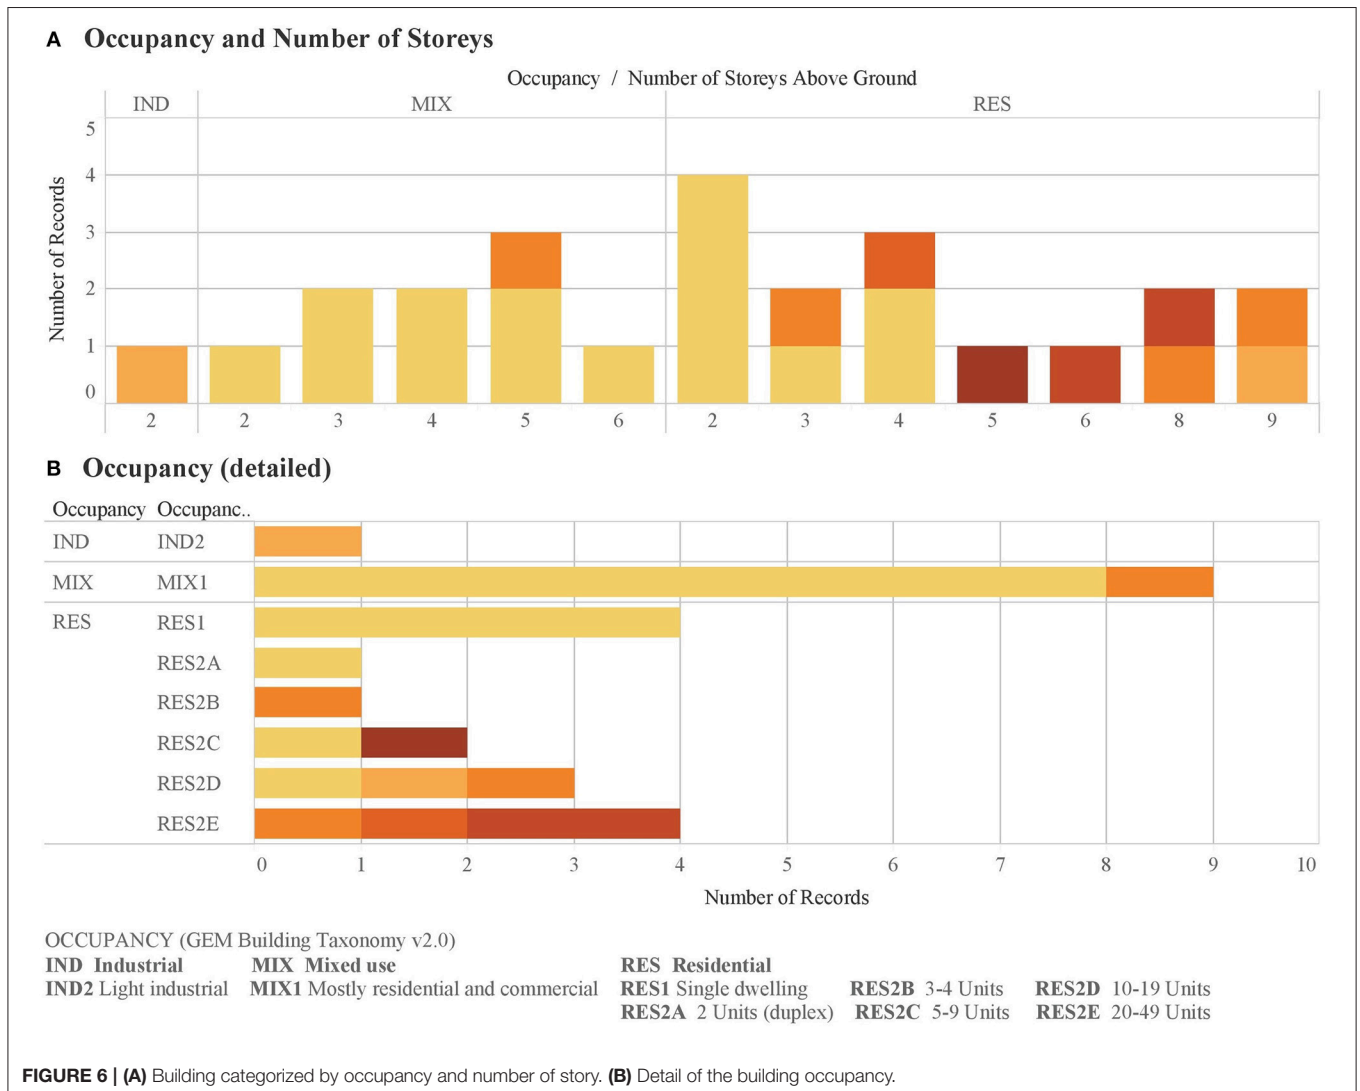
FIGURE 6 | (A) Building categorized by occupancy and number of story. (B) Detail of the building occupancy.

Figure 6A plots the damage grade distribution separated by the number of storeys and building occupancy. It is shown that five to eight storeys building were most severely damaged. From the assessed buildings, 60% are residential (RES) and 36% are mixed-used, mostly residential and commercial (MIX1), as

shown on **Figure 6B**. It is noteworthy that this analysis was able to show that residential units with 20–49 units were the most damaged.

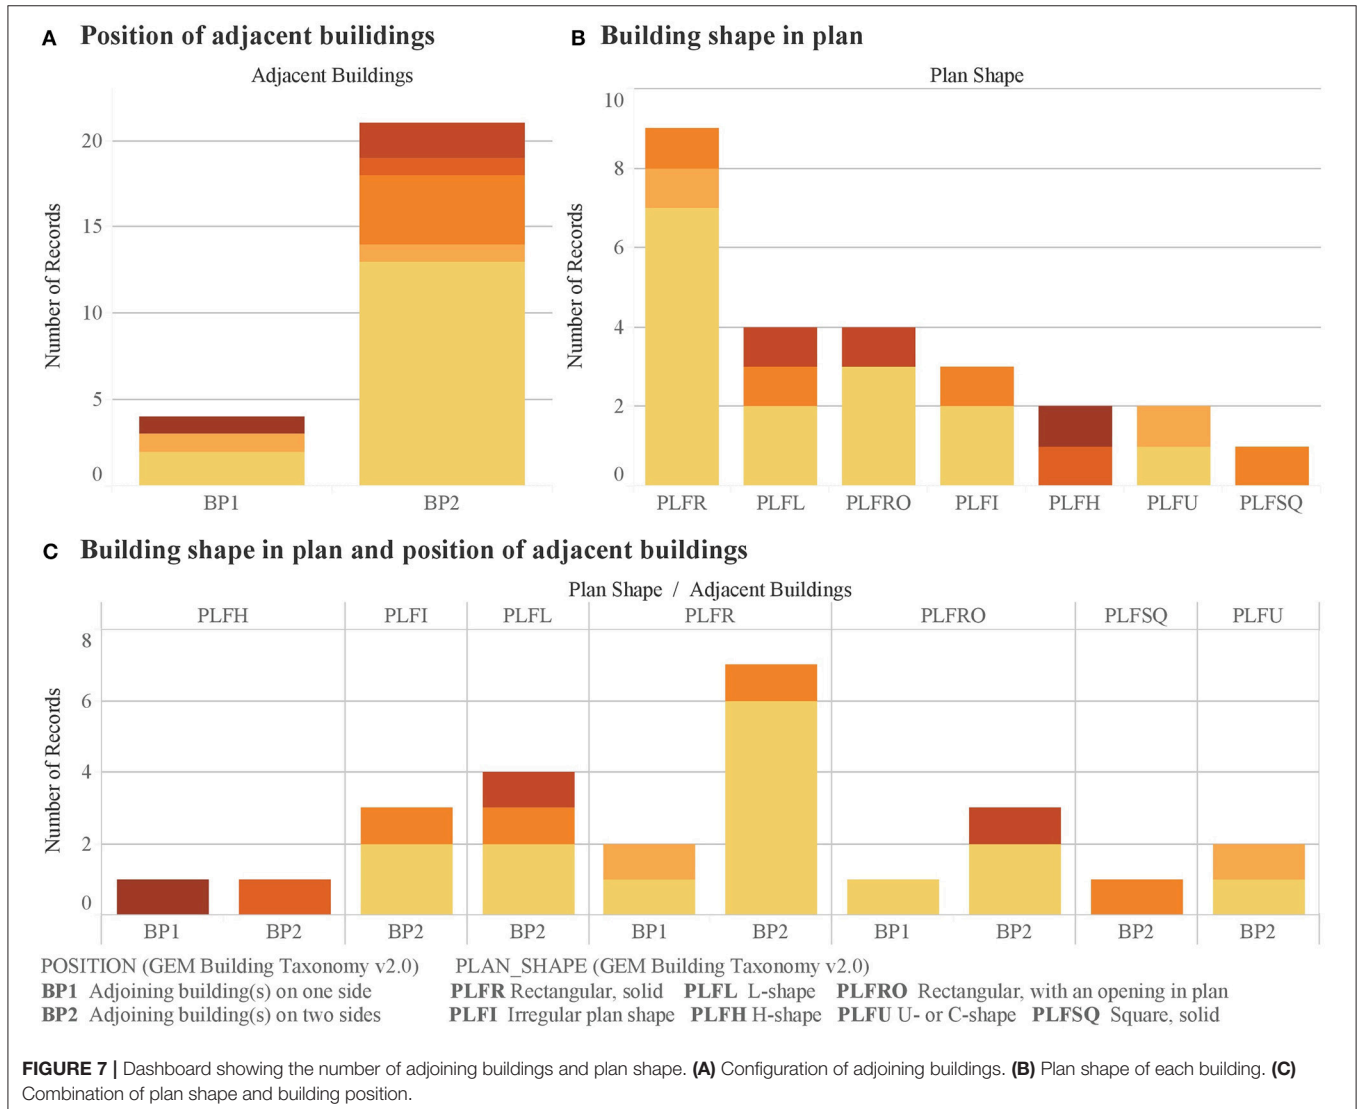
The building position and building plan shape influence damage as shown in **Figure 7**. Buildings are classified into bins according to their plan shape and their position as per the GEM Building taxonomy definitions. Eighty-four percent of the buildings assessed were surrounded by two adjoining structures and 16% have only a building on one side. The plan shape observed in Calle La Morena Street were diverse. Overall the buildings with a solid rectangular plan suffered little or moderate damage. In contrary, H-shaped building experienced very heavy damage. **Figure 8** shows the building material and the lateral load resisting system, respectively. Fifty percent of the building are concrete buildings and 10% are masonry buildings. In 40% of the cases, it was not possible to determine the material of the structural elements. It was even more challenging when attempting to identify the lateral load resisting system in the field. It was not possible to identify the lateral load resisting system of 70% of the buildings in the case study. Like other reconnaissance missions, the field assessment in Mexico City following the 2017 Puebla earthquake highlighted the difficulty in obtaining accurate classification from external observations. This is oftentimes made more difficult with the lack of official authority of scientific data collection teams and health and safety concerns. The difficulty of defining the building structural system and material of the structural elements from external observation increases the variability. This variability should be captured in the data analysis process and represented as epistemic uncertainty. One possibility to overcome the limitation of external inspections, is to access to buildings plans. For some buildings in Mexico City outside the scope of this case study, building plans and structural drawing were available. For most of these cases it was possible to determine the structural system and the material of the

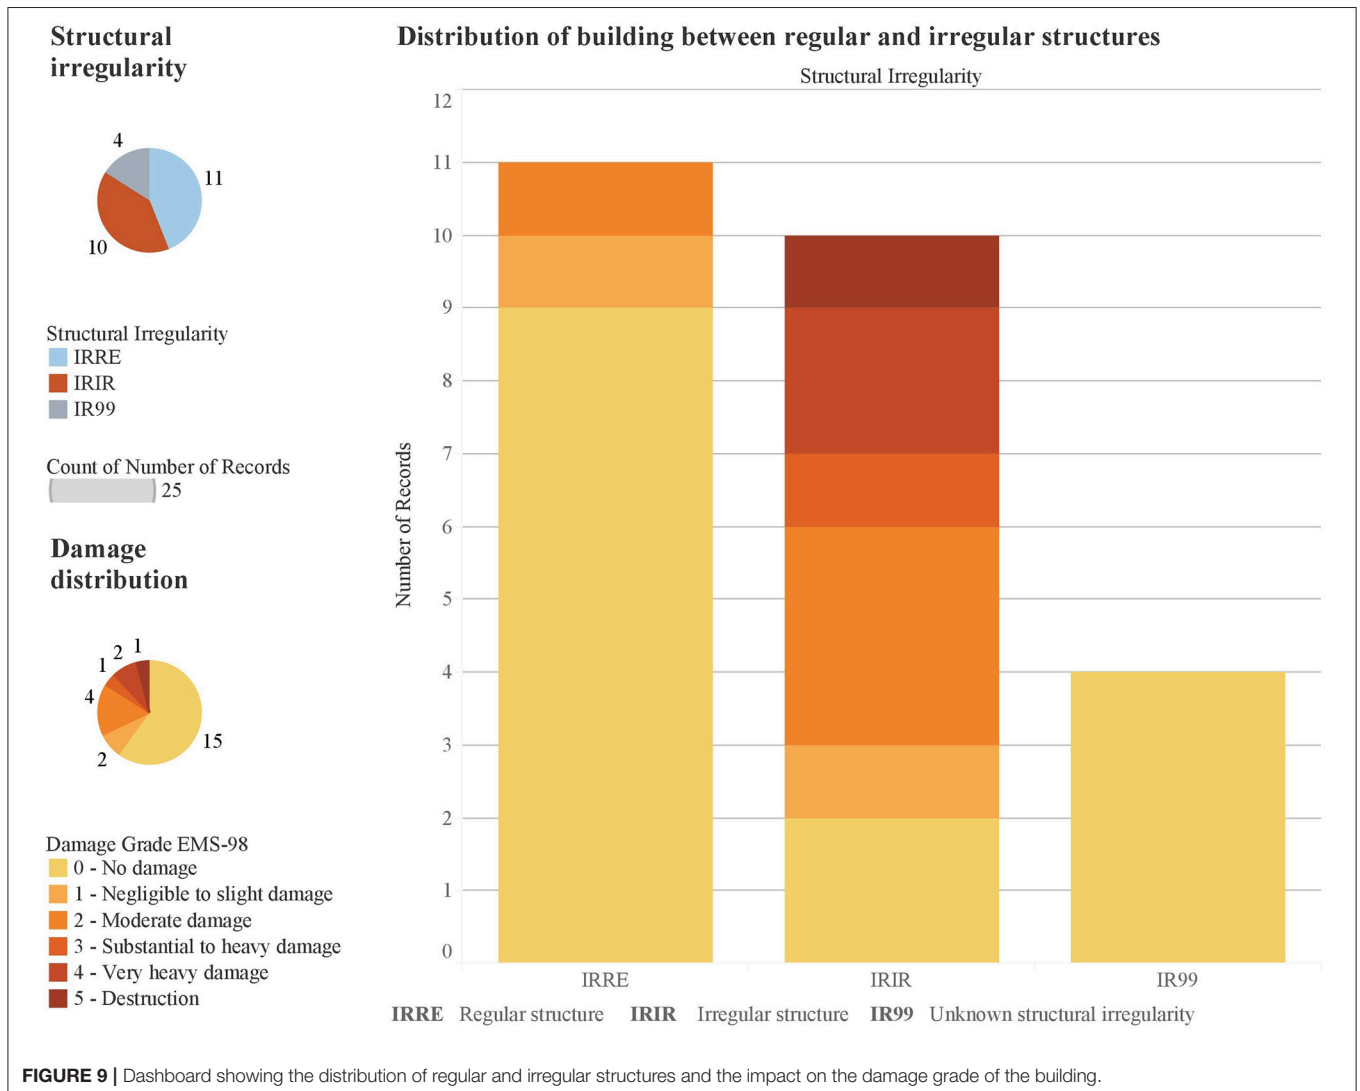
Figure 9 shows that 40% of the structures present at least one structural irregularity (IRIR) in the vertical or horizontal plane whereas only 44% of the building were regular (IRRE) (in 16% the regularity of the structure is unknown). While regular structures experienced moderate damage or less, 30% of the irregular structures experienced moderate damage and 40% suffered substantial damage or more. **Figure 10** shows the type of building irregularity observed in the vertical and horizontal directions. Two-fifth of the structures are irregular. The most common horizontal irregularity is TOR with half of the irregular buildings having torsion issues.

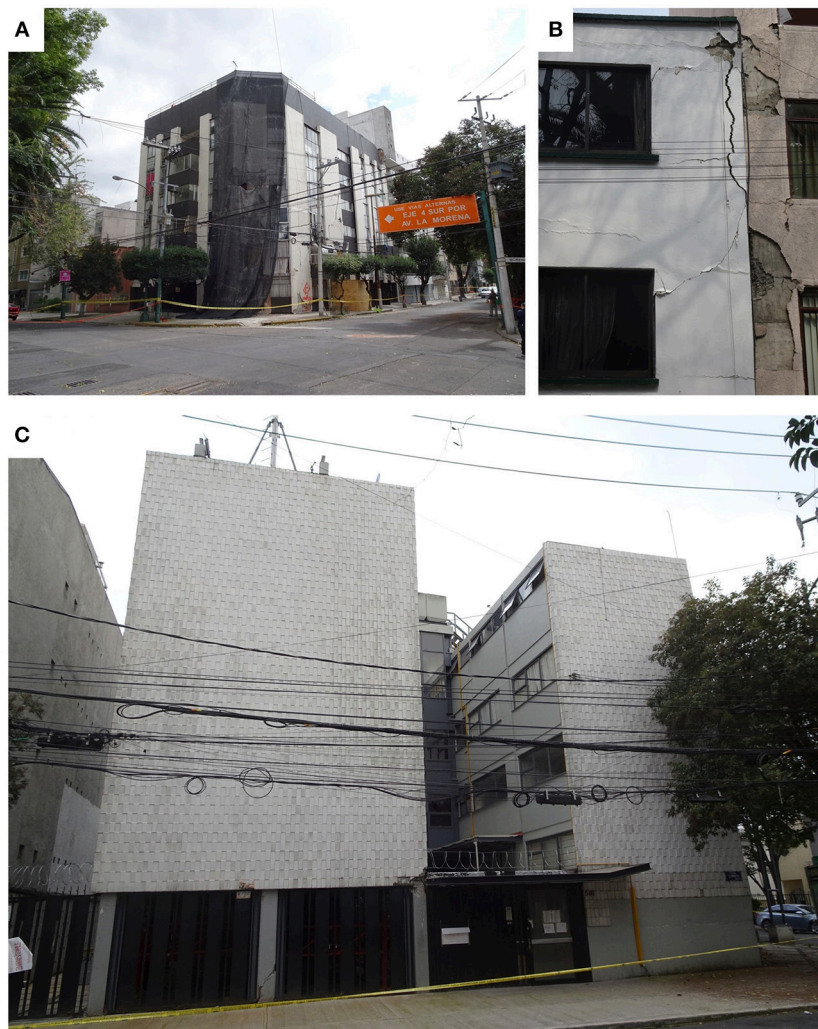
FIGURE 11 | Damage in La Morena. **(A)** Corner building with torsion eccentricity. **(B)** Pounding failure. **(C)** Soft storey in the ground floor.

Figure 11A depicts an example of a corner building with torsion eccentricities. Buildings with substantial and heavy damage all presented problems with torsion. The collapsed building had a re-entrant corner (REC). **Figure 11B** shows that 30% of the vertically irregular structures experienced pounding (POP) and 60% had soft storey (SOS) failure. In fact, all heavily damaged buildings presented a soft storey. **Figure 11C** shows a building with a soft storey on the ground floor. In the case study, only residential buildings suffered heavy damage or more. Buildings with a residential and commercial use (often with shops located in the ground floor) were less damaged. One possible explanation lies in the structural elements of the ground floor. Where commercial facilities are present, structural elements are sized appropriately to carry the load. However, in residential buildings, the ground floor is often used as parking spaces (**Figure 11C**). Building designers often try to maximize the parking spot and structural design is compromised leading to fewer elements and

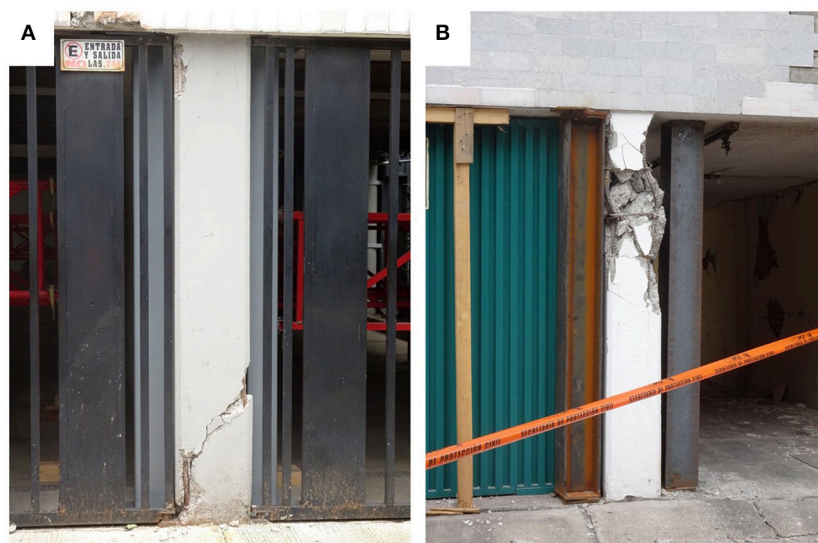
FIGURE 12 | (A) Failure of the column in shear. **(B)** Buckling of the longitudinal reinforcement bars.

or slender columns, to sustain the loads from the upper floors. During the assessment following the Puebla earthquake, the team saw several cases of failed columns. Assessors observed shear cracks, as exposed on **Figure 12A** or total column failure with buckling of the longitudinal reinforcement bars due to insufficient confinement from widely spaced stirrups (**Figure 12B**).
