# SHM of Reinforced Concrete Elements by Rayleigh Backscattering DOFS

This document showcases the latest research conducted within UPC–BarcelonaTech on the performance of distributed optical fiber sensors (DOFS), more specifically the case of the optical backscattered reflectometry (OBR) system, in the structural health monitoring (SHM) of bridges, and large scale structures. This technology has demonstrated promising results for monitoring applications in a wide range of fields but due to its novelty, still presents several uncertainties which prevent its use in a more systematic and efficient way in civil engineering infrastructures, being this even more evident in the case of concrete structures. Therefore, different laboratory experimental campaigns were devised where multiple aspects of the instrumentation of DOFS technology in civil engineering applications were assessed and scrutinized. Such as the study of new implementation methods, comparison, and performance analysis of different bonding adhesives and spatial resolution. Additionally, the fatigue performance of this sensing typology was also assessed. Furthermore, the use of the OBR system technology was applied in a re

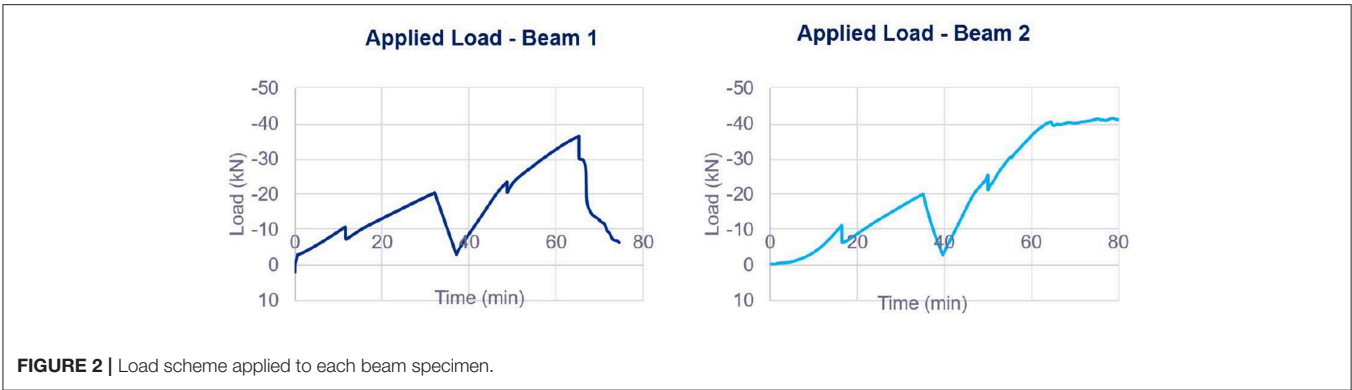
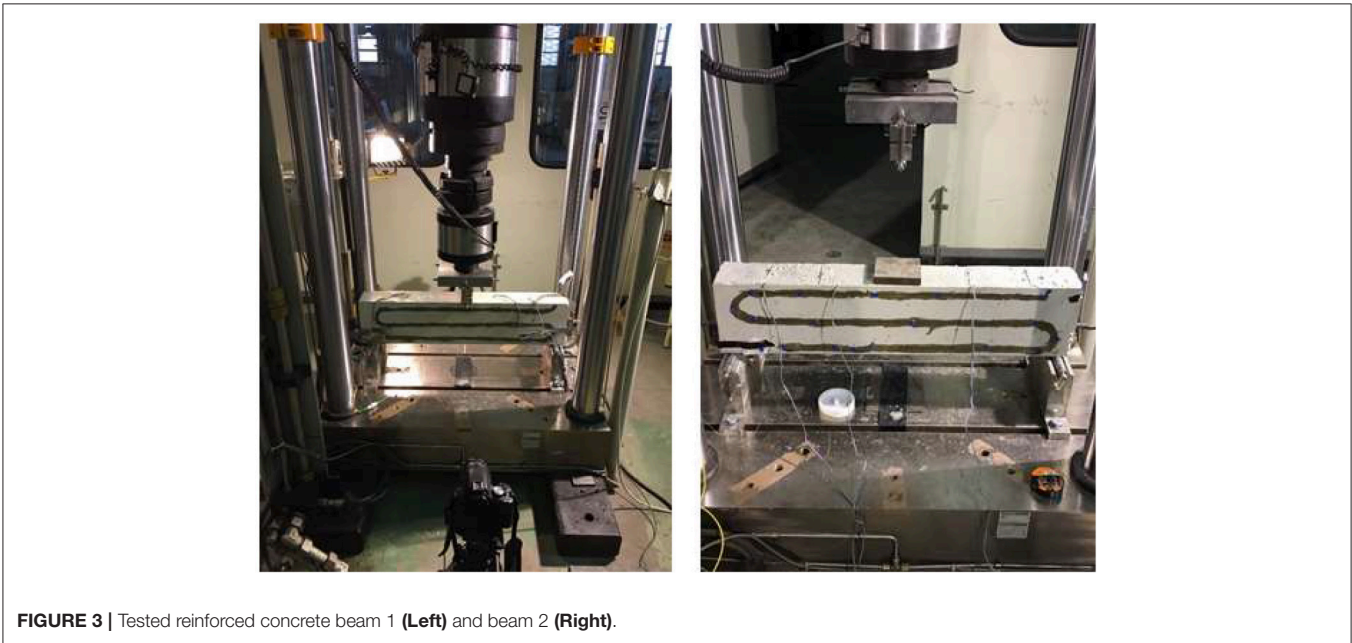
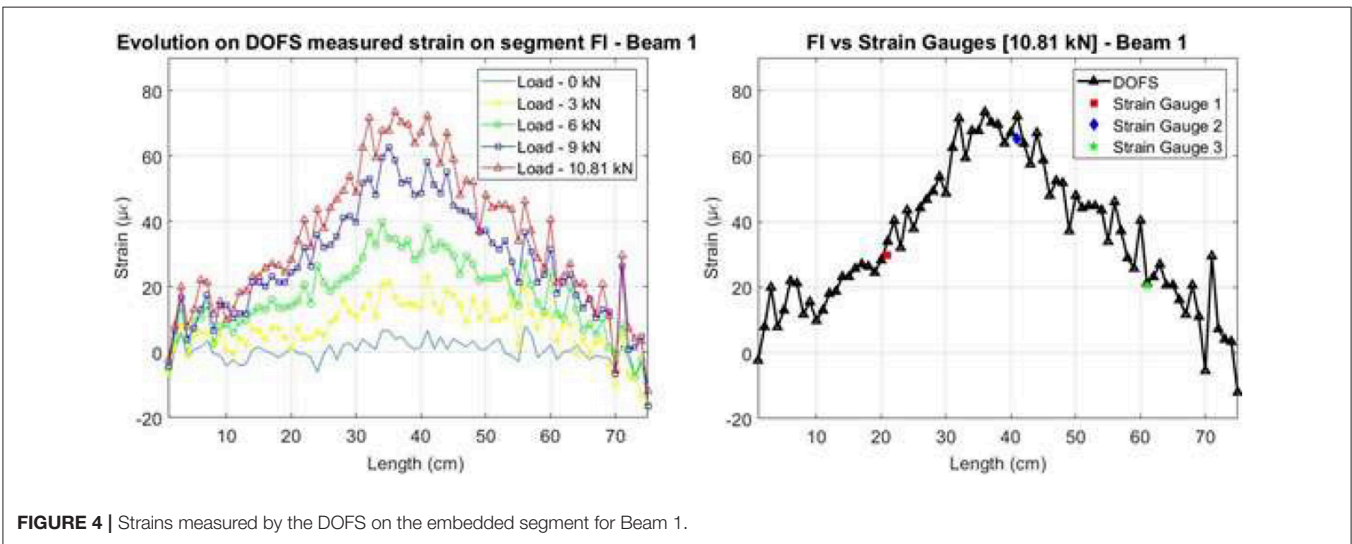
Two single reinforced concrete beam specimens [100 x 180 x 800 mm] were instrumented with a 5.2 m length DOFS and tested, **Figure 3**. The DOFS were bonded in each specimen, initially to the rebar (along its longitudinal rib), and, after hardening of the concrete, to the external surface. The bonded segments were in this way positioned to measure the strain at the rebar and multiple locations of the concrete surface (both in compression and tension). A single fiber was used.

installation time and ease of use when compared with the two-component epoxy. The loading scheme applied to each specimen is shown in **Figure 2**.

The DOFS performed very satisfactorily in all segments until the occurrence of cracking, **Figures 4, 5**. In Beam 1, DOFS detect and localize the crack formation for a load of 7.5 kN while it is not visually observable. The same occurs in Beam 2, where the expected tensile strength is surpassed for a load of 9.2 kN although this crack is not yet detected visually.

When comparing the DOFS segment attached to the rebar (FI) in each specimen, besides the good agreement with the strain gauges it is recognized a better performance of the measurements in Beam 1 (cyanoacrylate bonded) when compared to Beam 2 (epoxy bonded) especially for its initial unloaded stage reading. Moreover, for load levels where cracking had already occurred, as detected by the segments bonded externally to the concrete surface, damage is not yet noticed at the rebar level.

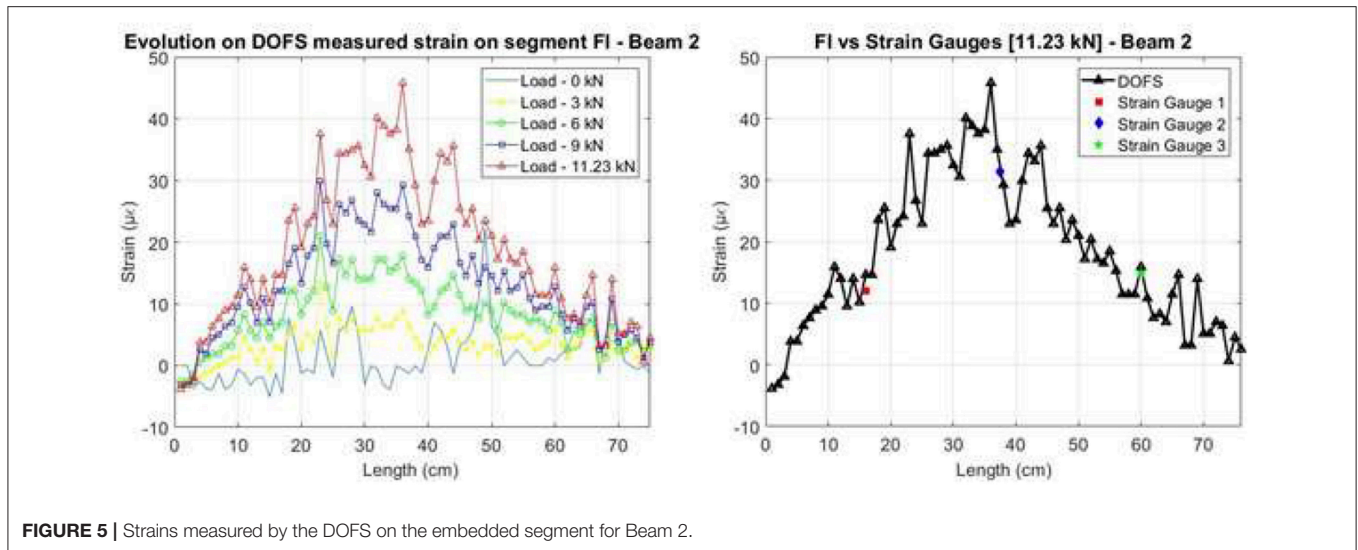
FIGURE 5 | Strains measured by the DOFS on the embedded segment for Beam 2.

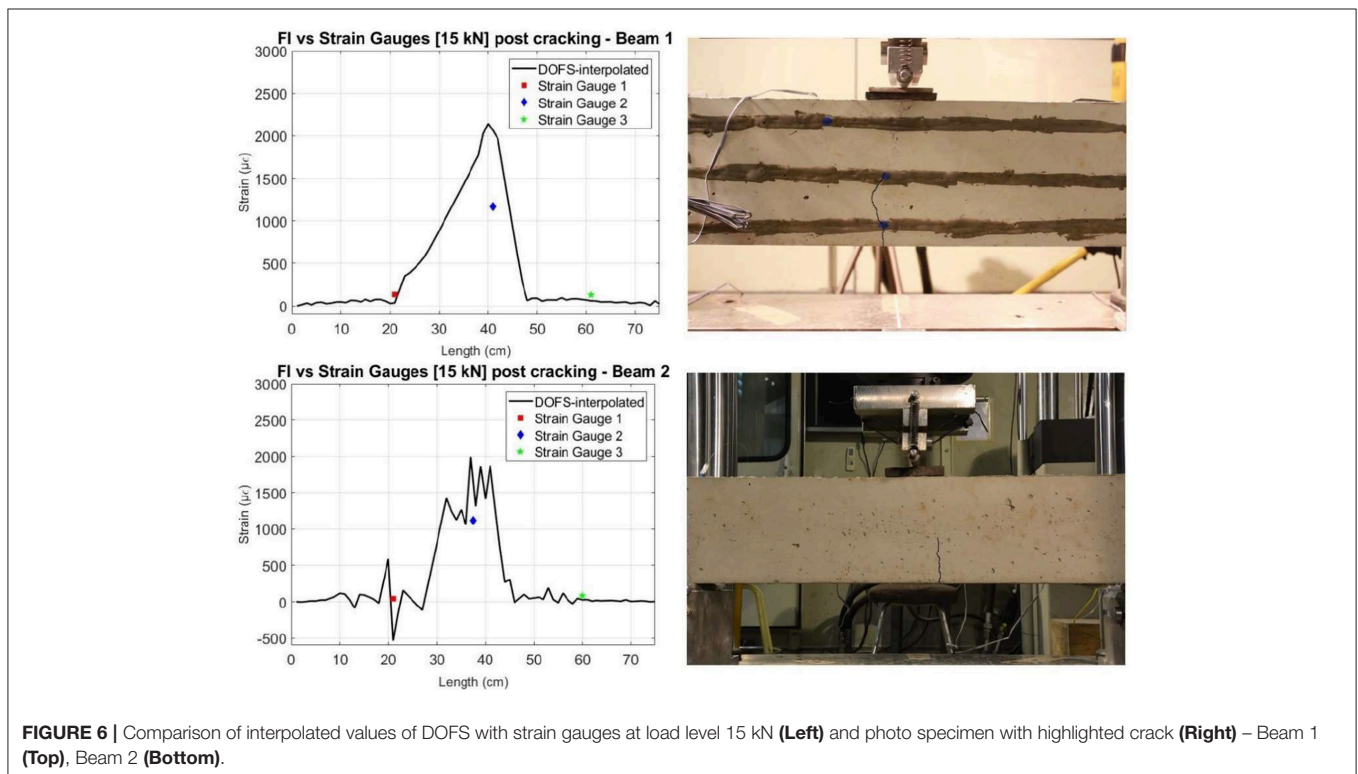
FIGURE 6 | Comparison of interpolated values of DOFS with strain gauges at load level 15 kN (Left) and photo specimen with highlighted crack (Right) – Beam 1 (Top), Beam 2 (Bottom).

After the conduction of this process, and when comparing the strain values after cracking with what was measured by the strain gauges and with what was visually observed directly on the beam specimens for the corresponding load level a good agreement is observed for both beams, **Figure 6**.

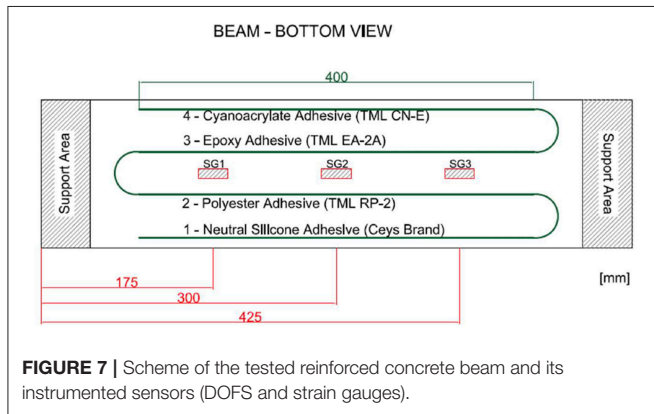
**FIGURE 7** | Scheme of the tested reinforced concrete beam and its instrumented sensors (DOFS and strain gauges).

of a reinforced concrete beam using four different adhesives: epoxy, cyanoacrylate, polyester and neutral cure silicone and tested under a three-point load test. These adhesives were chosen based on previous experience of the research group and through what was found during a literature review on this topic. The DOFS were bonded to the concrete performing a pattern with four equal segments (each one bonded with aforementioned selected adhesives) on the bottom surface of the beam, **Figure 7**, with the objective of inducing the same strain levels, allowing the direct comparison between them. For comparison purposes, three strain gauges were also deployed—SG1, SG2, and SG3.

For this purpose, a laboratory experiment was devised where 2 million load cycles were induced on two reinforced concrete beams (FA1 and FA2), instrumented with Rayleigh based DOFS, in a similar way as depicted in **Figure 7**. The applied load cycles were defined in a way to replicate expected real world conditions for the case of a standard highway bridge.

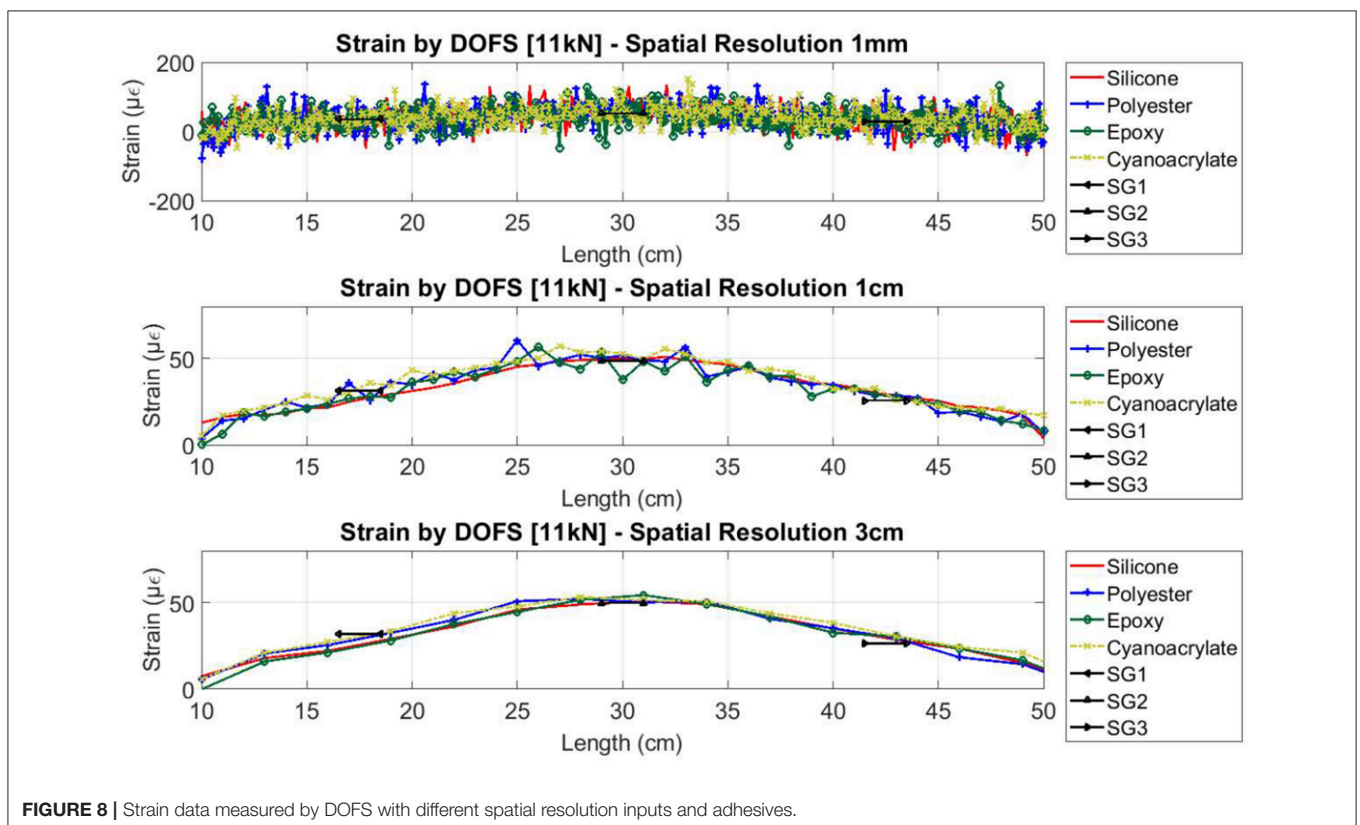
**FIGURE 8** | Strain data measured by DOFS with different spatial resolution inputs and adhesives.

To perform the analysis of the influence of different spatial resolutions, it was decided to conduct three separate but identical load cycles with different spatial resolution with a maximum applied load of 11 kN and therefore without inducing cracking. Three spatial resolutions were tested: 1 cm, 3 cm, and 1 mm, thus representing 520, 174, and 5,191 measuring points, respectively. The obtained results are depicted in **Figure 8**. Here, it is observed how the data collected with a 1 mm spatial resolution presents a significantly higher spatial variability when compared with the other two.

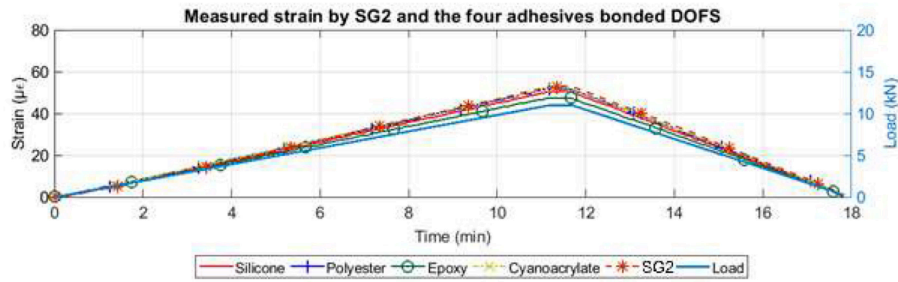
**FIGURE 9** | Comparison of strain measured by DOFS at SG2 location with inputted load at right axis.

Using the same load cycles as in the previous study of the spatial resolution influence, the performance of the different used bonding adhesives while not inducing cracking was also assessed. Here, it was verified that all bonded segments were able to follow the applied load correctly and presented a good agreement with the data from the strain gauges, **Figure 9**.

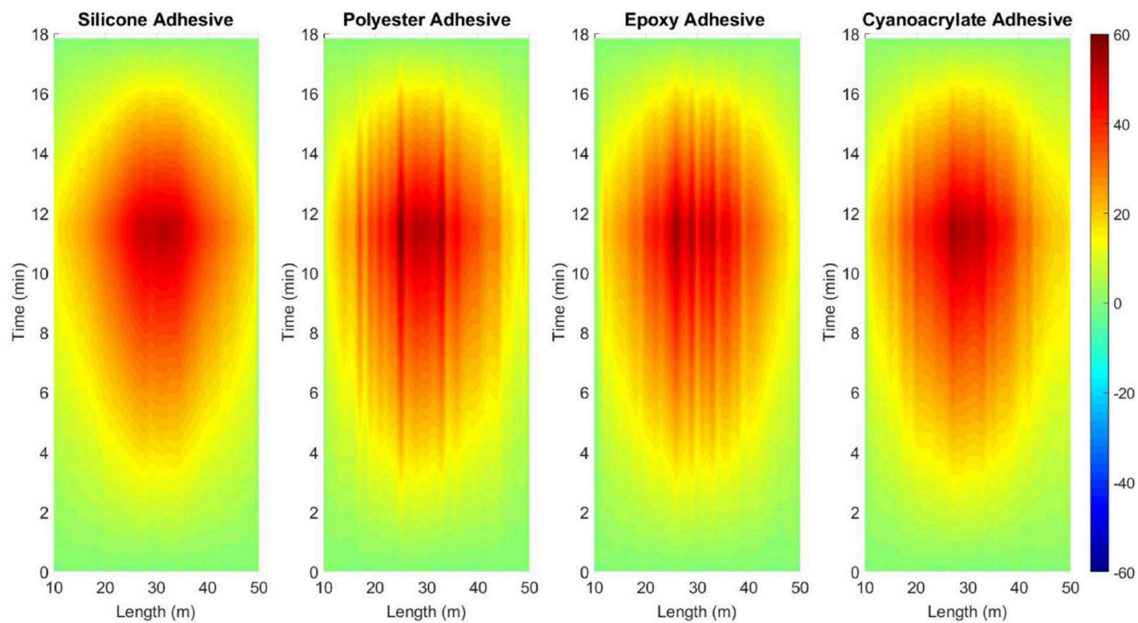
**FIGURE 10** | Measured strain by the four different bonded segments under elastic range.

Additionally, when assessing the measured strain spatial variability achieved by each bonded segment throughout the applied load sequence, **Figure 10**, it was observed how the silicone bonded segment presented smoother and more homogenous readings. This is related with its inherently lower shear elasticity modulus, which allows for a fiber adjustment movement within the adhesive.

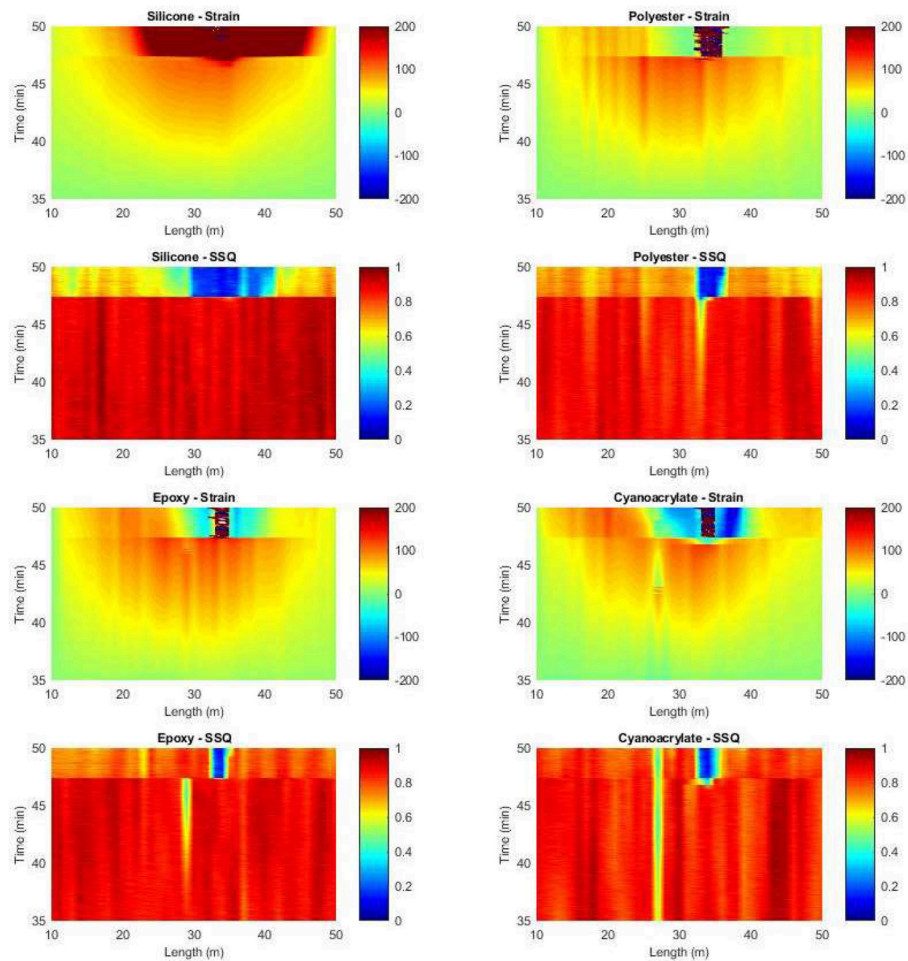
**FIGURE 11** | Measured strain and corresponding SSQ values for each bonded segment between minute 35 and 50.

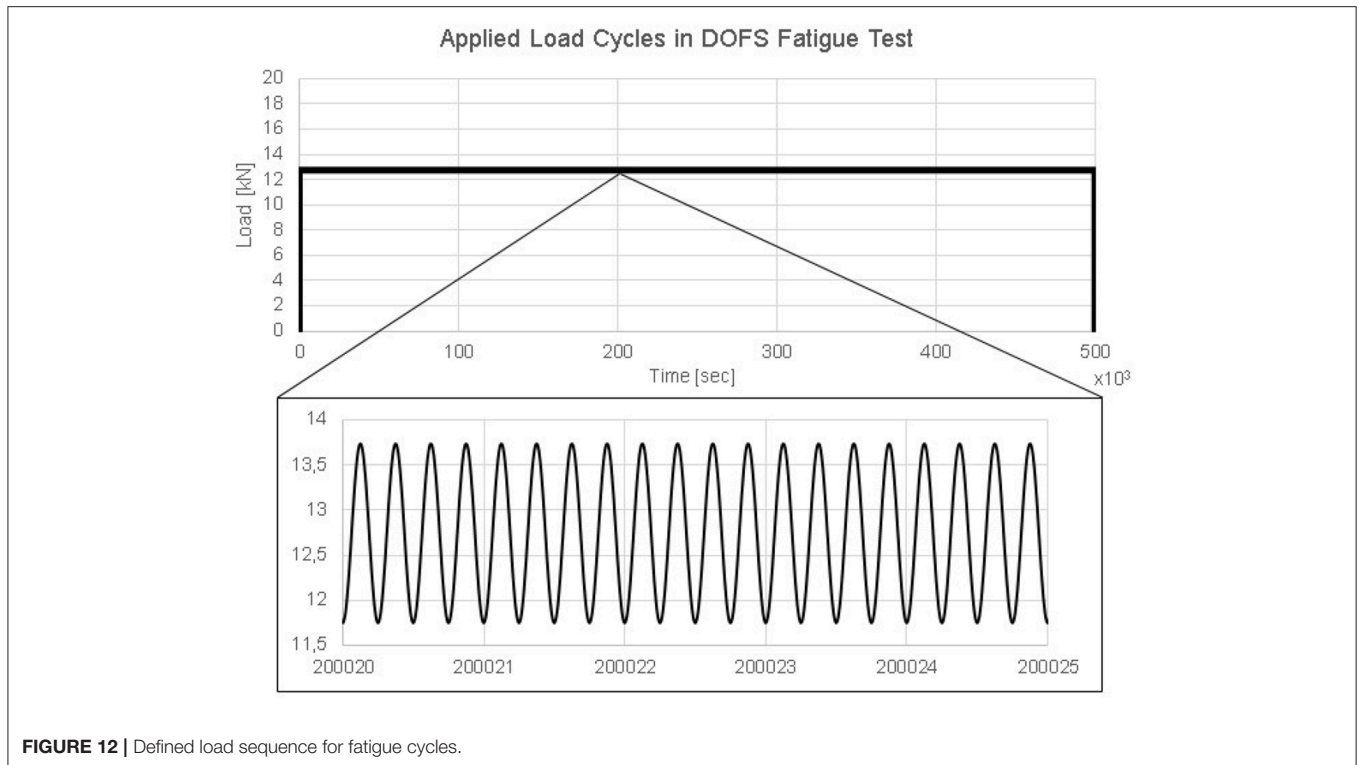
FIGURE 12 | Defined load sequence for fatigue cycles.

Therefore, and in order to reproduce these stress levels in the tested beam specimens in the laboratory, the load cycles range was from 11.75 to 13.73 kN. The cycling load was applied with a frequency of 4 cycles per second with a sinusoidal profile until reaching 2 million cycles (500 ks) as illustrated in **Figure 12**. This

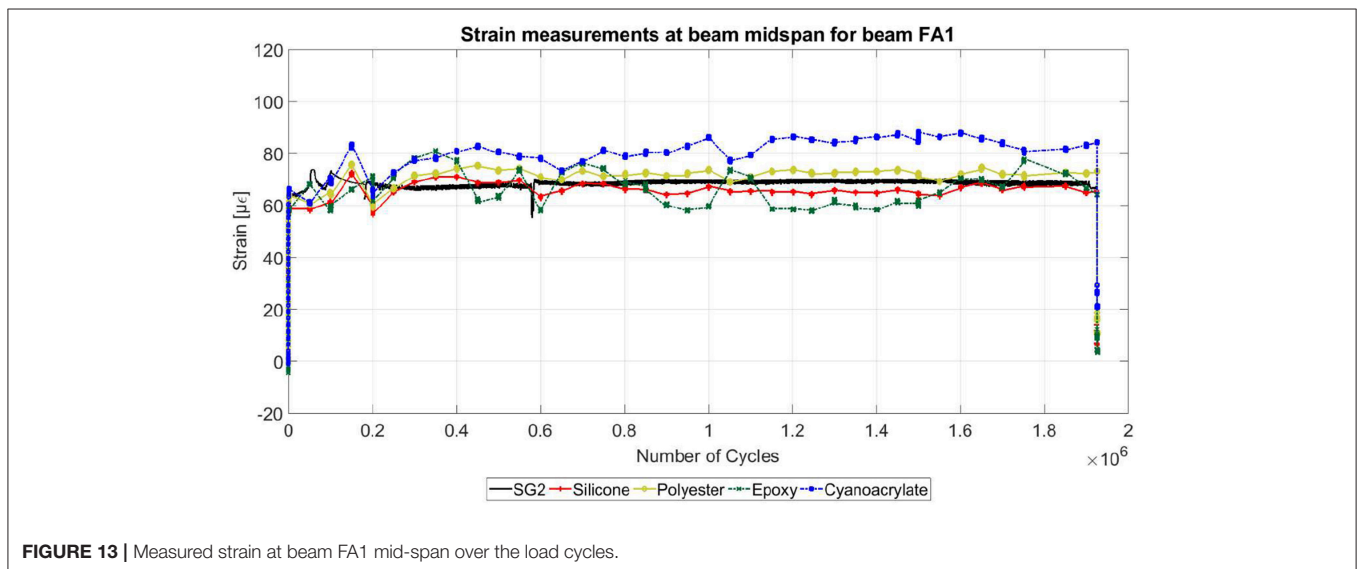
FIGURE 13 | Measured strain at beam FA1 mid-span over the load cycles.

point out that the applied load frequency was of 4 Hz while the sampling acquisition of the DOFS was of one measurement every 5 s while being of 1 Hz for the strain gauges. This partly explains the observed difference between both set of sensors as the magnitude of the applied strain range was of around 12  $\mu\epsilon$ .

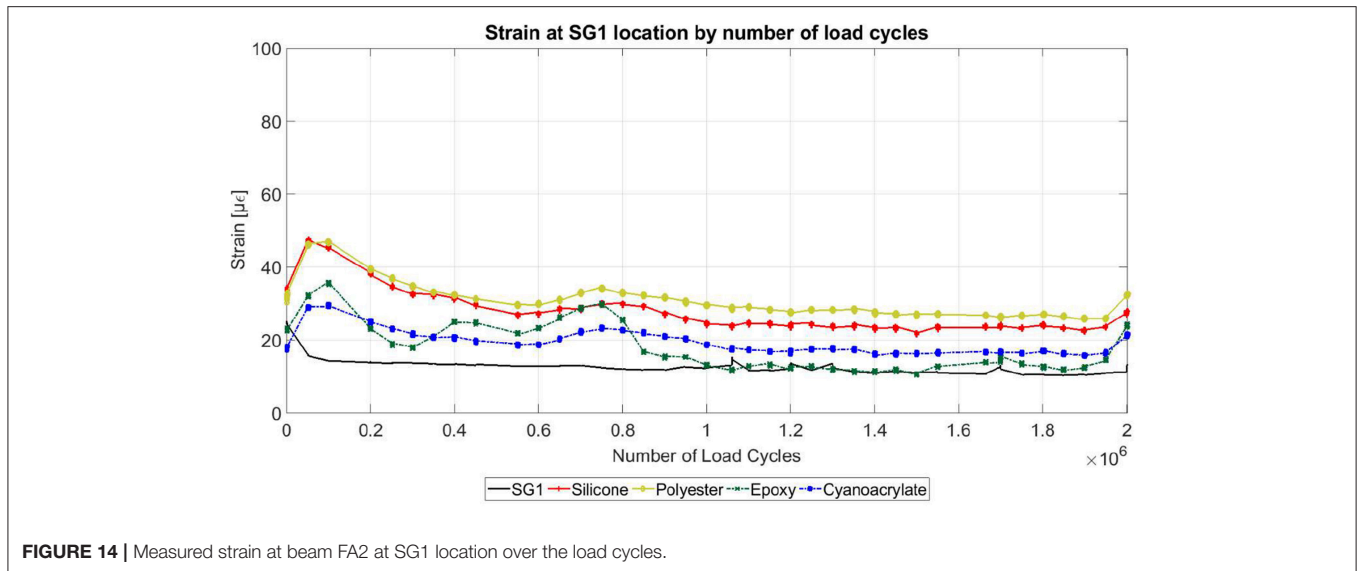
**FIGURE 14** | Measured strain at beam FA2 at SG1 location over the load cycles.

Nevertheless, when assessing the measured strain during the 2 million load cycles, it was again observed a reasonable good agreement with the data measured by the strain gauges as seen in

**Figure 14.** The observed difference between both set of sensors was more relevant for the DOFS using silicone and polyester and almost negligible for epoxy and cyanoacrylate. Notwithstanding, these differences were, as in the case of beam FA1, related with the system strain resolution ( $\pm 2 \mu\epsilon$ ), different sampling rates in the acquisition systems and strain range due to the amplitude of the load cycles ( $12 \mu\epsilon$ ).

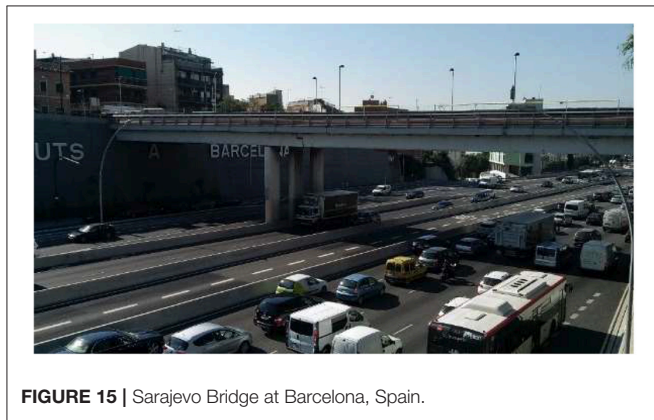
**FIGURE 15** | Sarajevo Bridge at Barcelona, Spain.

with a high traffic flow during peak hours, **Figure 15**. It is a two-span bridge with span lengths of 36 and 50 m and where each span is built up by three box-girder prestressed concrete beams connected by an upper reinforced concrete slab.

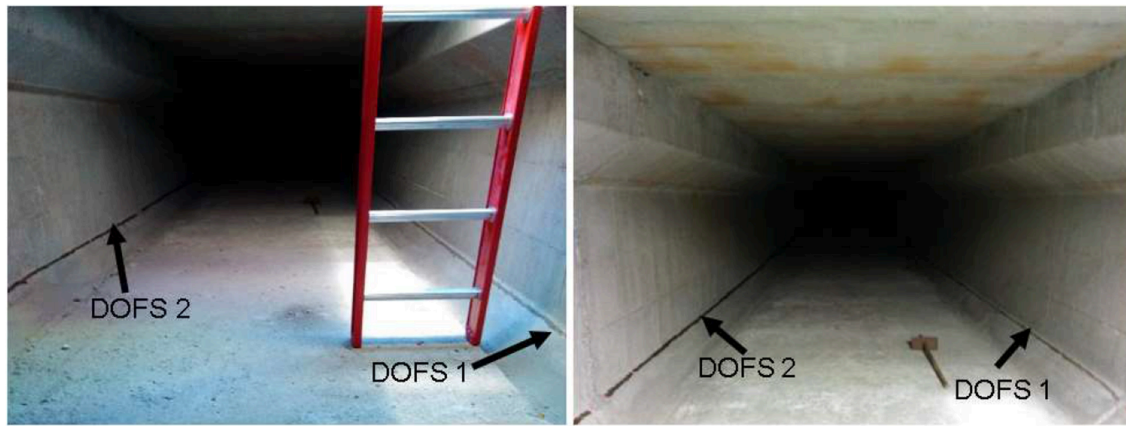
**FIGURE 16** | Instrumented DOFS in interior of box-girder beam at Sarajevo bridge.

In this way, two 50 m length DOFS (DOFS 1 and DOFS 2) were placed in the internal bottom surface of the box-girder

beam most susceptible to be subjected to a larger load increment in the 36 m length span, **Figure 16**. The fibers were bonded using an epoxy adhesive, adjusting to the length of the span while the remaining 14 m of the DOFS were left unbonded and later used for temperature compensation as explained in Barrias et al. (2018).

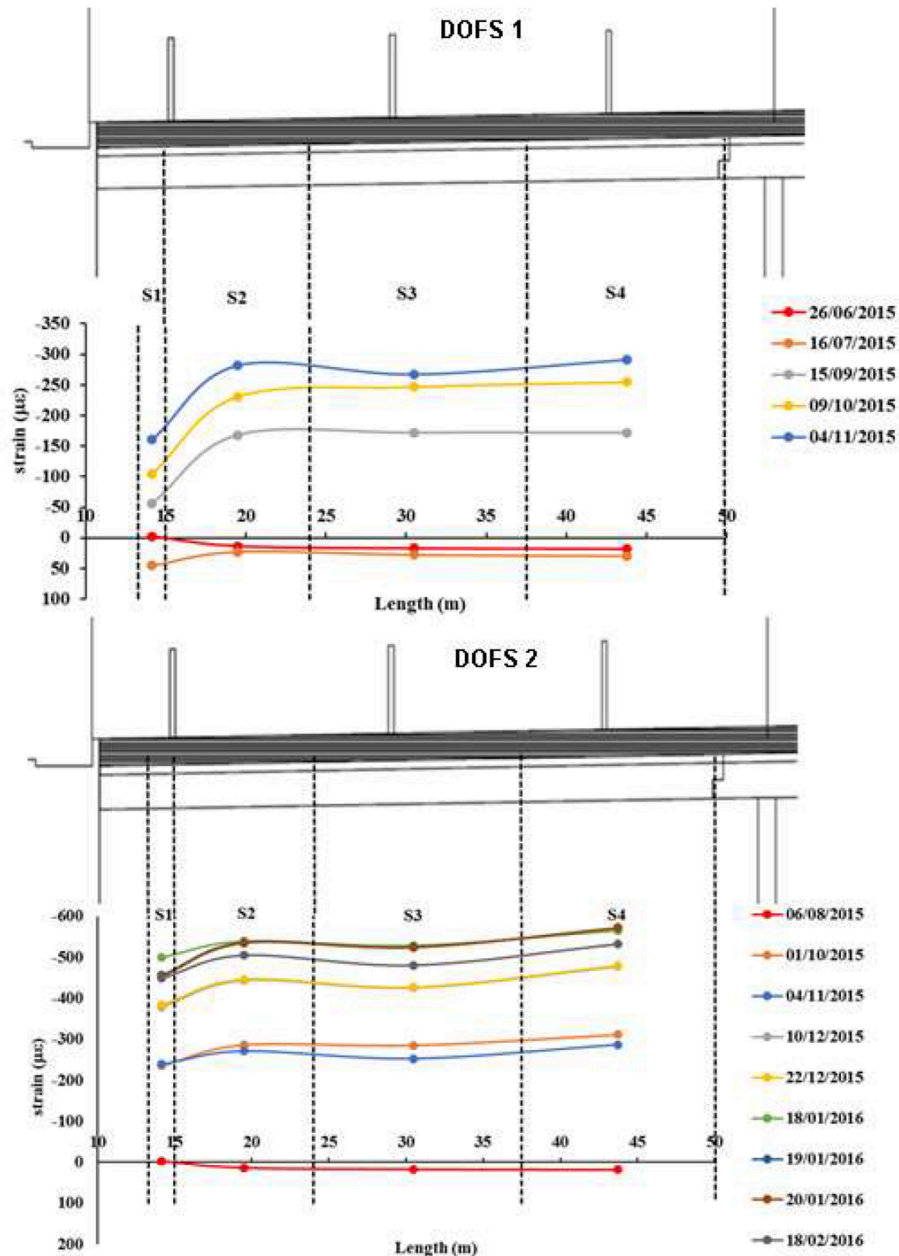
FIGURE 17 | Mean mechanical distribution measured by DOFS 1 (Top) and DOFS 2 (Bottom).

As mentioned above, by using this thermal compensation by fiber loop, it is assumed that the ambient temperature variation is the same along the entire length of the monitored box-girder. This restricts the use of the DOFS data to a global structural behavior analysis. However, by dividing the entire deployed DOFS length in different smaller segments this analysis can be improved. Five different segments (corresponding to different span adjusting DOFS lengths) were proposed, where a thermal compensation is conducted for each one. In this way, the average and purely mechanical induced strain evolution for each section of the monitored span is obtained as depicted in **Figure 17**.

It should be noted that segment S0 corresponds to the unbonded segment of the DOFS and is not plotted in the mentioned figures. Moreover, it was seen that apart from segment S1 which presents a relative lower mechanical strain than the other segments of the DOFS length due to its proximity to the

bridge elastomeric bearing, the remaining ones present a uniform mechanical strain distribution. Therefore, it can be concluded that the main responsible for the verified strain variation is the decrease of temperature between summer and winter translated to a uniform shortage of the box-girder.
