# Seismic Vulnerability Analysis and Retrofitting of the SS. Rosario Church Bell Tower in Finale Emilia (Modena, Italy)

Antonio Formisano<sup>1\*</sup> and Gabriele Milani<sup>2</sup>

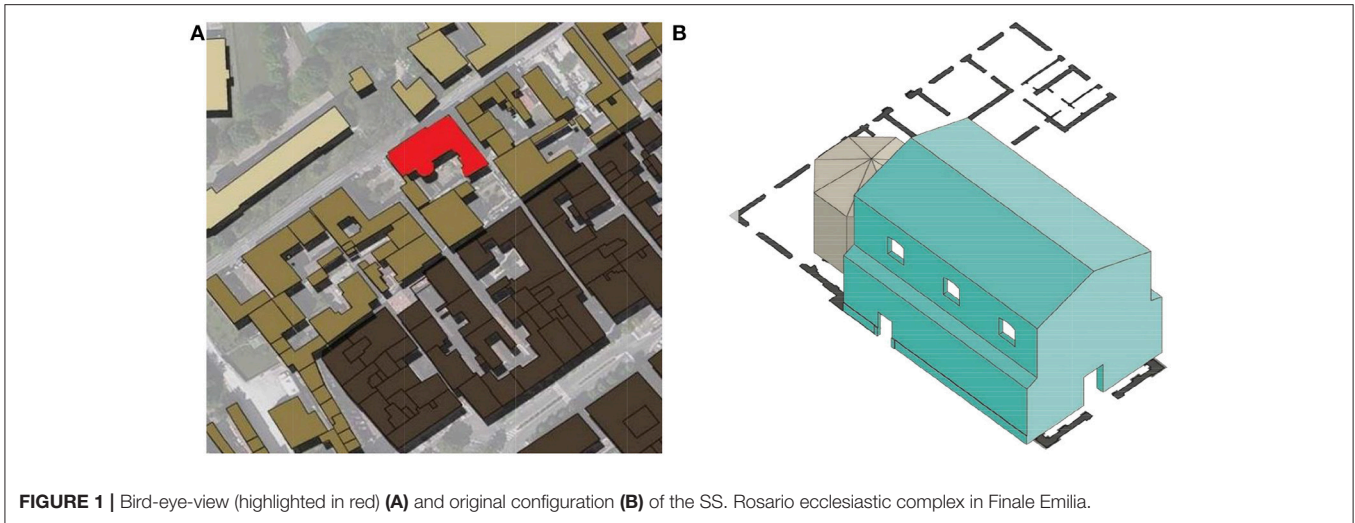
**FIGURE 1** | Bird-eye-view (highlighted in red) (A) and original configuration (B) of the SS. Rosario ecclesiastic complex in Finale Emilia.

The knowledge phase activities above listed have been used to characterize the SS. Rosario ecclesiastic complex placed in Finale Emilia, that is the most eastern municipality of the province of Modena, in the corner between Andrea Costa street and Guglielmo Oberdan one (**Figure 1A**).

The Church of the Rosary was built around 1580. The original structure, built on the ground of the old ditch of the northern walls, was originally smaller and simpler than the current one, which dated back to the second half of the seventeenth century, when behind the main altar there was probably also a sacristy compartment. A century later, the altar was set back and a compartment of octagonal shape, housing the sacristy, was

created (**Figure 1B**). In 1646 the carved altars made of timber were manufactured and the ground was acquired to obtain a forecourt. Probably, in that time the church was enlarged. In the first decades of the nineteenth century, with the Napoleon's government, the church passed to the demesne and it was used as a barracks for the French soldiers under the orders of General Montrizard. Such a condition caused enormous damage to the building. With the fall of Napoleon and after the request of the bishop, the confreres of the Rosary resumed possession of their ancient seat, restored the Brotherhood and undertook to reopen the church, which was however deprived of many of its assets. In 1814 the sacristy modified its shape from octagonal to rectangular, also annexing the rectory and the stairs for access to the upper floor (**Figure 2A**). The bell tower was built only in 1856 and later on, in 1890, the façades were also transformed in the neoclassical style (**Figure 2B**). Starting from 1928, the church and the bell tower were restored. Damaged during the bombardments of the Second World War, the bell tower was again restored in 1955. In 1975 the building was closed to the faithful cult to eliminate the problems of humidity by means of both the total renovation of the roof and floor and the renovation of walls. Suspended and resumed several times during 90s, the restoration interventions ended in 1997.

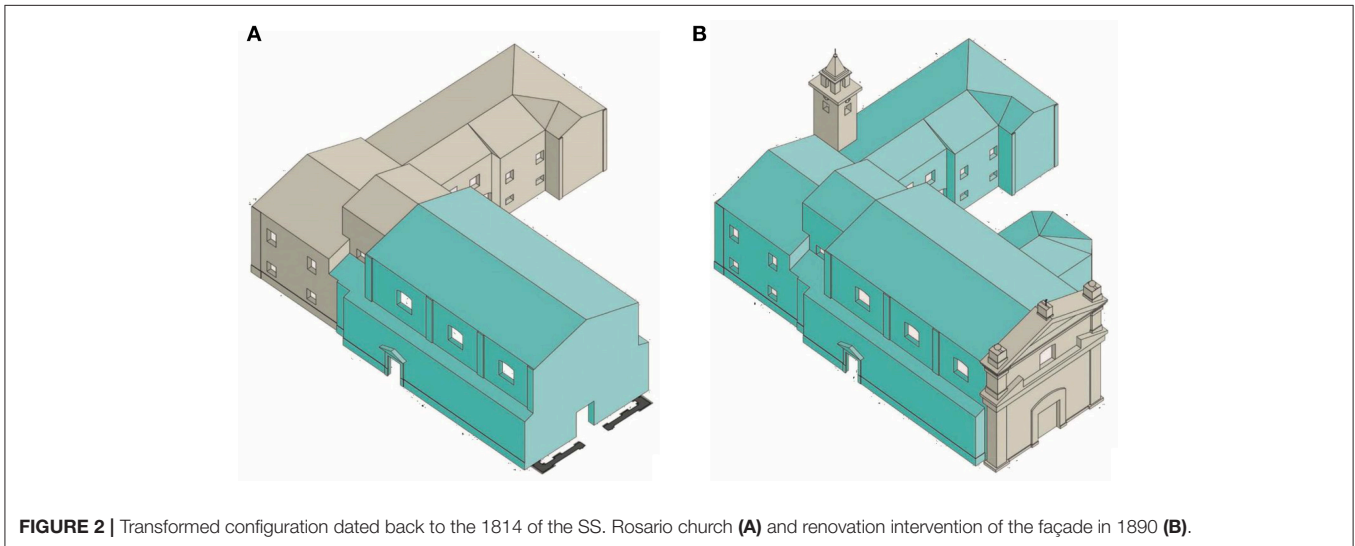
**FIGURE 2** | Transformed configuration dated back to the 1814 of the SS. Rosario church (A) and renovation intervention of the façade in 1890 (B).

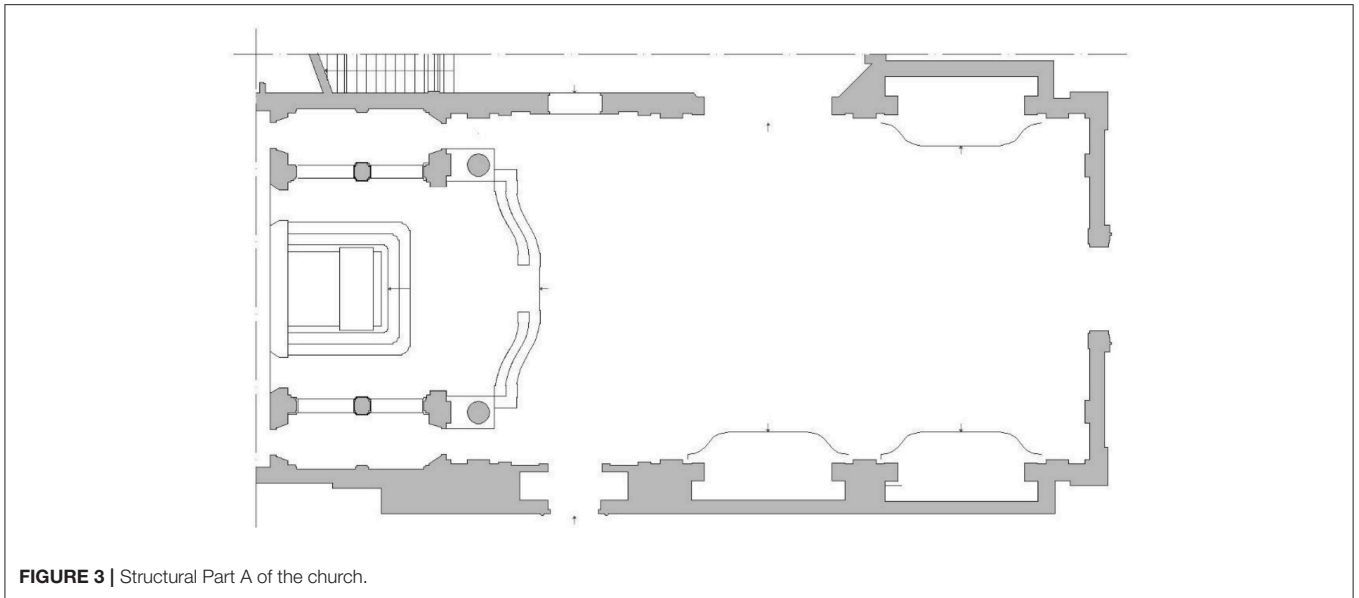
**FIGURE 3** | Structural Part A of the church.

The structural part A (**Figure 3**) has plan measures of  $24.00 \times 11.20$  m, excluding ornamental elements, and develops on a maximum total height (at the ridge) of 16.50 m. The coverage is represented by a pitched roof made of timber beams with pushing actions. On the long side of the church there are numerous shelters in the masonry walls in order to host the altars and the chapels, as well as two openings, one on the street side and the other toward the inner courtyard.

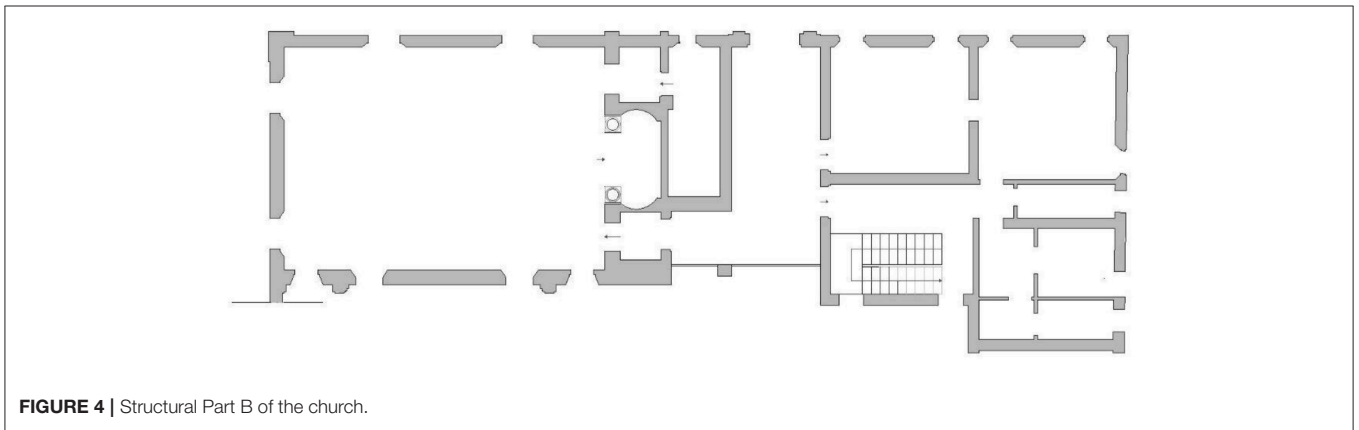
**FIGURE 4** | Structural Part B of the church.

The structural part B (**Figure 4**), instead, has plan dimensions of  $26.50 \times 7.30$  m and develops on two levels, one at the ground floor with height of 3.70 m and the other at the first floor with height equal to 4.60 m. The total height at the ridge of this structural part is 10.70 m. On the facades there are several openings with arched shape. Vaulted floors, which in some cases are masked by false ceilings, represent the horizontal structures.

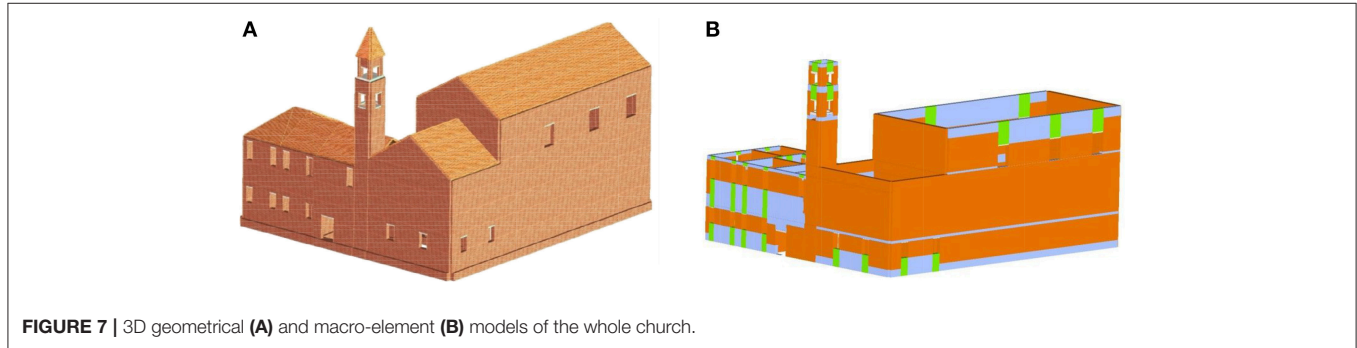
**FIGURE 7** | 3D geometrical (A) and macro-element (B) models of the whole church.

The seismic behavior of the bell tower has been also investigated when it is included in the aggregate of constructions given by the ecclesiastic complex, whose 3D geometrical and macro-element models are depicted in **Figure 7**.

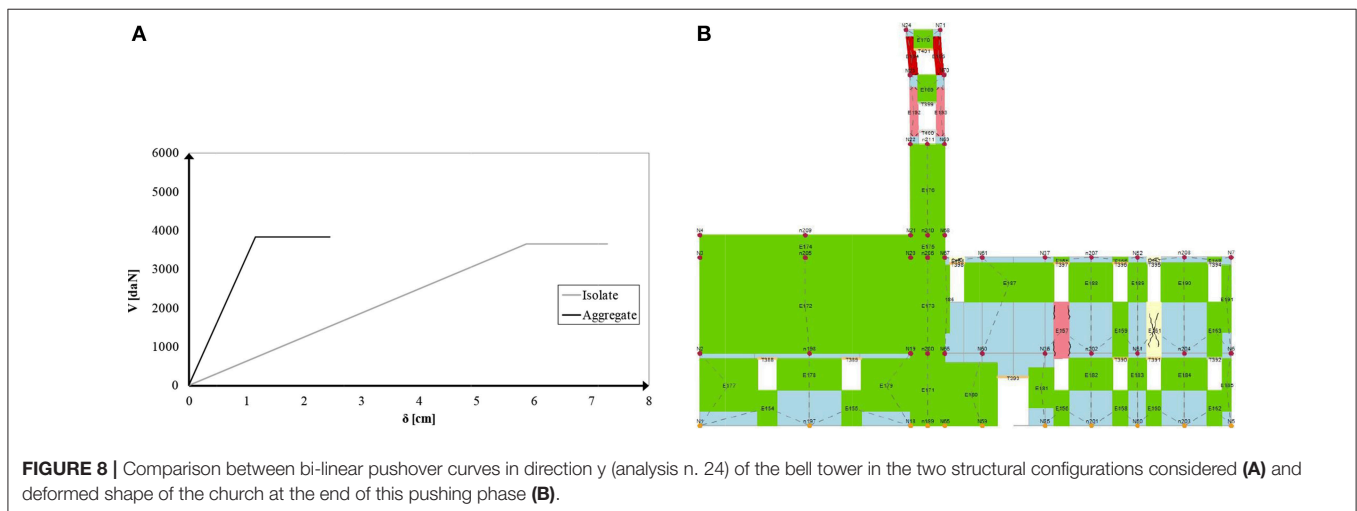
**FIGURE 8** | Comparison between bi-linear pushover curves in direction y (analysis n. 24) of the bell tower in the two structural configurations considered (A) and deformed shape of the church at the end of this pushing phase (B).

In this case the pushover curves of the bell tower have been reconstructed starting from those of the ecclesiastic complex by monitoring step-by-step both the base shear of own masonry walls (considering the influence of loads transmitted by the adjacent parts of the church) and the displacements of the top level centroid. For the sake of comparison, the MDOF bi-linear pushover curve of the bell tower related to the analysis n. 24 in direction y, which corresponds the worst result to, has been plotted and compared to that of the isolate structure, as reported in **Figure 8A**.

The final deformation of the structure corresponding to this analysis is shown in **Figure 8B**, where it is noticed that, differently from the isolate case, the bending-compression failure of the top level occurs.

From the comparison with the isolate condition it appears that, when the bell tower is inserted in the building aggregate, the base shear is basically unaltered, while the stiffness and ultimate displacement are reduced of about 80 and 65%, respectively.

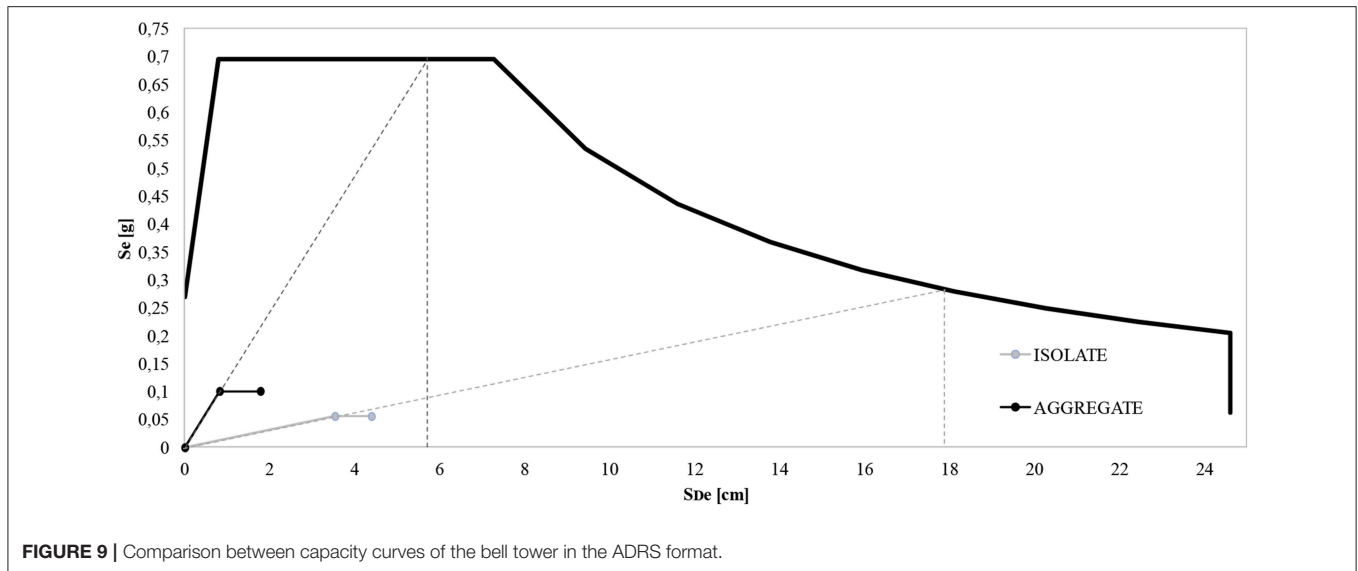
Moreover, the comparison among the isolate case and the aggregate one has been performed in the ADRS format, providing

the capacity curves of **Figure 9**. The vulnerability index, intended as the ratio between the demand displacement and the capacity one, assumes values of about 4.03 and 3.15 in the cases of the isolate tower and of the aggregate one, respectively. This means that the aggregate condition reduces the seismic vulnerability of more than 20%.

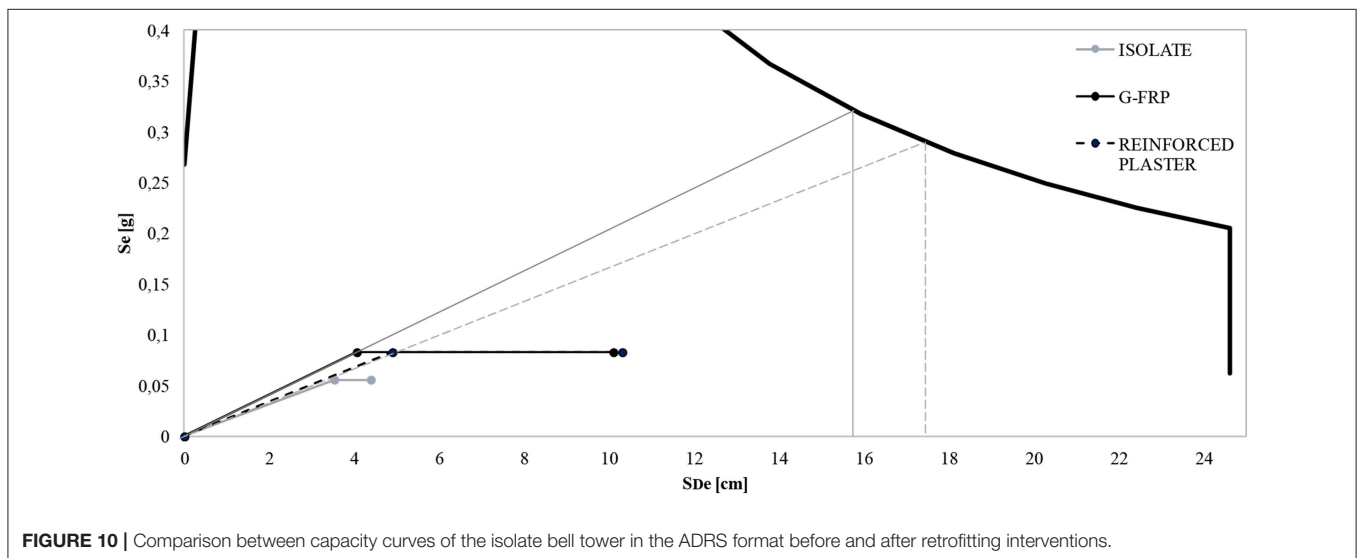
The application of the above mentioned reinforcing interventions has provided the capacity curves in the ADRS format of **Figure 10**, where the comparison with the seismic response of the isolate tower has been also reported.

From the comparison it has been achieved that the vulnerability index passes from 4.03 (isolate tower) to about 1.55 and 1.70 in the cases of interventions with G-FRP and reinforced plaster, respectively. This means that in both cases the seismic upgrading of the bell tower is achieved. Nevertheless, from the seismic point of view, intervention with G-FRP is slightly preferable to that with reinforced plaster. In fact, in the former case a reduction of seismic vulnerability of about 62% is attained, whereas in the latter one the vulnerability decrease

is about 58%. Contrary, a strong preference toward G-FRP is recognized in terms of Life Cycle Assessment, since glass fibers have environmental impact lower than that of plasters reinforced with steel bars.

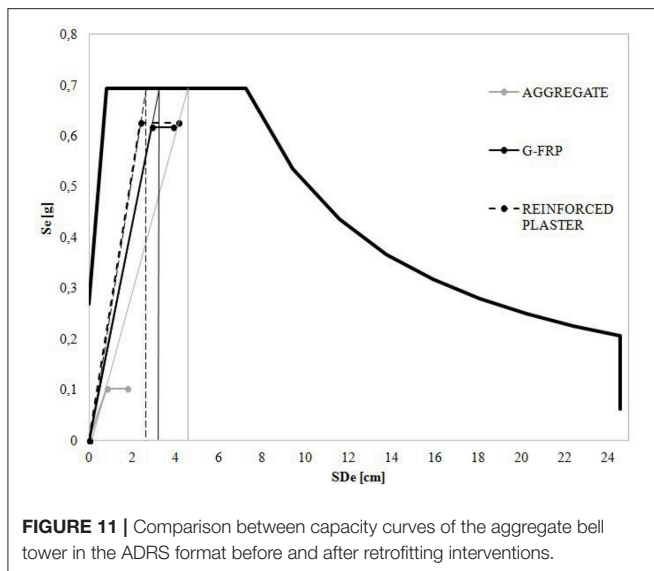
Finally, the same interventions above described have been applied to the case of the aggregate bell tower and the comparison among capacity curves has been done, as depicted in **Figure 11**.

From the analysis results it is obtained that the vulnerability index is changed from 3.15 (aggregate condition) to 0.85 and 0.65 in case of interventions with G-FRP and reinforced plaster, respectively. This means that, since vulnerability indexes are lower than one, both considered interventions are able to retrofit seismically the bell tower. In addition, vulnerability indexes provided by interventions with G-FRP and reinforced plaster are about 27 and 21% of the index achieved on the aggregate tower, respectively. Finally, even if more impacting from the

environmental point of view, reinforced plaster represents the best intervention, since it provides the lowest vulnerability index and it is less expensive than G-FRP.
