Monitoring and Diagnostic Load Testing of a Damaged Railway Bridge

This study presents a complex experimental research of a damaged steel railway bridge. Before the reconstruction, the elastic behavior of the material was evaluated using the hole-drilling strain gauge method of determining residual stresses at the relevant cross-sections. During the reconstruction project (lifting of the structure), a short-term monitoring system was installed at the critical cross-sections for continuous recording of strain. The aim was to evaluate the quality of the reconstruction intervention and prevent further damages. Following a successful reconstruction, a diagnostic load testing was performed according to Croatian standards. The purpose of the load testing (static and dynamic) was to evaluate the ability of the bridge to carry the design loads and calibrate the finite element models. During static load testing vertical displacement was measured as well as strain. Dynamic load testing of the bridge was performed in order to determine the main dynamic parameters of the structure and to calculate the dynamic factor. In order to select the appropriate measurement parameters and methods used d

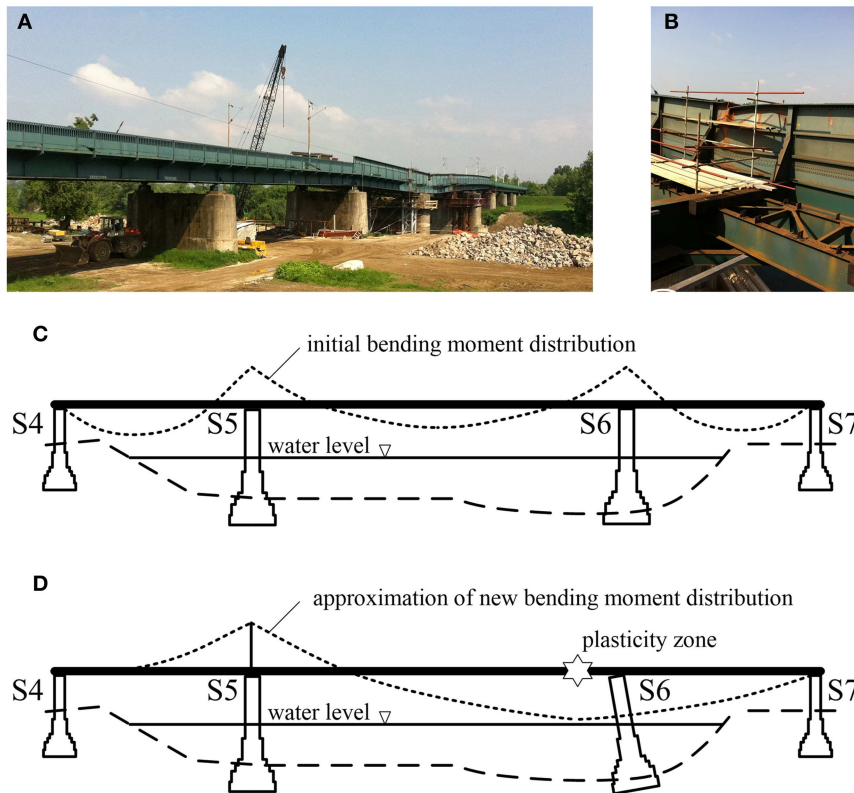
FIGURE 1 | (A) Damaged steel railway bridge; **(B)** plastic hinge on the upstream girder; **(C)** bending moment before damage; **(D)** approximation of bending moment after damage.

In March 2009, one of the piers lost its stability due to scour development during years of exploitation causing a permanent deformation of the bridge and the railway tracks (Figure 1A). At the distance of 8 m from the upstream bearing (S6) and 11 m from the downstream bearing (S6), a plasticity zone was developed in the middle span (Figure 1B). The upstream main girder deflected 1.6 m and the downstream main girder deflected 0.95 m. Furthermore, under the weight of the structure and the development of a new static system (continuous girder with a plastic hinge), one of the two main girders at the side span was lifted and no longer supported by the pier S4 (Duvnjak et al., 2018). This further increased the bending moment on the support S5 (Figure 1D). In addition to the vertical movement, the bridge suffered a horizontal shift and serious damage of the bottom secondary members. Following a detailed analysis and a provisional strengthening of the damaged pier, the reconstruction project of the bridge was developed. The reconstruction project was based on the fact that the plasticity zone was developed near the location where the initial bending moment was close to zero (Mujkanović et al., 2012) (Figure 1C). The stages of the reconstruction included the elevation of the bridge superstructure over the provisional piers to the original grade level, reconstruction of the hinge and finally, releasing the superstructure on permanent bearings. Numerical analysis was performed for all stages of the reconstruction and the results can be found in Mujkanović et al. (2012). During the lifting of the superstructure, an experimental research was performed based on strains and stresses at critical cross-sections.

cross-sections. The critical (relevant) cross-sections were selected at the location of extreme values of the bending moment after damage (Figure 1D), i.e., at the location of the fixed bearing at pier S5 and adjacent to the plasticity zone and pier S6 (Figures 3A,B). The measurement was performed in order to exclude plastic deformation in relevant cross-sections. Residual strains were measured at the flanges of the upstream main I-section girder (R1 and R2) considering the more significant plastic deformation of that girder. Residual strain measurements recorded during the drilling of the hole and calculated stresses according to Equation (1) are presented in Figure 4A. Under the assumption that the neutral axis will occur at the mid-depth of

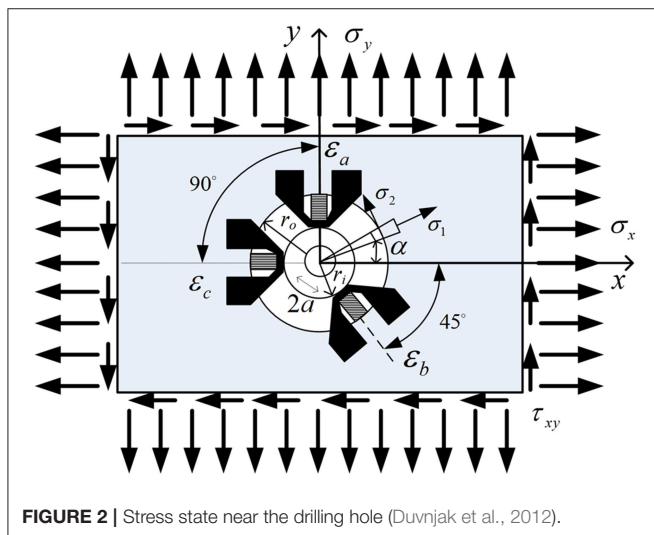
FIGURE 2 | Stress state near the drilling hole (Duvnjak et al., 2012).

The hole-drilling method is used to measure the magnitudes and distributions of principal residual stresses. This method involves attaching strain gauge rosettes to the surface, drilling a hole at the center of the gauges, and measuring residual strains caused by the relaxation of the material surrounding the drill-hole. Figure 2 shows the stress state near the drilling hole. The hole radius is $2a$, and the stresses are σ_x and σ_y , while σ_1 and σ_2 are the radial and tangential stress caused by the hole drilling. The value α represents an angle between the stress σ_x and the radial stress σ_1 .

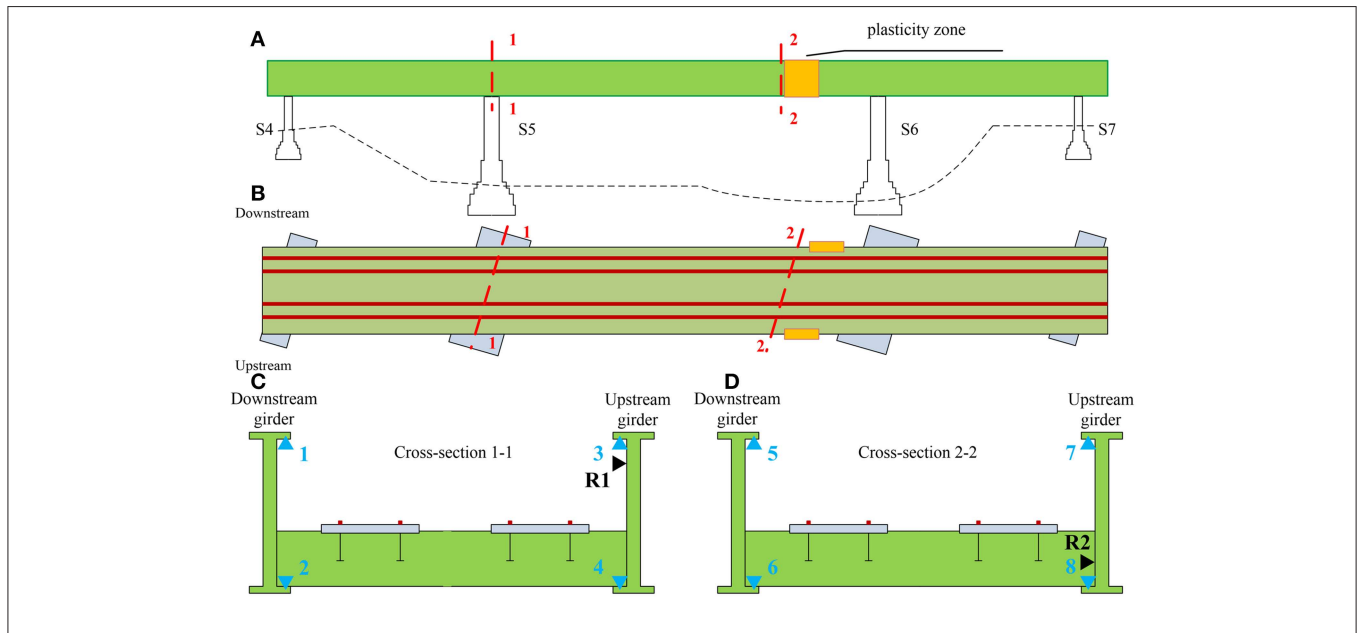
FIGURE 3 | Strain measuring points: (A) longitudinal section of the bridge over the river; (B) plan view of the bridge; (C) cross-section 1-1; (D) cross-section 2-2.

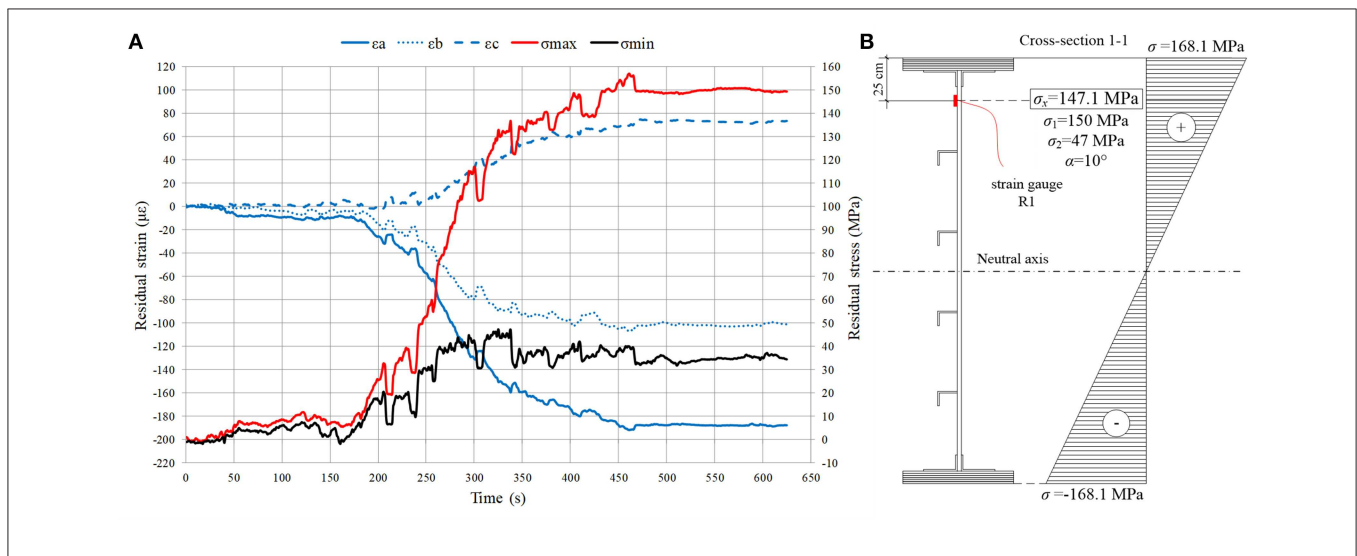
FIGURE 4 | Cross-section 1-1: (A) Measured residual strains and calculated stresses; (B) Estimated residual stress distribution.

the girder, the estimated stress distribution in the critical cross-section 1-1 derived from the measured values of residual strain is shown in Figure 4B.

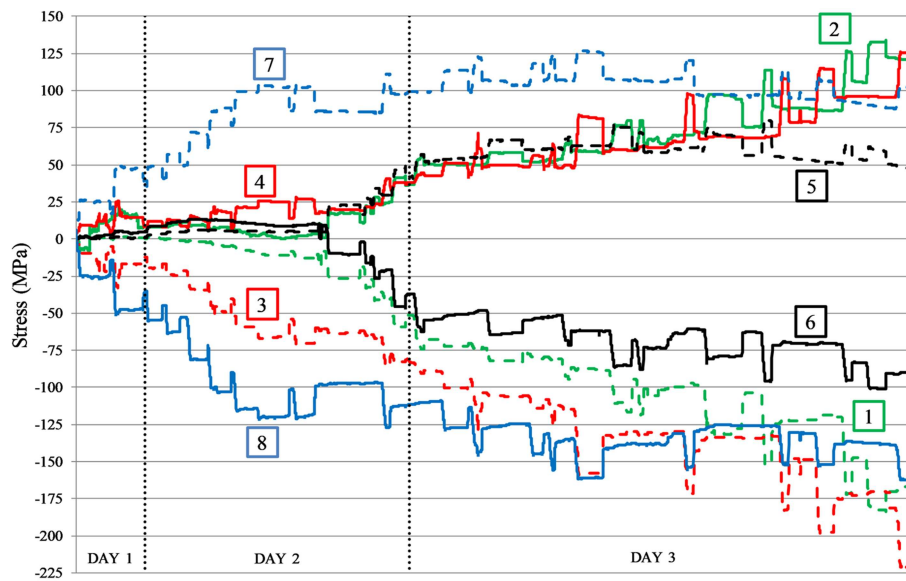
FIGURE 5 | Calculated stresses at all measuring points (reconstruction).

During the reconstruction, the main girders were gradually lifted with hydraulic jacks over a period of 3 days in steps of 5–10 cm. During that time, strain was measured. The measurement setup (4 measuring points on each girder) for the relevant cross-sections is shown in Figure 3C (cross-section 1-1) and Figure 3D (cross-section 2-2). Every lift of a main girder caused a “jump” in values of strains and consequently calculated stresses (Figure 5). The maximum stresses at all measuring points were below the yield strength of steel.

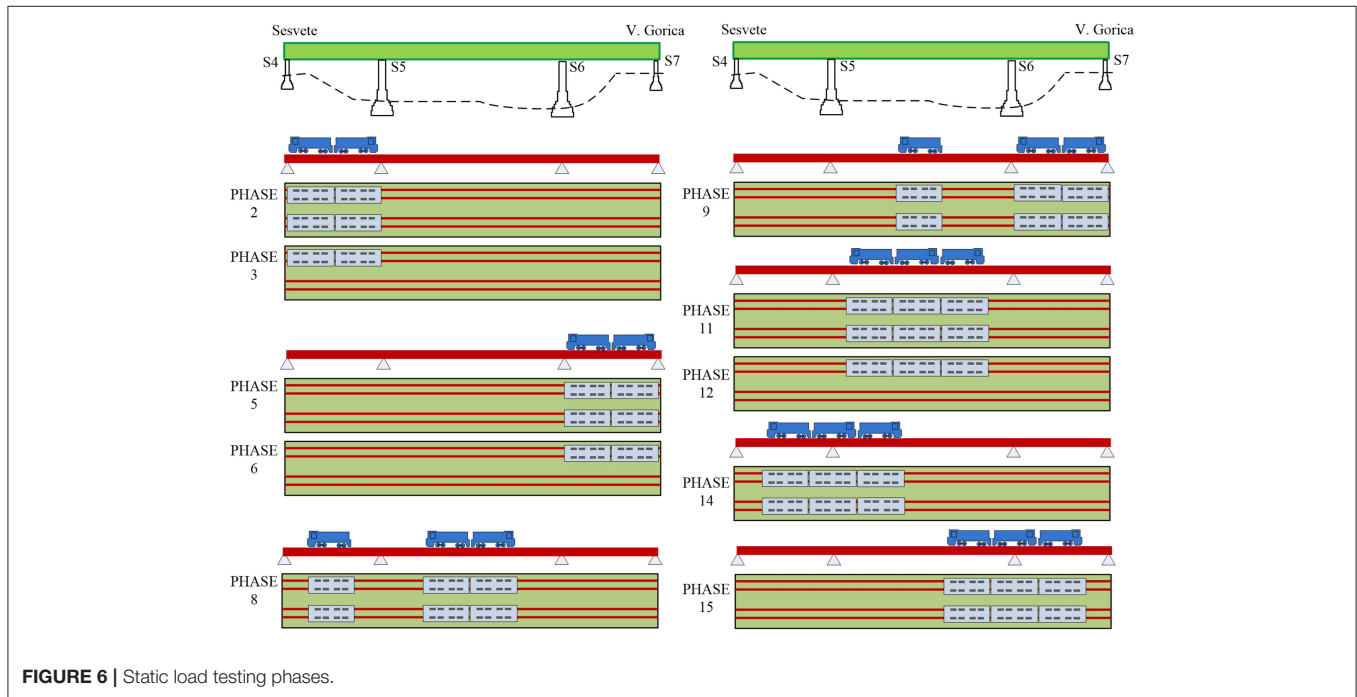
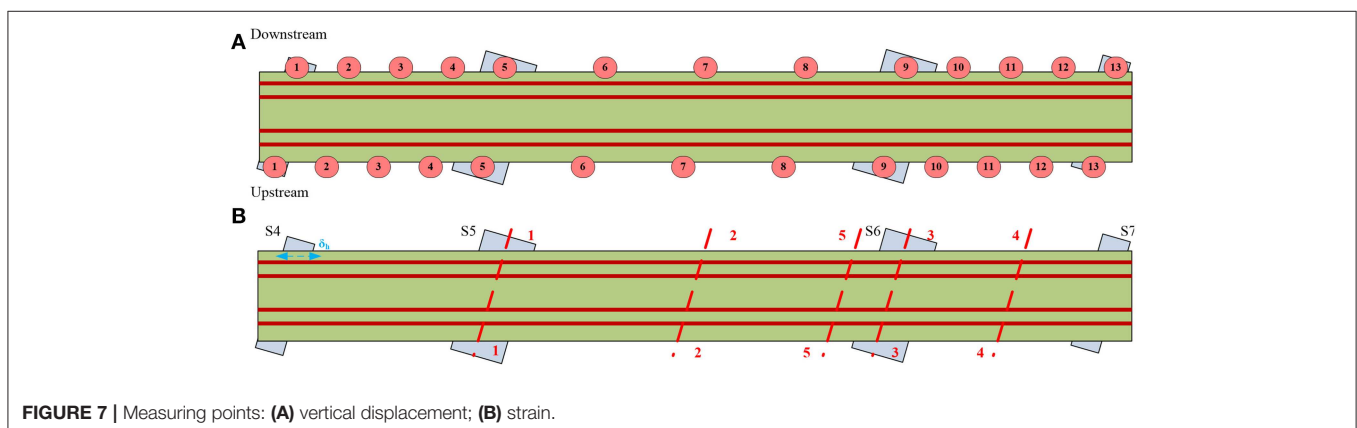
Static load testing of the bridge was performed by using 6 electric locomotives in 10 loading and 6 unloading phases. The average mass of the locomotives was 80 t (± 1.6 t). The locomotives were positioned symmetrically and asymmetrically in different spans in order to obtain maximum internal forces and displacements of the main carrying structural elements (**Figure 6**). During the static load testing, vertical displacements of the bridge were measured using a method of geometric and trigonometric leveling. Overall, there were 13 measuring points in the middle and at the quarter of each span as well as above the supports along two parallel lines coinciding with the main girders (**Figure 7A**). The maximum measured vertical displacements in the middle of the span during different loading phases are compared to the results of the numerical analysis with actual test loads in **Table 1**. The residual displacements measured during the unloading phases are also shown in **Table 1**. Calculated bending

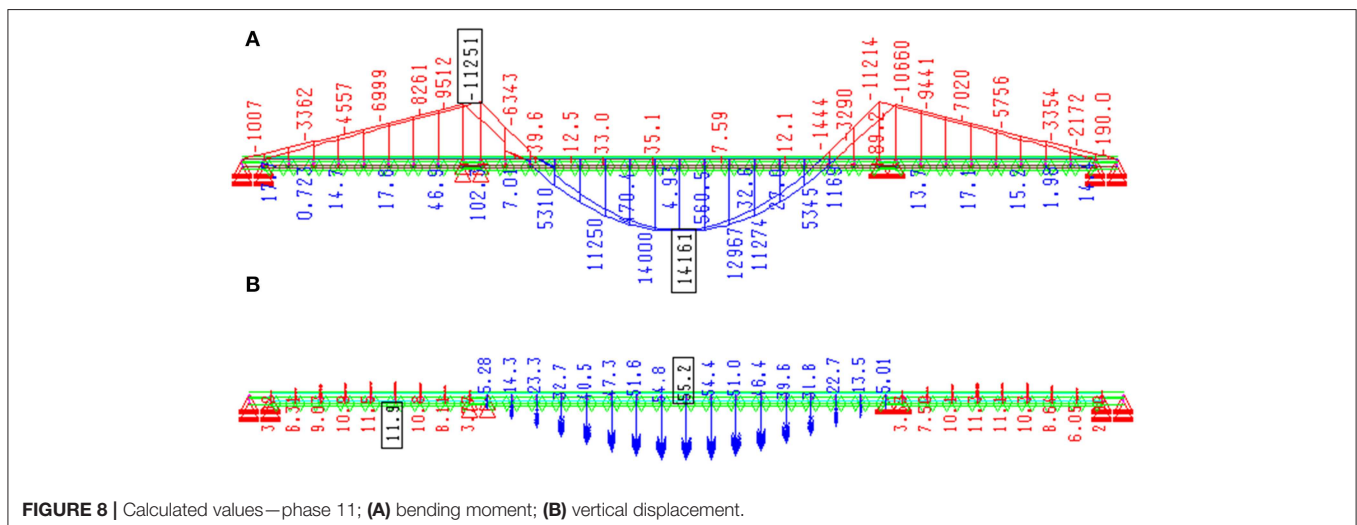
FIGURE 8 | Calculated values—phase 11; (A) bending moment; (B) vertical displacement.

moments and displacements obtained from the loading phase 11, i.e., maximum test load in the central span are shown in **Figure 8**.

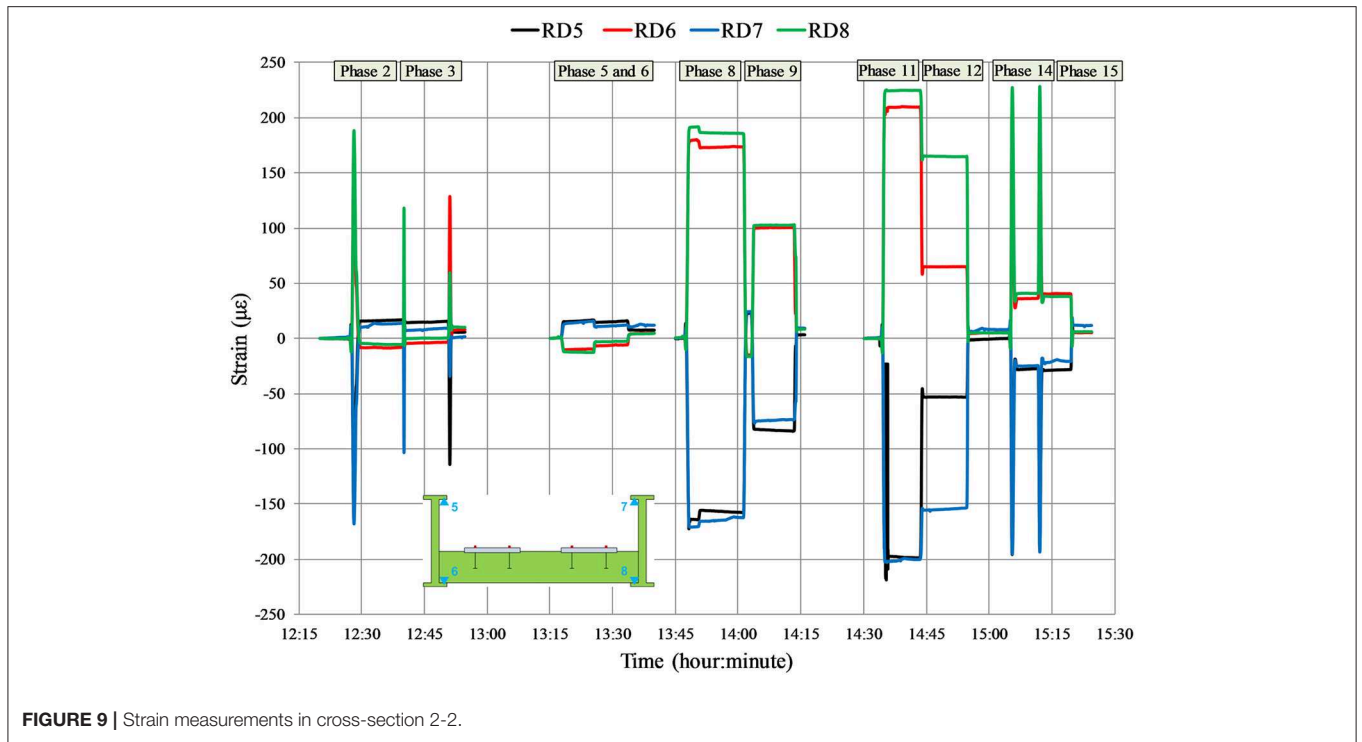
FIGURE 9 | Strain measurements in cross-section 2-2.

Strains were measured with a total of 22 LVDT sensors in five cross-sections and the longitudinal displacement of the main girder was measured with an additional LVDT sensor on pier S4 (**Figure 7B**). The gauge length of the LVDT sensors was 200 mm and a data acquisition system (HBM MGCplus) was used to continually record the data. Four LVDT sensors were located at the flanges of the main girders in the middle of the spans (cross-sections 2-2 and 4-4) and above the piers S5 and S6 (cross-sections 1-1 and 3-3). There were two LVDT sensors on the secondary longitudinal girder near pier S6 and on the cross girder in the middle of the span S5-S6. Strains were also measured on the main girders with the replaced web plates (damaged area) in cross-section 5-5. Strain measurements in the middle

of the central span (cross-section 2-2) are shown in **Figure 9**. During the loading phase 11, at the measuring points 6 and 8 the values of measured strains were $211 \mu\epsilon$ and $228 \mu\epsilon$, respectively. Calculated stresses at the same measuring points were 44.35 MPa and 47.94 MPa and in accordance with the numerical value of 47 MPa.

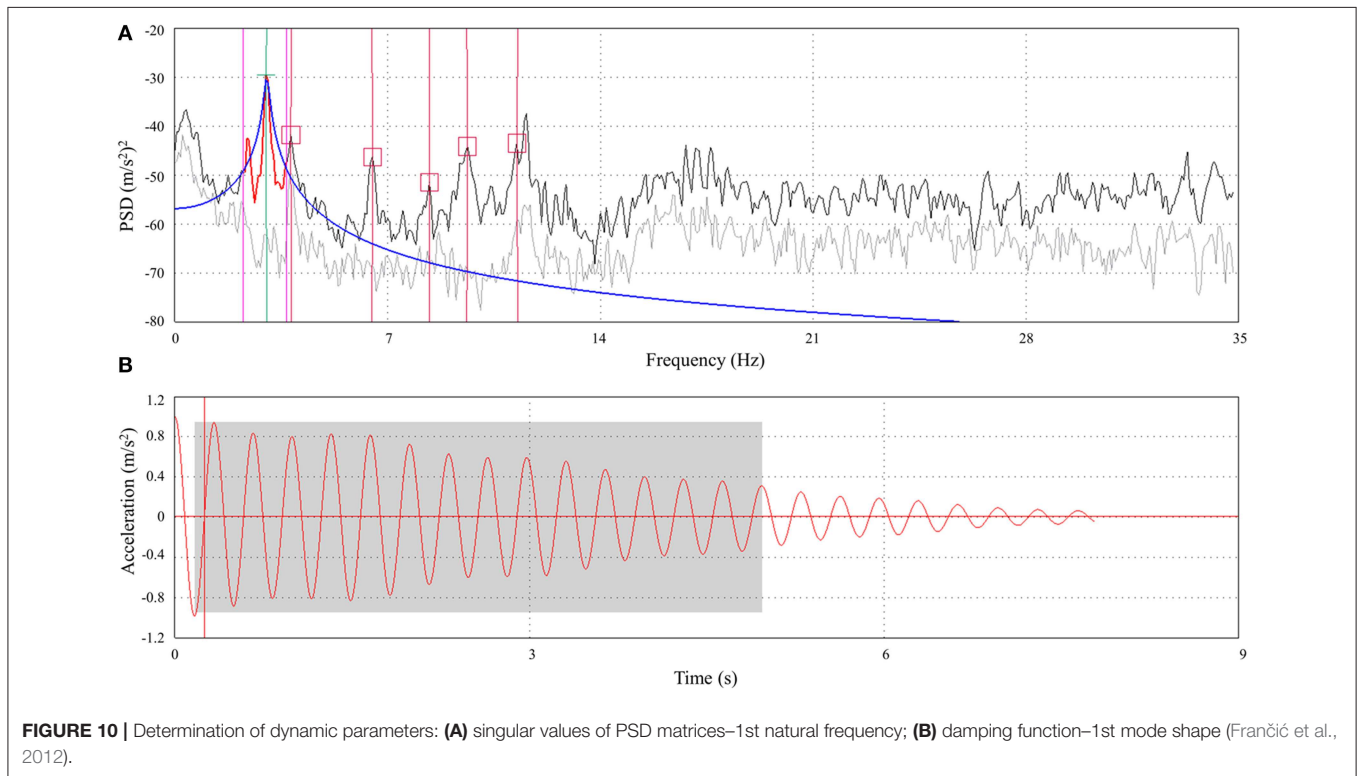
FIGURE 10 | Determination of dynamic parameters: (A) singular values of PSD matrices–1st natural frequency; (B) damping function–1st mode shape (Frančić et al., 2012).

Dynamic measurements during diagnostic load testing of the bridge was performed in two phases. In the first phase, main dynamic parameters of the structure (i.e., natural frequencies, mode shapes, damping ratios) were determined by means of the Operational Mode Analysis (OMA) (Zhang and Brincker, 2005). The measurement was performed during ambient excitation of the bridge which has the characteristics of Gaussian white noise process. Accelerations were measured in 6 measuring points in the vertical direction on both main girders, in the middle and at the quarters of the central span. The measuring points were determined in a way to ensure a quick execution of the measurement and on the other hand to provide enough DOF's for identification of main vertical and torsional mode shapes of the bridge which were used for the calibration of the FE model. High sensitivity accelerometers, 10 000 mV/g, were used during the measurements (B&K 8340 and PCB 393B31) together with data acquisition system B&K 3560-C and appropriate software. The data acquisition was performed using sampling frequency of 400 Hz, over 64 s which resulted in 25,600 captured samples for each accelerometer. Processing of the measured data consists of the Fast Fourier Transform (FFT) of time domain recordings, determination of Power Spectral Density (PSD) and Singular Value Decomposition of PSD matrices. Natural frequencies were determined as resonance peaks from the diagram of singular values of the PSD matrices (**Figure 10A**). Mode shapes were estimated as first singular vectors at the resonance peak and damping ratios were determined using the Inverse Discrete Fourier Transform (IDFT) of the estimated SDOF functions (**Figure 10B**). Measured and numerical values

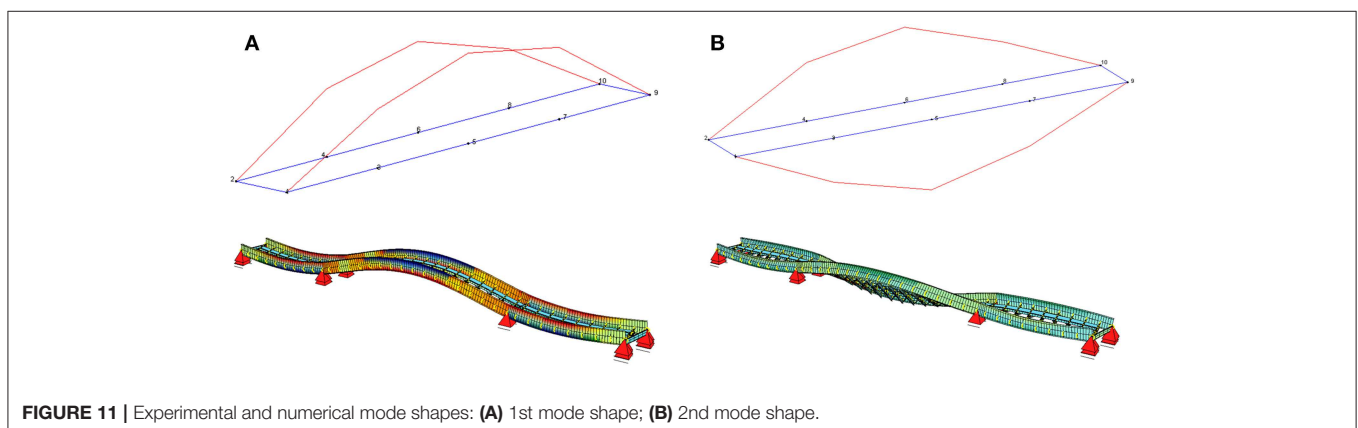
FIGURE 11 | Experimental and numerical mode shapes: (A) 1st mode shape; (B) 2nd mode shape.

of natural frequencies as well as the measured damping ratios are given in Table 2, six modes were determined experimentally. First two mode shapes obtained experimentally are compared to the corresponding numerical mode shapes in Figure 11.

Measured natural frequencies were in accordance with the calculated values (Table 2). Experimental and numerical mode shapes were also in accordance (Figure 11). Calculated values of
