Assessment and Restoration of an Earthquake-Damaged Historical Masonry Building

This paper presents an assessment of the capacity and enhancement of the seismic performance of a historical masonry structure in Plomari, a town on the south coast of Lesbos island in Greece. Owing to uncertainties regarding the properties of the material and the effectiveness of the members in providing lateral resistance, the study was particularly challenging. In addition, the fact that the structure consisted of a variety of structural element types, e.g., unreinforced masonry from natural stones, timber-framed masonry (with burned clay masonry units), and timber girders, while lacking horizontal diaphragms, introduced complexities to the response of the structure in both directions. In the design of the retrofit, the need to preserve the building's architectural and historical value by minimizing interventions posed several problems. To solve them, conventional as well as state-of-the-art strengthening methods are proposed. Moreover, the procedures of these methods are in accordance with the Greek seismic design code of 1959 and European standards (Eurocodes) related to earthquake-resistant mason

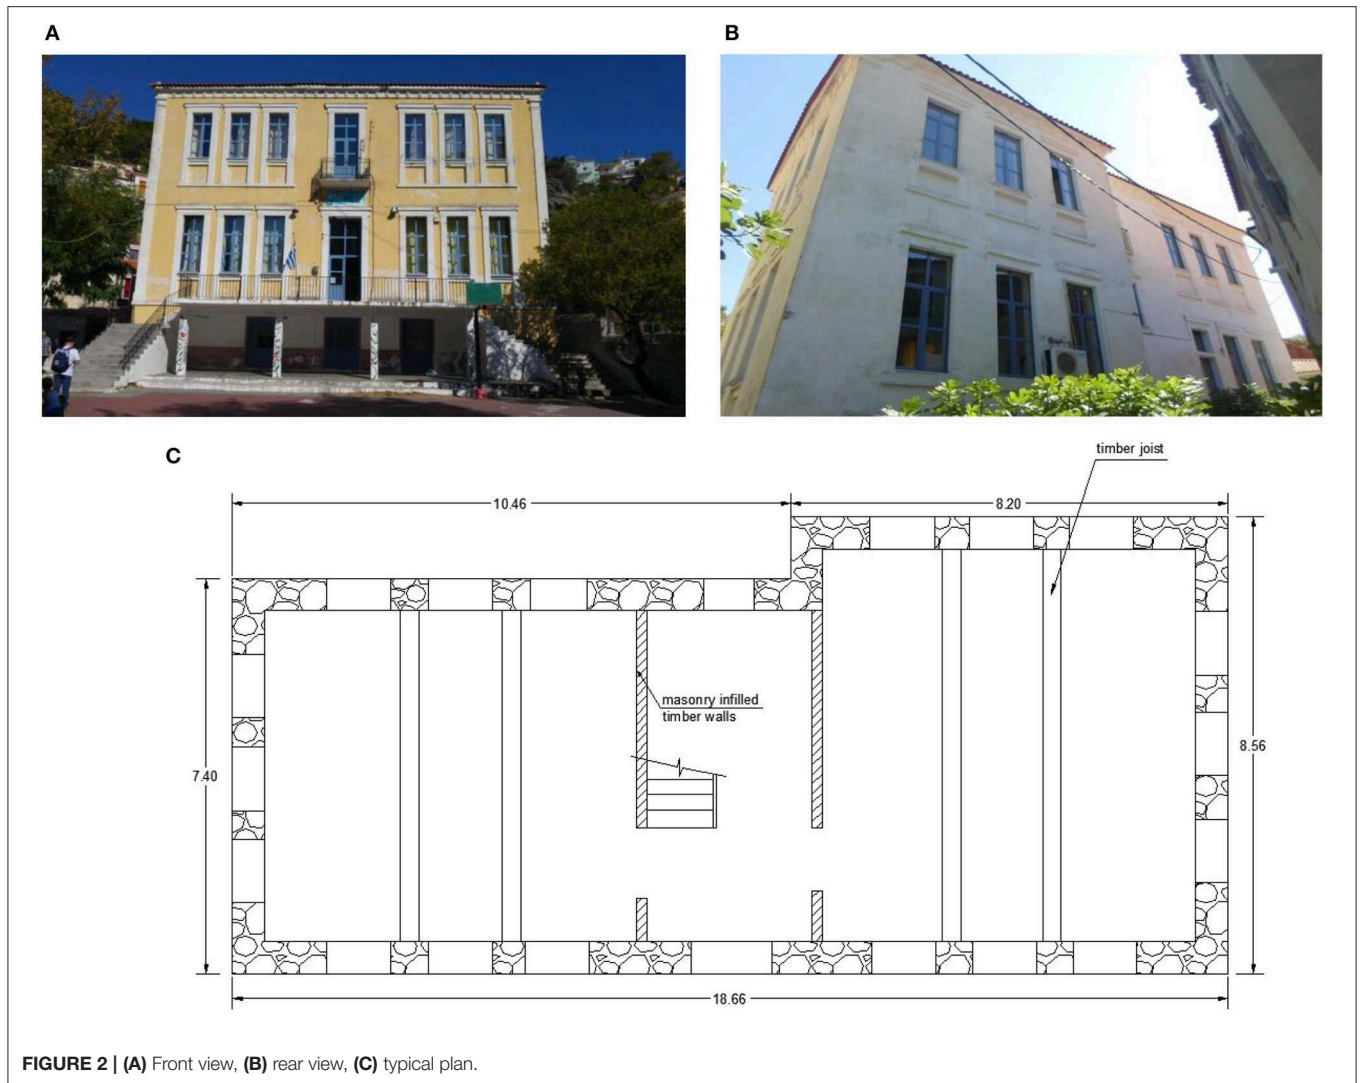
FIGURE 2 | (A) Front view, (B) rear view, (C) typical plan.

nearly two times longer than those in the other main direction. Therefore, lateral stiffness and mass were not symmetrically distributed. The building had three floors with heights of 2.9, 5.75, and 4.7 m with a roof 1.4 m high. Owing to the architectural requirement of daylighting, each wall consisted of several large openings with dimensions of 1.2–1.5 × 1.2–4.2 m, occupying ~45% of the surface of each wall. This, of course, reduced the strength of the walls. Their thickness varied from 0.50 m at the top to 0.80 m at the base. Photographs of the exterior of the building (façade) are shown in **Figures 2A,B** while a typical plan of the building is presented in **Figure 2C**.

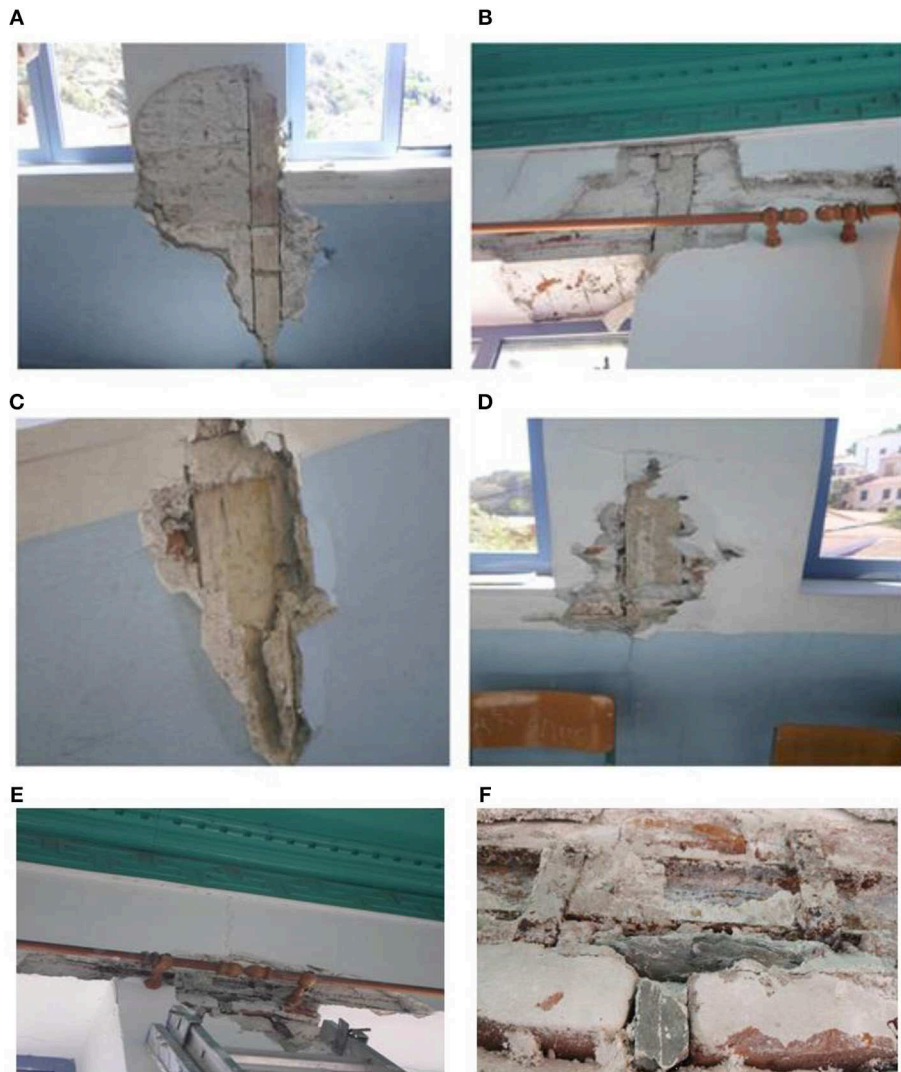
FIGURE 5 | (A–D) Damages indicating weak connections between timber frames and masonry. **(E,F)** Damages attributed to weak mortar and the presence of voids inside the masonry panels.

complicates the seismic assessment of the examined structure. It is typical of historical buildings that the connections between timber elements and unreinforced masonry are weak (lack of shear connection), which leads to the separation of single parts from the rest of the building and causes them to behave as independent structural elements (Gabellieri et al., 2012). The seismic behavior of timber walls with masonry infills is a complex topic in earthquake engineering. The most important parameter of the seismic response of such structures is the connection between the different materials (Dutu et al., 2017). Even in cases where the interaction between timber and masonry is limited, overall seismic behavior improves. The timber carries the horizontal forces induced by the earthquake while the masonry carries mainly the gravitational loads, also dissipating energy through joints sliding after the cracking of mortar (Dutu et al., 2012). As shown in **Figures 5A–D**, the connection between the timber frames and the masonry is practically absent, leading to damage in specific regions under seismic loads.

Moreover, as shown in **Figures 5E,F**, damage during the 2017 earthquake revealed cracks inside the masonry, which verifies the characterization of mortar as weak during the laboratory tests.

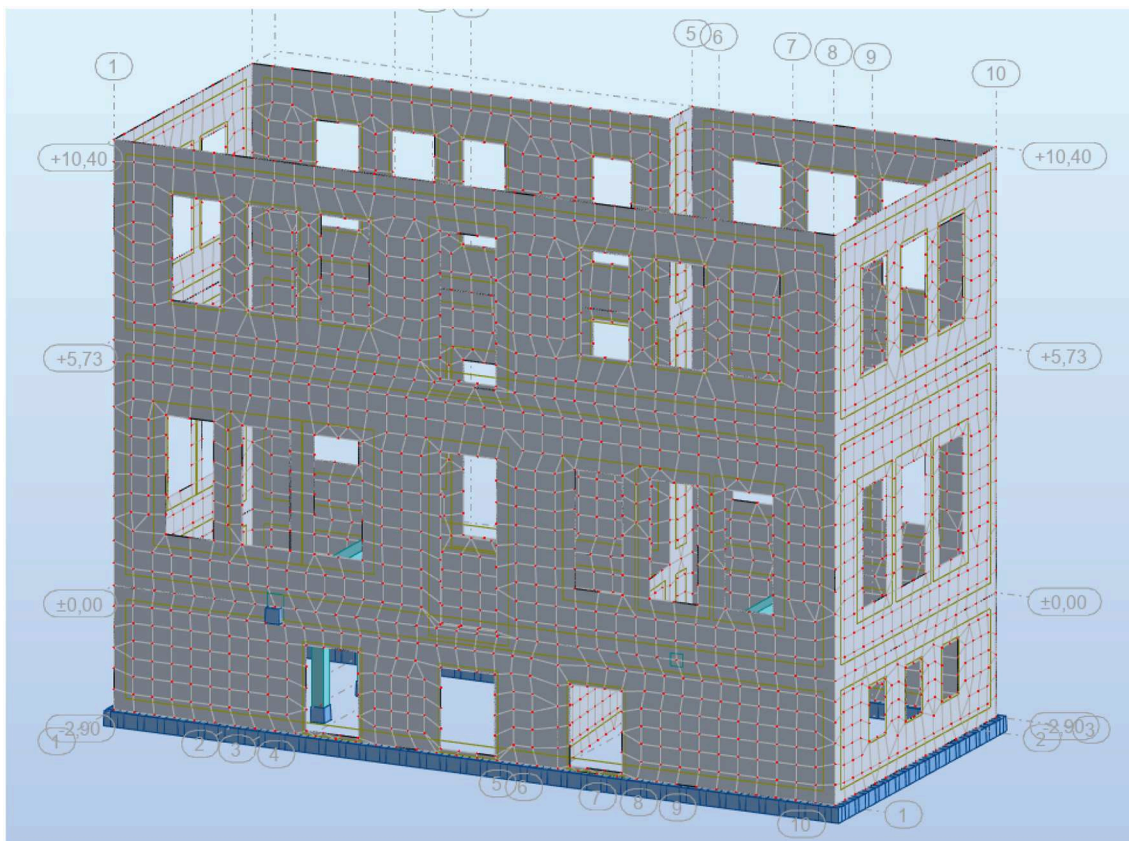
FIGURE 6 | Finite element model in Robot Structural Analysis software (Autodesk Robot Structural Analysis Professional, 2016).

in addition to membrane forces. In this study, 4-noded shell elements were employed with 0.50 m thickness, a Young's Modulus, E , of 6,610 MPa and a Poisson's ratio, ν , of 0.30. A sensitivity analysis was also performed to define the finite element mesh size. In **Figure 6**, a 3D view of the model along with the meshing consisting of shell elements is presented. In regard to the boundary conditions at the ground level, fixed connections were considered in depth of 1.5 m as the foundation is deep. After sensitivity analysis, of fixed boundary conditions at -1.5 m and hinged at 0.00 m, it has been found that the results were the same (except of local stresses at supports). As shown in **Figure 6**, the timber roof was not included in the model because the connection between the roof and the masonry structure was considered weak, thus making interaction unlikely. Moreover, the timber-framed masonry elements were conservatively considered as unreinforced masonry elements.

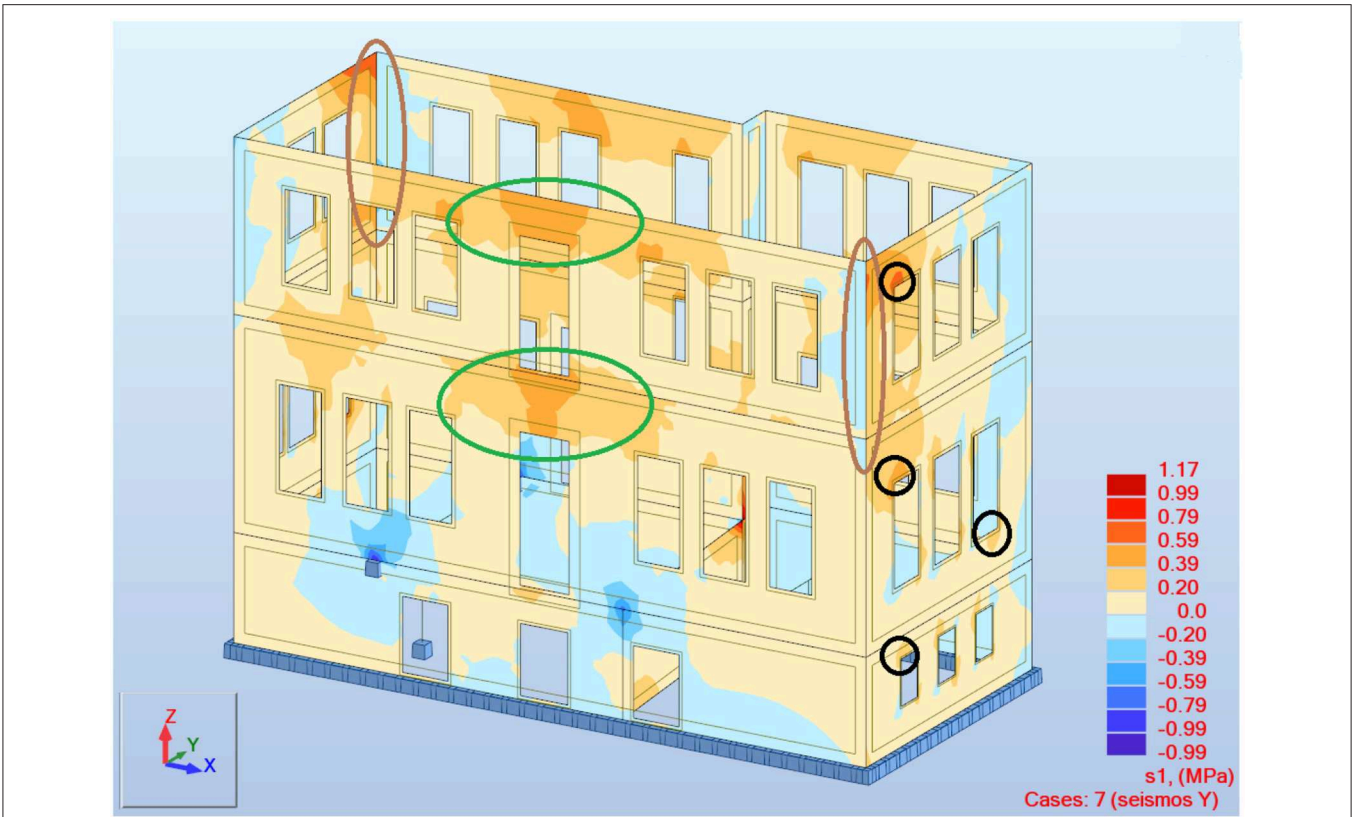
The results of the analysis were validated by comparison with damage recorded during a visit to the site. **Figure 7** shows the results for seismic forces acting in the y direction according to the First Greek Seismic Code (Royal Decree on the Seismic Code for Building Structures, 1959), while **Figure 8** show some damage recorded at the site. The stress concentrations of **Figure 7** match the recorded damages in **Figure 8**, and are indicated by circles or ellipses of varying color. Specifically, the black circles indicate stress concentrations at the corners of the openings for walls parallel to the seismic action and the associated damage at those regions, green ellipses highlight stress concentrations approximately at the middle of the walls perpendicular to the seismic action (out-of-plane behavior) and the resulting cracks in masonry, and brown ellipses indicate the different behaviors of intersecting walls, where one of them was under tensile and

the other under compressive stresses, and the associated vertical crack was at the intersection of the walls.

FIGURE 7 | Results of principal stresses (MPa) for seismic action in the y direction according to the First Greek Seismic Code (Royal Decree on the Seismic Code for Building Structures, 1959).

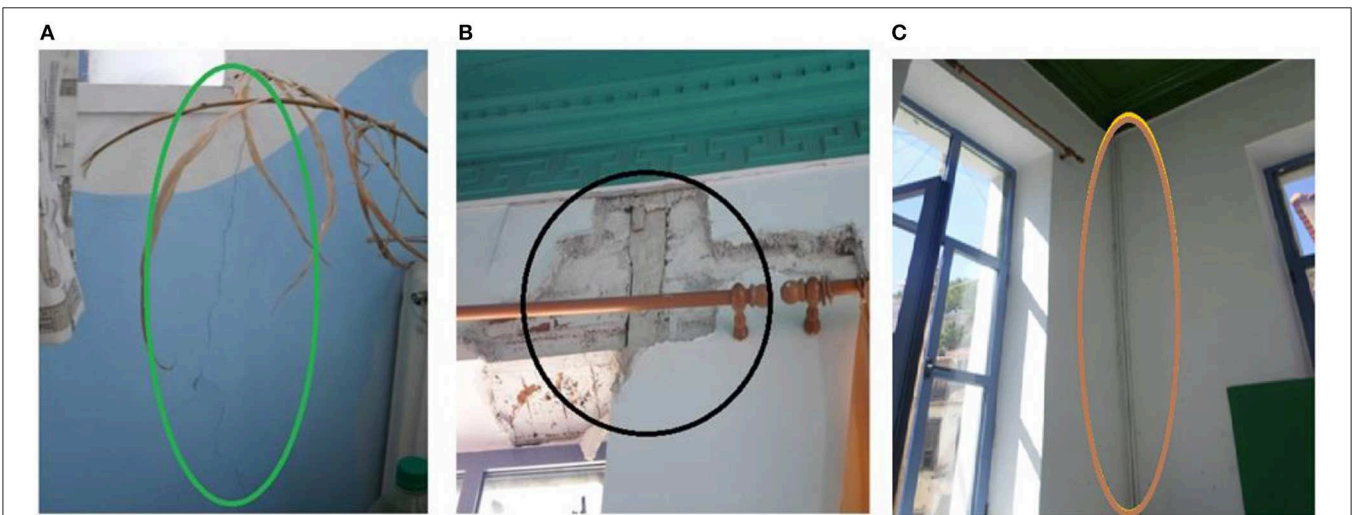
FIGURE 8 | Damages recorded during the site visit. **(A)** Crack due to out of plane bending of the masonry wall. **(B)** Stress concentration under in plane bending of the masonry wall. **(C)** Crack attributed to poor connection between the intersecting walls.

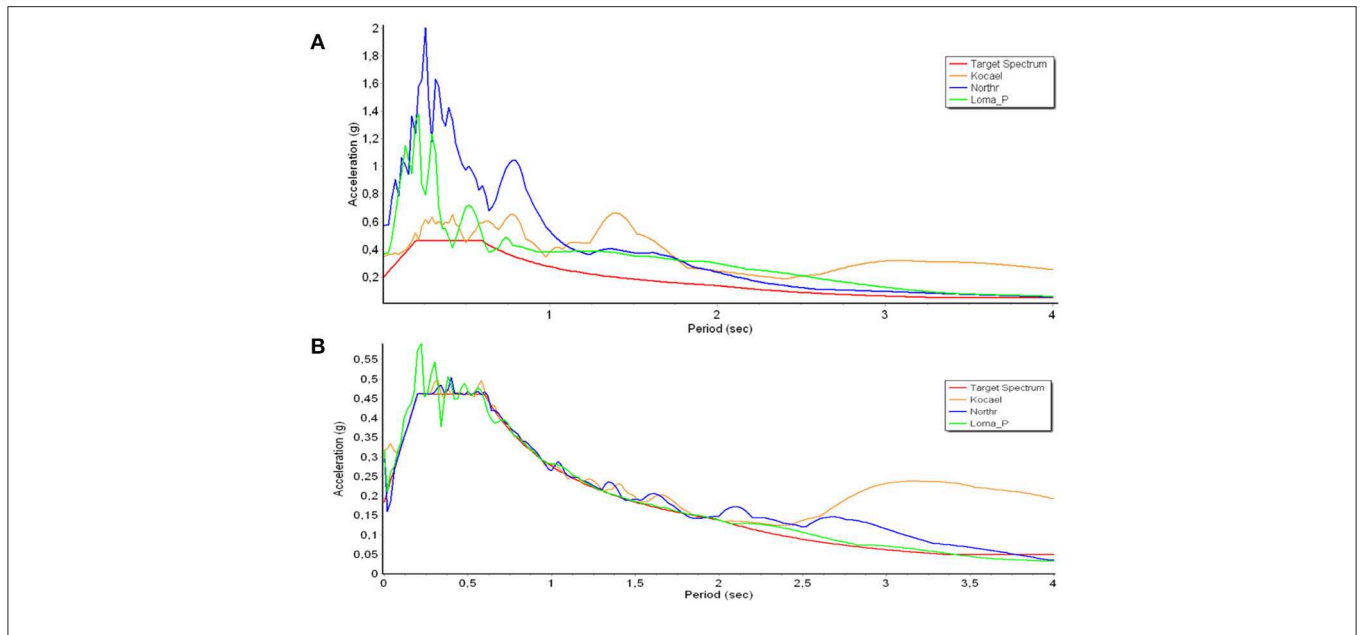
Figures 9A,B present the response spectra of the initial records and the matched spectra, respectively, along with the target spectrum. The original (blue) and scaled (red)

FIGURE 9 | (A) Response spectra of the original accelerograms, and **(B)** response spectra of the matched accelerograms.

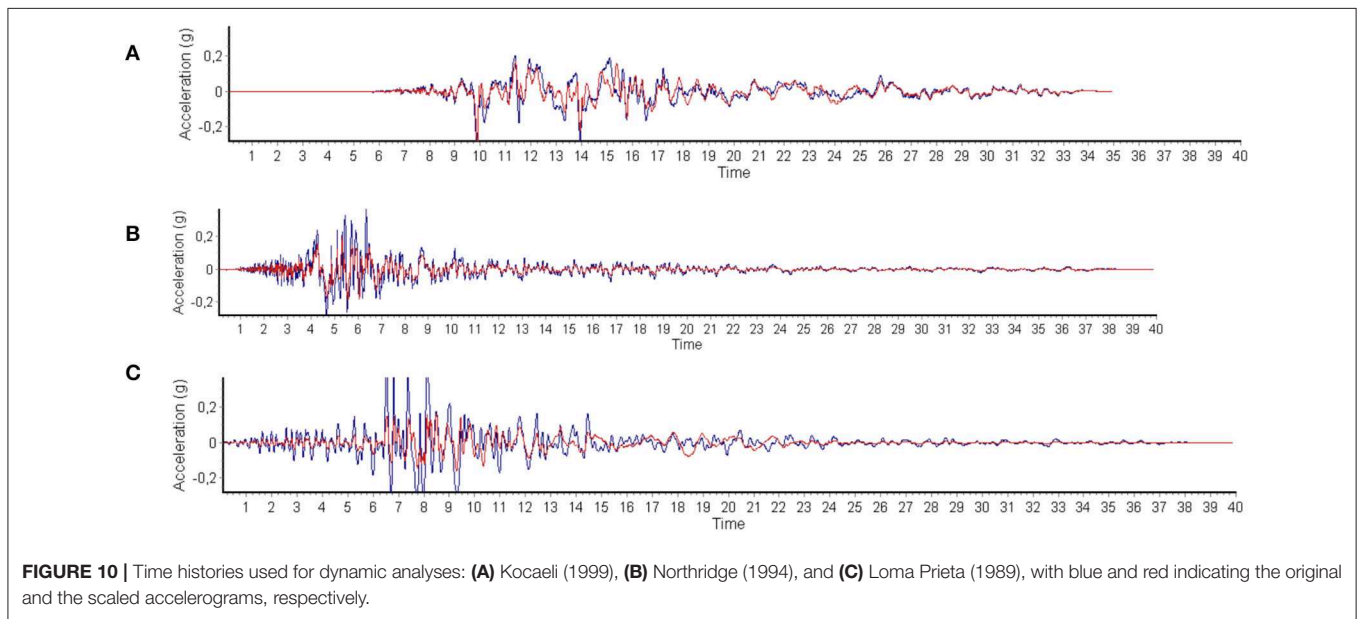
accelerograms corresponding to the employed seismic motions are presented in **Figure 10**.

FIGURE 10 | Time histories used for dynamic analyses: (A) Kocaeli (1999), **(B)** Northridge (1994), and **(C)** Loma Prieta (1989), with blue and red indicating the original and the scaled accelerograms, respectively.

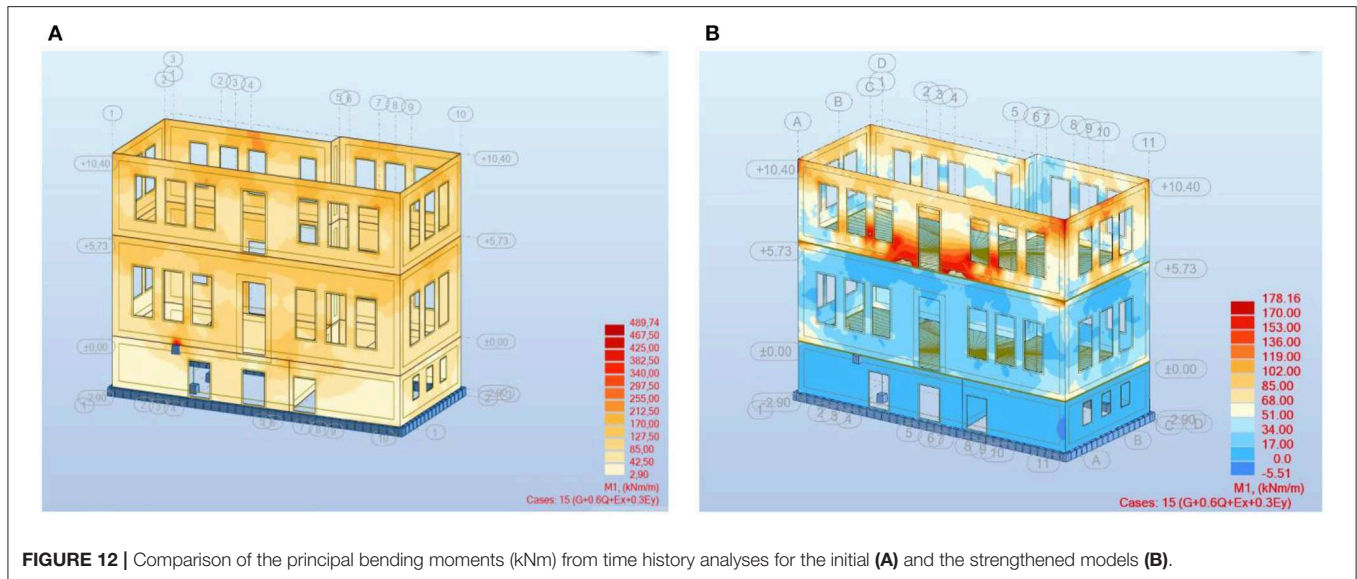
A schematic of the results (in terms of principal bending moments) of time history analyses for the initial and the retrofitted model (including diaphragms) is presented in **Figures 12A,B**, respectively. In the absence of diaphragms, the bending moments spread freely from the foundation to the top of the building, while for the strengthened model, the bending moments were limited to low values with the exception of walls of the top floor, which act as cantilevered walls.
