Automatic assessment of roofs conditions using artificial intelligence (AI) and unmanned aerial vehicles (UAVs)

Ammar Alzarrad^{1*}, Ibukun Awolusi², Muhammad T. Hatamleh³
and Saratu Terreno⁴

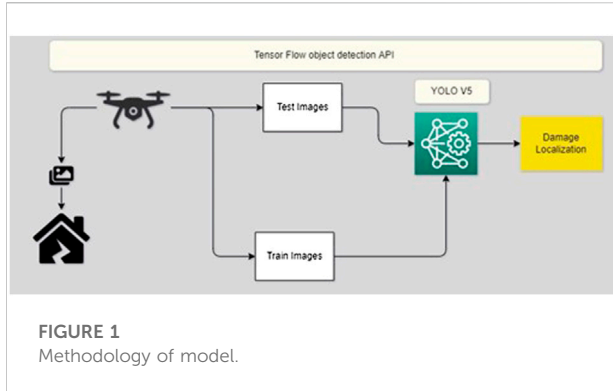
As shown in Figure 1, high-resolution RGB images of damaged roofs are captured using a UAV which are

annotated using a labeling toolkit. The dataset is then classified into test and train sets and are further trained on YOLO v5 using python library “Tensor Flow Object Detection API”. Tensor flow is an open-source platform developed by Google, having special emphasis on deep learning models. Once the dataset is trained, its accuracy is checked against the test images for model evaluation (Adams et al., 2014).

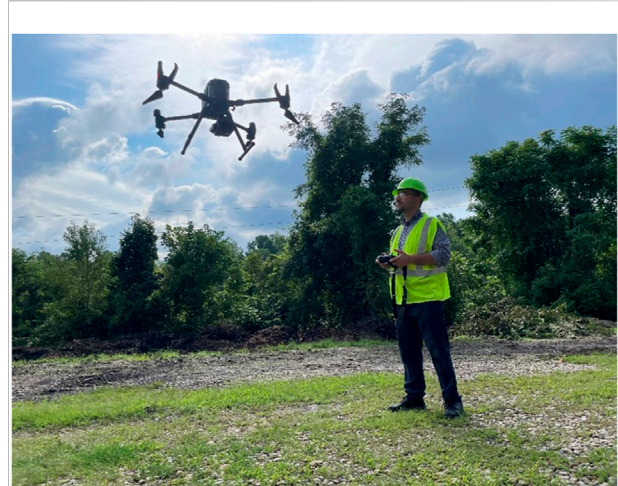
FIGURE 2
Collecting data using DJI Matrice 300 RTK drone.

To illustrate an implementation of the presented model, a case study is used to verify and validate the model’s robustness. The researchers used DJI Matrice 300 RTK drone equipped with Zenmuse H20T, which has the capacity to zoom up to 20x (Figure 2) to collect roof images for two different houses in Hurricane, West Virginia.

The drone covered each roof by means of manually composing and capturing mainly oblique aerial images. The individual roof inspection images were carefully composed by means of “first person view” (FPV); a facility which presents the drone operator with a real-time view of the scene as it is being captured by the on-board camera. To ensure completeness, a methodical sequence was followed in a flight that generally went around the roof in a counterclockwise fashion. Given the complex design and considerable height of the roof profiles (the highest point of the roof being some 28 ft above ground level) the inspection by air certainly saved considerable costs in time and money, and generally reduced the risk of injury and the potential for disturbance to the occupants. Figure 3 below shows the most common defects, namely cracked or slipped roof tiles, identifiable on the manually composed aerial images.

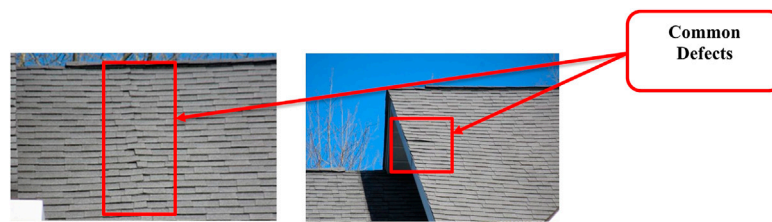
FIGURE 3
Common defects identified on the manually composed aerial images.

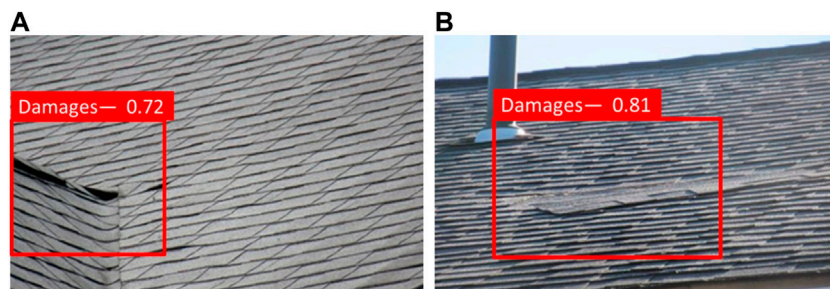
FIGURE 4
(A) (left) shows the accuracy of the model for the training photos, which is 72%. (B) (right) shows the accuracy of the model for validation photos which is 81%.

Figure 4A shows a sample of the photos that have been used to train the model. Figure 4B shows a sample of the photos that have been used to validate the model. The accuracy of the model using training data was 72%, while the accuracy of the model using the validation photos from the second house was 81%. The model did not pick up 19% of the defects, mainly because of poor photo quality or defects being too small. The model has not detected a defect when there was no defect (no false positive detection).

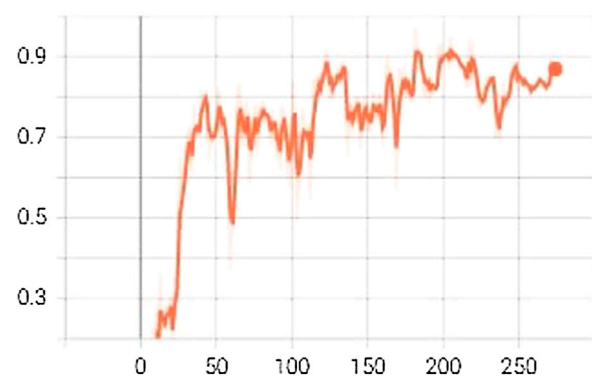
FIGURE 5
The model precision.

Precision quantifies the number of positive class predictions that actually belong to the positive class (i.e., how many good condition photos have been classified as good conditions). The model precision was 0.86, as shown in Figure 5.

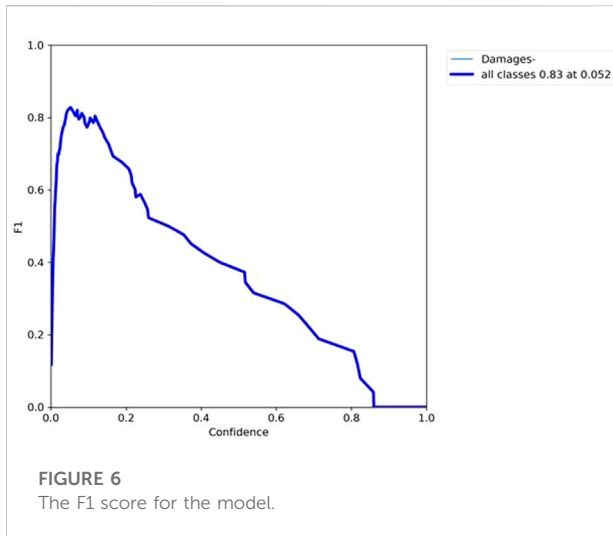
Further, the researchers examine the model F1 score. F1 score measures the percentage of correct predictions that the model has made. An F1 score is considered perfect when it is 1, while the model is a total failure when it is 0. The F1 score for this model was 0.832, which is good as shown in [Figure 6](#).
