# Natural and nature based features for environmental enhancement and coastal storm risk management: a case study on Marco Island, Florida, United States

Mohamed A. Dabees\*, Matthew Fleming and Marc Damon

Humiston & Moore Engineers, Naples, FL, United States

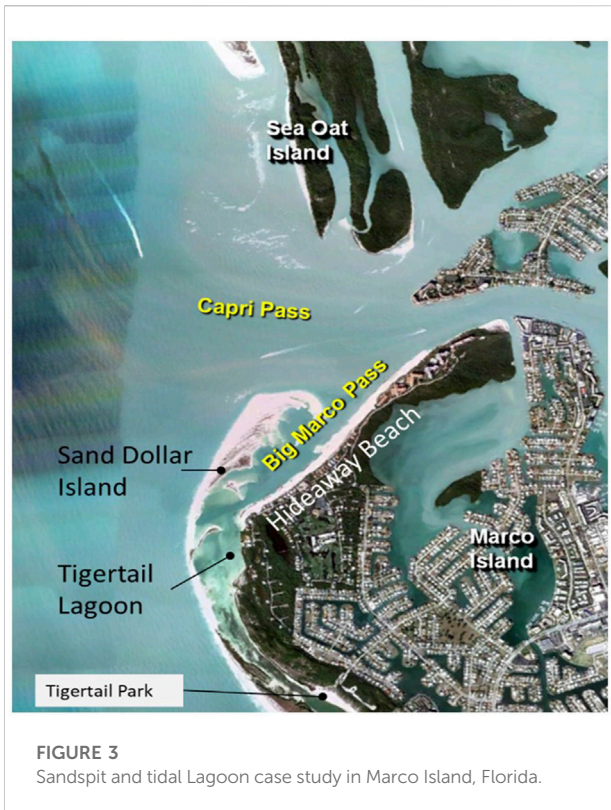
**FIGURE 3**  
Sandspit and tidal Lagoon case study in Marco Island, Florida.

Figure 3 shows the location of the study area which extends from the central part of Marco Island's Gulf coast to the northwest part of the island. The evolution of Tigertail Lagoon and Sand Dollar Island is part of the ongoing large scale natural tidal inlet evolution at the north end of Marco Island. Prior to the 1960s, Big Marco Pass was the main inlet between Marco Island and Sea Oat Island. In 1967 Capri Pass developed when Sea Oat Island was breached by natural processes. The breach on the up-drift side of Big Marco Pass created a dual inlet system that persisted for a few decades until Capri Pass became the main inlet for this system in the early 2000s.

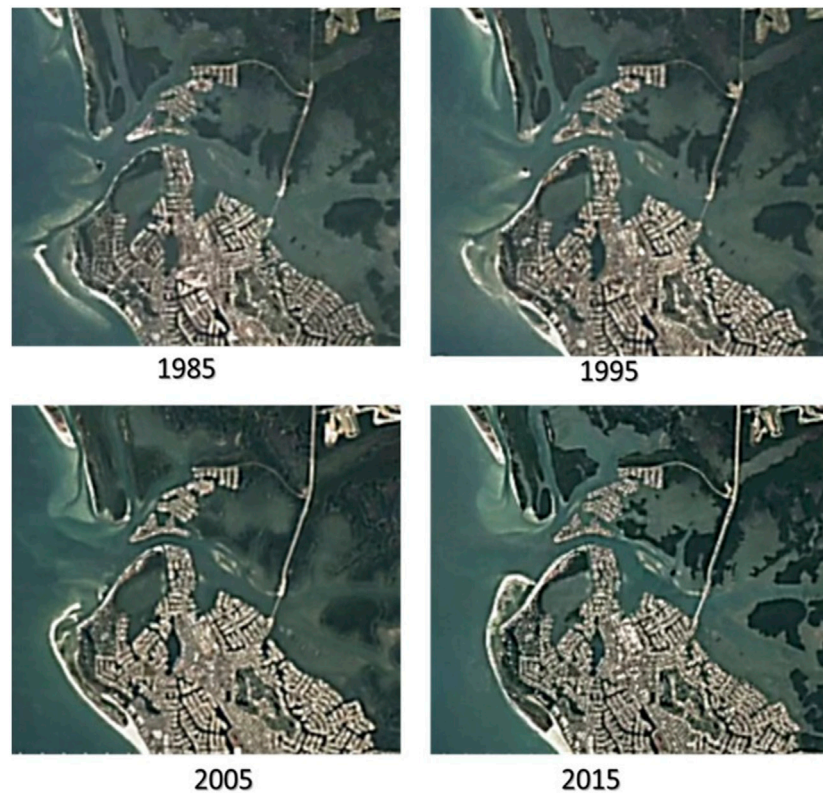
**FIGURE 5**  
Decadal stages of Sand Dollar Island evolution.

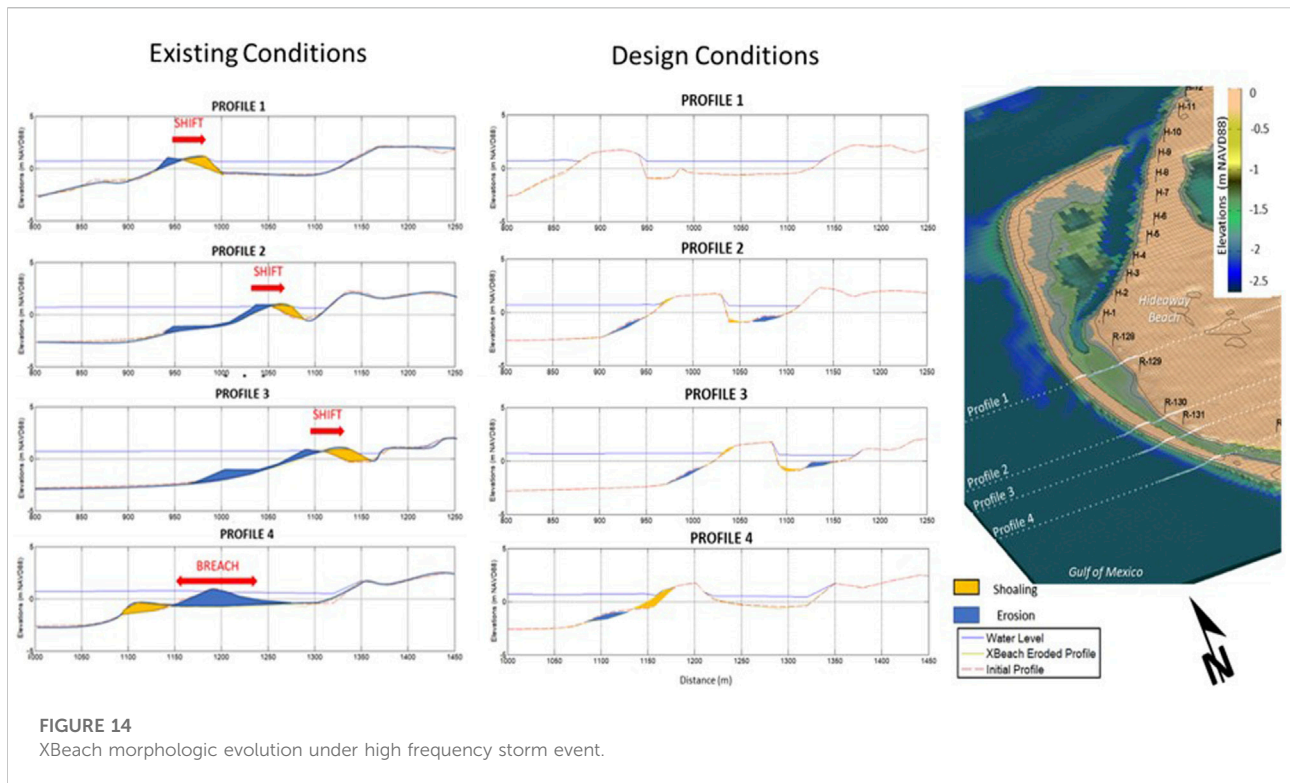
FIGURE 14 XBeach morphologic evolution under high frequency storm event.

At peak surge (T2), the model shows the water level (including waves) overtopping Sand Dollar Island. At that stage the berm has already started to shift landward (towards the east). At the end of the simulation (T3), the model results show the shifted shoreline. The lagoon channel is narrower than the initial conditions. The model also shows breaches through the berm connecting the Gulf of Mexico to the lagoon. Such breaches were documented during tropical storm Eta. Their exact location can vary and will typically follow areas along the berm with the lowest elevations. Because of the high sediment transport in the region and low tidal prism from the lagoon, these breaches tend to fill in with sand carried along the shore through wave action. Figure 14 presents the same model results extracted at four

profiles along Tigertail for the existing conditions at left. For each profile, the initial conditions are shown as a dashed line and the final profile is indicated in blue with areas of erosion and shoaling shaded in blue and orange respectively. Profiles one through three show a landward shift of the berm, shoreline recession, and narrowing of the channel. Profile four falls in one of the areas which experienced breaching during the simulated storm, therefore the eroded profile is flat because the berm completely eroded.
