CITATION  
Al-Akhras N and Othman O (2022),  
Bond behavior of NSM strips in  
corroded/cracked reinforced concrete.  
*Front. Built Environ.* 8:966351.  
doi: 10.3389/fbuil.2022.966351

# Bond behavior of NSM strips in corroded/cracked reinforced concrete

Nabil Al-Akhras\* and Osama Othman

Civil Engineering Department, Jordan University of Science and Technology, Irbid, Jordan

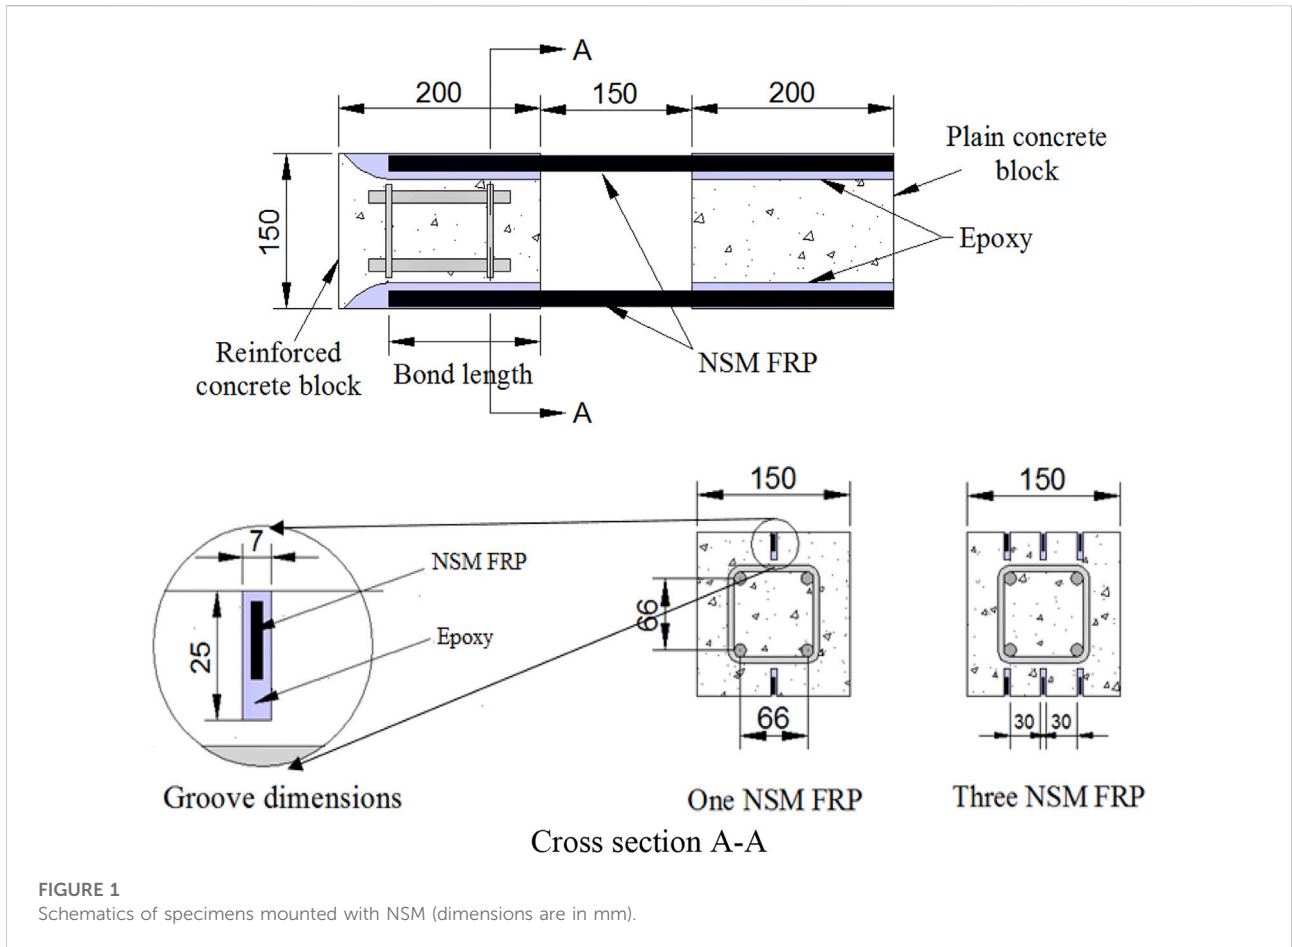
The testing program is composed of thirty-two concrete specimens. Each specimen consists of two concrete blocks (reinforced and plain). Each concrete block has dimensions of 150 × 150 × 200 mm. The two concrete blocks are mounted with NSM strips at the two opposite sides. The RC block is reinforced with four steel bars with diameter of 12 mm and two stirrups with diameter of 6 mm as shown in Figure 1. Twenty-four specimens were immersed in 3% NaCl solution and exposed to accelerated corrosion process. While eight specimens were kept in water bath at laboratory temperature

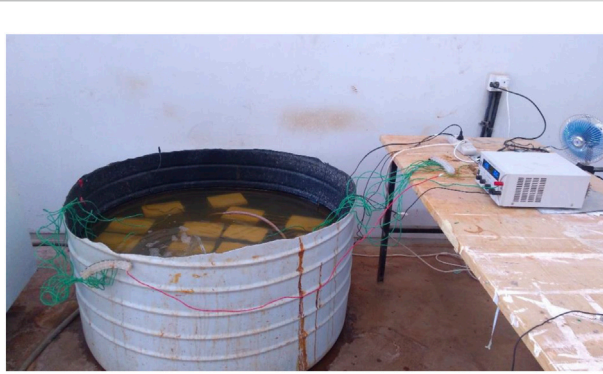
**FIGURE 4**  
Accelerated corrosion process using power supply.

Twenty-four specimens (RC and plain concrete blocks) were immersed in a circular plastic tank (600 by 1,200 mm) containing 3% NaCl solution for the accelerated corrosion process. The reinforcing steel were connected on parallel to the positive pole of the power supply to act as the anode. The

negative pole was connected to rectangular steel plate (cathode) immersed in the tank (Figure 4). Each specimen was exposed to an electrical current of 0.15 A and 12 V for time-periods of 5 (Lee et al., 2000; Mukhopadhyaya and Swamy, 2001; Nguyen et al., 2001; Okamura et al., 2003; Kreit et al., 2011; Lorenzis and Nanni, 2015; Mosallam et al., 2022), days for the first, second and third level of corrosion, respectively. The electrical current values were

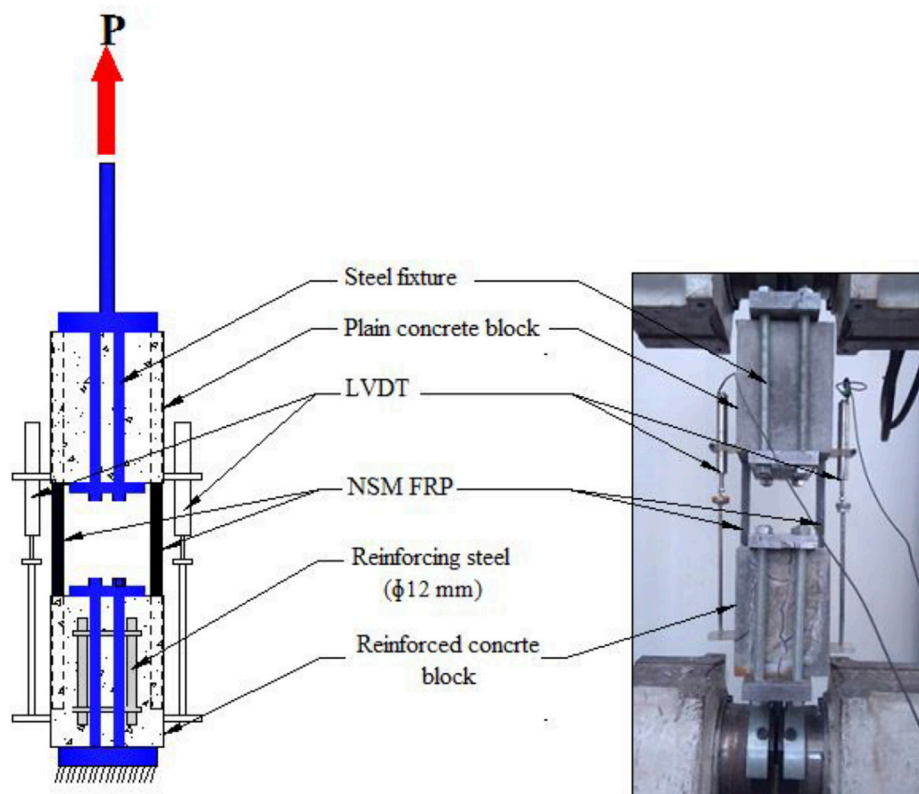
**FIGURE 5**  
Test setup of the double pullout test.

subjected to pullout test using universal testing machine with capacity of 600 kN. The two concrete blocks (plain and reinforced) were pulled from each other using steel fasteners at rate of 0.44 mm/min until failure of the bond of NSM strips. Linear variable differential transducers (LVDT) were placed at each bonded side to measure the

slip. The load and displacement measurements were collected using data acquisition system connected to computer. Figure 5 illustrates the pullout test.

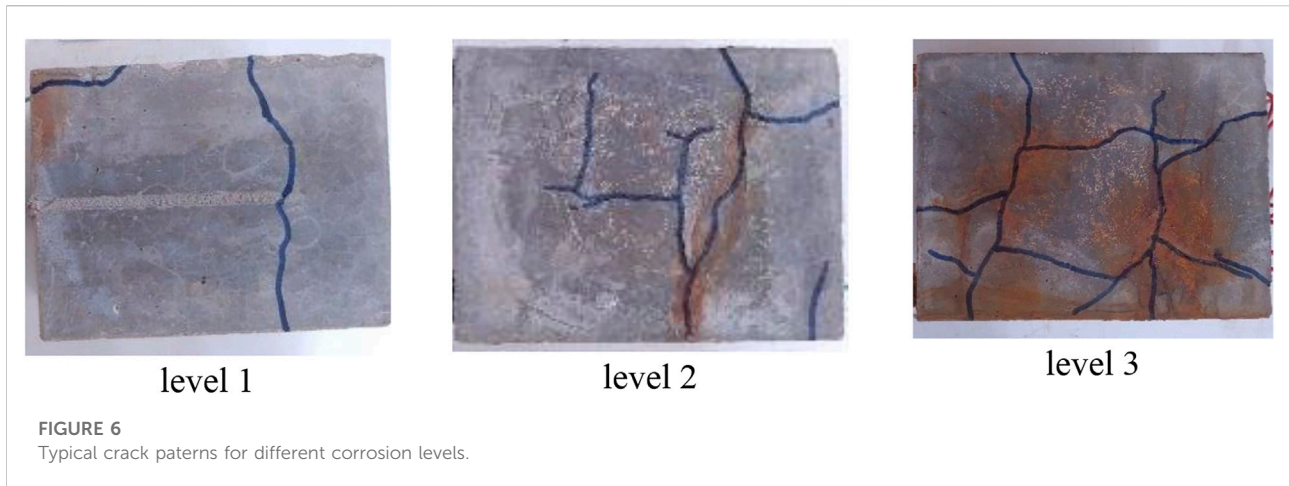
**FIGURE 6**  
Typical crack patterns for different corrosion levels.

The corrosion crack pattern was monitored for different corrosion levels as shown in Figure 6. The corrosion crack pattern varied with different corrosion level. The number of corrosion cracks increased with the increase of corrosion level. Two small corrosion cracks were observed after the first corrosion level. However, six corrosion cracks were detected for the second corrosion level. Moreover, a network of 10 corrosion cracks was noticed at the third corrosion level.

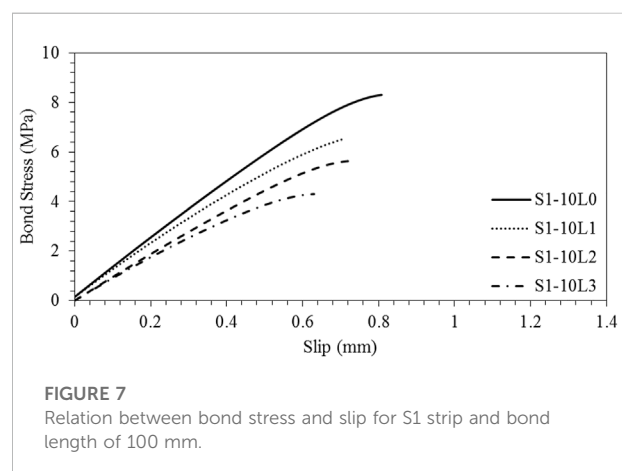
**FIGURE 7**  
Relation between bond stress and slip for S1 strip and bond length of 100 mm.

Figures 7–10 depict the effect of corrosion on the bond behavior between NSM strips and concrete. The bond stress

was determined based on the average of two specimens using MS Excel. The scatter of the data was small with coefficient of variation of less than 2%. The bond-slip behavior followed similar behavior that consists of linear trend in the beginning then nonlinear behavior up to failure. The post peak behavior did

The bond characteristics decreased significantly with the increase of the corrosion level. The ultimate load and maximum slip of the one NSM strip at bond length of 100 mm were decreased from (27 kN and 0.81 mm) for uncorroded specimens to (14 kN and 0.63 mm) for corroded specimens at corrosion level 3. The percent reduction in the ultimate load and maximum slip were 48 and 22%.

The toughness and stiffness for one NSM strip with 100 mm bond length were also decreased from (3802 J/m<sup>2</sup> and 13.1 GPa/m) for uncorroded NSM strips to (1580 J/m<sup>2</sup> and 8.9 GPa/m) for corroded NSM strips at corrosion level 3. The percent reduction in the toughness and stiffness were 58 and 32%.

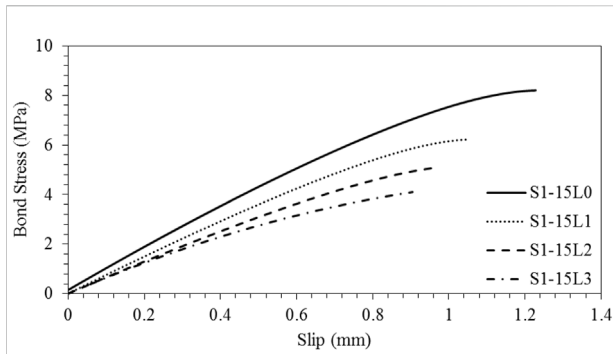
**FIGURE 8**  
Relation between bond stress and slip for S1 strip and bond length of 150 mm.

The bond characteristics were increased with the increase of the bond length from 100 to 150 mm. The ultimate load and maximum slip at corrosion level 2 were increased from (18.3 kN and 0.73 mm) for bond length of 100 mm to (24.8 kN and 0.97 mm) for bond length of 150 mm. The toughness at corrosion level 3 was increased from (1580 J/m<sup>2</sup>) for bond length of 100 mm to (2154 J/m<sup>2</sup>) for bond length of 150 mm.

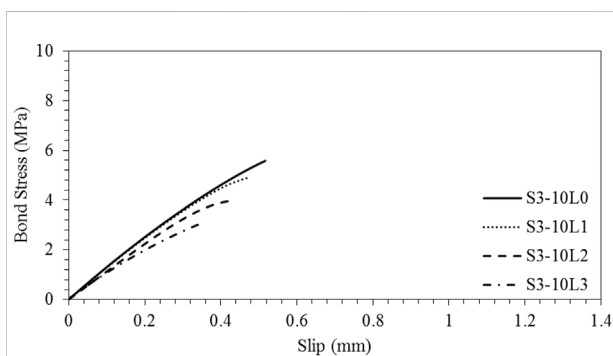
**FIGURE 9**  
Relation between bond stress and slip for S3 strip and bond length of 100 mm.

The ultimate load and maximum slip for one NSM strips (S1) were higher compared to those for 1 strip of three adjacent NSM strips (S3). This behavior may be explained because the overlapped area between the three adjacent NSM strips cause stress concentration on each NSM strip. Therefore, causing premature failure of the three adjacent NSM strips prior to reaching the maximum capacity of the bond strength (Figure 12).

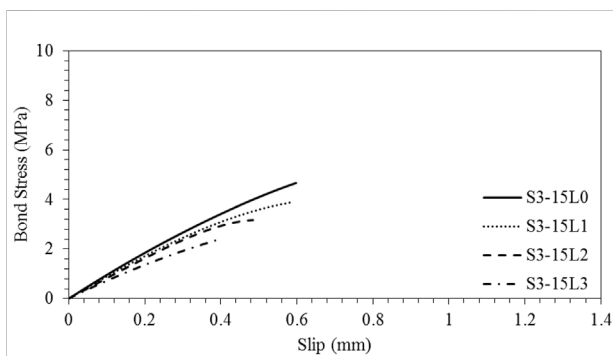
**FIGURE 10**  
Relation between bond stress and slip for S3 strip and bond length of 150 mm.

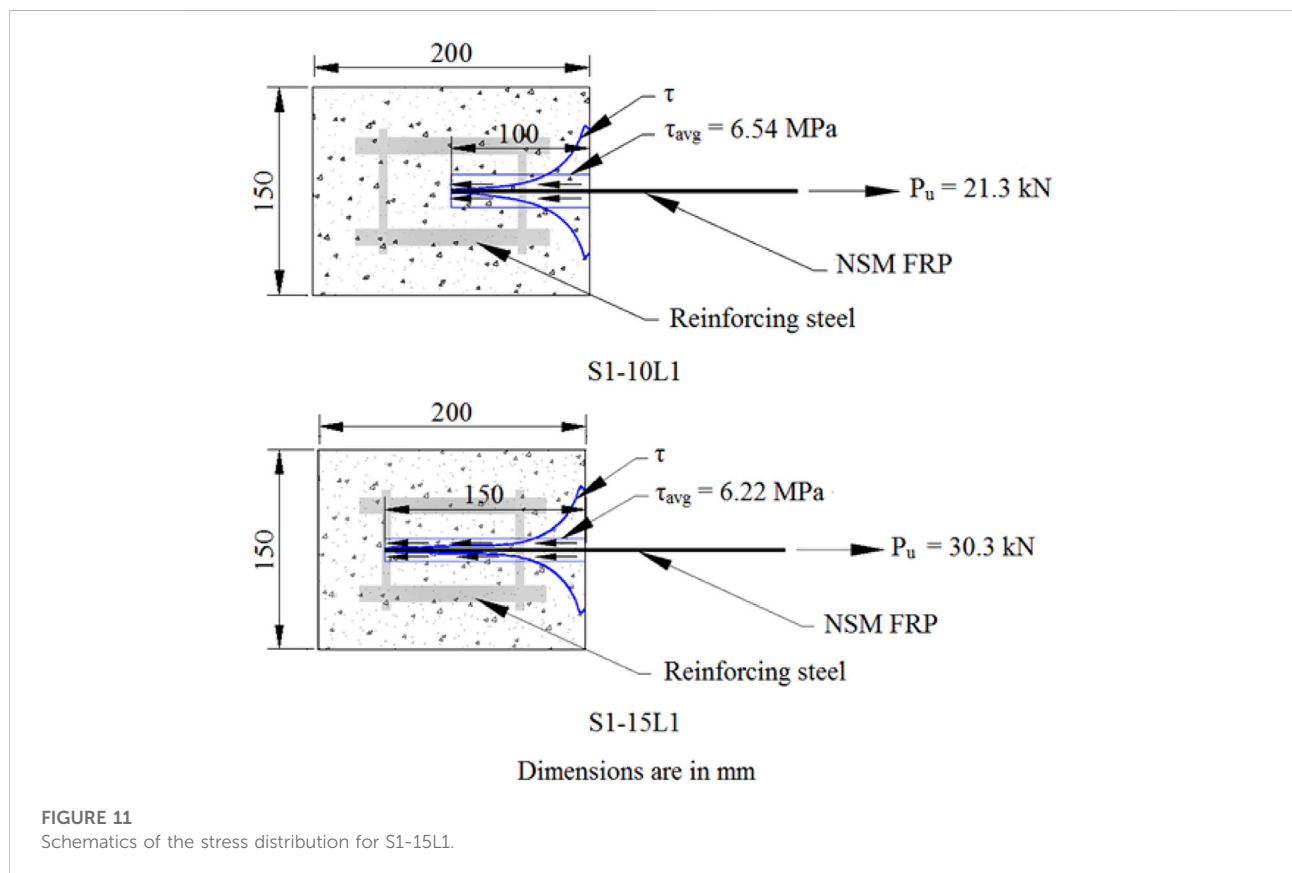
The bond stress for NSM strips with length of 100 mm is observed higher than that for NSM with length of 150 mm. However, the pullout load for NSM strips with length of 100 mm is lower than that for NSM with length of 150 mm. This behavior is explained as follows. The bond stress is determined by dividing the pullout load by the area of the NSM strip. The area of the NSM strip increases with the increase of the NSM bond length. Therefore, the bond stress decreased as the bond length increased (Figure 11).

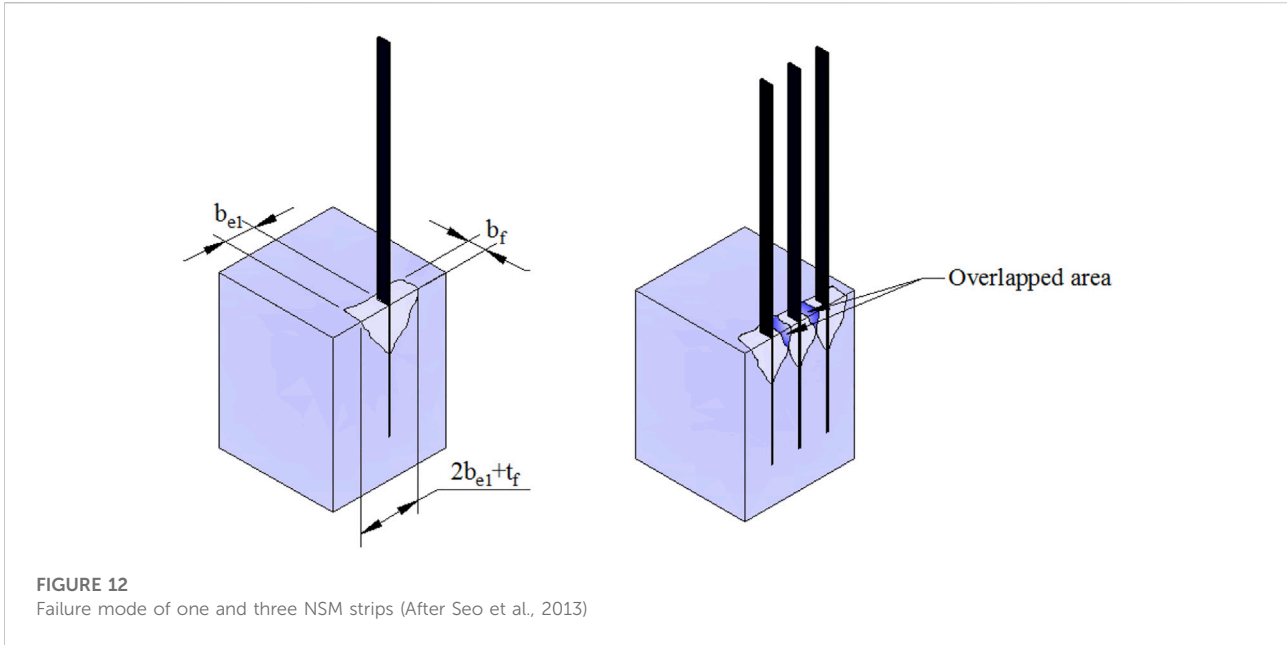
**FIGURE 12**  
Failure mode of one and three NSM strips (After Seo et al., 2013)

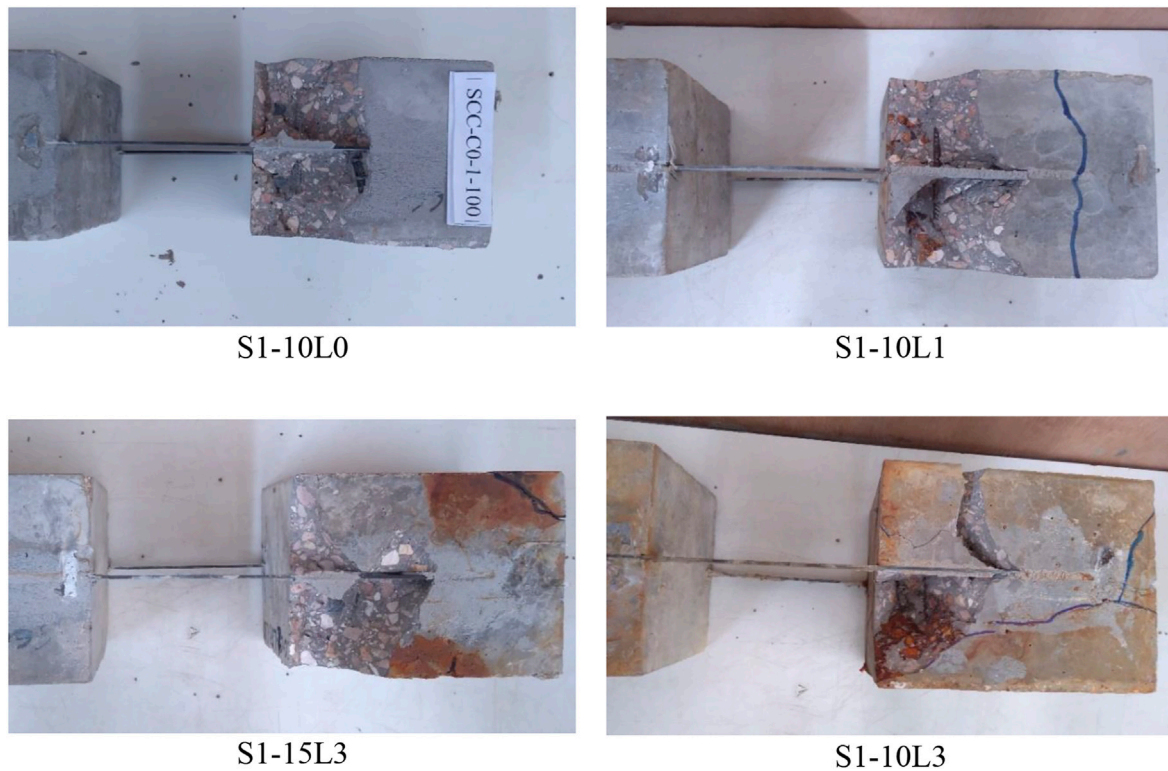
FIGURE 14 Failure mode of the NSM bond with concrete.

The failure mode of the bond between NSM and concrete was splitting of concrete as shown in Figure 14. This behavior is explained by the fact that the tensile strength of the epoxy bond (17 MPa) is significantly higher than the splitting strength of the concrete (3.4 MPa). Therefore, the concrete failed and split before the epoxy bond failed. Small concrete fractures of the split concrete remained attached to the NSM strips after failure. These concrete fractures increased in size with the increase of

corrosion level. Large parts of split concrete remained attached to the NSM strips after failure at corrosion level 3. This behavior is due to the fact that corrosion cracks significantly weakened the concrete.

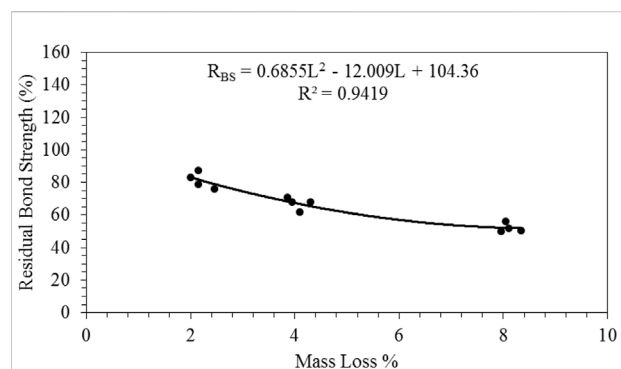
FIGURE 15 Correlation model between residual bond strength ( $R_{BS}$ ) and mass loss (L).

Correlation models between the residual bond strength of NSM and (steel mass loss and maximum crack width) were developed. Quadratic equation models were considered since they showed the best fit compared to other models. The correlation models showed excellent fit between the residual bond strength and steel mass loss with R-square of 0.94 and between residual bond strength and maximum crack width with R-square of 0.95 as shown in Figures 15, 16.
