Khadka SS, Acharya S, Acharya A and Veletzos MJ (2023), Enhancement of Himalayan irregular stone masonry buildings for resilient seismic design. *Front. Built Environ.* 9:1086008. doi: 10.3389/fbuil.2023.1086008

Enhancement of Himalayan irregular stone masonry buildings for resilient seismic design

Shyam Sundar Khadka^{1*}, Sabin Acharya¹, Ayush Acharya¹ and Marc J. Veletzos²

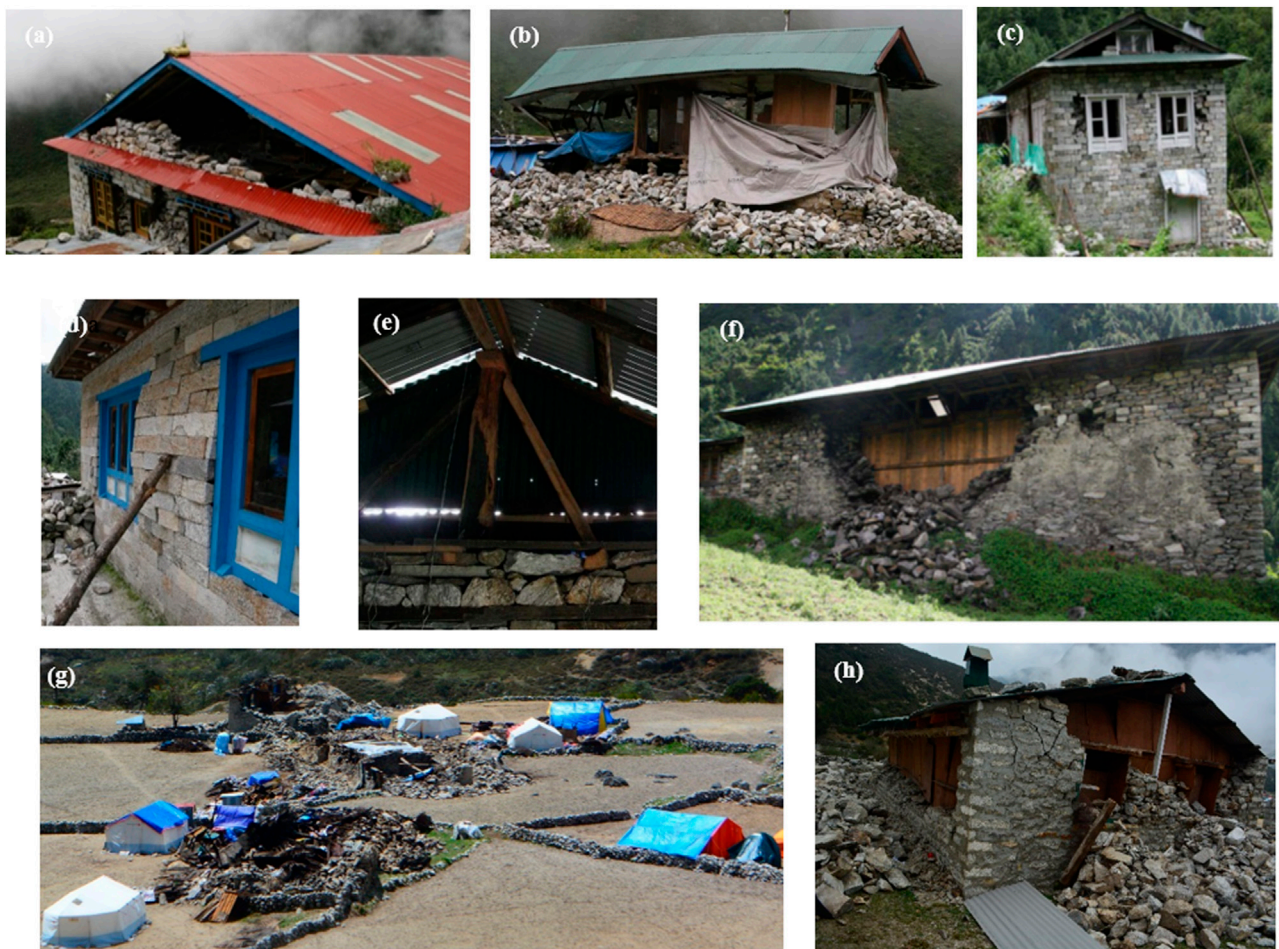
FIGURE 3

Damage in stone masonry buildings: (A) collapsed roof gable wall, (B) collapse and detachment of the outer wall of the buildings with wood frames, (C) masonry walls separating from windows and corners, (D) bulging of the masonry wall and delamination, (E) poor roof and wall connection, (F) failure of the longer wall, (G) complete collapse of the sherpa houses, and (H) failure of both the long and short walls.

One of the authors of this paper inspected the Thame Valley immediately after the 2015 Gorkha earthquake to assess damaged community buildings. Out-of-plane failure of the long and thick stone masonry wall was the most common damage due to the lack of cross walls and the absence of seismic bands. Figure 3 illustrates the different damage in stone masonry buildings as follows: a) collapse of the roof gable wall, b) collapse and detachment of the outer wall of the buildings with a timber frame, c) masonry walls that separated from the windows and corners, d) bulging of a masonry wall and delamination, e) poor roof and wall connection, f) failure of the longer wall, g) complete collapse of the house, and h) both long and short wall failure. These results indicated that there was a lack of lateral load resistance mechanism and no appropriate roof-to-wall connection during building construction. There were no cross walls supporting the longer wall and seismic bands in the different levels of the walls, and out-of-plane failure was dominant in stone masonry walls. The construction practice of using dry stone stacks in masonry walls and pointing and plastering from outside does not contribute to masonry joint strength. Therefore, in most cases, the failure arises from individual masonry unit failure.

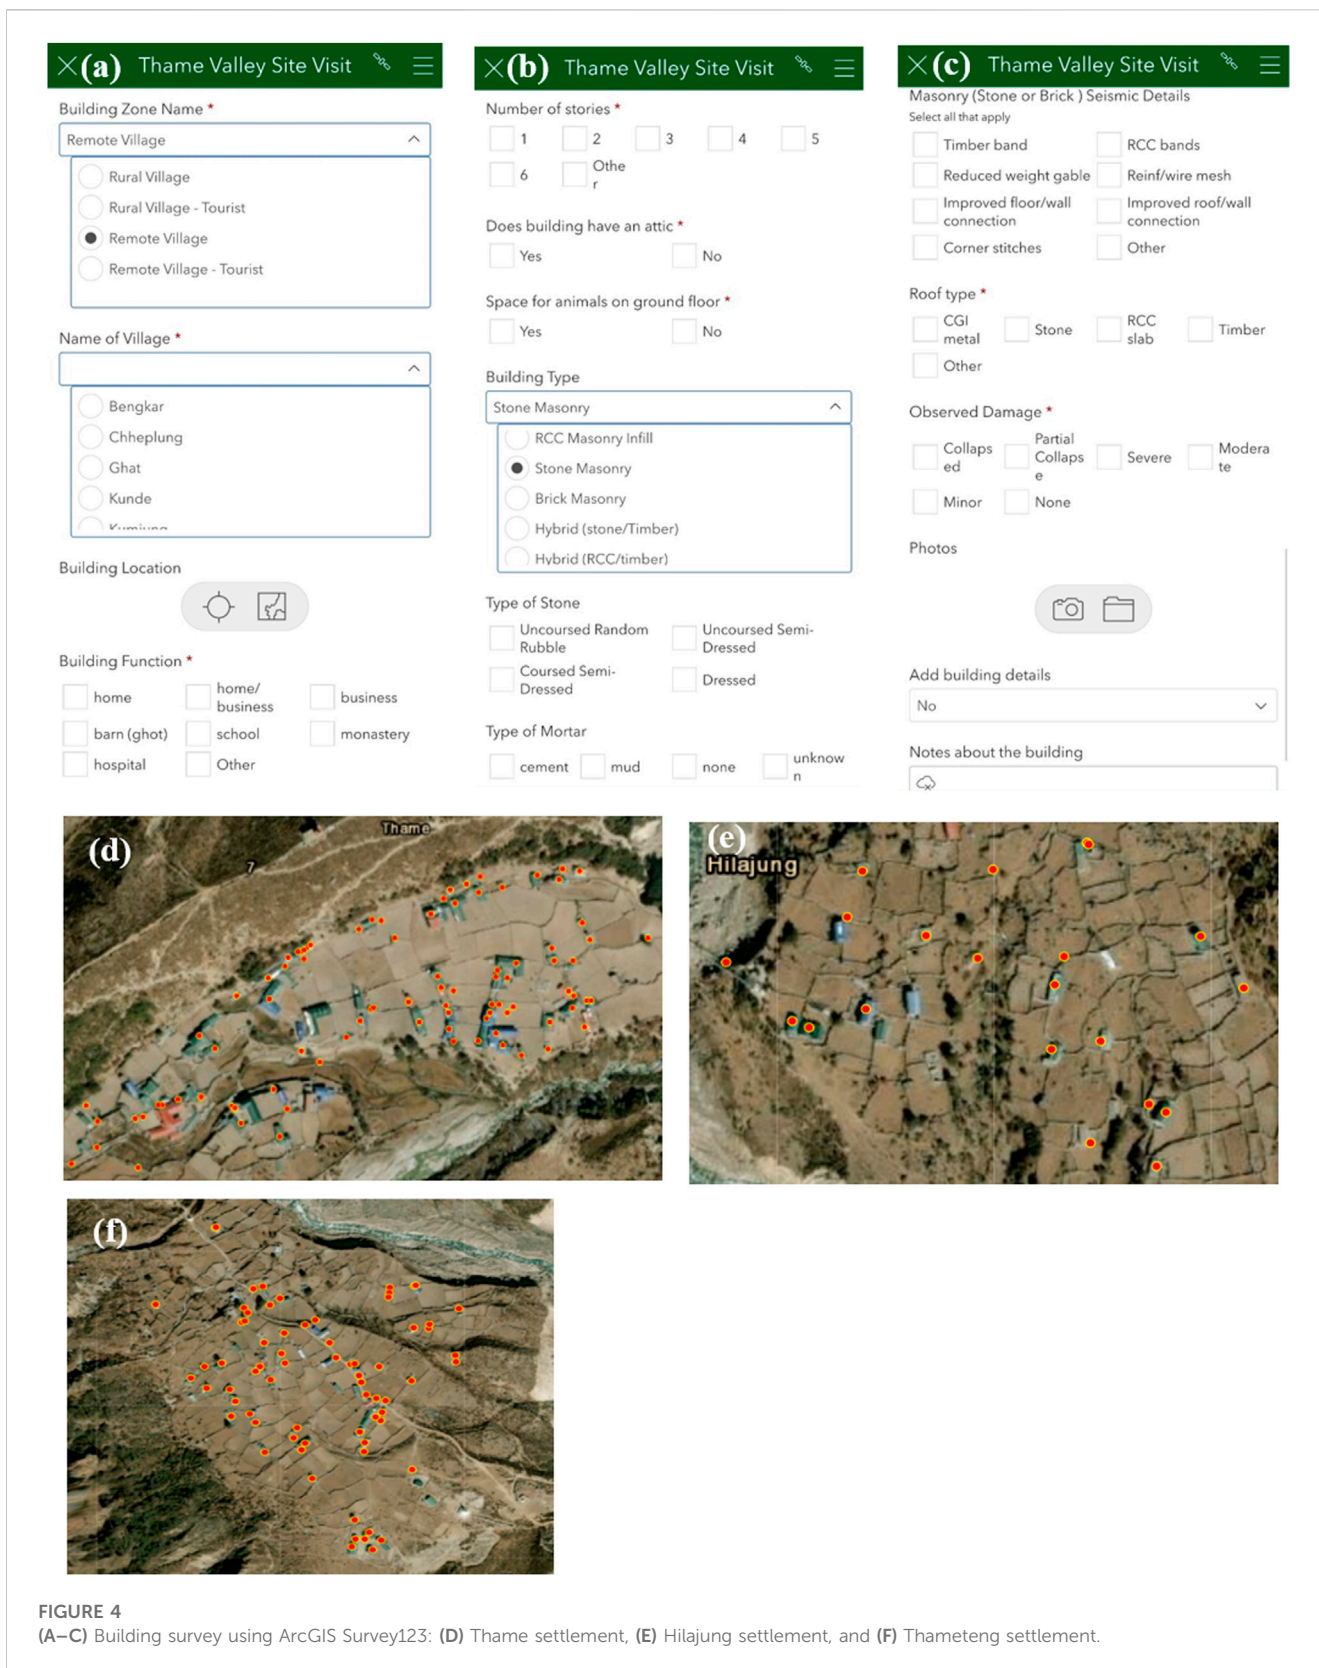
FIGURE 4 (A–C) Building survey using ArcGIS Survey123: (D) Thame settlement, (E) Hilajung settlement, and (F) Thameteng settlement.

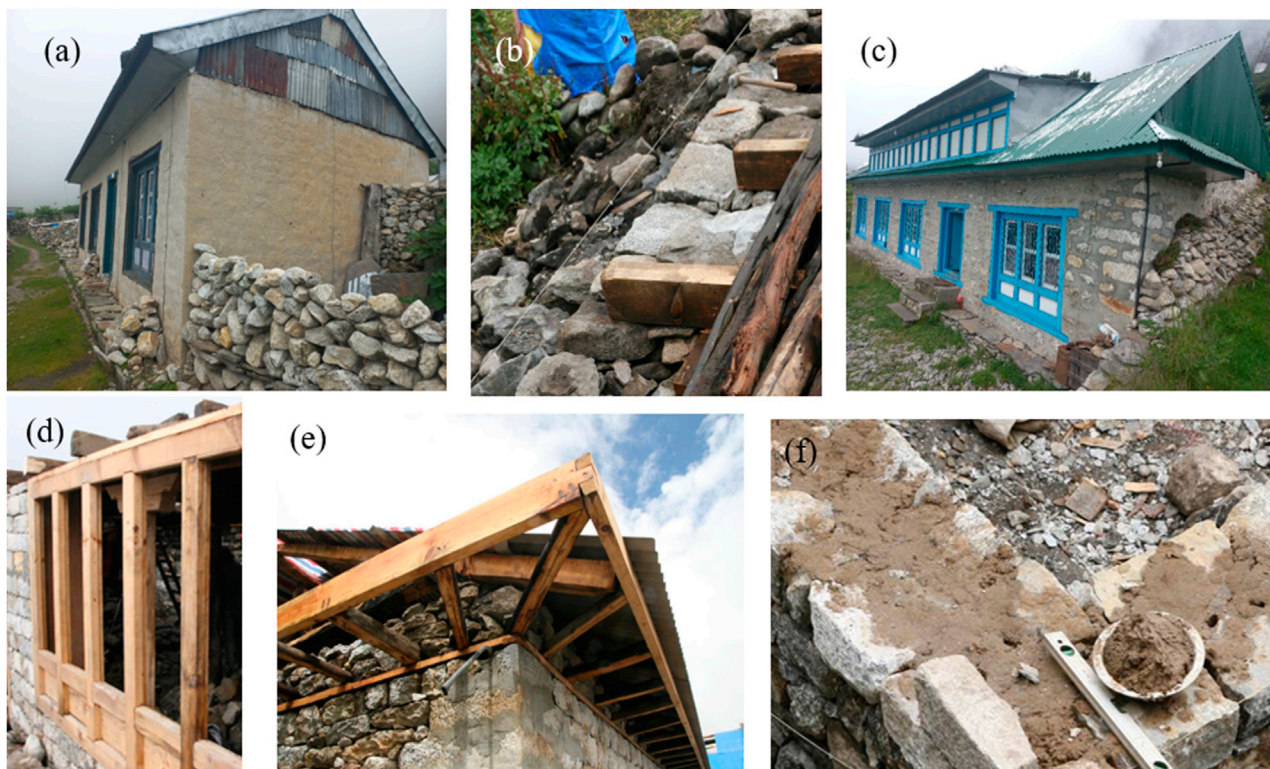
FIGURE 6

Current construction practices in the Thame Valley include (A) a reduced weight gable, (B) laying of the floor joist in the wall, (C) a light upper story, (D) resting of the floor joist on the window frame, (E) a roof-to-wall connection, and (F) a thin layer of mud mortar in the masonry.

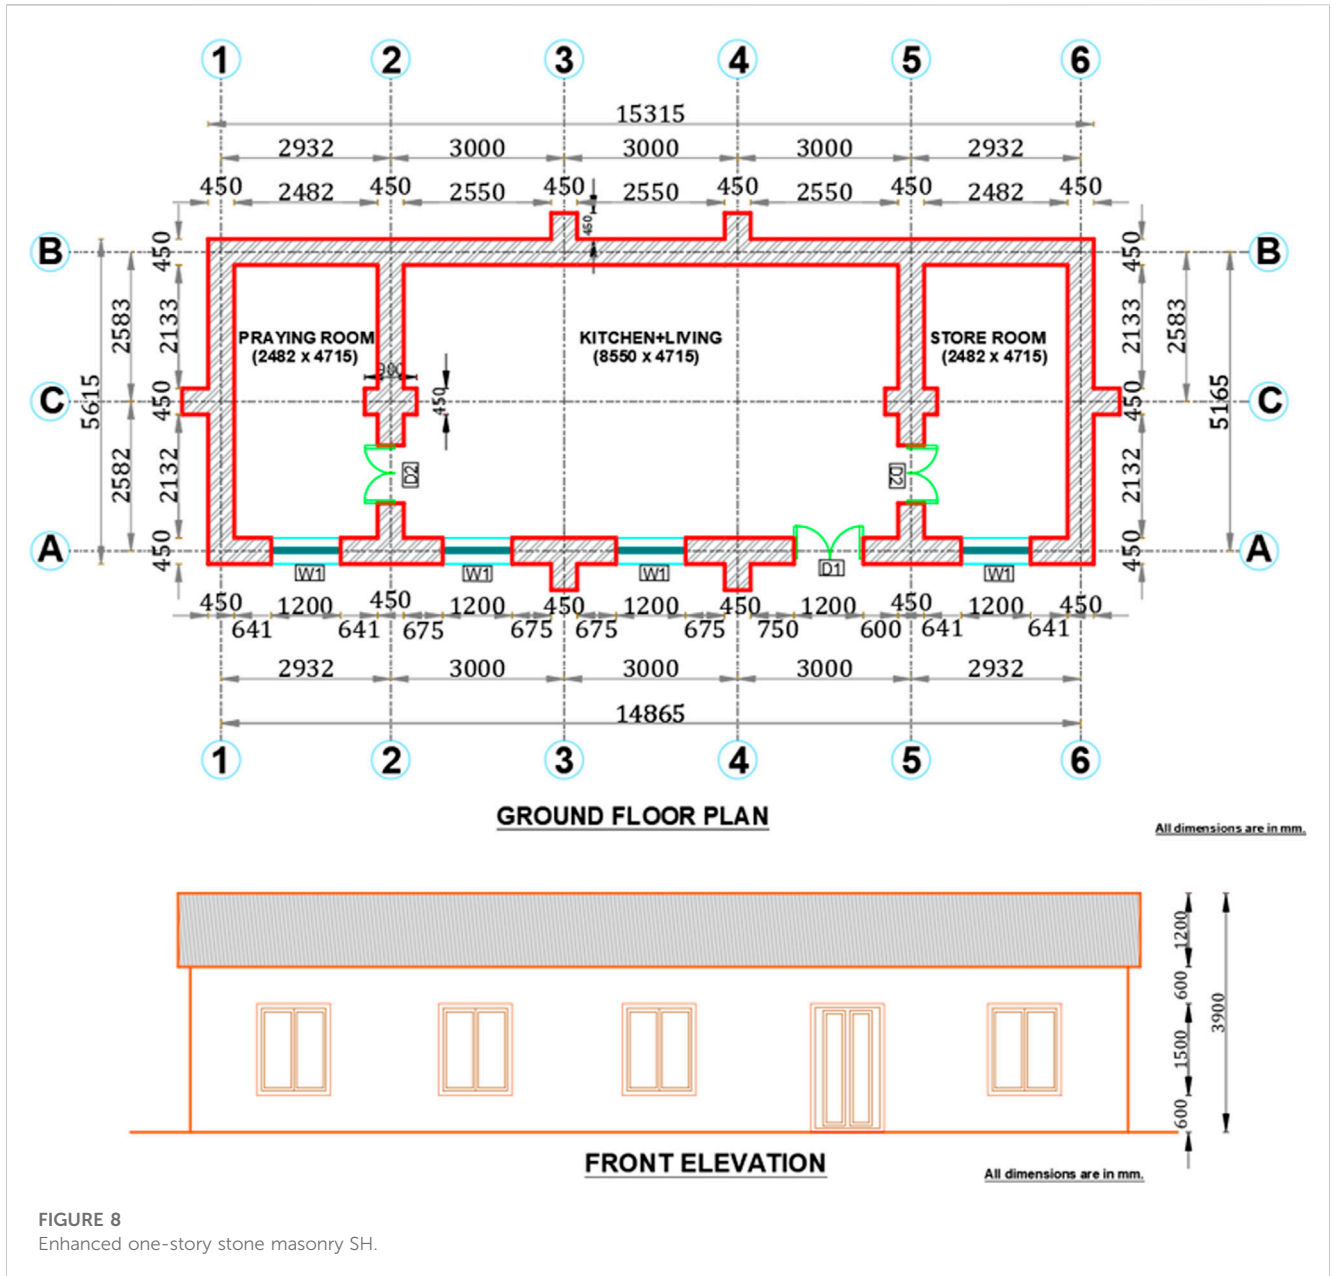
FIGURE 8
Enhanced one-story stone masonry SH.

In the E-ISMB, the two cross walls with door openings are provided to separate the praying room and storeroom from the open kitchen/living area in the middle of the building. The two buttresses are of the same thickness as the wall provided on either side of the long wall, and one on each short wall and cross wall is used to maintain an unsupported wall length of 3 m (according to Table 1). The other features of E-ISMB are kept the same as C-ISMB. These buildings were investigated for their performance in terms of lateral load capacity, induced stress, and induced failure patterns.

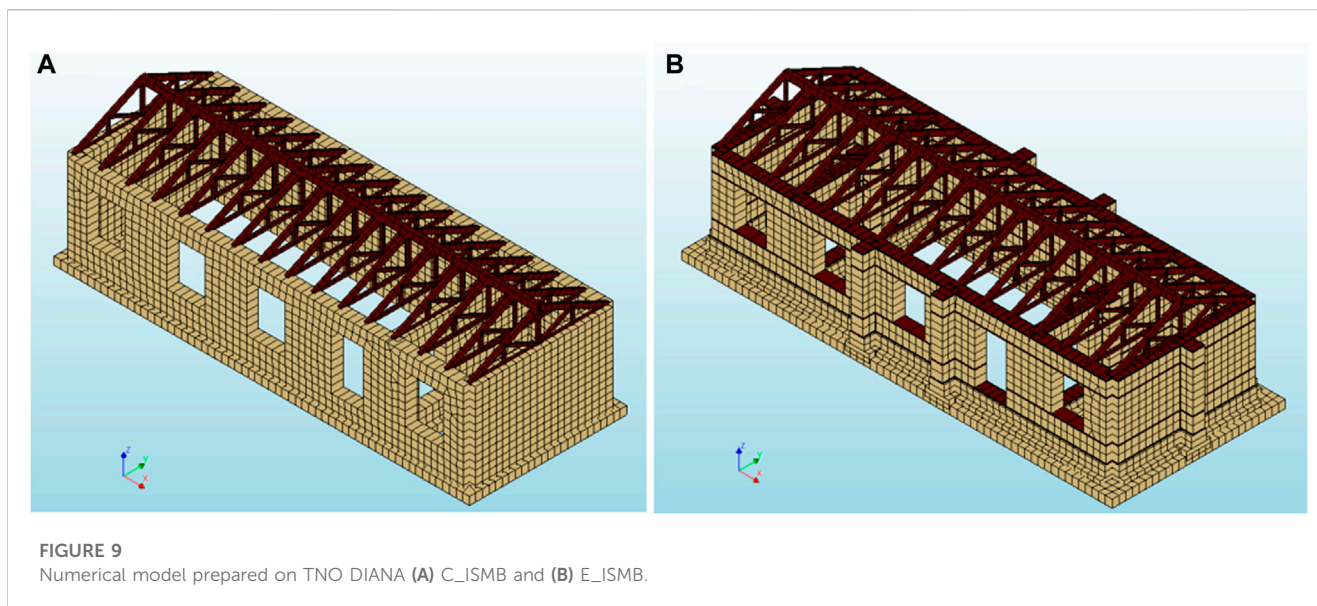
FIGURE 9 Numerical model prepared on TNO DIANA (A) C-ISMB and (B) E-ISMB.

for drawings of Figure 7 and Figure 8 are shown in Figure 9. However, it should be considered that the focus of numerical modeling was to feel the improvement in performance of the Sherpa house after interventions, rather than to use it as a verification method. It should also be noted that considering the limitations to the numerical modeling for this type of stone masonry, which has large variability in material properties, boundary conditions, the effect of openings, a lack of continuum and cracking, that modeling alone cannot be fully relied upon. The local failure mode such as the cracking of individual stones, displacement of mortar joints, loosening of stones, and bulging of walls greatly depends on good workmanship and is very difficult to characterize through numerical analysis. Therefore, numerical analysis only attempts to focus on a global failure mode of masonry.

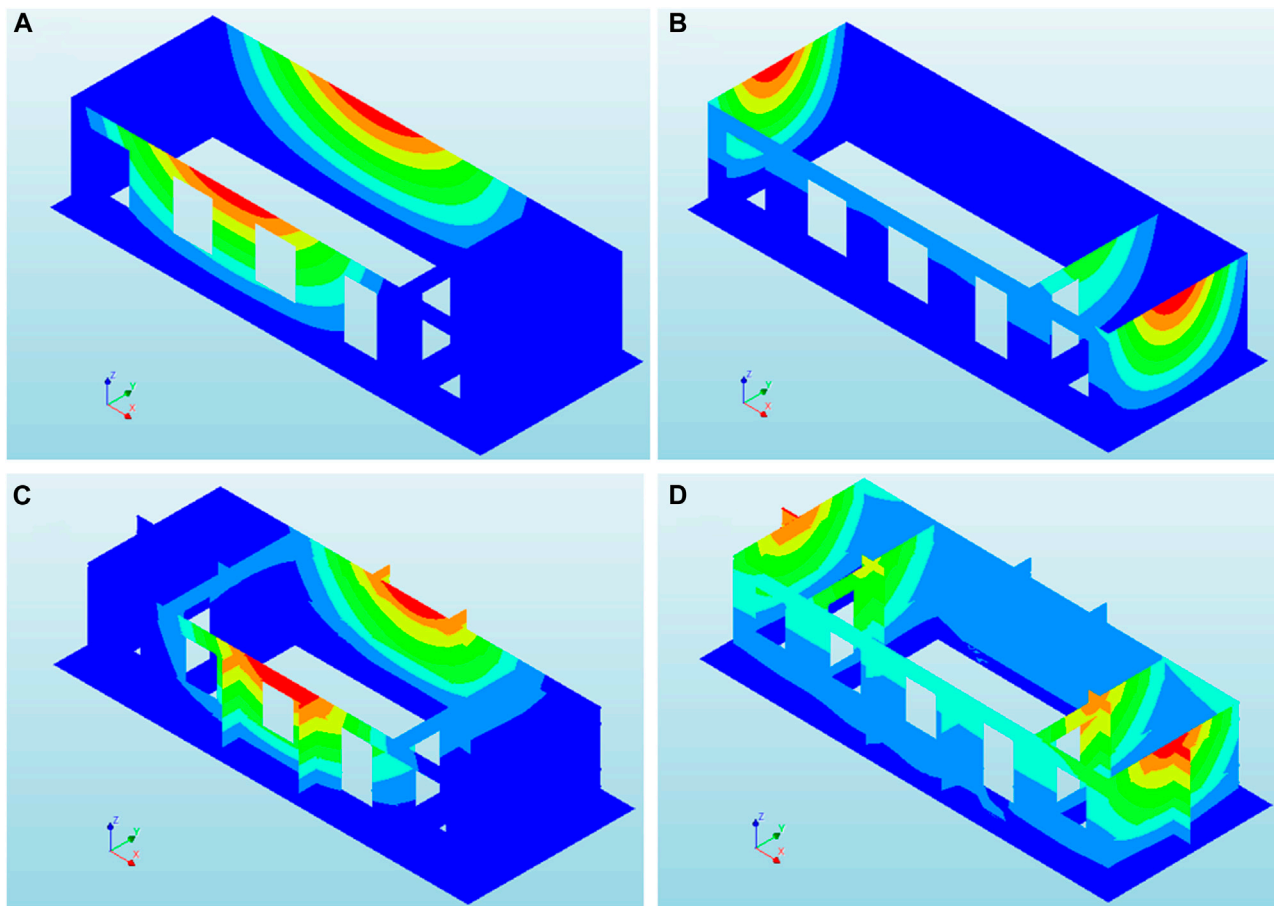
FIGURE 11
Fundamental mode shapes associated with bending (A) mode one transverse C_ISMB, (B) mode 3 longitudinal C_ISMB, (C) mode 1 transverse E_ISMB, and (D) mode 3 longitudinal E_ISMB.

Prior to the non-linear analysis, a model analysis was performed. The fundamental time period of the structure was found to be 0.216 s for C_ISMB and 0.155 s for E_ISMB, which confirms the high rigidity of the E_ISMB. The fundamental mode

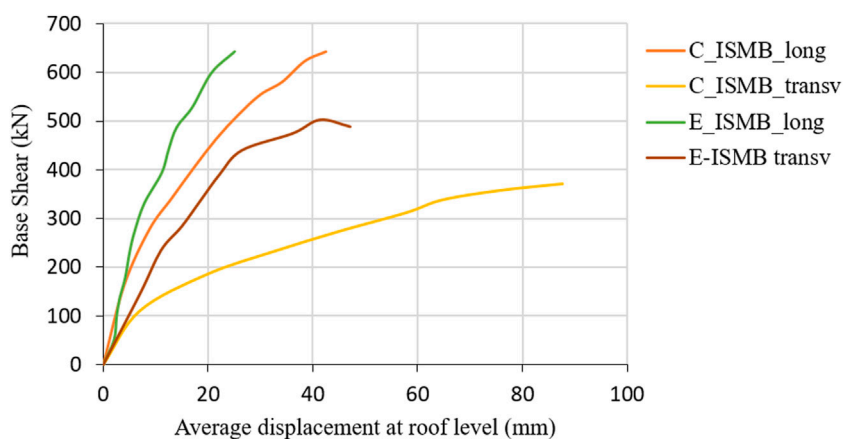
FIGURE 12
Capacity curves in the two-loading direction for C_ISMB and E_ISMB.

The introduction of timber bands and wall buttresses (i.e., E_ISMB) showed significant building improvement under lateral loading. [Figure 12](#) C_ISMB showed slight failure at the lateral load at approximately 200 kN, whereas E_ISMB showed slight failure at the lateral load at approximately 410 kN. In C_ISMB, the whole wall height was engaged by the collapse mechanism at a lateral load of 370 kN, but in the same case in E_ISMB, cracks started to develop in the corner of buttresses and walls. The presence of the buttress delayed the activation of the out-of-plane mechanism and showed a lateral capacity of approximately 642 kN before failure occurred. The lower time period of E_ISMB signified that the structure was stiff because of the presence of buttresses. The long wall of C_ISMB was more vulnerable as the wall was significantly deflected under a lower lateral load.
