CITATION
Nqasha T, Akombelwa M, Singh M and Kijko A
(2025) Review and characterization of the
2014 Orkney damage datasets for damage
pattern mapping and fragility curve
construction.
Front. Built Environ. 10:1524618.
doi: 10.3389/fbuil.2024.1524618

Review and characterization of the 2014 Orkney damage datasets for damage pattern mapping and fragility curve construction

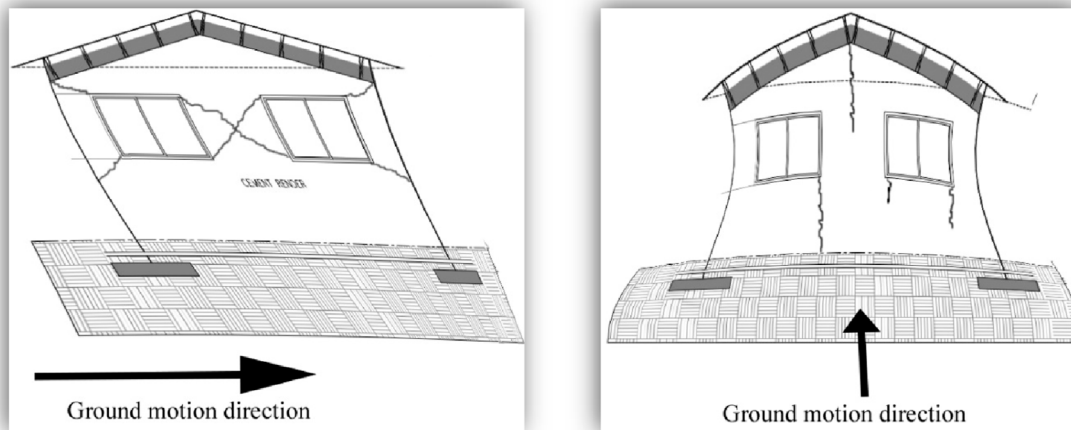
FIGURE 4
Typical deformation of masonry building walls due to earthquake loading: left) in-plane deformations; and right) Out-of-plane deformations.

During an earthquake, low-rise URM building walls can generally experience either in-plane or out-of-plane forces (Nochebuena-Mora et al., 2023). When the movement is in-plane, shear walls may develop diagonal cracking (Figure 4 left). If these cracks extend to the corners and create a kinematic mechanism, the situation can become critical and lead to failure (Ortega et al., 2018). For out-of-plane motion, the response is similar to the response of during wind loading, tension cracks are observed in form of vertical cracks (Figure 4 right), if the loading is significant, the walls may fall out (Ortega et al., 2018). In areas with scarce resources or old buildings that were constructed prior to the 1970s, the structures are often not designed to withstand the strains caused by earthquakes, leading to the collapse of masonry-style construction and resulting in thousands of fatalities (Işık, 2023; Vlachakis et al., 2020). Unreinforced masonry is considered the most unsuitable type of structure for earthquake-prone regions.

Certain features make URM buildings vulnerable to earthquake damage, including poor mortar, weak load and non-load bearing walls, lack of vertical confining elements, poorly supported wall openings, inadequate brick strength, and heavy and stiff structural design. The weight of the roofs and roof beams of these buildings is supported by brick walls (Figure 2). During an earthquake, masonry walls have to transfer the earthquake load from the foundation to the roof. If the load-bearing walls of the building are stiff and weak, then the building will most likely experience damage (Kaya et al., 2023; Ma et al., 2021). This is typically depicted by pushover curves; these curves depict the relationship between base shear and roof displacement in a structure (Figure 5). These curves are instrumental in assessing how a structure responds to seismic forces and evaluating the seismic vulnerability of unreinforced masonry (URM) buildings. Common damage patterns associated with seismic vulnerability include diagonal and vertical cracking (Figures 4, 6) (El-Maissi et al., 2022). Structures exhibiting

Poorly unsupported wall openings such as windows and doors present unavoidable weak points, and that is where most of the damage starts to occur (Figures 4, 6). Doğangün et al. (2008) noticed a pattern of damage in URM buildings in Turkey caused by earthquakes between 1992 and 2004. Most of the damages were cracks propagating from structural openings such as windows and doors. When the actual stresses in bricks exceed their design strength, then these brick units become weak points of the structure and may fail when subject to earthquake loading.

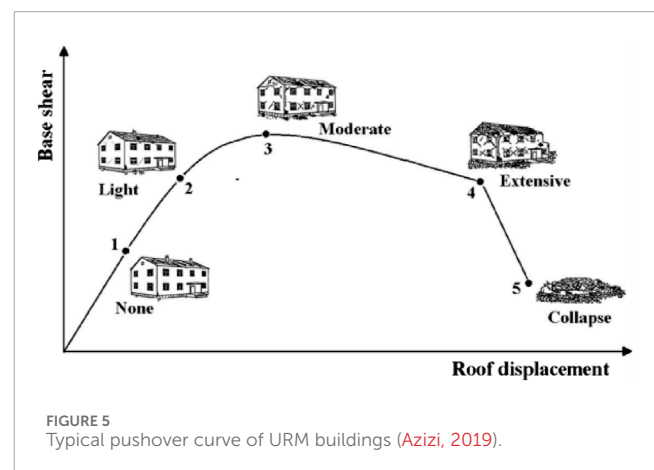
FIGURE 5
Typical pushover curve of URM buildings (Azizi, 2019).

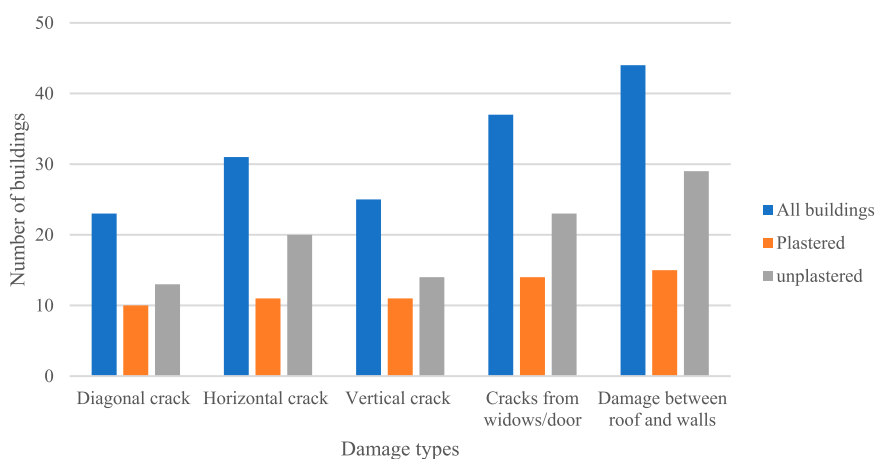
FIGURE 7 Common observed damages after the 2014 Orkney earthquake.

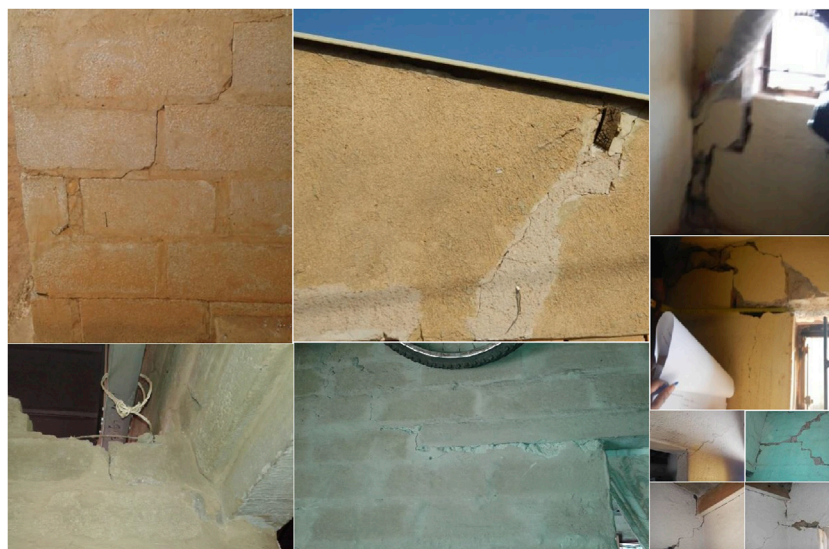
FIGURE 8
Diagonal cracks observed in low-cost URM buildings after the 2014 Orkney earthquake.

After these questionnaires that were used to capture details about the damage and images were analysed, the most observed types of damages captured following the 2014 Orkney earthquake included, diagonal cracks (Figures 7, 8), horizontal cracks (Figure 9), vertical cracks (Figure 10), cracks at window/ door frames and cracks between the walls and the roof (Figures 7–10). The most observed type of damage were damages between the roof and walls. Some of the buildings were un-plastered and some were plastered; most of the damages were observed in unplastered buildings.

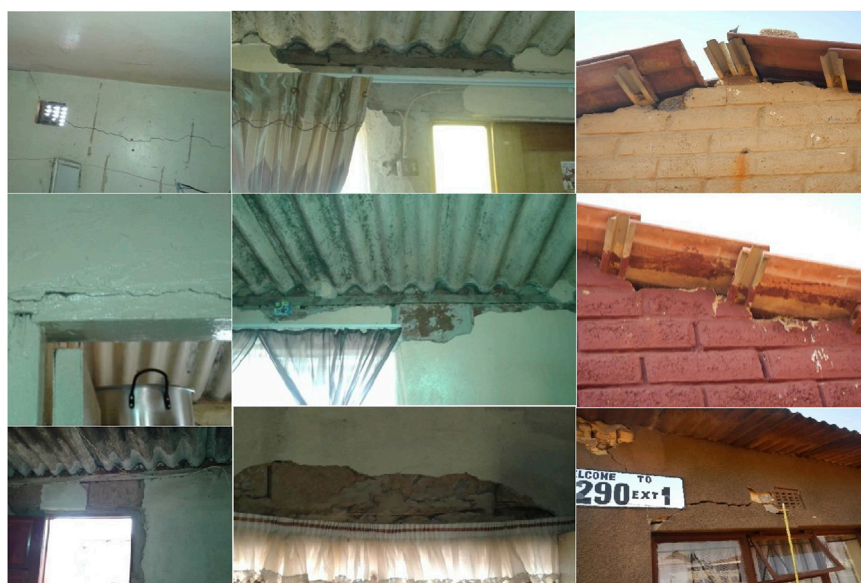
FIGURE 9
Horizontal cracks observed in low-cost URM buildings after the 2014 Orkney earthquake.

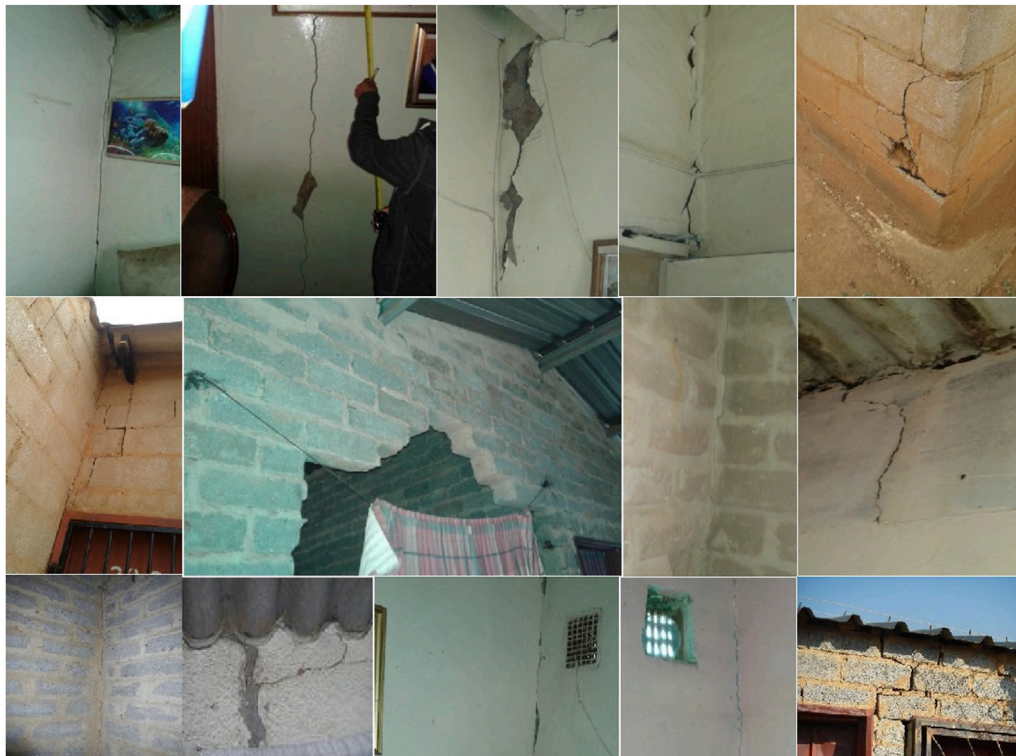
FIGURE 10
Vertical cracks observed in low-cost URM buildings after the 2014 Orkney earthquake.

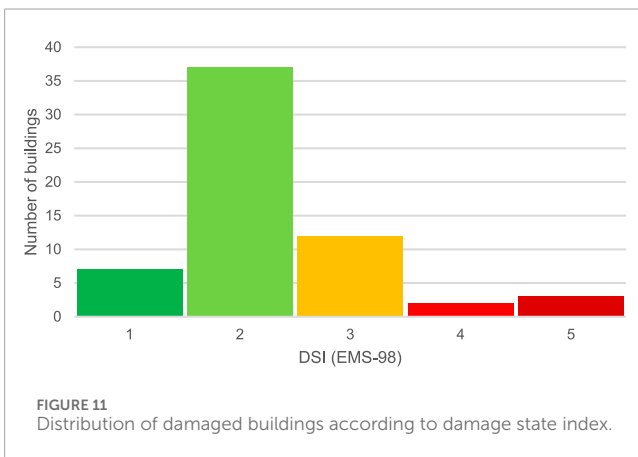
FIGURE 11
Distribution of damaged buildings according to damage state index.

The observed damages were measured using the EMS-98 damage scale. After the damage was assigned using the EMS damage scale, the majority of buildings had a damage state index (DSI) of 2, while the maximum damage had a DSI of 5 (Figure 11). As stated

in Chapter 2, buildings with DSI of 1 and 2 are considered safe for occupation; hence, a total of 44 buildings are safe for occupation while 12 buildings would need further investigation and a total of 5 buildings are considered unsafe for occupation.

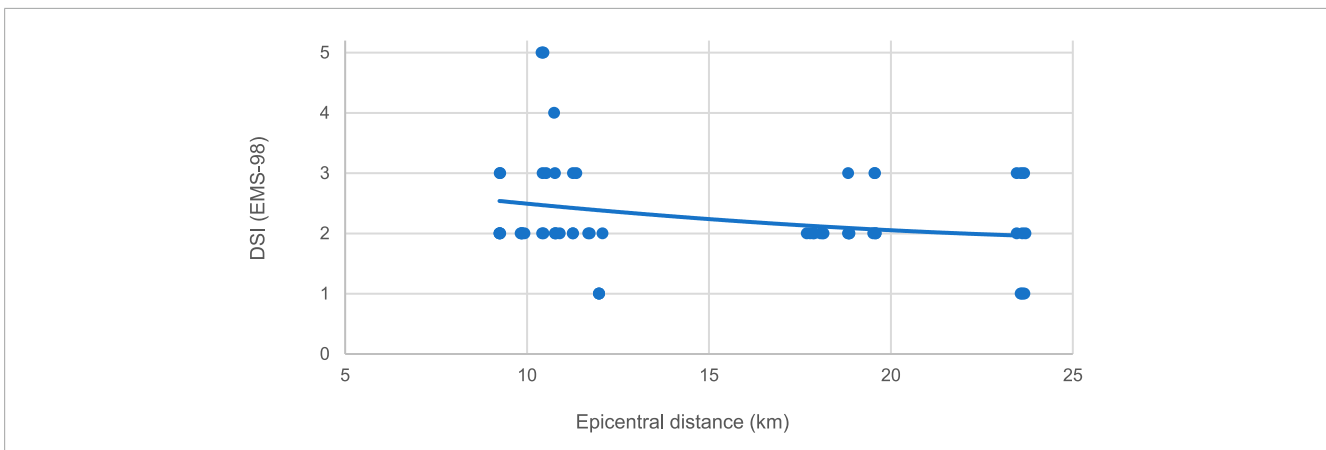
FIGURE 13 Effects of epicentral distance level on damage state index.

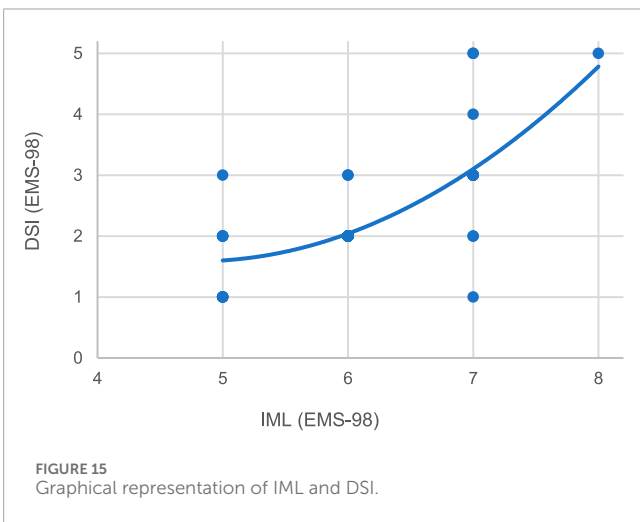
FIGURE 15 Graphical representation of IML and DSI.

IML and DSI is plotted in Figures 14, 15 to gain understanding of seismic shaking on observed damage in URM buildings. Buildings that had higher IML experienced significantly higher damage; all the buildings that collapsed (DSI = 5) had an IML range of VII-VIII (Figures 14, 15). Overall increases in IML results is an increase in DSI. However, similar to Figure 13, this trend does not account for buildings that were not damaged, which significantly reduces the reliability and validity of the trendline.

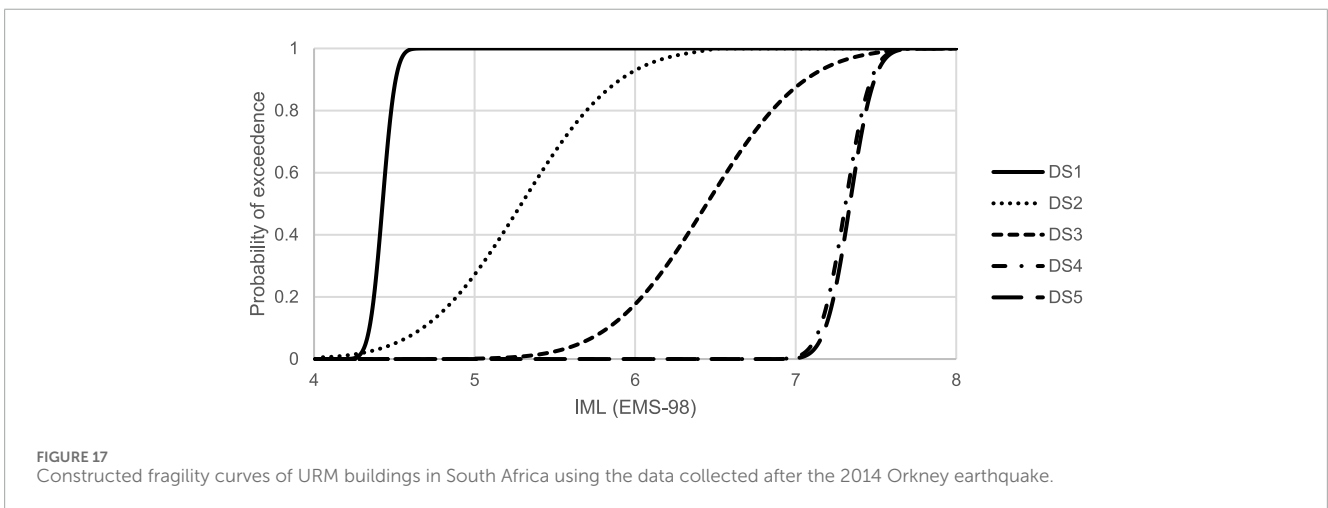
The effect of the weighted mean per IML, combined with the exclusion of buildings with a DSI of 0, resulted in significantly higher probabilities of exceedance (Figure 17). The probability of exceedance increased with increasing IML for all DSI levels. According to Figure 17, the probability of reaching or exceeding DS1 reaches 1 at IML 5, indicating that all buildings with an IML of 5 will have at least DS1. Similarly, the probability of reaching or exceeding DS2 reaches 1 at IML 7. Maximum probabilities are observed at IML 8 for all DSI levels, suggesting that all buildings experiencing seismic shaking at IML 8 will undergo total collapse. However, this can be cross-verified with Figures 12, 14. These figures show numerous buildings with an IML of 7 that were not reported as damaged. According to the generated fragility curves, these buildings should have at least DS2, indicating that the fragility curves are unreliable and invalid. This highlights the importance of including all buildings in the study area, including undamaged ones, for constructing reliable fragility curves.
