Formation-Evolutionary Mechanism Analysis and Impacts of Human Activities on the 20 August 2019 Clustered Debris Flows Event in Wenchuan County, Southwestern China

Keywords: debris flow, formation mechanism, supply condition, dynamic evolutionary process, human activities

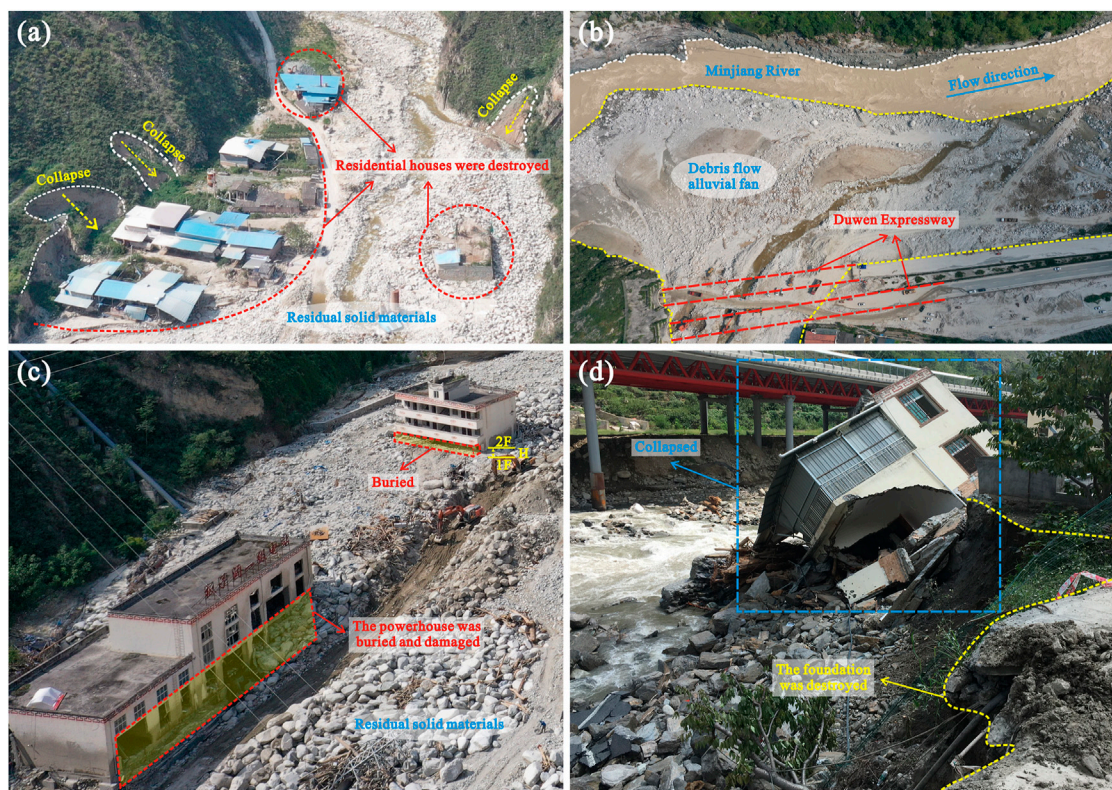
FIGURE 3 | Damage caused by debris flows in the “8-20” event: **(A)** buried houses in Banzi Gully; **(B)** the blocked Minjiang River and destroyed traffic facilities at the mouth of the Dengji Gully; **(C)** damage to the Banzi Gully Grade I Hydropower Station; and **(D)** destroyed buildings along the Minjiang River.

hydropower stations were seriously damaged (Figure 3). Furthermore, some debris flows transported large amounts of solid material into the Minjiang River thereby causing a partial blockage or forming a debris dam, resulting in a series of secondary disasters (Figure 3B). This event caused substantial economic losses (approximately 3.4 billion RMB) and heavy casualties (48,862 people were displaced, 16 people died, and 22 people went missing).

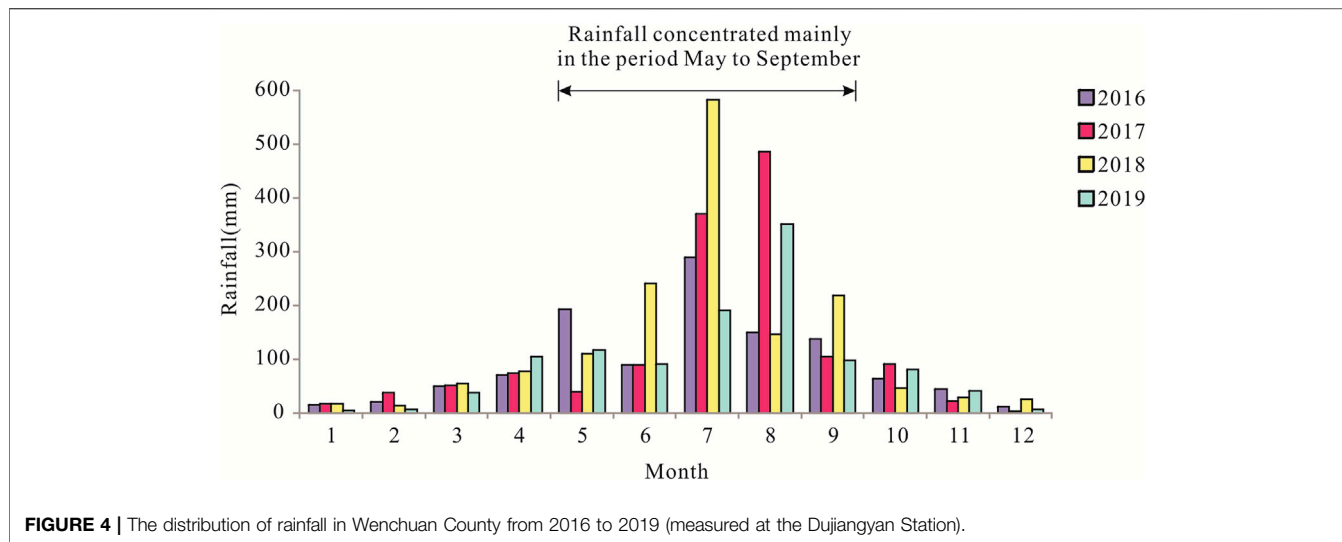
FIGURE 4 | The distribution of rainfall in Wenchuan County from 2016 to 2019 (measured at the Dujiangyan Station).

1,190.9 mm and the precipitation is unevenly distributed from month to month. As shown in **Figure 4**, the rainfall varies considerably during the monsoon and dry seasons. Moreover, the annual precipitation is mainly concentrated in the period from May to September.

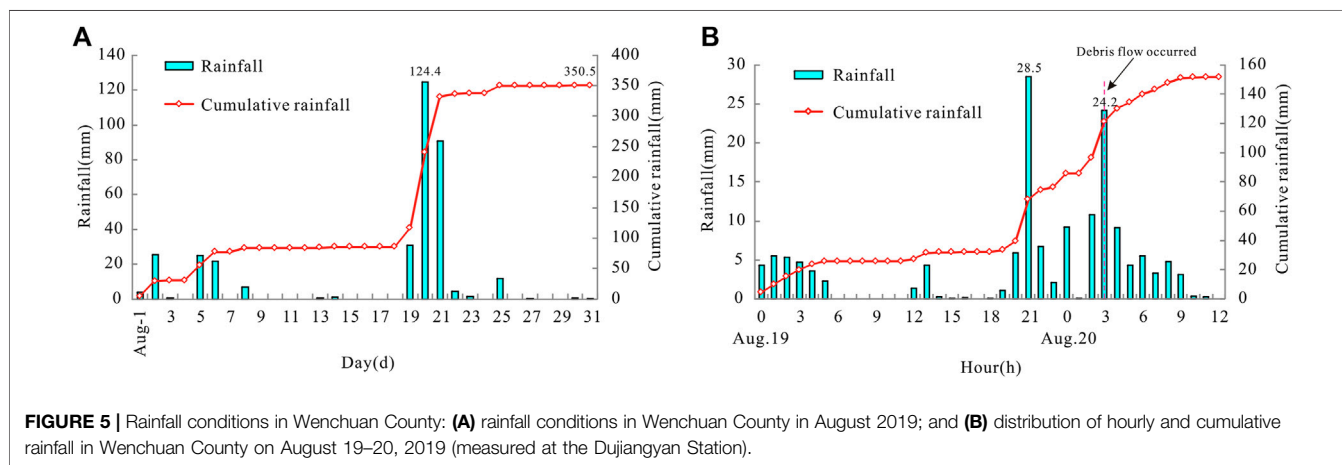
FIGURE 5 | Rainfall conditions in Wenchuan County: **(A)** rainfall conditions in Wenchuan County in August 2019; and **(B)** distribution of hourly and cumulative rainfall in Wenchuan County on August 19–20, 2019 (measured at the Dujiangyan Station).

Figure 5A illustrates the daily rainfall history in the study area in August 2019. The monthly total rainfall in August was 350.5 mm. Of this amount, the rainfall on August 20 was the largest (124.4 mm), reaching the rainstorm level. From 02:00 on August 19 to 14:00 on August 22, a heavy storm occurred in Wenchuan County, where there were 12 stations with accumulated rainfall over 100 mm and five stations with rainfall over 200 mm, and the maximum accumulated rainfall was 332.6 mm at the Shouxu Sanjiang station. According to the

rainfall data from the Dujiangyan surface meteorological station presented in **Figure 5B**, the rainstorm that triggered the “8.20” clustered debris flows event started at approximately 20:00 on August 19 and ended at approximately 09:00 on August 20, and the accumulated rainfall amount was 117.6 mm. The maximum hourly rainfall intensity was 28.5 mm, which occurred at 21:00 on August 19. The accumulated precipitation and rainfall intensity that triggered the debris flow were 87.5 and 24.2 mm/h, respectively, which were recorded at 03:00 a.m. on August 20, 2019.

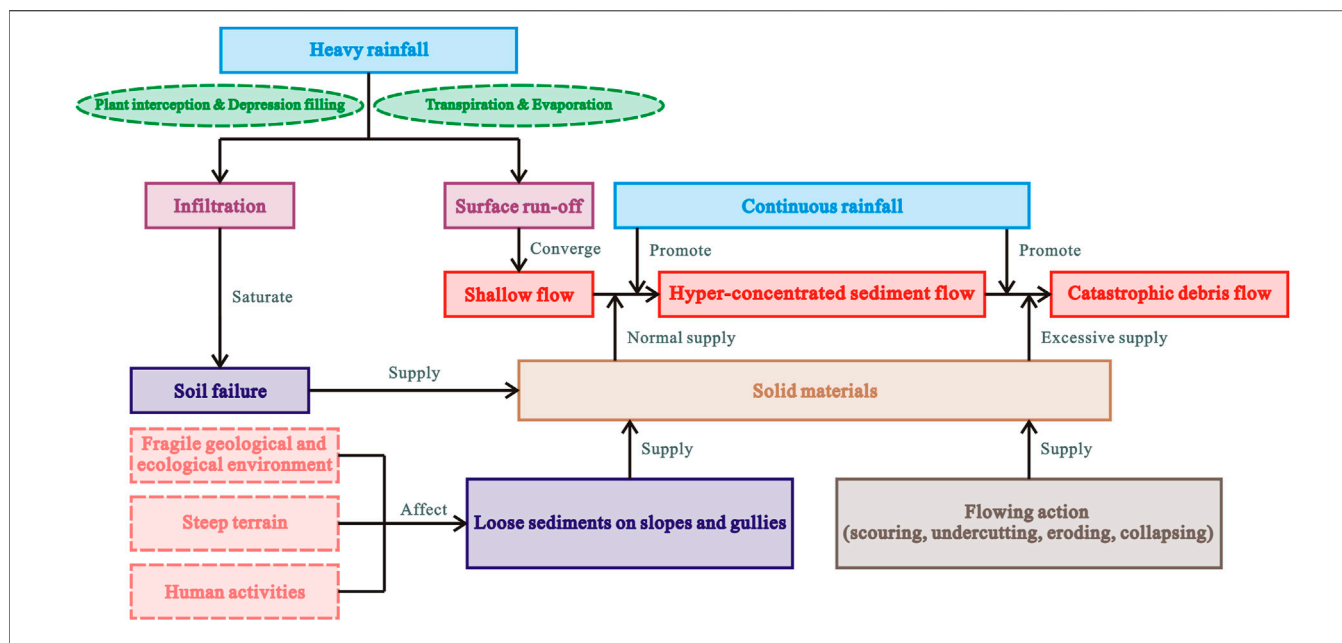
FIGURE 6 | Analysis of the formation and dynamic evolutionary mechanism of the debris flow disaster in southwestern China.

As shown in **Figure 6**, the formation of a debris flow is very complicated and mainly includes basin hydrological processes, rainfall infiltration processes, soil instability and failure processes, slope and gully erosion processes, solid material supply processes, and soil-water coupling processes. The rainwater falling into the basin produces surface run-off and underground run-off after a series of processes, such as evaporation, plant interception, depression filling, and infiltration. However, there are mostly

The hazard pattern changes with the dynamic evolution of disasters. As shown in Figure 6, the formation and development of a catastrophic debris flow event is a result of the sufficient and continuous interaction of water and sediment. Indisputably, abundant antecedent rainfall provides hydrodynamic conditions for the formation of debris flow, triggering the movement of loose solid material (Tang et al., 2011b; Guo et al., 2016; Hu et al., 2016). Furthermore, the rapid flow ceaselessly incorporates a supply of new solid material through new landslides and collapses, slope-rill erosion, and channel-bed erosion. Consequently, the ratio of sediment to water is constantly increasing, and finally, when the flow density is larger than 1.3 g/cm^3 (Institute Of Mountain Hazards And Environment, 2000), it turns into a debris flow. As a result of the oversupply of loose material, the scale, velocity, and transportation capacity of the debris flow continue to increase, consequently producing tremendous destructive power. In addition to the characteristics of a simultaneous occurrence, rapid movement, and strong destructive impact, the field investigation also found that the “8-20” clustered debris flows event presented an extremely apparent chain of disaster effect.

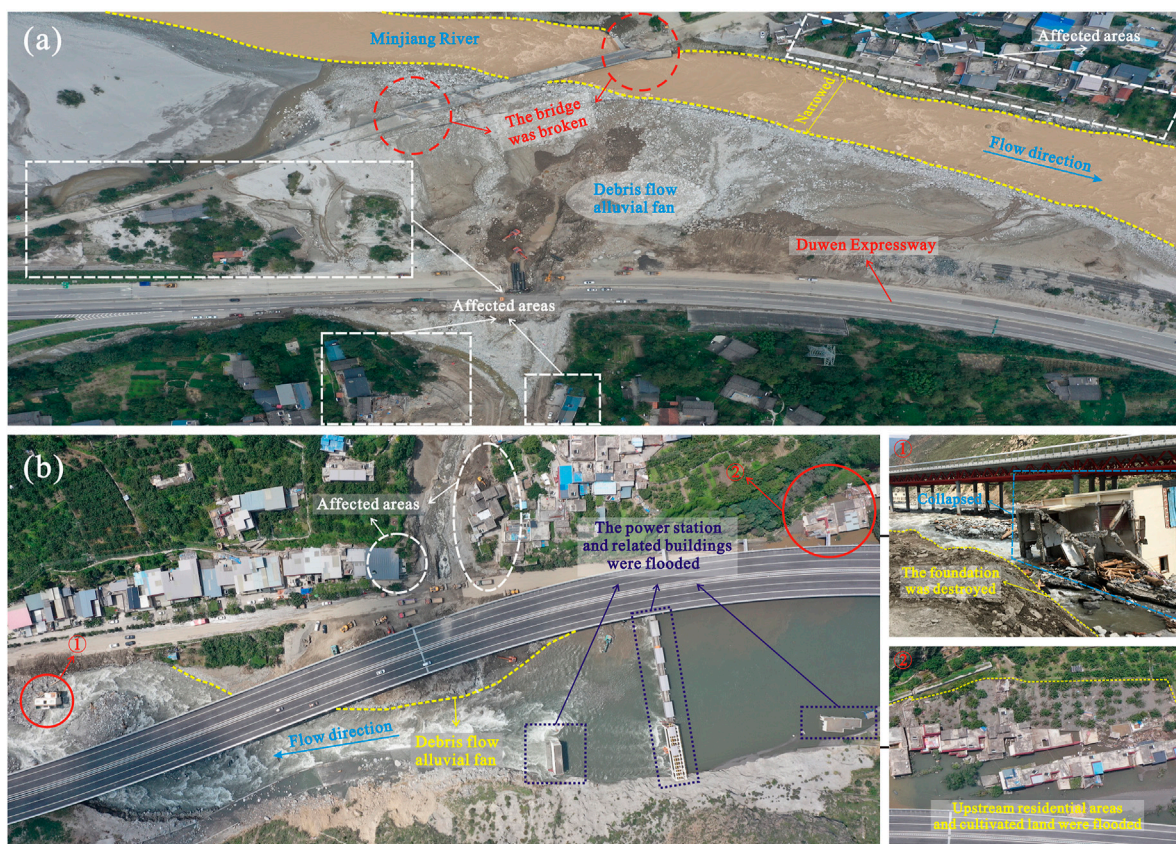
FIGURE 8 | Extrusion of the channel caused by the alluvial fan from the debris flow and the typical disaster characteristics: **(A)** blockage of the Minjiang River and long-distance abnormal scouring to the opposite bank caused by the alluvial fan at the mouth of the Cutou Gully; and **(B)** severe flood disaster caused by the alluvial fan at the mouth of the Chayuan Gully.

The field investigation has shown that the severe flood disaster caused by the debris flow, which poured into the Minjiang River and blocked the river partially or completely, is another factor in the disastrous outcome. Affected by heavy rainfall, many rivers in Wenchuan County suffered major floods or even extraordinary floods. According to the statistical results in recent years, the two main tributaries of the Minjiang River, the Caopo River Basin and Shouxu River Basin, reached a peak discharge of 573 m³/s with a return period of more than 100 years and 1,860 m³/s with a 50-years return period, respectively. The debris flow transported a large mass of solid material into the Minjiang River, forming debris-flow alluvial fans, thereby blocking the river. Therefore, the flow area of the river decreased rapidly, causing the water level in the upper reaches to rise sharply and the velocity and erosion potential of the flood to increase (Liang et al., 2001; Yanites et al., 2006; Liu et al., 2016). As shown in Figure 8, farmland, houses, transportation routes, hydropower stations, and other important infrastructure in the upper reaches were completely submerged by flooding caused by the debris-flow alluvial fan blocking the Minjiang River. Moreover, since the debris-flow alluvial fan forced flooding to divert to the opposite bank, which developed long-distance abnormal scouring downstream, the foundations

of the houses near the riverbank were damaged, resulting in the collapse of several houses, as shown in **Figure 8B**.
