Analysis of Failure Models and Deformation Evolution Process of Geological Hazards in Ganzhou City, China

This article was submitted to
Geohazards and Georisks,
a section of the journal
Frontiers in Earth Science

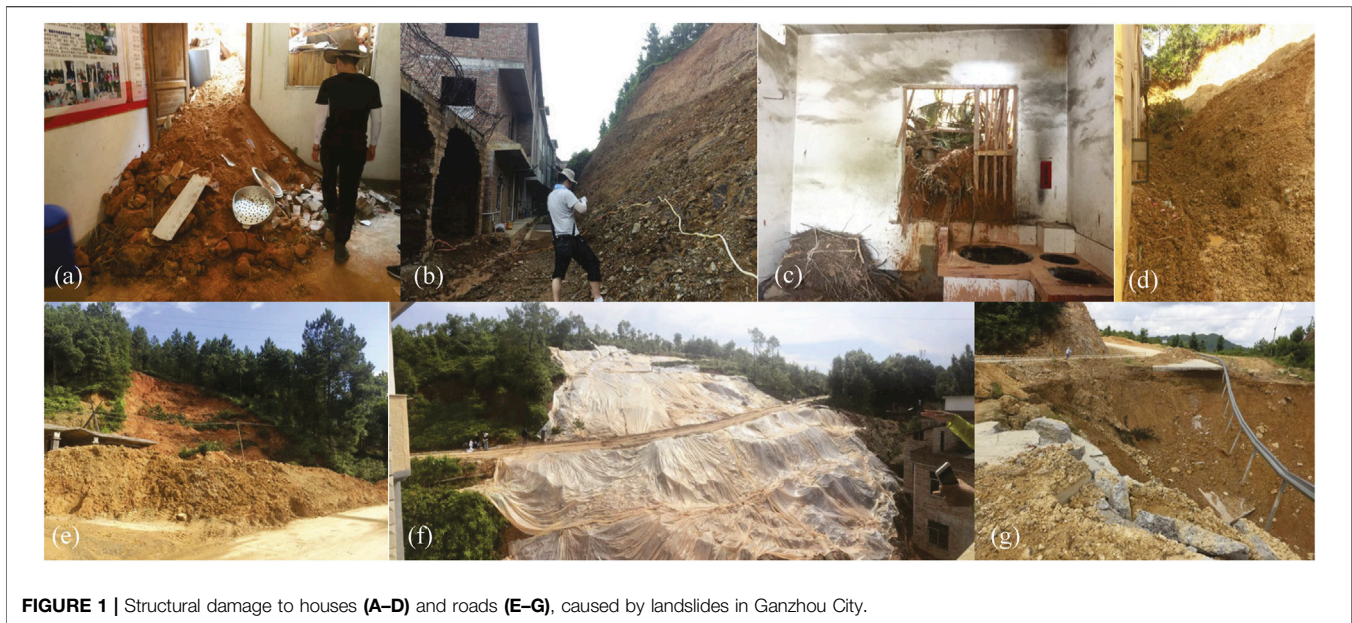
FIGURE 1 | Structural damage to houses (A–D) and roads (E–G), caused by landslides in Ganzhou City.

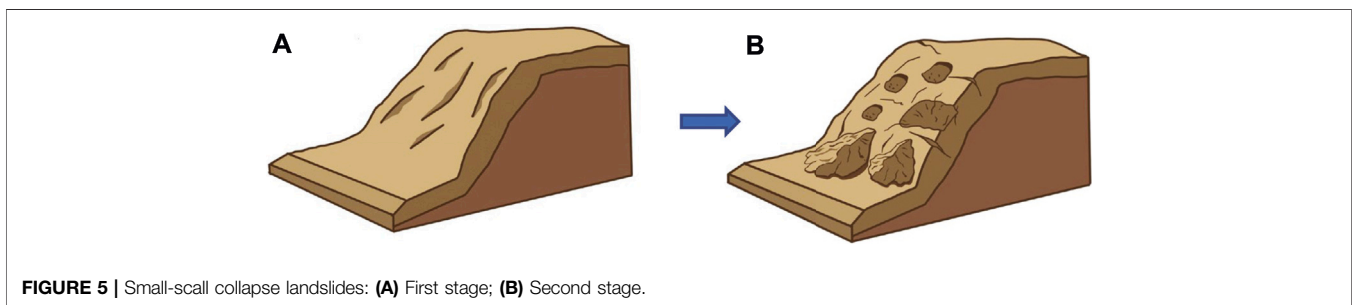
FIGURE 5 | Small-scale collapse landslides: **(A)** First stage; **(B)** Second stage.

- 1) Owing to artificial slope cutting, the slope surface is unloaded and tension fissures appear (**Figure 5A**).
- 2) Under continuous rainfall, rainwater infiltrates the slope, and the weight of the soil increases. The softening of the soil decreases its shear strength, which causes the slope to slip along the underlying bedrock towards the free direction, eventually forming scattered deposits of collapsed soil (**Figure 5B**).

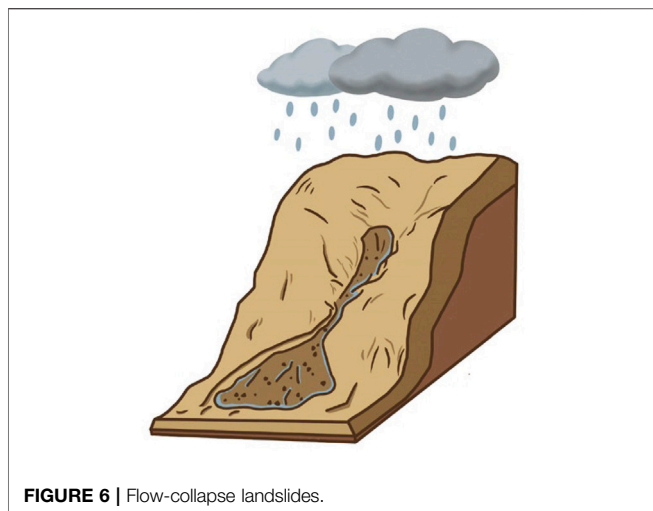
FIGURE 6 | Flow-collapse landslides.

In the study area, flow-collapse landslides occur mainly on fully weathered granite, slate and phyllite slopes. These slopes are steep, more than 15 m high, and formed on a thick weathering mantle with a loose, cohesive soil of low permeability. The slope failure mechanism is shown in **Figure 6**.

Under continuous heavy rainfall, the soil reaches a state of supersaturation with water, and its shear strength is greatly reduced. The upper soil collapses and disintegrates, and the loose collapse debris mixes with water to form a debris flow. Soils slide rapidly down the steep slope, forming a flow landslide that travels at a distance of more than 50 m. Such collapse events can cause significant long-range damage.

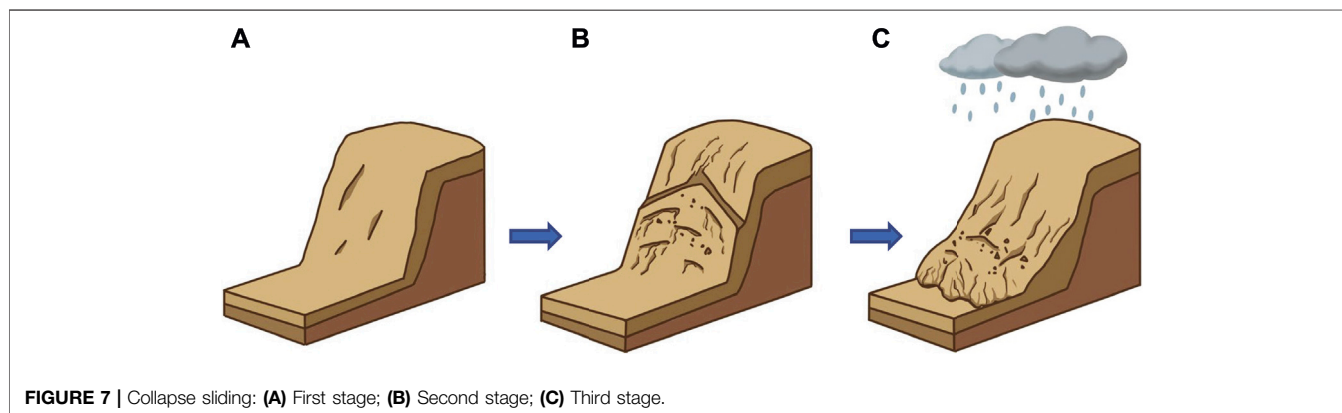
FIGURE 7 | Collapse sliding: (A) First stage; (B) Second stage; (C) Third stage.

- 1) Unloading fissures appear on the surface of steeply inclined, natural or artificial slopes due to the decrease in soil weight (**Figure 7A**).
- 2) As slope erosion progresses, unloading fissures link with structural joints (**Figure 7B**).
- 3) The fissured soil collapses under heavy rainfall. The collapsed soil impacts loose soil at the lower part of the slope, resulting in the sliding of the loose soil (**Figure 7C**).

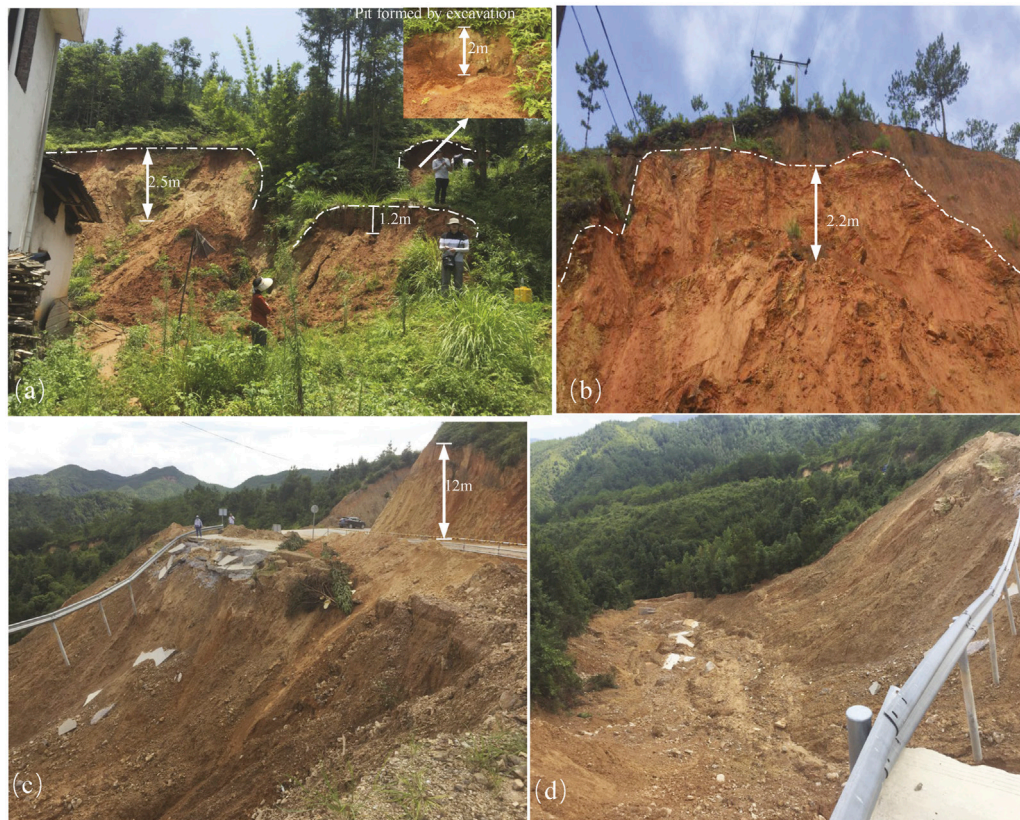
FIGURE 8 | (A) Small-scale collapse landslide on a weathered granite slope behind a house in Qixia Village, Ganzhou City. **(B)** Collapse landslide on a steep slope on weathered granite, behind the Dinglong Village Committee House, Ganzhou City. **(C,D)** Steep, high slope on metamorphic rock next to the Kuantian County Road (Ganzhou City), which was damaged by a flow-collapse landslide.

A small-scale collapse landslide was located behind the Tunixia residential house in Qixia Village, Ganzhou City. The bedrock was coarse-grained porphyritic biotite monzonitic granite, covered by an approximately 1–3-m-thick layer of cohesive soil. This soil underwent continuous deformation during the rainy season, and some of it collapsed (**Figure 8A**).

slope soil slid downward, initiating a mudflow that destroyed the nearby highway. The trailing edge of the landslide was completely emptied, forming an approximately 15-m-high scarp. The mudflow spread over a distance of more than 400 m, and the fan-shaped debris accumulation at its lower part was approximately 40 m. This landslide affected approximately 30 m of the highway (Figures 8C,D).

constructed, the slope was cut and its gradient was steepened. On July 10, 2019, during a rainstorm, the slope suddenly failed, and the upper soil collapsed (**Figure 8B**).

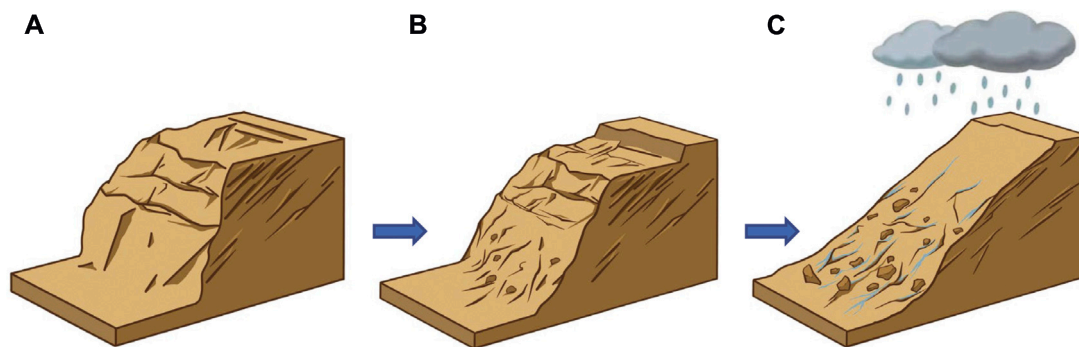
FIGURE 9 | Rock sliding along a bedrock stratum: **(A)** First stage, **(B)** Second stage, **(C)** Third stage.

1) One or two groups of dominant structural planes (joints, fissures, bedding planes) were present in the bedrock, inclined in the same direction as the slope, at an inclination lower than that of the slope (**Figure 9A**).

- 2) As a result of artificial slope cutting, the structural plane(s) and unloading fissures propagated in the outer part of the slope. The length and width of the fissures expanded, and the fissured bedrock blocks detached from the parent rock body (**Figure 9B**).
- 3) The proliferation of fissures leads to an increase in permeability. Rainfall infiltration reduces the shear strength of the structural surface and increases the weight of the rock mass. As a result, the slope failed along the structural surface. The front and back sections of the unstable slope disintegrated, due to the lack of support and traction during sliding. Most of the collapsed debris accumulated at the toe (**Figure 9C**).

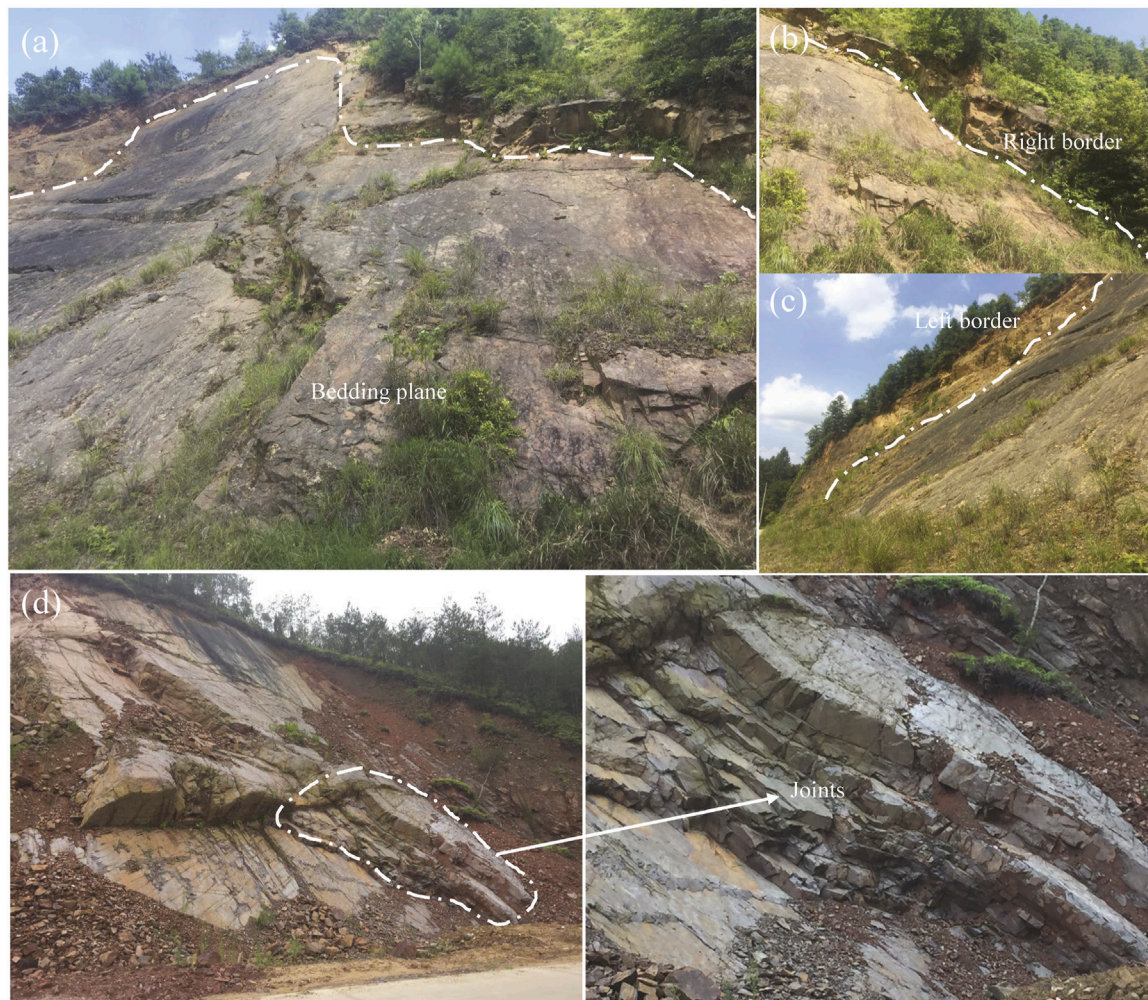
FIGURE 10 | Rockslides along a bedrock stratum in Ganzhou City: **(A–C)** Slope failure along a bedding plane in sandstone, X824 County Road. **(D)** Metamorphic slope near the Xinwuxiacun Village road.

feldspar quartz sandstone intercalated with shale. The landslide was located near a fault, and the bedrock was cut by dominant structural planes of tectonic origin. At this site, the weathering mantle slipped along such a structural plane after heavy rainfall (Figures 10A–C).

enlarged the tectonic joints and fissures in the bedrock. The rock blocks also collapsed along the dominant structural plane (Figure 10D).
