Influences of Spillway Section Morphologies on Landslide Dam Breaching

Yang M, Zhong Q, Mei S and Shan Y
(2021) Influences of Spillway Section
Morphologies on Landslide
Dam Breaching.
Front. Earth Sci. 9:799742.
doi: 10.3389/feart.2021.799742

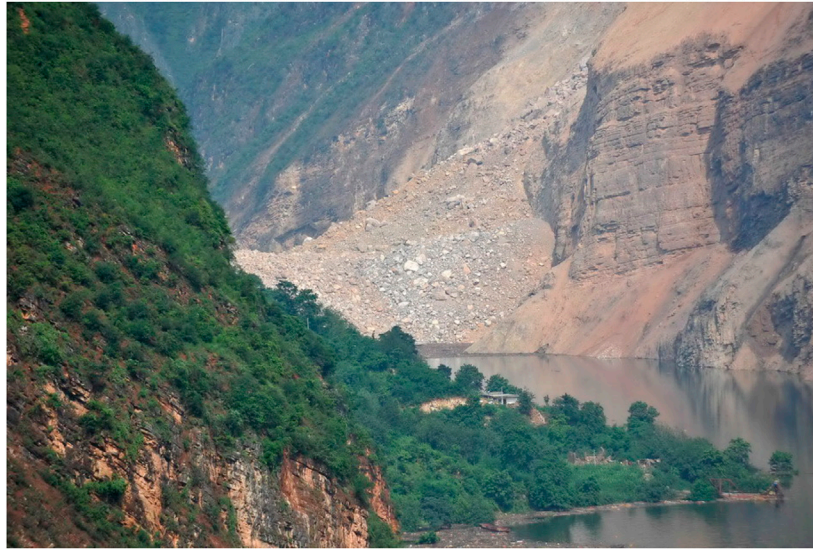
FIGURE 1 | Hongshiyuan landslide dam in China.

Landslide dam is formed by mass movements of rock and debris blocking the river channel due to earthquakes and intense rainfall (Costa and Schuster, 1988); **Figure 1** presents the Hongshiyuan landslide dam that occurred on August 3rd, 2014 in China. The landslide dam stability is usually related to grain-size distribution of landslide debris, landslide volume, and hydrodynamic conditions (Liao et al., 2019; Shan et al., 2020; Peng et al., 2021). Dissimilar to artificial dams, landslide dams do not have a structure that enables flood discharge (Zhong et al., 2021). The water level in the dammed lake increases eventually after the landslide dam formation due to the continuous inflow from the upstream; hence, overtopping is the most common cause of failure mode for the dam (Zhong et al., 2018).

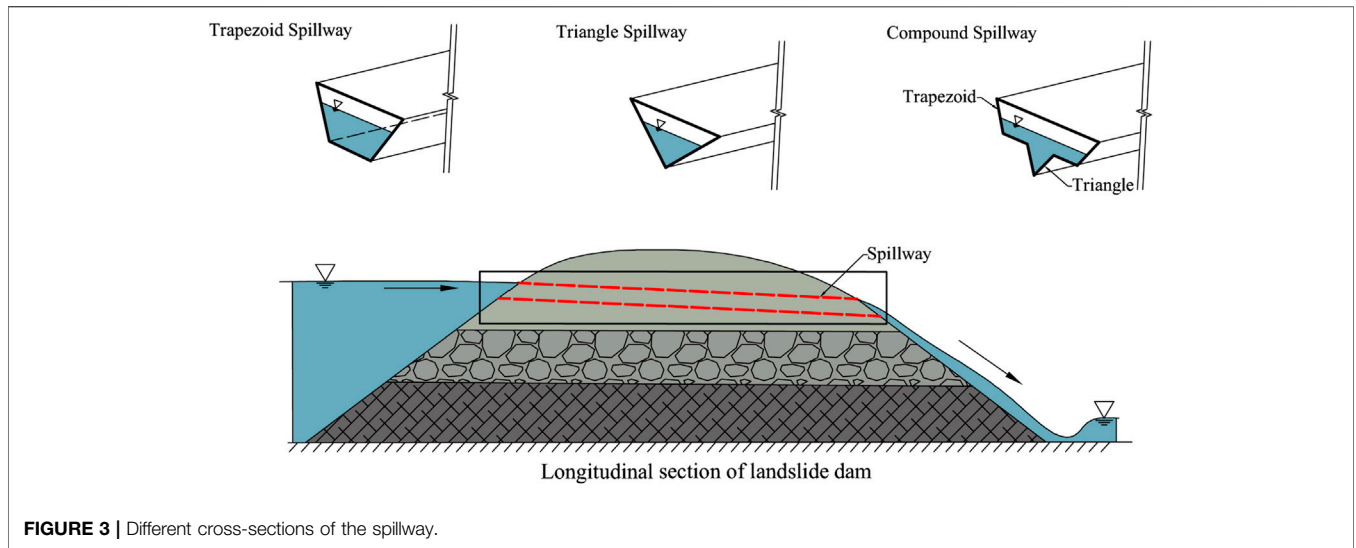
FIGURE 3 | Different cross-sections of the spillway.

The cross section of the spillways of the selected Tangjiashan, Xiaogangjian, and Baige landslide dams is all trapezoidal. Here, ten conditions of spillways are set to comprehensively reflect the influence due to the variations of the spillway on the breach process of landslide dams. The first condition is the actual situation on-site, which is expounded in the “Case studies” section. The second condition is set as the landslide dams without spillways. In addition, eight other conditions aim to highlight the effect of variations in depth (conditions 3 and 4), bottom width (conditions 5 and 6), slope ratio in cross section (7 and 8), and longitudinal section (conditions 9 and 10) are also set for the comparison. The morphological parameters of spillways for each condition are listed in **Table 3**.

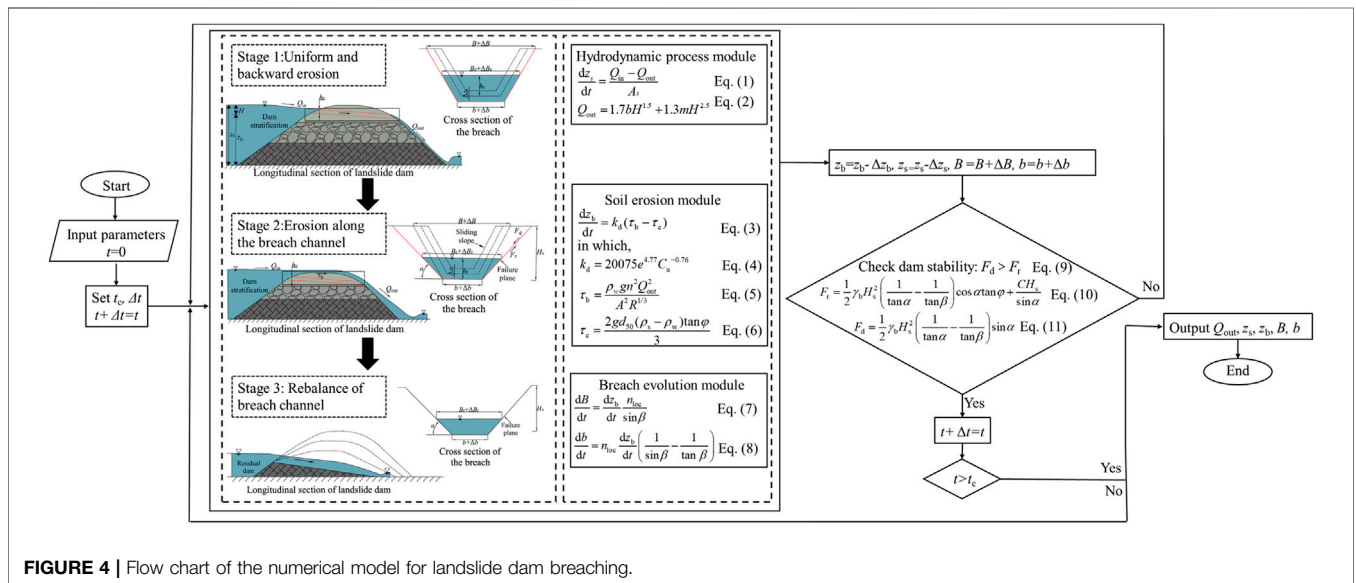
FIGURE 4 | Flow chart of the numerical model for landslide dam breaching.

Based on the breach process, a numerical model that can consider the hydrodynamic conditions of the dammed lake, the morphological, structural, and material characteristics of the landslide dam was proposed by Zhong et al. (2020a). The model consisted of three parts: the hydrodynamic process module, the soil erosion module, and the breach evolution module. The flow chart of the numerical model was created using the time step iteration-based calculation method to simulate the water and soil connection during the dam failure process is shown in **Figure 4**.

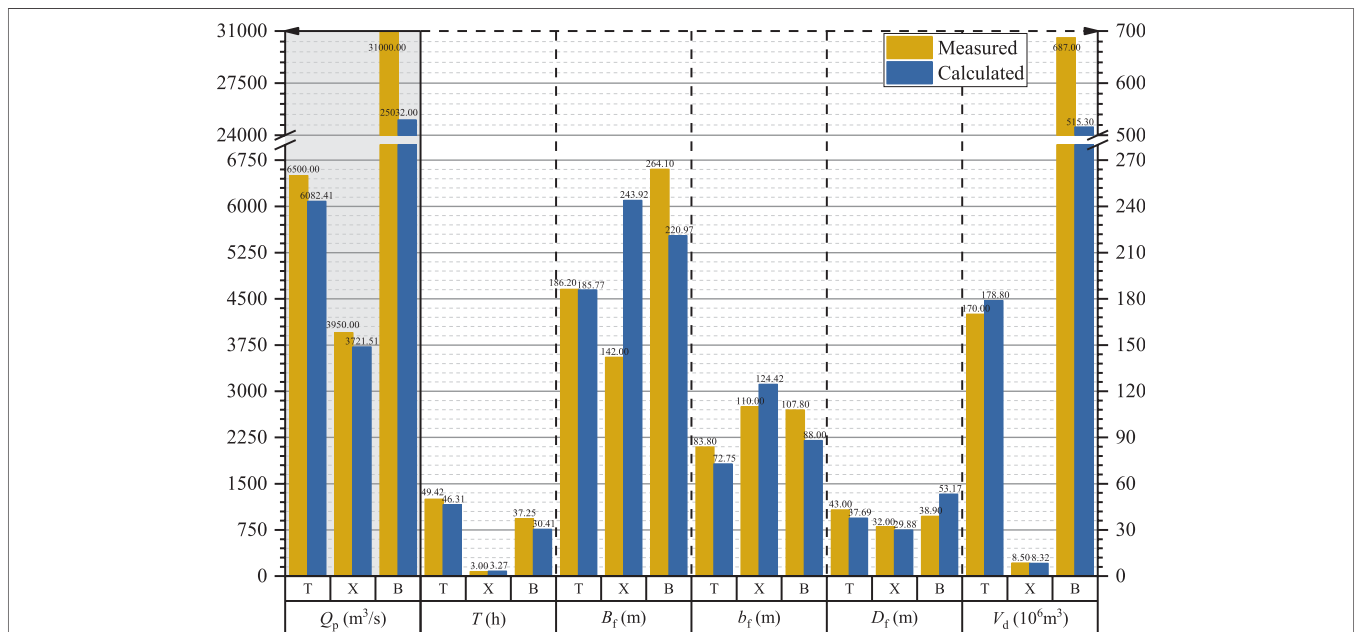
Based on the numerical model developed by the authors, the breach processes of the three cases have been simulated. The morphological, hydrodynamic, and mechanical parameters of the three landslide dams are listed in **Table 1**. The stratification of the landslide dams, physical and mechanical parameters of each layer are shown in **Table 2**. The comparison of measured and calculated breaching parameters (i.e., peak breach flow, time to peak, final breach top width, final breach bottom width, final breach depth, and released water storage) of the three landslide dams are shown in **Figure 5**.

The comparison in **Figure 5** shows that, for Tangjiashan landslide dam, the relative errors of all breaching parameters of are less than $\pm 15\%$; for Xiaogangjian landslide dam, except for the final breach top width has a relative error of 71.8%, the relative errors of all the other breaching parameters are less than $\pm 15\%$; for Baige landslide dam, except for the final breach depth has a relative error of 36.7%, the relative errors of all the other breaching parameters are less than $\pm 25\%$. As the top layer of
