Dai Z, Yang L, Zhang N, Zhang C,  
Zhang Z and Wang H (2023),  
Deformation characteristics and  
reactivation mechanism of an old  
landslide induced by combined action  
of excavation and heavy rainfall.  
*Front. Earth Sci.* 10:1009855.  
doi: 10.3389/feart.2022.1009855

# Deformation characteristics and reactivation mechanism of an old landslide induced by combined action of excavation and heavy rainfall

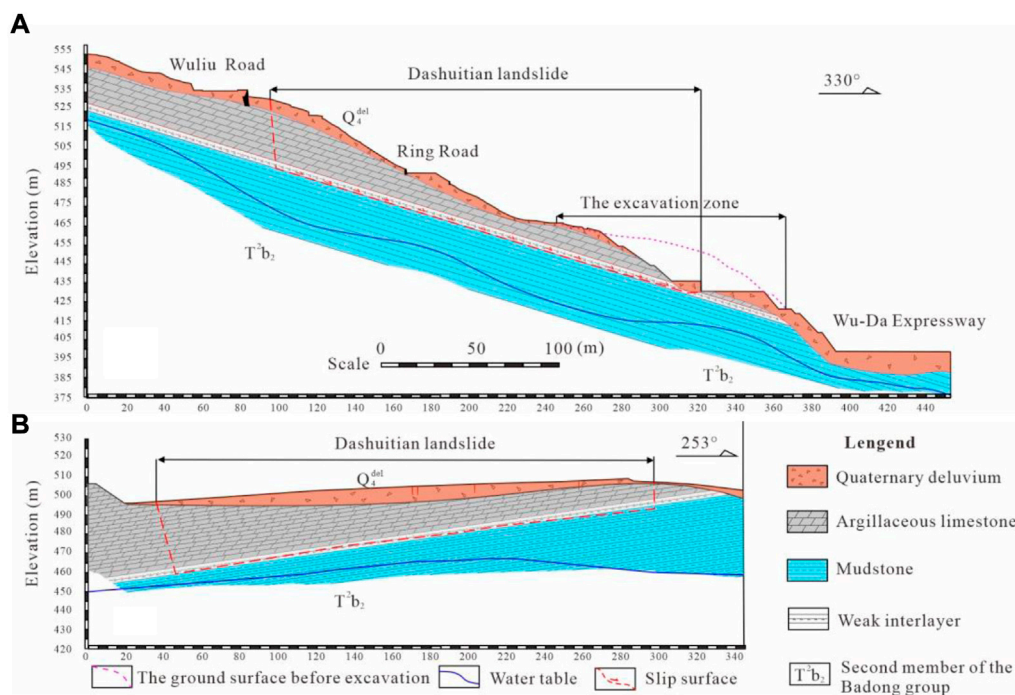
**FIGURE 3**

Cross sections (sections shown in Figure 2) of the Dashuitian landslide. (A)—Geological I-I' cross-section; (B)—Geological II-II' cross-section. The blue lines are the groundwater levels.

The sliding mass consists of Quaternary landslide deposits ( $Q_4^{del}$ ) and argillaceous limestone of the Middle Triassic Badong Formation ( $T_2b^2$ ). The composition of the sliding mass varies greatly in the vertical direction. The upper part is a thin layer of

gravel soil, and the lower part is a thick layer of broken limestone (Figure 3). Based on remote sensing images (Figure 1), the horizontal length of failed material is about 250 m, the maximum width is about 240 m, and the plane distribution area is about  $6 \times 10^4 \text{ m}^2$ . In addition, the field investigation and drilling data revealed that the sliding direction of the landslide is  $7^\circ$ , the average thickness of the sliding body is about 25 m, and the unstable volume is about  $150 \text{ m}^3 \times 10^4 \text{ m}^3$ .

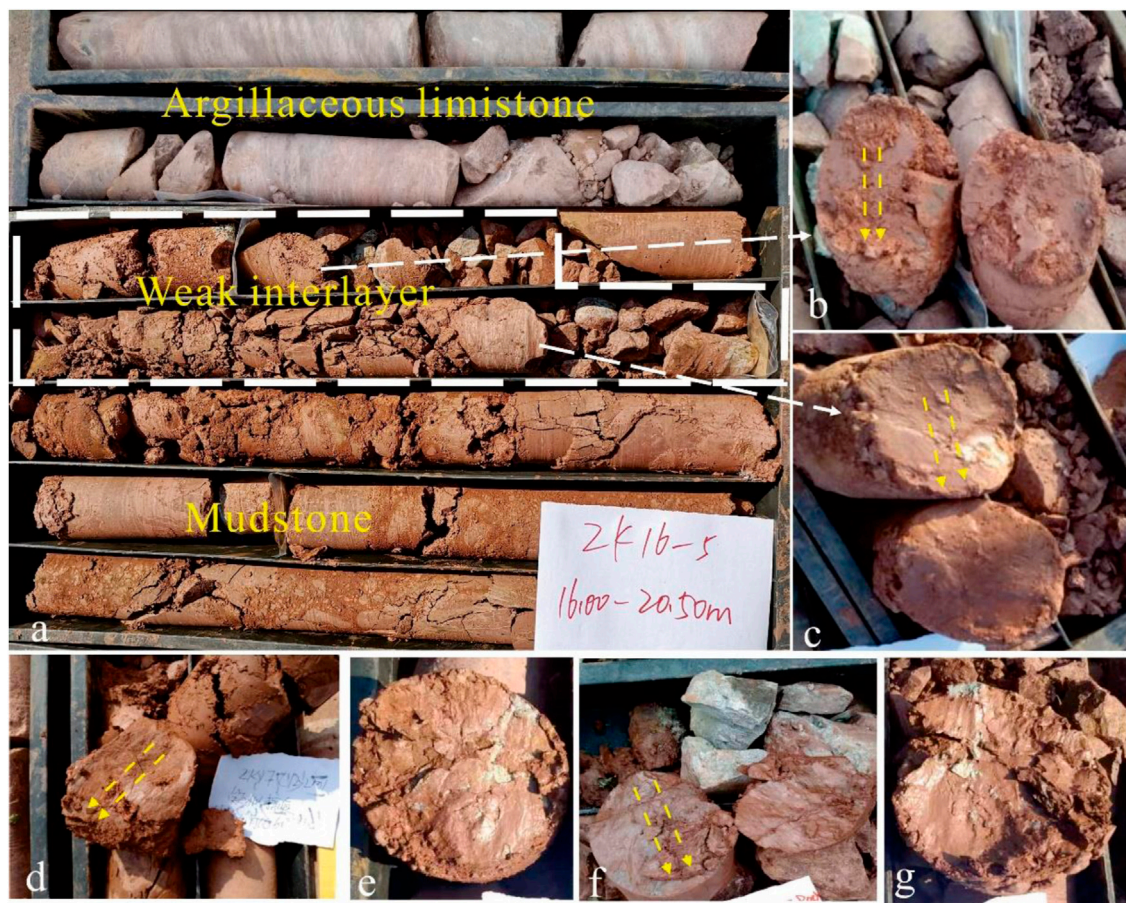
**FIGURE 4** (A) is a weak interlayer in the sliding zone composed of broken mudstone and argillaceous limestone, which is revealed in Zk16, located at 17.5–18.6 m with a thickness of 1.1 m; (B,C) are argillaceous limestone and weathered mudstone, as revealed in Zk16, with respective depths of 17.7 m and 18.1 m; and (D–G) are revealed in Zk3, Zk7, Zk8 and Zk9, respectively, and contain many polished surfaces and slickensides.

The sliding zone occurs at depths of 7.5 (Zk6) to 32.9 m (Zk1) and is the contact zone between the argillaceous limestone and mudstone of the Middle Triassic Badong Formation ( $T_2b^2$ ) with a thickness of about 0.8–1.3 m (Figures 4A–C). The dip angle of the sliding surface is about  $17\text{--}25^\circ$  and exhibits characteristics of deep burial depth in the southwest and shallow burial depth in the northeast. There is a weak interlayer in the sliding zone, which is composed of broken argillaceous limestone and mudstone clasts (Figures 3, 4B,C). Many polished surfaces, scratch, and slickensides were observed in the sliding zone (Figures 4D–G). Based on the results of direct shear tests, the mechanical properties of the sliding zone materials are poor, especially in the saturated state (Table 1).

The monitoring curve of SY02 shows an obvious sliding surface at a depth of 19–21 m, and the unstable rock and soil masses above the sliding surface moved as a whole, suggesting that the Dashuitian landslide has a well-defined deep sliding surface (Figures 3, 9). The cumulative horizontal displacement and deformation rate above the sliding surface reached 48 mm and 1.6 mm/day from October 20 to 2 November 2019. Based on information from borehole Zk7 (Figure 4E), the contact zone between the argillaceous

In conclusion, the locations of the sliding surface revealed by the two inclinometers (Figure 9) are nearly consistent with the contact zone between the argillaceous limestone and mudstone revealed by the boreholes (Figure 4).

The study area is located in the northwest wing of the Wushan syncline where the Baishuihe syncline is developed. Due to the effects of regional tectonic action, the rock and soil masses in the landslide area are extremely broken (Figure 4) and easily infiltrated by rainwater and groundwater.

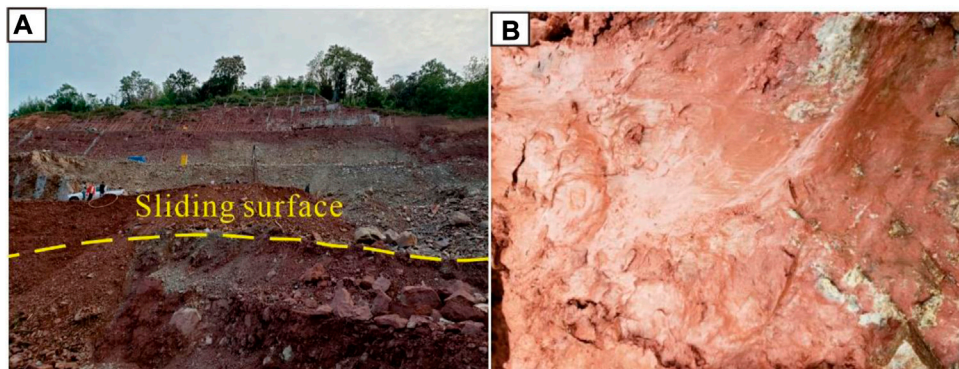
**FIGURE 5**  
(A) is the sliding zone revealed by the excavation; (B) is the softened sliding zone exposed by TC5 (Figure 2) at a depth of 16 m.

The sliding bed is composed of the mudstone, and the attitude of the strata is 330° with a dip of 25°. The mudstone is purple, features a medium-thick layered structure and appears relatively intact compared with the overlying argillaceous limestone. However, the mudstone near the sliding zone is highly weathered due to softening by groundwater (Figure 5).

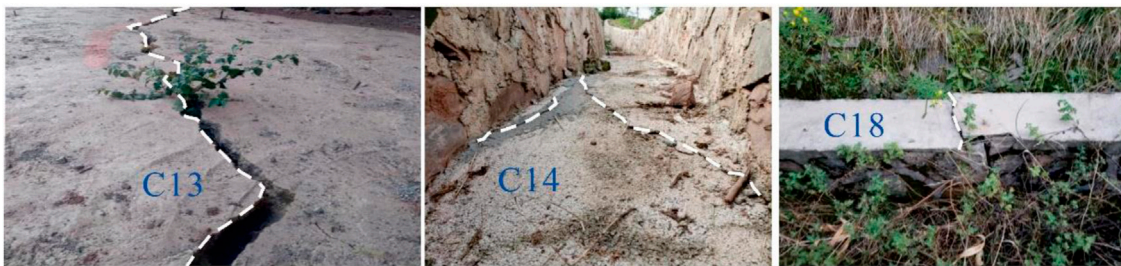
**FIGURE 6**  
The typical old cracks developed in 2007 and 2008 due to deformation of the old Dashuitian landslide.

Five typical old cracks (C13, C14, C18, C19, C20) were developed prior to this event and were revealed during a detailed field investigation (Figures 2, 6). C13 is a tension crack of about 30 m in length, 5–20 cm in width and 50 cm in depth, and is located

at the rear part of the Dashuitian landslide (Figure 6). C14 is also a tension crack that developed at the middle-rear part of the landslide with a length of 2 m and width of 2–4 cm (Figure 6). C18 is a shear crack located at the leading part of the landslide (Figure 6). The investigation indicated that these cracks are historical cracks that were induced by the excavation of the G42 Expressway in 2007 and 2008.

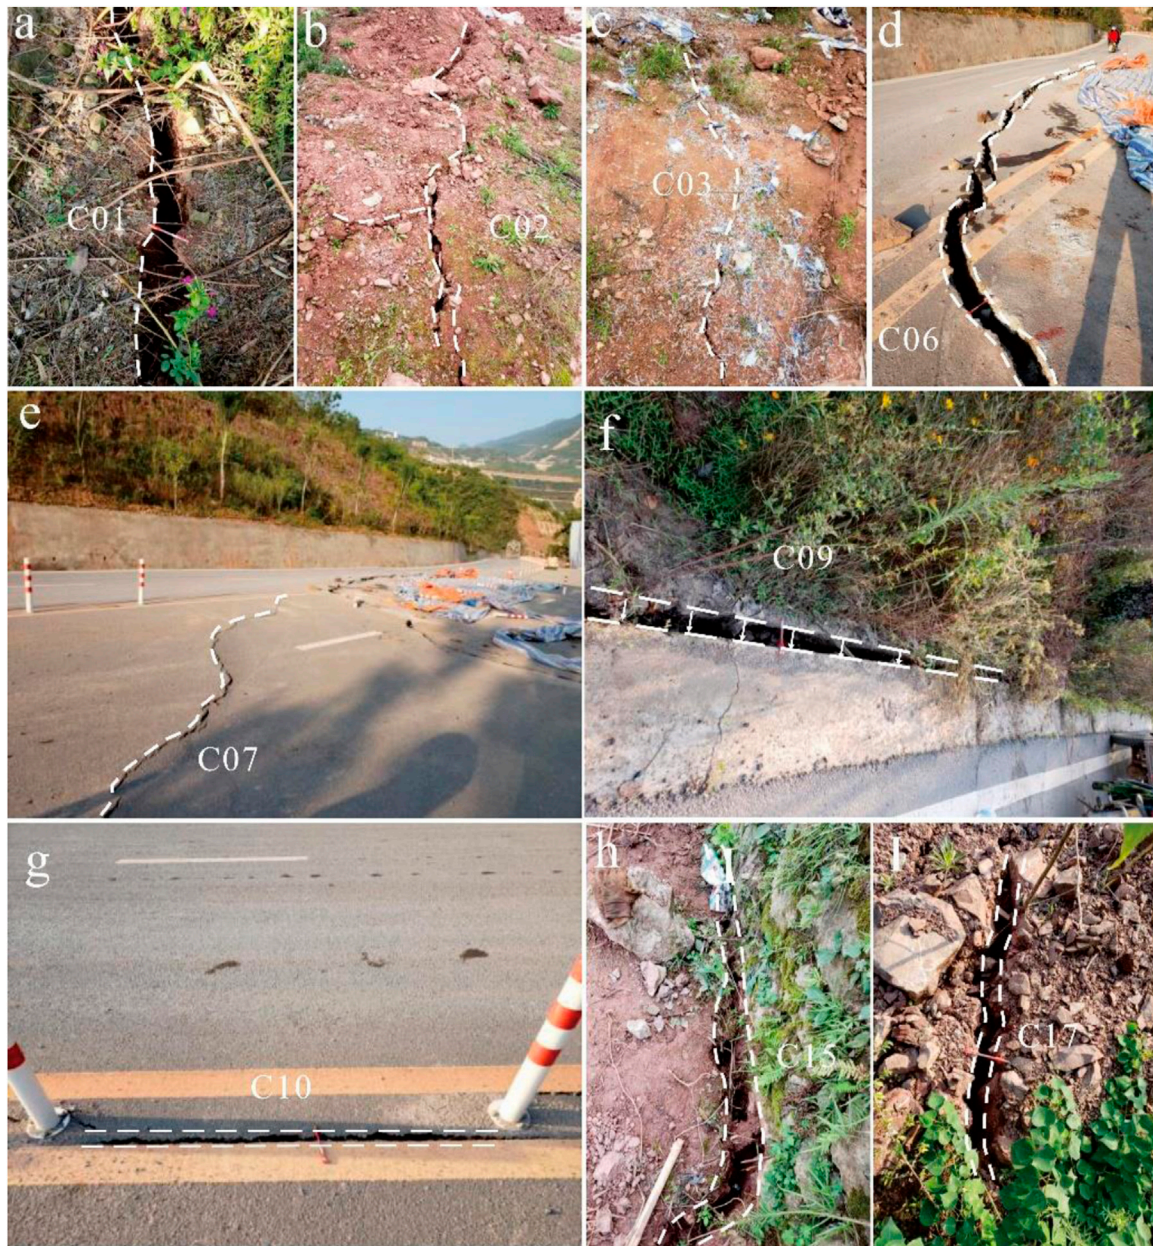
**FIGURE 7**

New deformation signs of the Dashuitian landslide. (A,B) are tensile cracks located at the rear part; (C–E) are shear cracks located at the eastern edge; (F,G) are large tensile cracks develop along Ring Road at the middle-rear part; (H,I) are tensile cracks located at the leading part.

The new deformation signs of the Dashuitian landslide that were identified during the field investigation mainly include cracks on the roads and ground surface (Figure 7). Deformation signs became evident after the heavy rainfall event of October 4 to 22, 2019, when about 228 mm of precipitation fell (Figure 8). The new deformation signs mainly developed at the leading part, rear edge, the middle-rear part and eastern edge of the landslide. C15, C16 and C17 developed at the leading part of the landslide, reaching a length and width of 7–10 m and 1–2 cm, respectively. The deformation signs at the rear edge developed along Wuliu Road and consist of several transverse tension cracks, such as C01 and C02. The length of these is 20–50 m, the width is 1–40 cm and the visible depth is 20–200 cm. C09–C12 are large tension cracks along Ring Road at the middle-rear part of the landslide with a length of 8–120 m. C03–C08 are feathery shear cracks, located along the eastern edge of the landslide, with a

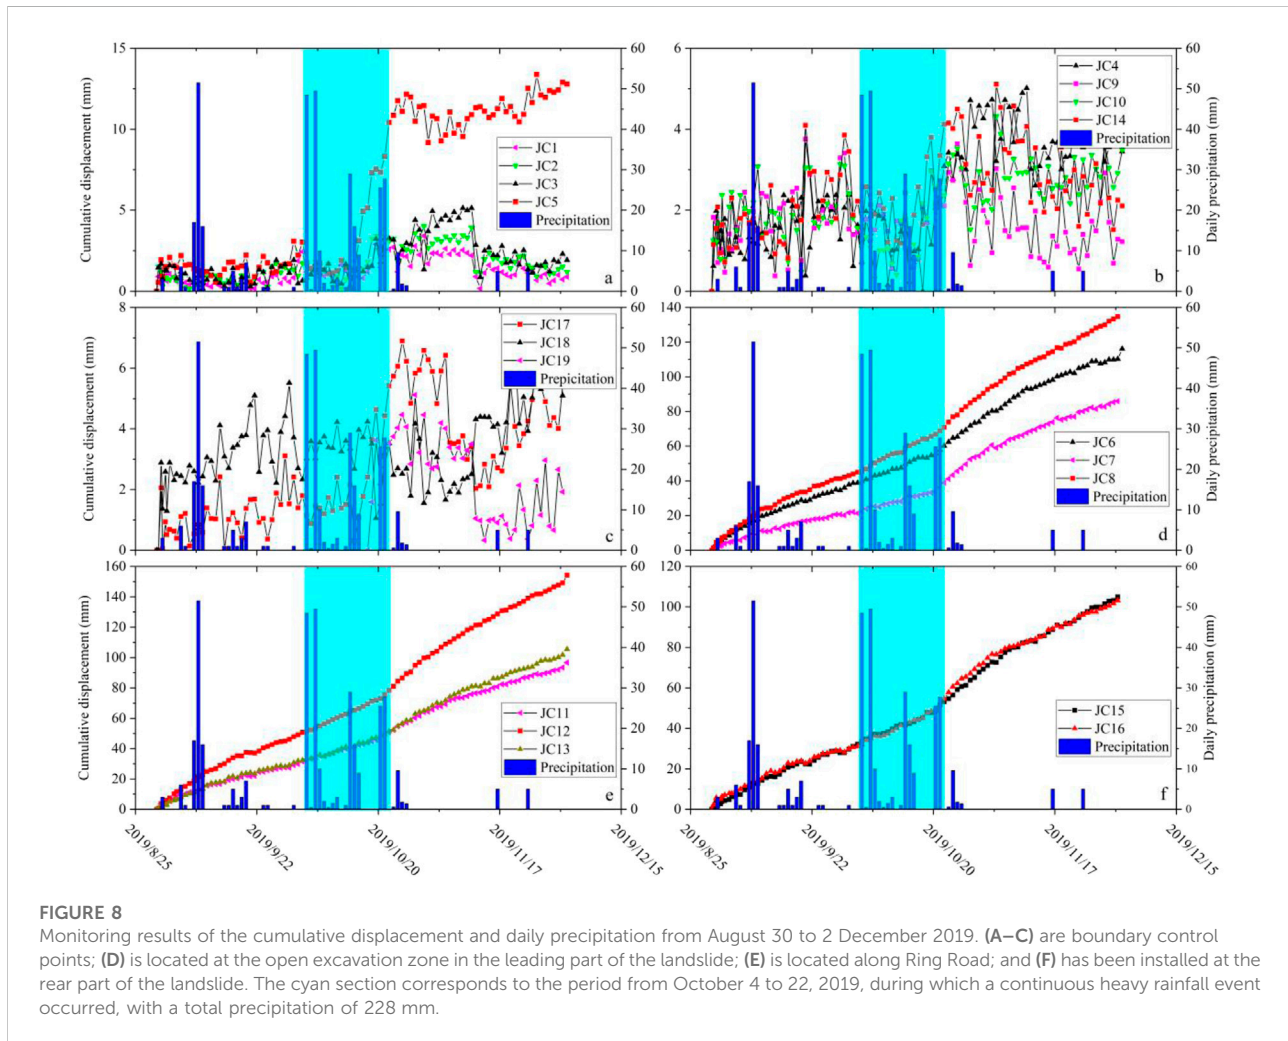
After 30 August 2019, we installed GNSS (Global Navigation Satellite Systems) in the study area to monitor the ground deformation, as shown in Figure 2. Based on the results of the field investigation and the geomorphological features of the study area, the gully located at the western edge of the landslide was determined as the western boundary. Moreover, in order to further determine the northern, southern and eastern boundaries of the landslide, monitoring points JC1, JC2, JC3, and JC5 were installed on the northern side, JC17, JC18, and JC19 were developed at the southern edge, and JC4, JC9, JC10, and JC14 were situated along the eastern side. The monitoring results showed that the cumulative displacement of all 11 monitoring points was about 2–10 mm, and the deformation rate was only 0.02–0.09 mm/d from August 30 to 2 December 2019, indicating that the positions of the monitoring points are relatively stable (Figures 8A–C).

Regarding the activated zone, two typical stages in the deformation curves are shown in Figures 8D–F, which correspond perfectly with the concentrated rainfall events from October 4 to 22, 2019, with a total precipitation of

228 mm. Monitoring points JC6, JC7, and JC8, which are located at the open excavation zone in the leading part of the landslide, had a maximum deformation rate of 1.29 mm/day before the rainfall event and 1.61 mm/day after the rainfall

event. The highest deformation rate of monitoring points JC11, JC12 and JC13, located at Ring Road in the middle part of the landslide, reached approximately 1.43 mm/day and 1.87 mm/day before and after the rainfall event, respectively. The highest deformation rate of monitoring points JC15 and JC16, located at the rear part of the landslide, was approximately 0.97 mm/day and 1.25 mm/day before and after the rainfall event, respectively. In addition, the total cumulative displacement in the leading (JC6, JC7, and JC8), middle (JC11, JC12, and JC13) and rear (JC15, JC16) parts of the landslide were about 85.9–134.7, 96.5–154.3, and 103.1–105 mm, respectively.

(Figure 2). No obvious deformation had occurred since then. In August 2019,  $30 \text{ m}^3 \times 10^4 \text{ m}^3$  of rock and soil masses was excavated from the toe area during the construction of the Wu-Da Expressway, which provided the necessary conditions for reactivation. In addition, the anti-sliding force of the landslide was reduced due to damage to 13 of the anti-sliding piles at the toe (Figures 1C, 2), which triggered the overall slow deformation of the Dashuitian landslide during August 30 to 22 October 2019 (Figure 8).

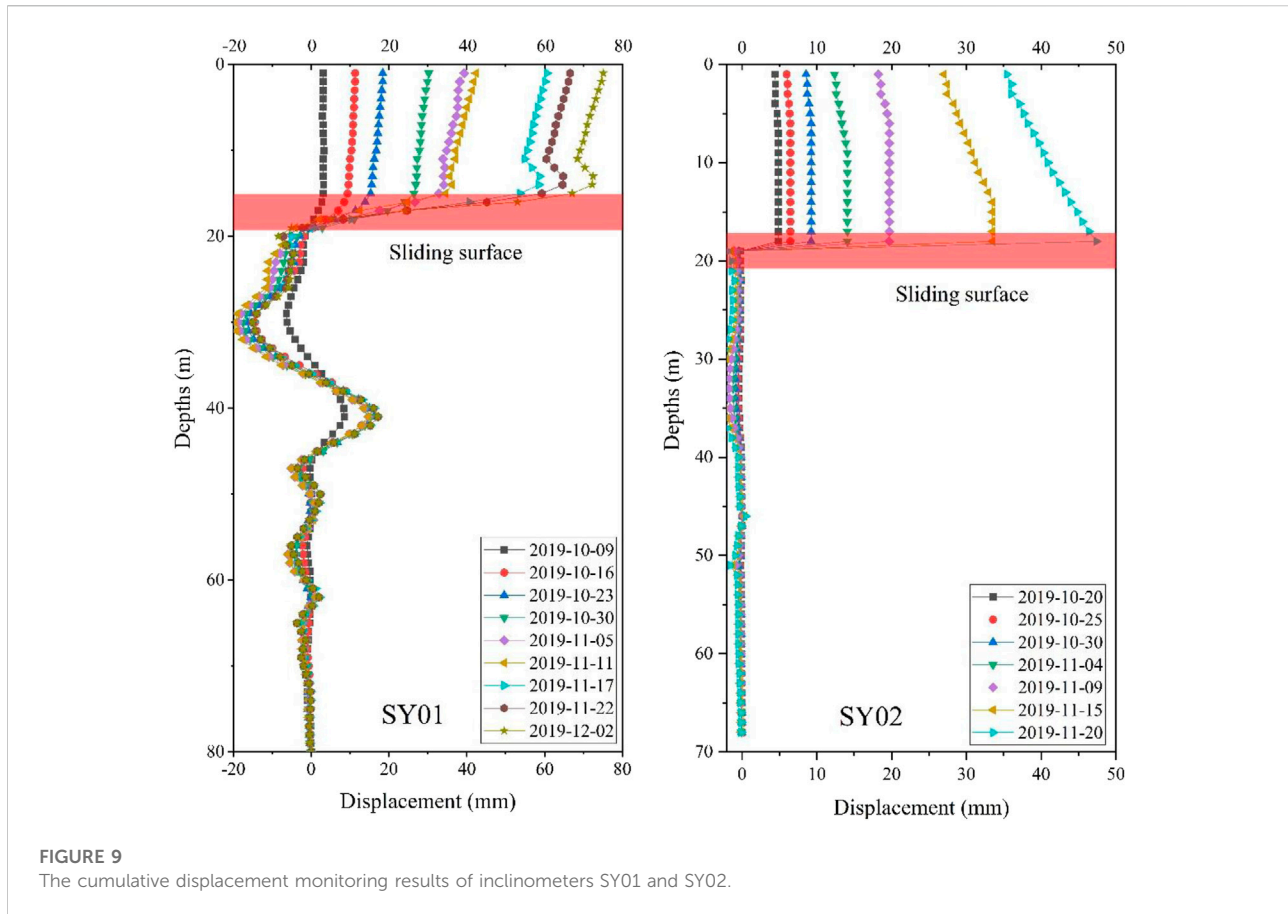
The monitoring displacement curve of SY01 indicates that the displacement increased gradually from the bottom to the top (Figure 9). An obvious sliding surface was evident between 17 and 20 m. From October 9 to 2 December 2019, the cumulative horizontal displacement and deformation rate above the sliding surface reached 78 mm and 1.5 mm/day, respectively. Based on data from borehole Zk16 (Figure 4A), the weak interlayer was inferred at a depth of 16–20.5 m, which is the contact zone between the argillaceous limestone and mudstone. Given that scratches were apparent in the borehole core, the contact zone is considered to be a sliding surface.
