Study of fatigue damage of pumping rods based on finite element simulation

This study performed in-depth analysis of onsite fatigue damage and stress distribution in pumping rods. Two aspects of fatigue damage were analyzed: macroscopic morphology and chemical properties. In terms of chemical properties, the crystalline phase composition and hardness of the product at fatigue damage were analyzed; the stress distribution was analyzed in term so of the rod-body stress and the connection-section stress. The cross-sectional characteristics of the fatigue crack expansion were summarized, and the types of fatigue fracture and the influencing factors of the pumping rod were obtained from these cross-sectional characteristics. Finally, modeling and stress analysis of the pumping rod were performed using SolidWorks and ABAQUS software. By comparing the stress cloud diagrams of different thread root shapes, the factors that cause fracture in the pumping rod and the locations of stress concentrations and dangerous cross-sections of the rod were determined. The highest principal stresses were obtained at the rod body near the upsetting flange of the pumping rod, and fatigue damage was the mo

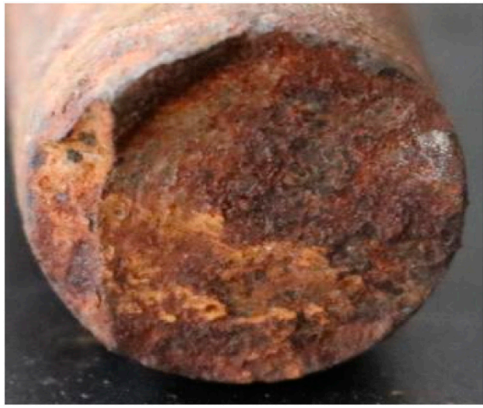
FIGURE 1
Fatigue cross-sectional shape of the pumping rod.

Under complex well conditions, the fatigue life of the pumping rod considerably decreased, and several obvious signs of fatigue fracture were observed in the fracture area. Furthermore, a substantial amount of information related to the fatigue fracture process was retained, with obvious morphological characteristics representative of fatigue fracture (Li, 2006). As displayed in Figure 1, a layer of red-brown oil well corrosion products

formed on the fracture surface of the pumping rod, and the fracture crack originated on the outer surface of the pumping rod. The area of the transient fracture zone accounts for about 1/5 of the entire fatigue fracture area, indicating that fracture load level was low in the transient fracture zone of the pumping rod; the fracture was relatively less severe, and no necking phenomenon occurred in the brittle transient fracture. Thus, the fracture occurred because of the alternating load and corrosion media under the combined effect of low stress brittle fracture.

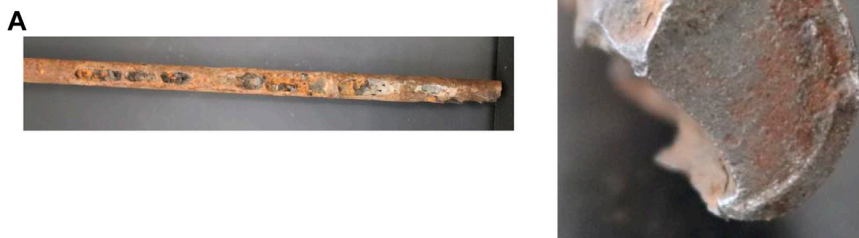
FIGURE 2
Fatigue cross-sectional shape of the pumping rod.

As displayed in Figure 2, the pumping rod was fractured from the rod body (As shown on the left A), are several corroded pits (As shown on the right B) were formed in the rod body. The corrosion caused a reduction in the fracture surface area of the pumping rod and in the load-bearing capacity. The formation of corrosion pits in the pumping rod body at the site of a local stress concentration resulted in fatigue cracks at the bottom of the corrosion pits in the cyclic alternating load and corrosion medium. Therefore, fatigue cracks continued to expand forward until the final fracture occurred, and the cycle corresponding to the low circumference corrosion fatigue fracture was relatively short.

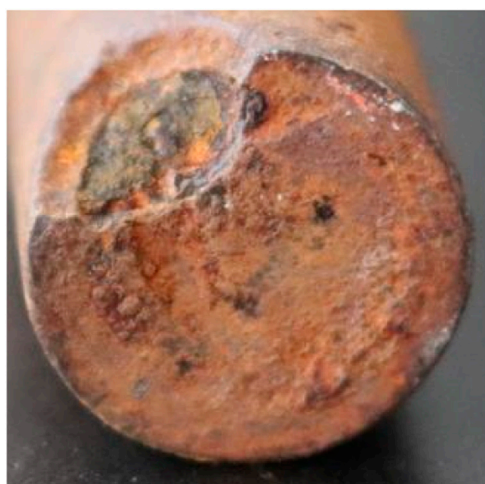
FIGURE 3
Fatigue cross-sectional shape of the pumping rod.

As displayed in Figure 3, the fatigue fracture occurred because of manufacturing defects in the pumping rod. Dark black inclusions were observed inside the rod when it was manufactured. During the upward and downward movement, the pumping rod was subjected to alternating load, resulting in gradual sprouting and expansion of the crack source. The fracture occurred rapidly when the fatigue crack expanded to the inclusions.

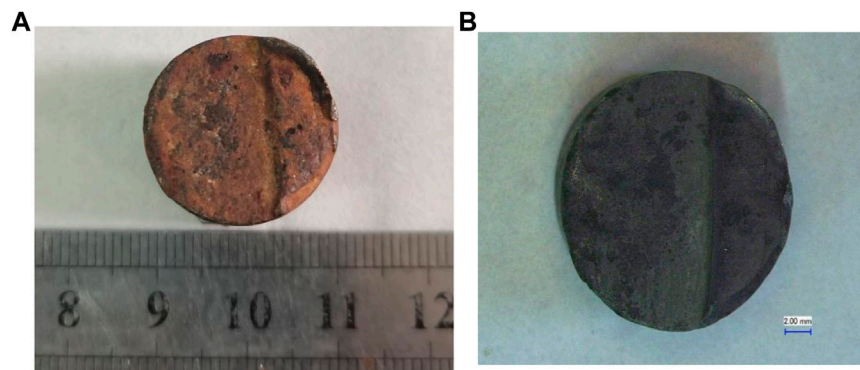
FIGURE 4
Before and after fracture cleaning of specimen No. 1. (A) Before fracture cleaning. (B) After fracture cleaning.

the crystalline phase of the fatigue damage products to determine the factors influencing the fatigue damage of the pumping rods. The two specimens were numbered 1 and 2, as displayed in Figures 4, 5.

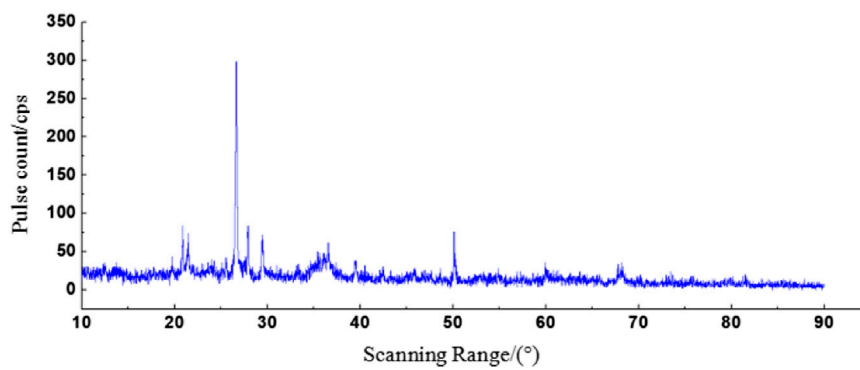
FIGURE 6
XRD pattern of specimen No. 1.

Samples obtained from specimen No. 1 and No. 2 were ground into powder and then analyzed for their physical phases. Figures 6, 7 display the XRD patterns of specimen No. 1 and specimen No. 2.

XRD analysis of specimen No. 1 and No. 2 revealed that the primary components of the products formed at the fatigue damage of the pumping rods were FeS compounds, Fe₂O₃, and silicon compounds. The FeS in the specimens was supposed to be produced by the corrosion of H₂S in the well fluid. The production of Fe₂O₃ is closely related to the CO₂ corrosion and HCO₃⁻ occurring in the well fluid, and the silicon-like compounds should be substances in the formation.

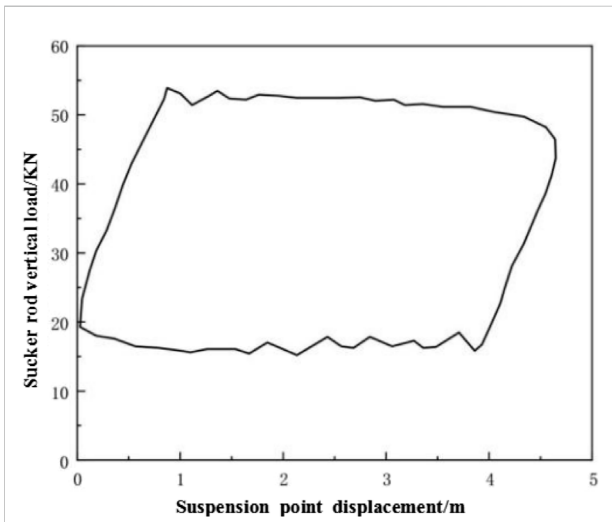
FIGURE 8
Function of the oil well.

As displayed in Figure 8, the workover diagram of the pumping rod over the length of one stroke was obtained by combining the well production data, the variation in the load of the pumping rod, and the displacement of the suspension point over one stroke (Lin and Smith, 1999). Furthermore, according to the suspension point displacement combined with the motion of the pumping machine, the obtained work graph of the pumping rod was transformed into a curve of load variation with time as displayed in Figure 9.

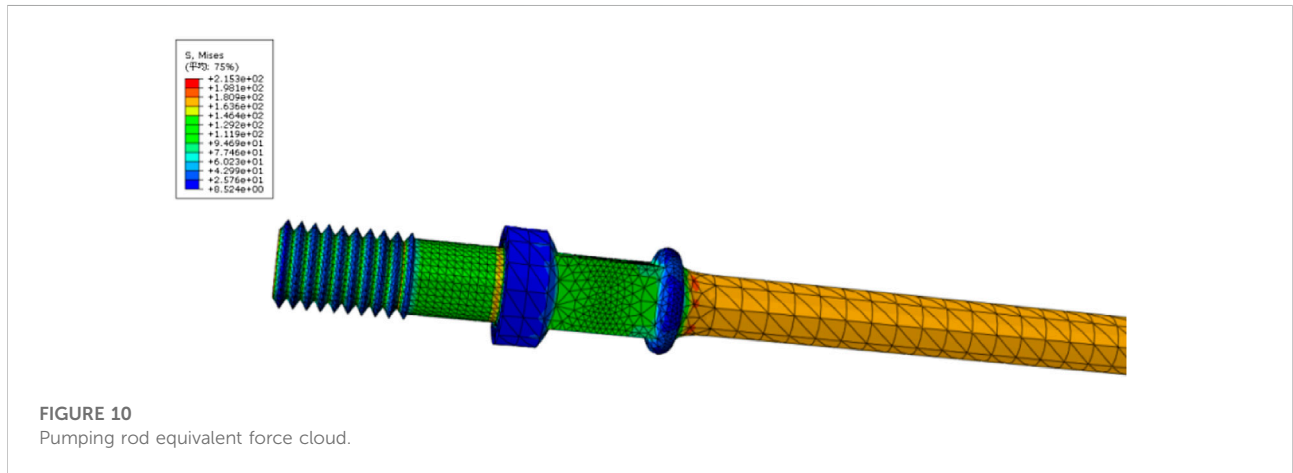
As displayed in Figure 10, the cloud map of the maximum principal stress distribution on the pumping rod was obtained

through simulation analysis, which revealed that the maximum principal stresses at the root of the threads at both ends of the rod, the root of the shoulder, the wrench side, and near the upsetting flange of the rod were large and hazardous. The shoulder of the unloading groove and the upsetting flange area were relatively safe

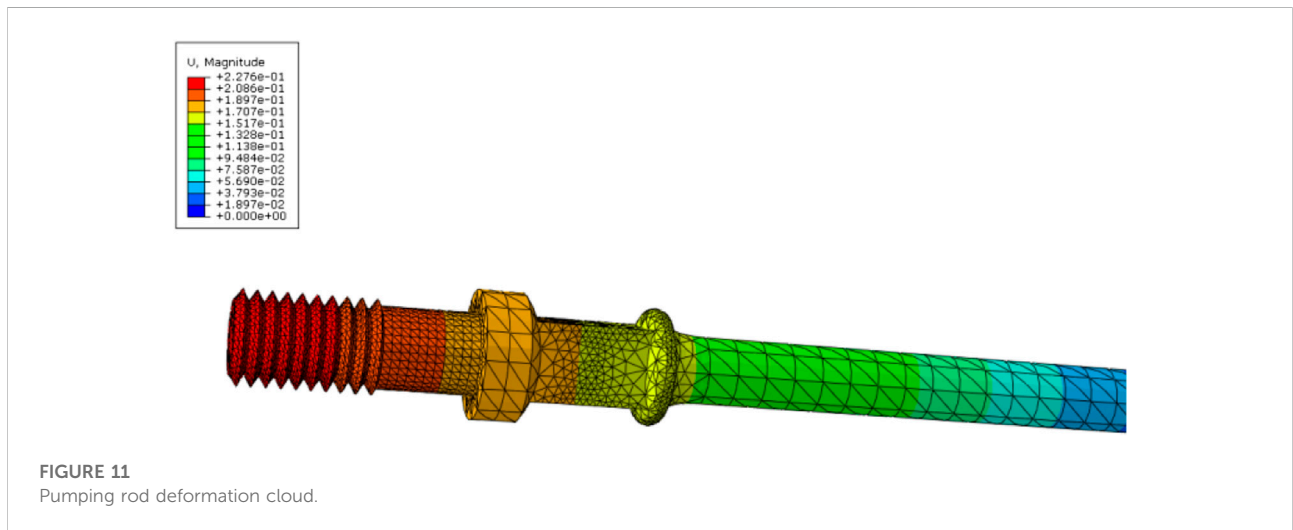
due to the large cross-sectional area and low stress concentration (Zhao, 2007; Bian et al., 2011). As displayed in Figure 11, the deformation cloud was small along the axis of the pumping rod in the working process, where the maximum deformation was 0.2267 mm.

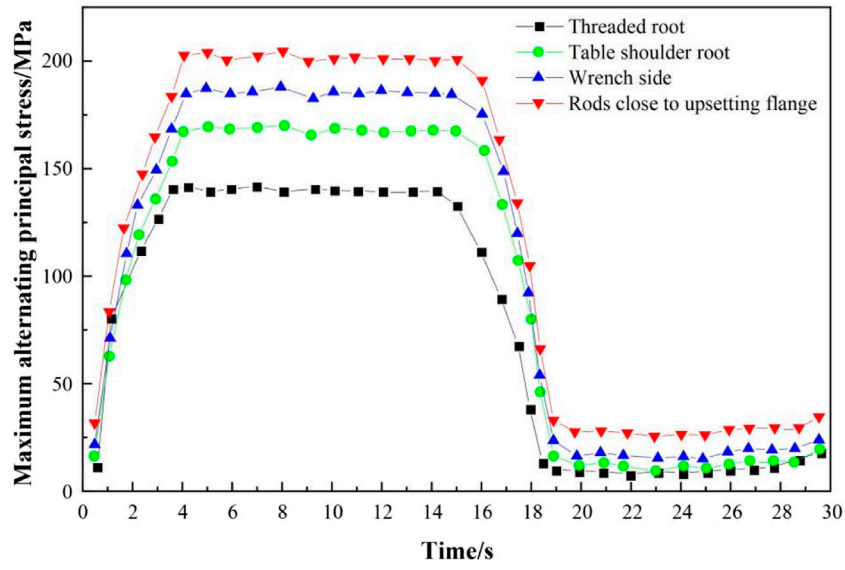
FIGURE 12
Stress variation curves at different locations within one stroke of the pumping rod.

As illustrated in Figure 12, the principal stress variation curves during strokes at the root of the thread, the root of the shoulder, the wrench side, and the rod body near the upsetting flange in the pumping rod were plotted according to the results of static analysis using ABAQUS. The maximum principal stress occurred during the upward stroke and the minimum principal stress occurred during the downward stroke of the pumping rod. Thus, the maximum principal stress was observed near the upsetting flange of the rod body, and the possibility of fatigue damage was the highest at this location of the rod, making it a hazardous section.

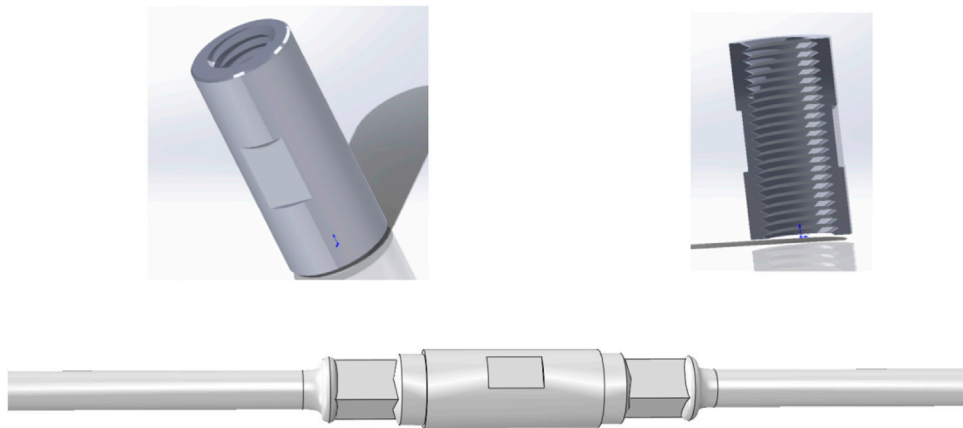
FIGURE 13
Connection diagram of joint and pumping rod.

The geometric model of the pumping rod coupling was constructed using SolidWorks modeling software and imported into ABAQUS software. The coupling was assembled with the pumping rod in the assembly environment, as displayed in Figure 13.

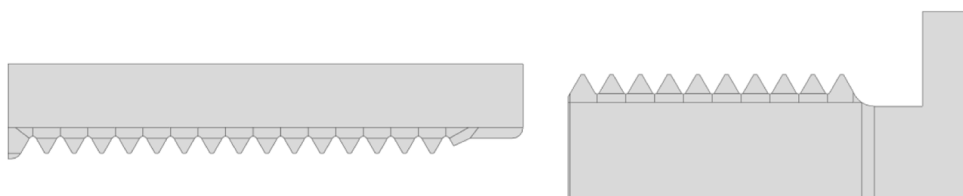
FIGURE 14
Cutting thread surface drawing.

for meshing, as displayed in Figure 14. Because the geometry of the threaded surface of the connecting section of the pumping rod was relatively complex, cutting the surface of the threaded surface to a quadrilateral was necessary for meshing; the irregular surface was thus cut into a quadrilateral and then meshed.

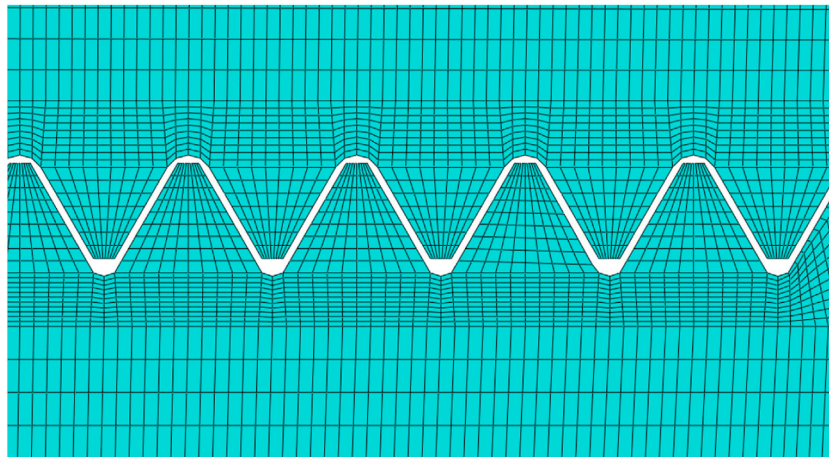
FIGURE 15
Mesh division diagram.

As displayed in Figure 15, the mesh at the threads was divided more densely for accurate analysis.
