Reaction and deformation mechanism of a slipping-stretching landslide: Example of the Liangtianao ancient landslide, Guangxi Province, China

Slipping-stretching landslides have long been recognized as a common type of landslide case, but such reactions have rarely been reported. There was a slipping-stretching landslide reaction at Liangtianao, Guangxi Province, China, and the geological background and deformation characteristics of the case were identified by detailed geological survey and long-term monitoring. A FEM model of the case was built using GEO5 to analyze the mechanism of reaction and deformation. The results are as follows. 1) The Liangtianao landslide is a bedding rock ancient landslide, which remained in a creeping state after the landslide occurred in geological history. 2) The new sliding surface in the Liangtianao landslide is basically consistent with the weak interlayers formed by ancient landslides, and the fault-type is a slipping-stretching type with the following deformation process: strain at leading edge by road excavation→ leading edge instability→ middle part shear and creep→ back edge tensile. 3) Micro-geomorphology, rock mass bedding, and weak interla

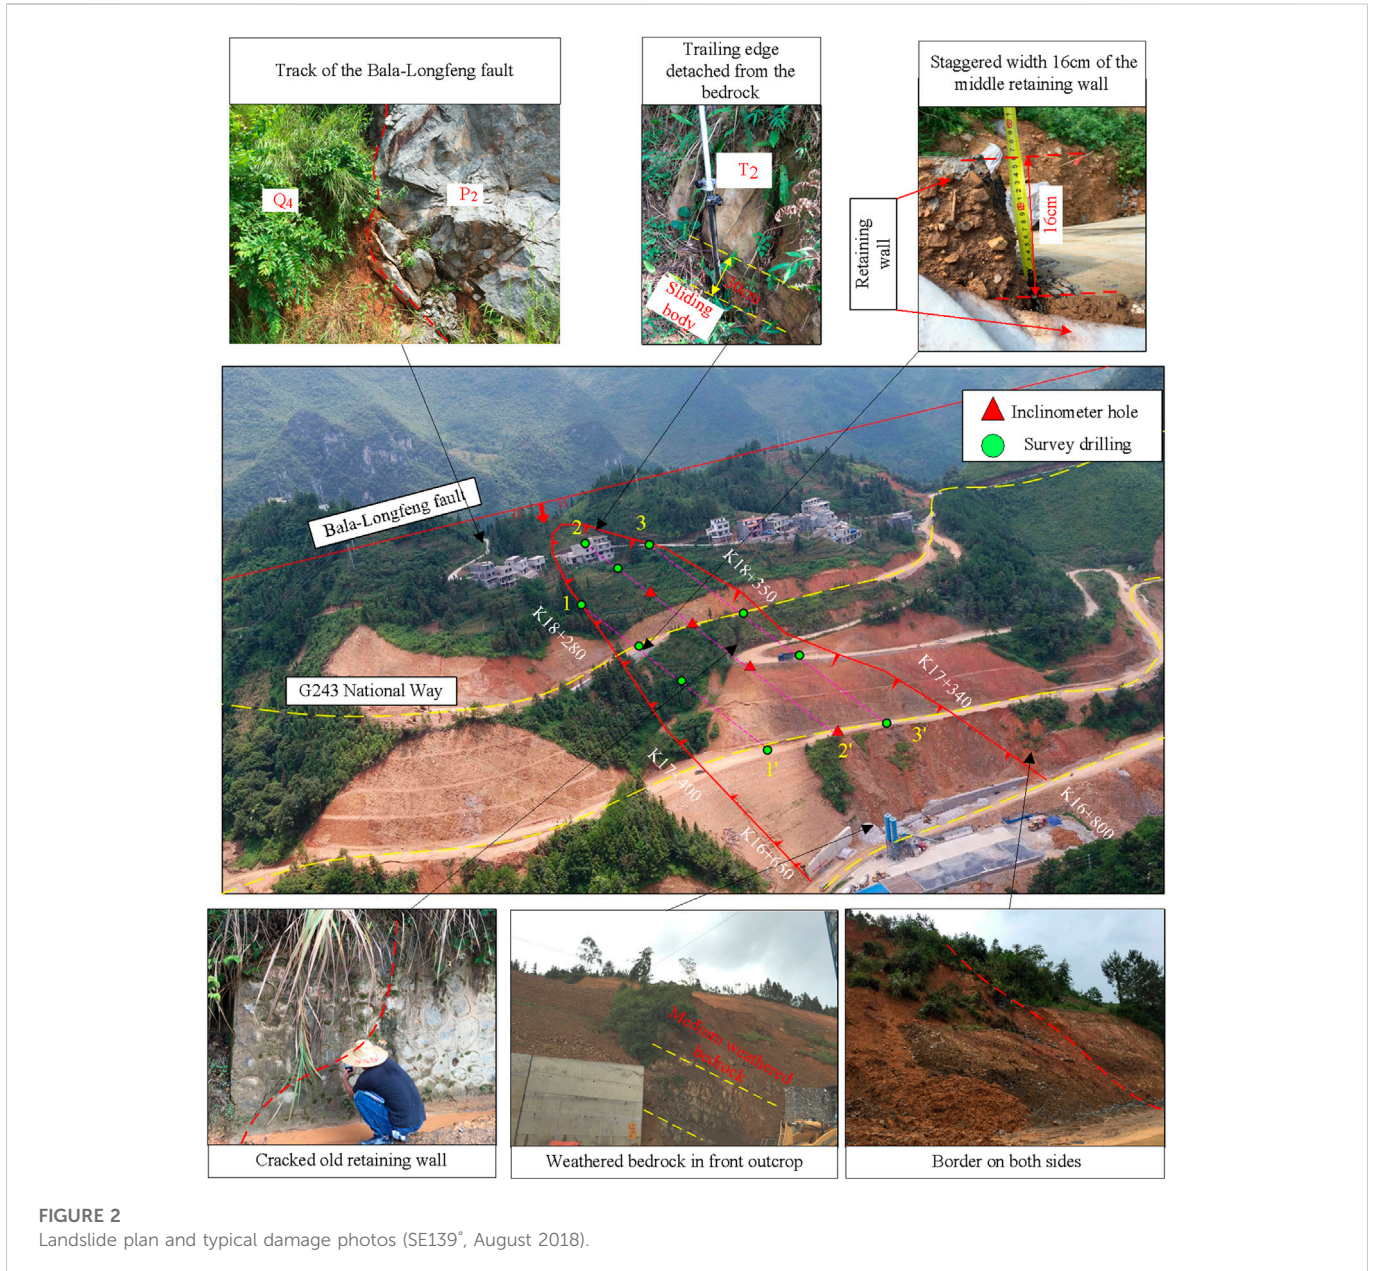
The case was in Liangtian'ao village (Figure 2). The G243 national way designed sections of K16 + 300 to K18 + 500 near this village. As the height difference between front and rear is 120 m, double-S turning curves were taken to overcome the longitudinal slope, with total excavation of these sections of 43,898 m³. All excavation was completed in July 2018 and formed platforms 11 m–20 m wide at 757.0, 790.0, 818.0, and 833.0 m. Nearly 22 concrete-brick houses with 100 villagers are scattered on the top of the slope.

The tongue-shaped landslide occurred suddenly on August 13, 2018, and its failure characteristics were as follows. a) At 870 m, the soil was separated from the steep rock wall behind it and slinked about 30 cm; at 860 m, three houses' load-bearing columns were cracked by 0.5 cm–1.0 cm. b) At 831 m–873 m, the shallow soil was stretched by 10 cm to 30 cm-thick, and the new retaining wall was staggered 10 cm–25 cm. c) At 790 m–818 m, the old road sustained goose-sharped shear dislocations, and the old retaining walls cracked diagonally 1–2 cm wide. d) At 750 m–790 m, there was only slope slump outside the boundary on both sides, and the sliding surface was not exposed. In order to determine the spatial characteristics of this

FIGURE 2
Landslide plan and typical damage photos (SE139°, August 2018).

landslide, three geological profiles were laid along the main direction, and deep displacement monitoring was set up. The specific layout positions and sliding surfaces are shown in Figures 2 and 3.

19 September 2019 (39 days) was 634.6 mm, of which the average daily rainfall from 17 September 2019 to 19 September 2019 was 61.0 mm/d. Consequently, shallow soil at the trailing edge slipped 219° , causing the village road to dislocate (Figure 5). The dry season had been from 19 August 2018 to 31 March 2019, with cumulative rainfall down to 502.8 mm (2.60 mm/d). By comparison, the average daily evaporation in the region was 3.40 mm, so the rainfall effect on the landslide was weak. However, the middle sliding body was still slipping. The subsidence gap of the retaining wall near ZK2-6 cracked in October 2018 (Figure 6). Moreover, as deep displacement monitoring was completed on 21 November 2019, the average displacement rate of all sliding surfaces during the dry season was 0.08 mm/d, 0.15 mm/d, 0.12 mm/d, and 0.42 mm/d. This reveals that, 152 d after the landslide reaction, landslide had entered a gradual stabilized stage from its rear to upper edge.

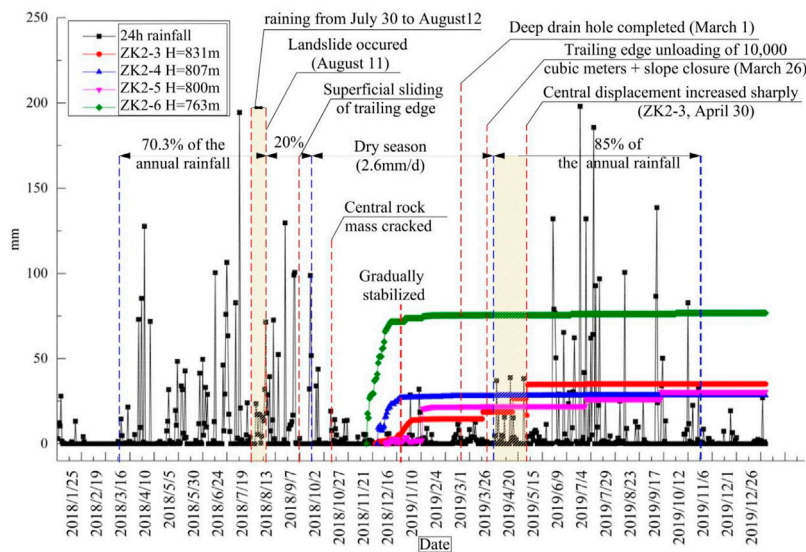
Pre-landslide rainfall was characterized by prolonged, high intensity (Figure 4). The cumulative rainfall from March 2018 to the landslide reached 2,137.0 mm, accounting for 70.3% of the whole year (3,040.0 mm). The average daily rainfall was up to 12.64 mm/d. Furthermore, the rain continued from 30 March 2018 to 12 August 2018 (11 days) before the landslide, with a large day rainfall of 72.6 mm on 11 August 2018. As all on-site works had stopped before the landslide occurred, it can be qualitatively judged that the rainfall contributed to the landslide.

FIGURE 4
Daily rainfall and deep displacement data in the study area.

After the landslide occurred, on-site construction was stopped until March 2019. However, the daily rainfall and deep cumulative displacement curve showed a continuous deformation trend, which was closely related to rainfall.

2) Rainfall can cause landslides to re-deform. On 1 March 2019, there was no change in the deep displacement monitoring data after the deep drainage holes were completed. However, with the average daily rainfall reaching 5.48 mm/d (26 March 2019 to 30 April 2019), the cumulative displacement of the sliding surface at ZK2-3 suddenly increased from 18.7 mm to 34.85 mm (+16.15 mm). In contrast, the ZK2-6 cumulative displacement did not change.

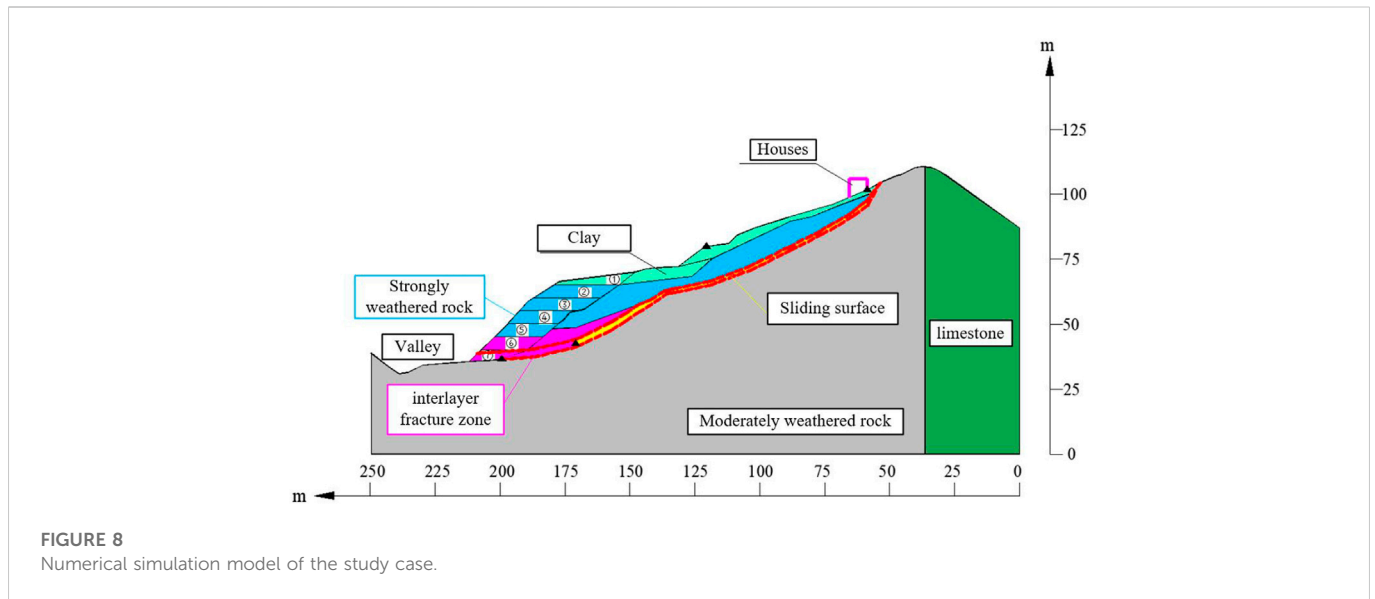
- 1) Determination for the position of the sliding surface. ZK2-6 has an interlayer broken zone 27 m (760 m) – 30 m (763 m), and a deep displacement monitoring curve change at 763 m. Thus, the sliding surface of the leading edge is located at an elevation of 760 m–763 m. The distribution of the sliding surface is shown in Figure 8.
- 2) Selection of physical and mechanical parameters. A comprehensive method that combines test evaluation, empirical assessment, and back calculation was used to evaluate the physical and mechanical parameters of the rock and soil. For the underlying bedrock, these parameters have little effect on the results of slope simulation analysis, which can be evaluated directly based on field investigation data. For

FIGURE 8
Numerical simulation model of the study case.

residual soil—interlayer zone and sliding surface—key parameters such as modulus and strength are calculated by a back analysis method according to the parameter interval provided by laboratory tests. According to the consistency requirements of landslide failure characteristics, stability coefficient in each excavation stage of landslide simulation analysis, and actual working conditions, the rock and soil conforms to the Mohr-Coulomb model, with the parameters under saturated conditions shown in Table 1. The displacement of the left and right model boundary is fixed in the X-direction, and the bottom constrains the displacement in the XY-direction. GEO5 software was used for this calculation.

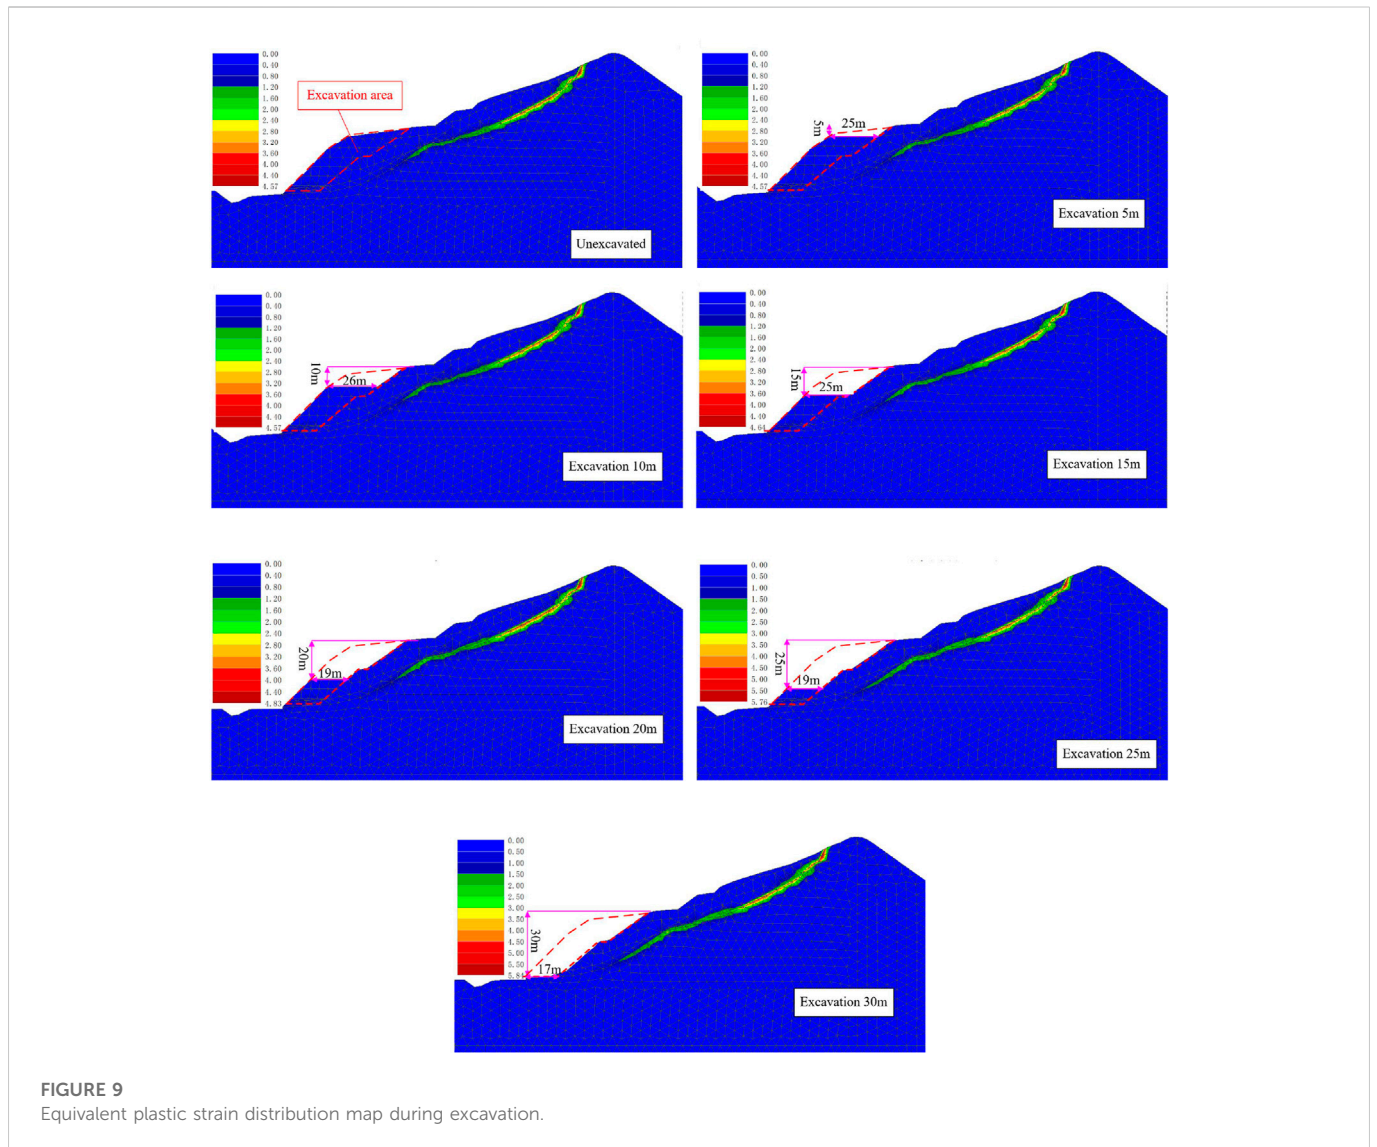
3) Simulation results. In vertical view, the equivalent plastic strain zone gradually expands from top to bottom with the excavation process, and the leading rock blocks the expansion while the excavation is completed. Taking half of the unloading height as a boundary, the expansion is not obvious when it is less than this value. In contrast, when it exceeds half, the expansion rapidly accelerates to the front edge of the landslide. During the excavation process, the slope deformation proceeds from back to front. When the unloading height of the leading edge reaches half, the middle sliding

surface is completely formed. When the unloading height of the leading edge reaches 25 m, the rock mass at the leading edge is deformed, and the influence range spreads 27–30 m below the surface. At the same time, F_s decreases 1.18–0.998 with the excavation time step. Overall, the deformation characteristics of the landslide extend from bottom to top.

FIGURE 9
Equivalent plastic strain distribution map during excavation.

As shown in Figure 9. The slipping-stretching ancient landslide remains stable before excavation, and the original sliding surface produces strain with the unloading process acting on the leading edge; at the same time, the stability of the ancient landslide gradually decreases. As gradual cutting at the leading edge support and slope stress is adjusted, the original sliding surface strain cumulates to a qualitative change, leading to a sudden ancient landslide reaction. The reaction is manifested as a chair-shaped crack on the back edge and a subsidence gap cracked onto retaining wall. The weathered rock mass in the front edge blocks the whole from sliding, leading to fewer signs of on-site deformation—consistent with on-site observations. The slipping-stretching landslide is still sensitive to rainfall; with a heavy rainfall season, even a secondary landslide will deform.
