Stability Control of Slopes in Open-Pit Mines and Resilience Methods for Disaster Prevention in Urban Areas: A Case Study of Fushun West Open Pit Mine

Zhou Jiaxing¹, Li Fei^{1*}, Wang Jin-an^{1,2}, Gao Anqi³ and He Chengyuan^{4,5}

This article was submitted to
Geoscience and Society,
a section of the journal
Frontiers in Earth Science

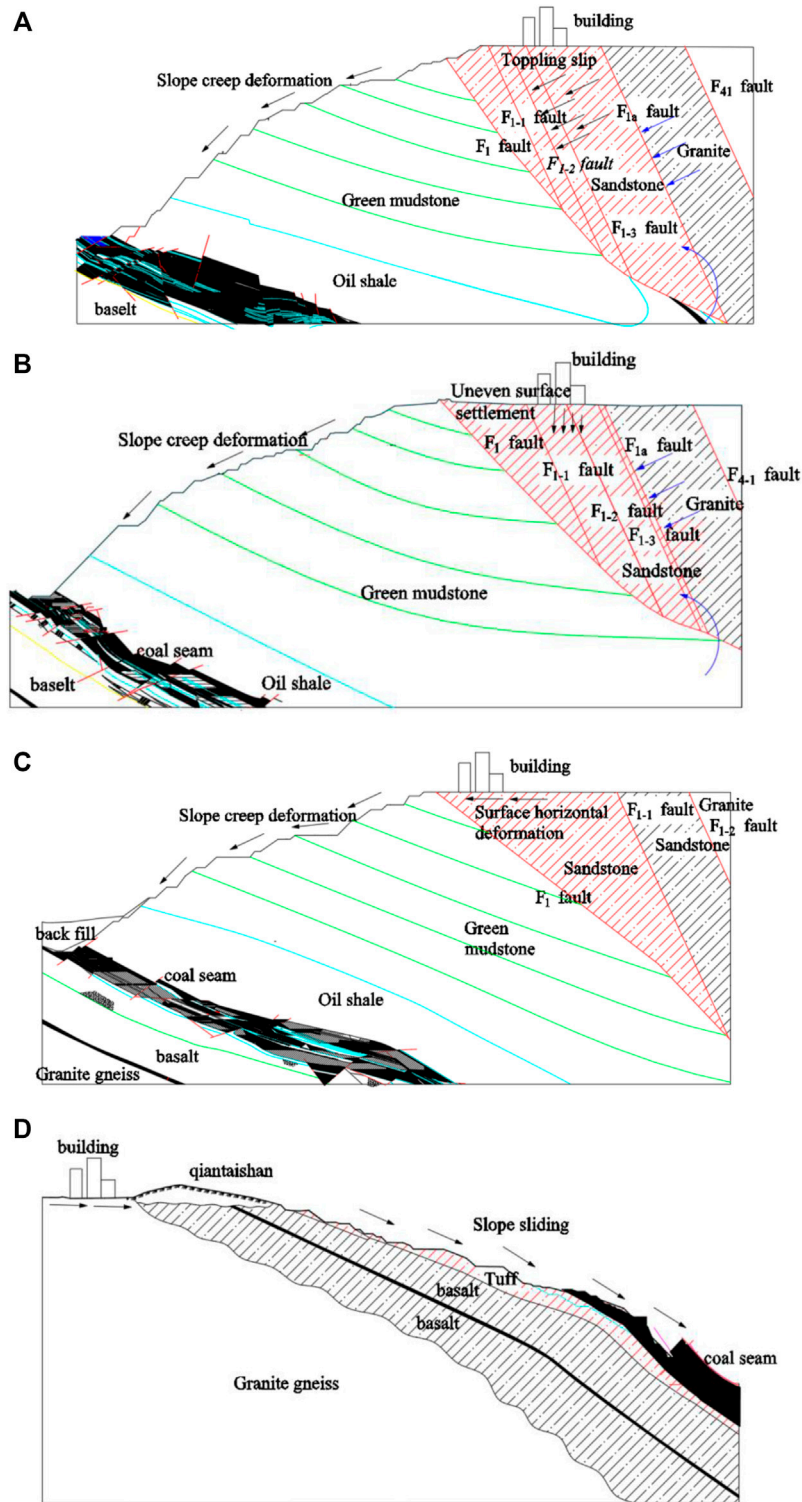
Feature-1 area is the area near the former petroleum plant on the north bank, and the regional stratigraphy is formed by sandstone wedge bodies bounded by the F_1 fault and the F_{1A} fault, as shown in **Figure 4A**. Due to the low strength and hardness of the rock formation, the wedge (red filled area) was affected by the coupled effect of the lateral pressure of the hard granite stress field on the east side and the unloading force on the surface near the side slope body on the west side. This resulted in

FIGURE 4 | Sliding deformation mechanism of slopes in each feature zone: **(A)** feature-1 Zone Wedge Rotating Slip; **(B)** feature-2 Zone Wedge Dumping Slip; **(C)** feature-3 zone Wedge Flush Slip; **(D)** feature-3 area south gang slope body downward sliding.

an overall rotational slip at the intersection of the two faults, which caused a large horizontal and vertical ground surface displacement. Owing to this, the surface deformation in the

The Qian-tai mountain area has a landslide history. As shown in **Figure 4D**, the surface deformation is relatively large due to the influence of adverse geological conditions, i.e., two sets of large fracture zones and down-sloping slopes. In recent years, with the implementation of slope management projects such as backfilling, the vertical deformation of the stratum has been reduced. The surface deformation in the area is mainly horizontal, and the exterior walls of the buildings are prone to cracking.

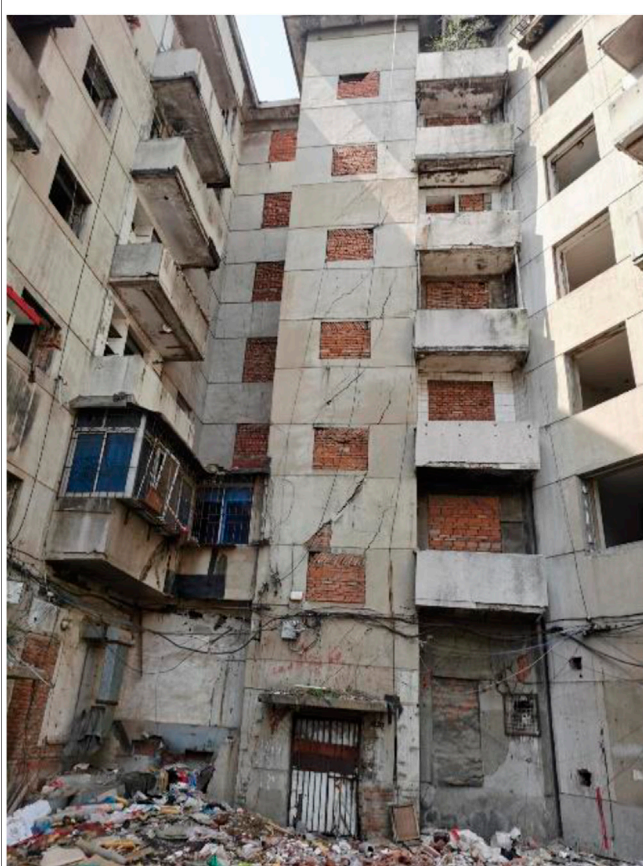
FIGURE 7 | Cracking of building wall and damage of balcony in feature-2 area.

Figure 6 shows the damage distribution of a masonry building affected by ground deformation action in each subjected region. Analysis showed that the masonry building in the feature-1 area was the most damaged, and the foundation part was almost completely damaged, and the damage to the bottom wall was also observed to be severe. Moreover, there were a few damaged areas existing at the top and bottom of the load-bearing columns in low level, while the damage to the non-bottom wall was relatively small, with only partial tilt-through cracks. This could also explain the dense and irregular distribution of reticulated cracks in the walls of the lower floors, the severe cracking and breakage of the bottom slabs of the balconies, and the severe penetration joints in the corners of the window and door openings of the buildings in this area. The damage to the foundation and walls of the building was relatively severe in the feature-2 area, as shown in **Figure 7**. Since the feature-3 area

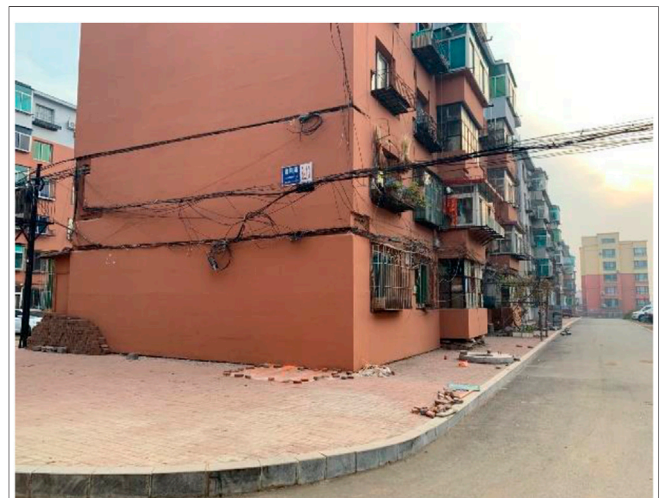
FIGURE 8 | Separation of building a wall from the foundation in feature-3 area.

was under the influence of horizontal displacement of the ground surface, the foundation components were mainly damaged, and the upper wall had a low degree of damage. This can better explain the problem of cracking and detachment of superstructure and foundation of building in this area (**Figure 8**).
