Wei S, Zhang X, Qin C, Wei P, Qin S, Liu L,
Chen Q and Yin C (2022), Influence of
vertical grouting steel-tube connection
mode on anti-sliding performance.
Front. Earth Sci. 10:986894.
doi: 10.3389/feart.2022.986894

Influence of vertical grouting steel-tube connection mode on anti-sliding performance

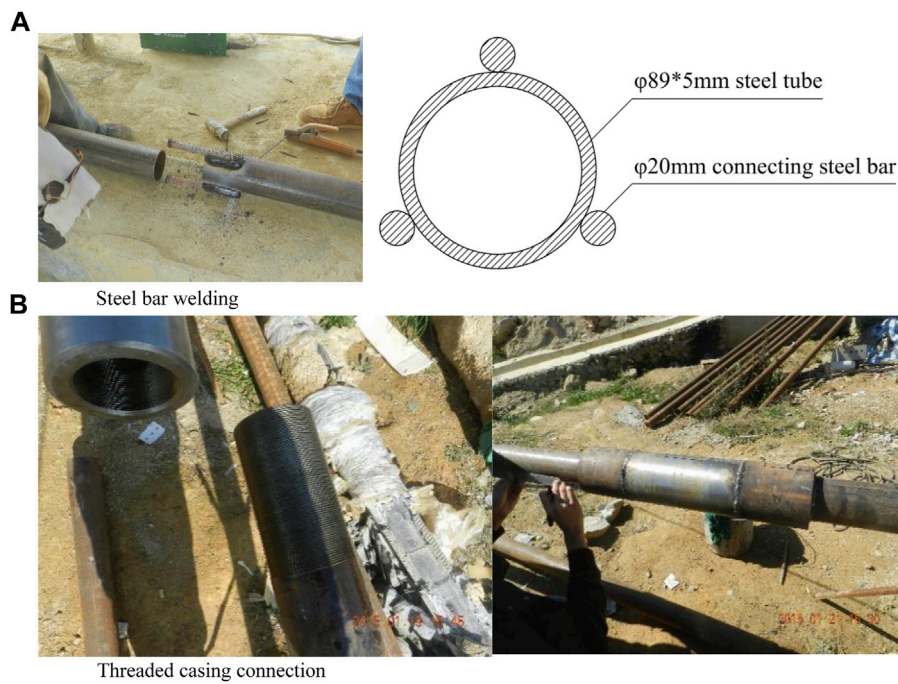
FIGURE 1 Steel bar welding and threaded casing connection. (A) Steel bar welding. (B) Threaded casing connection.

Two types of connections are generally adopted for steel tubes, including the reinforcement welding and threaded casing connections. According to the requirements of the Steel-Tube Pile Welding Process in Technical Code for Foundation Reinforcement of Existing Buildings (JGJ 123, 2012), floating rust, oil contamination, and other impurities on the connecting parts must be cleaned before the steel tube is connected to the pile. The grouted steel tube was a $\text{Ø}89\text{mm} \times 5 \text{ mm}$ seamless steel pipe, shown in Figure 1A. The butt welding was adopted at the joints between the steel tubes. Three connecting steel bars shown in Figure 1A, 20 mm in diameter were welded equidistantly at the joint, so that the steel tube could be positioned in the drilling hole. The verticality was strictly controlled during the welding of the upper and lower sections of the pile. The gap between the butt joints was maintained according to the design requirements, being 2–4 mm. The welding wire (automatic welding) or welding rod was dried. The welding was conducted in a symmetric and multi-layer pattern, and the joints of each layer of the steel-pipe pile weld were staggered. Meanwhile, the welding slags were removed.

A threaded casing connection was used to connect two steel pipes with the threaded casing, and its joint was welded with a welding rod. The grouted steel tube was a seamless steel tube with dimensions of $\text{Ø}89\text{mm} \times 5 \text{ mm}$, and butt welding was applied at the joints between the steel pipes. An overlapping seamless steel pipe with dimensions of $\text{Ø}120\text{mm} \times 15 \text{ mm}$ was used for the outer part of the tube, and the over-lapping length was no less than 100 mm at each end, shown in Figure 1B.

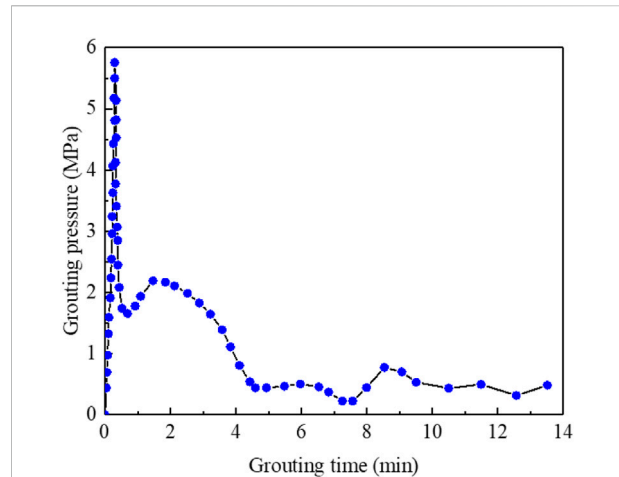
FIGURE 4
Controlled grouting pressure curve of the second group of experiments.

about 3 m. The interval between the first and second grouting time in the whole pile test of the second group was 7.5 h. [Figure 4](#) illustrates the variations of the grouting pressure with time. The secondary splitting pressure reached 5.8 MPa within 30 s after the splitting began, and then the pressure quickly dropped to 0–2 MPa, indicating that the primary grouting body was split successfully. The splitting time lasted 13 min, and the slurry feed exceeded 1.2 t. The test was terminated after the splitting slurry flowed from the bottom of the loading plate and the lower part of the slope surface simultaneously, as shown in [Figure 5](#).

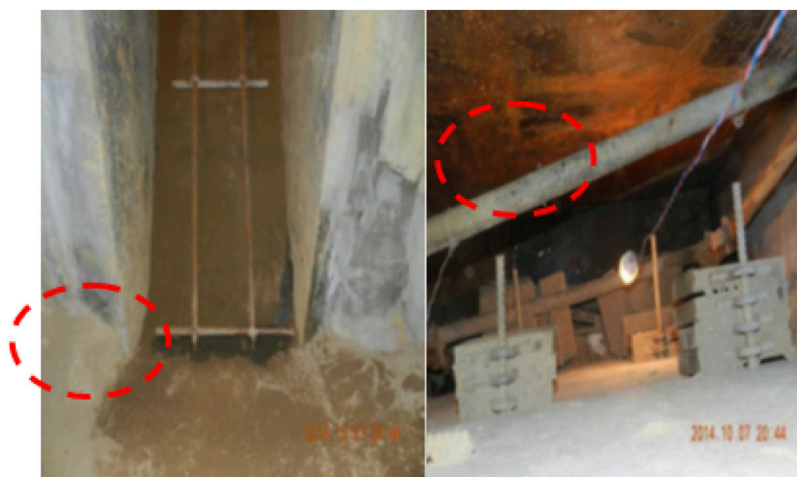
FIGURE 5

Slurry emerging from the bottom of the loading plate and the lower part of the slope at the same time in the second group of experiments.

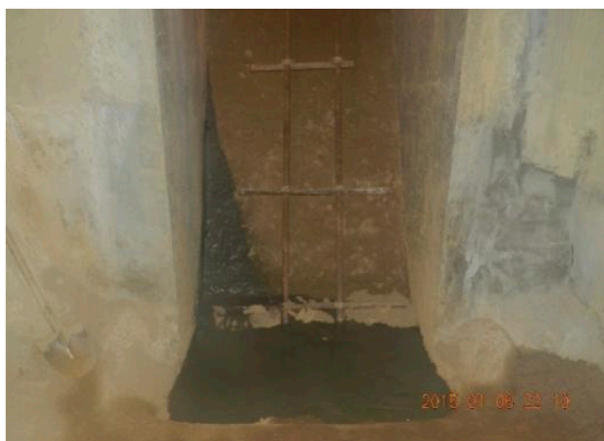
FIGURE 6

Slurry emerging from the lower part of the slope in the third group of experiments.

secondary splitting pressure reached 6 MPa within 30 s after the splitting began, and then the pressure quickly dropped to 0–2 MPa, implying that the primary grouting body was split successfully. The splitting time lasted 14 min, and the slurry feed exceeded 1.3 t. The test was terminated after the splitting slurry flowed from the lower part of the slope surface simultaneously, as shown in [Figure 6](#).

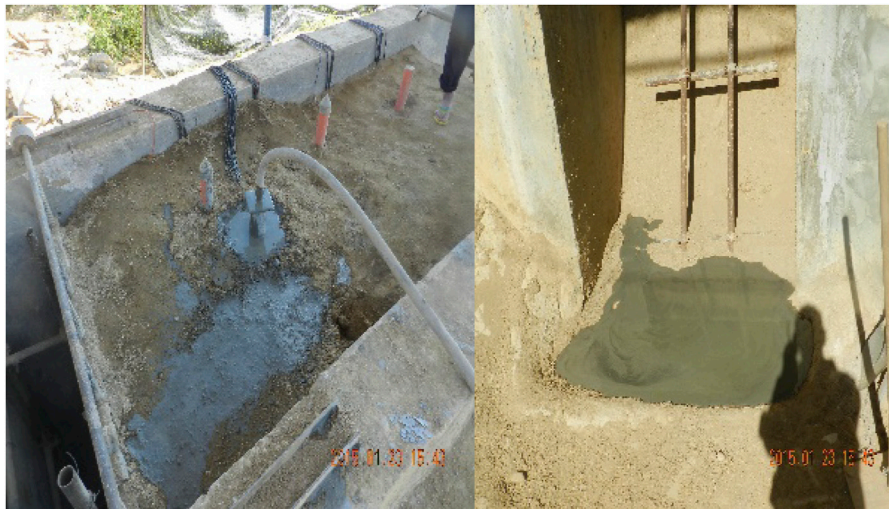
FIGURE 7

Slurry emerging from the top and bottom of the slope surface in the fourth group of experiments.

The interval between the first and second grouting in the threaded casing connected steelcasing connected steel-tube grouting test of the fourth group was 7.5 h. The secondary splitting pressure reached 6 MPa within 30 s after the splitting began, and then the pressure quickly dropped to 0–2 MPa, indicating that the primary grouting body was split successfully. The splitting time lasted 11 min, and the slurry feed exceeded 1.4 t. The test was terminated after the splitting slurry flowed from the bottom of the loading plate and the lower part of the slope surface simultaneously, as shown in [Figure 7](#).

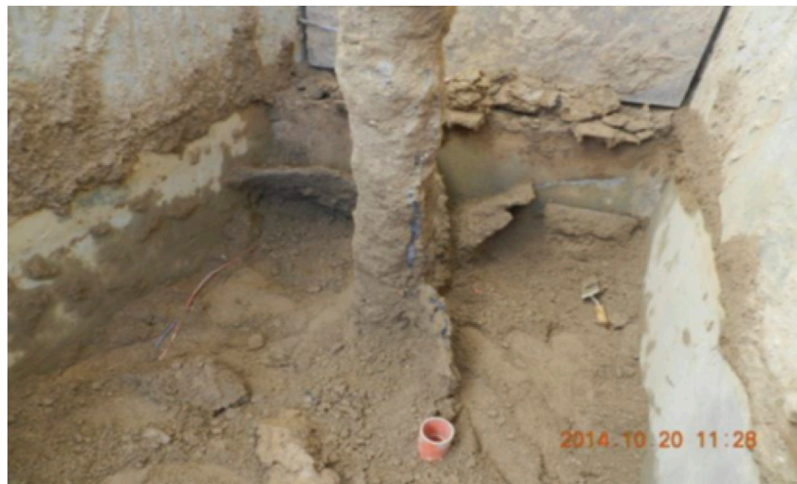
FIGURE 8

Test slurry formed a "tree root" cement column in the lower part of the pile.

The filling in the model tank was excavated after these three groups of tests were completed. The slurry was mainly distributed in the lower part of the sliding surface through the second split grouting. The bodies were joined together, and a “root-shaped” cement column formed at the bottom of the pile, as shown in [Figure 8](#).

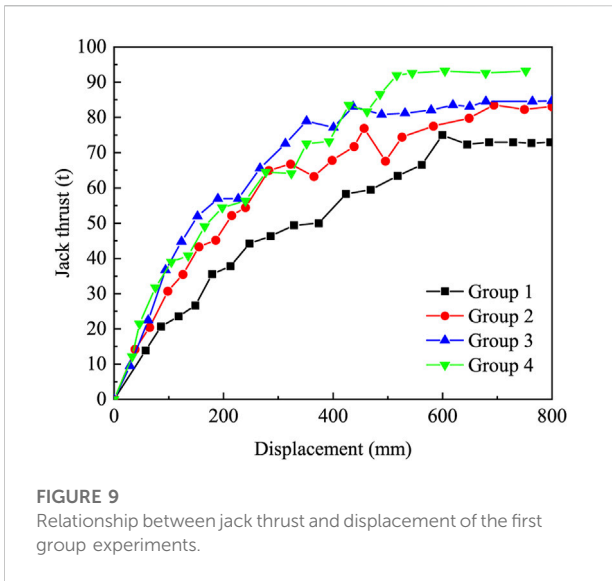
Through the analysis and comparison of the loading plate displacement and horizontal thrust in the four groups of tests (as shown in [Figure 9](#)), the test soil entered the plastic state after about 20 times thrust loading in the no-pile test, the single pile test, the single pile welding connection test and the single pile

casing connection test. The horizontal thrust at this time was considered to be the landslide thrust required for the plastic failure of the tested slope soil. The four groups of tests had roughly the same trend of the displacement curve under the action of horizontal thrust. After the soil body entered the plastic state, the landslide thrust was 72.9 t in the no pile test (the first group). Setting a single pile of the whole steel tube in the model (the second group) would make an increase of the landslide thrust to 83.3 t. The landslide thrust with the welded steel tube (the third group) was increased to 84.7 t. The landslide thrust

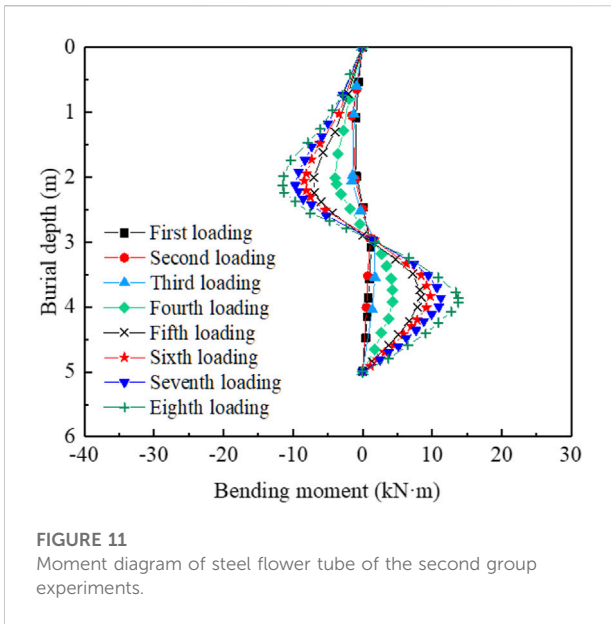
The bending moment distributions in the three groups of tests were similar, basically forming S shapes. The upper and lower parts of the sliding surface close to the loading plate side were compressed and tensioned, respectively. The maximum bending moment above the sliding surface was 2.0–2.5 m from the top. The maximum bending moment below the sliding surface was about 4.0 m from the top. The strain gauge was damaged after the eighth loading process (loading displacement: 144.2 mm; displacement at the top of the steel tube: 115.3 mm) in the second group of tests. At this time, the maximum bending moment of the steel-tube pile occurred at a position 4 m from the top, and its value was about 13.3 kN·m when the strain gauge failed. The whole pile steel tube exhibited 54.73% of the bearing capacity of the steel tube, shown in Figure 11.

The steel tube was used in the second, third, and fourth groups of tests. The bending moment of the steel-tube pile could be acquired by the inversion of the above calculation method, and the diagrams of the variations of the bending moment of the steel-tube pile during the test loading are shown in Figures 11–13.

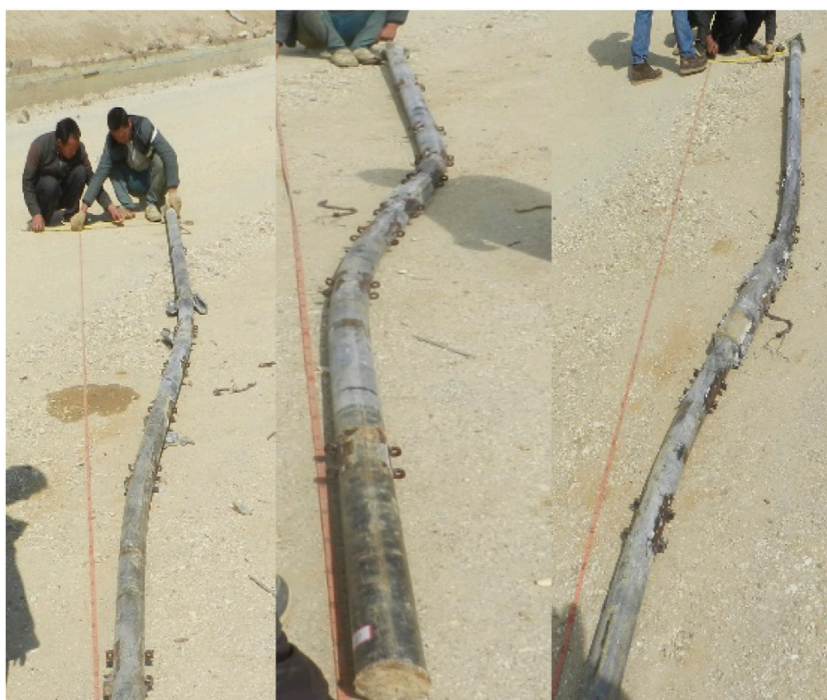
FIGURE 14
Steel flower tube failure of the second, third, and fourth group experiments.

To observe and study the stress condition and failure mode of the steel tube, the slope body was excavated after completing the tests in the second, third, and fourth groups of tests. All three sets of steel tubes were bent under the landslide thrust, and bending failure occurred at the position of the sliding surface.

In the second, third, and fourth group, all the steel tubes suffered bending failure. While the steel tube in the fourth group was subjected to a larger bending moment, and the maximum negative bending moment exceeded the ultimate bending moment of steel tube. This can mainly due to the diameter of the steel tube increased by the casing connection. As shown in [Figure 14](#), although the steel tube in the fourth group withstood a larger bending moment, the bending degree at the time of failure was much lower than that of the third group (welding connection). Therefore, the steel tube connected by the casing had better bending resistance.
