Research on the dismantling of double-arch tunnel after long-term service—the case study of Huangmeishan Tunnel demolition project

Xinyu Kou¹, Xiaojun Li¹, Jiangning Xie², Adili Rusuli¹, Tao Li¹ and Yi Rui^{1*}

¹Department of Geotechnical Engineering, Tongji University, Shanghai, China, ²Anhui Transportation Holding Group Co., Ltd., Hefei, China

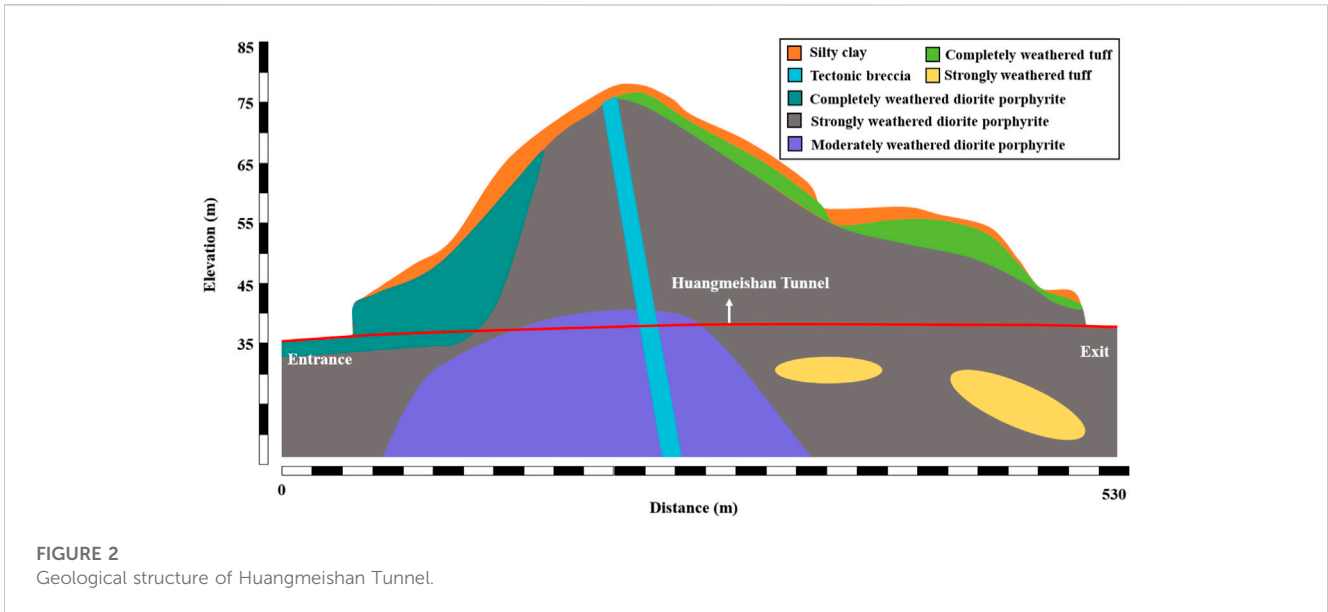
FIGURE 2 Geological structure of Huangmeishan Tunnel.

The Huangmeishan Tunnel was located at the central part of the southern section of the Ningyan Volcanic Depression in Yangzihuai Terrace. The overlying soil comprised primarily of artificial fill and Quaternary Holocene alluvium. The basement strata mainly consisted of Upper Jurassic Tuff and Yanshanian epidote andesite. The surrounding rock was severely weathered and the rock quality was poor. The main lithology that the tunnel passed is shown in Figure 2. The tunnel area suffered from frequent flooding due to the heavy rainfall and cloudy weather from late June to early July each year.

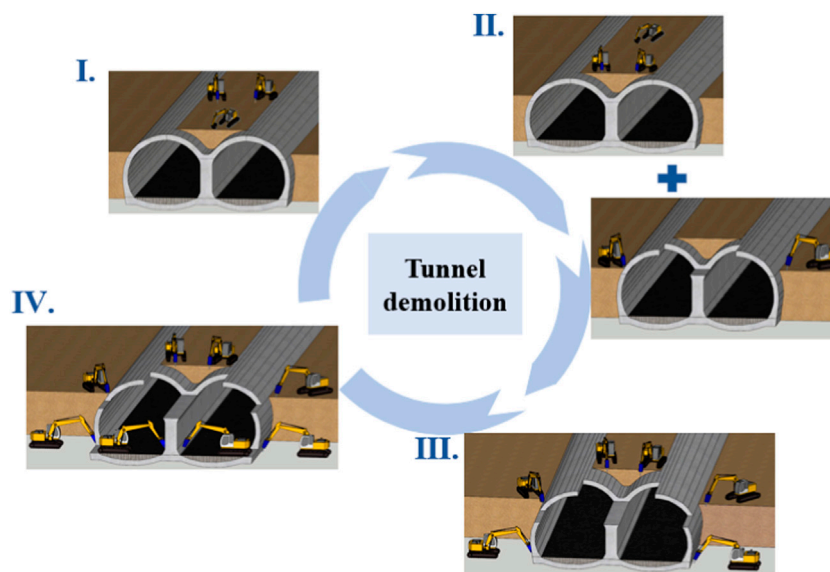
FIGURE 5
The demolition process of each section.

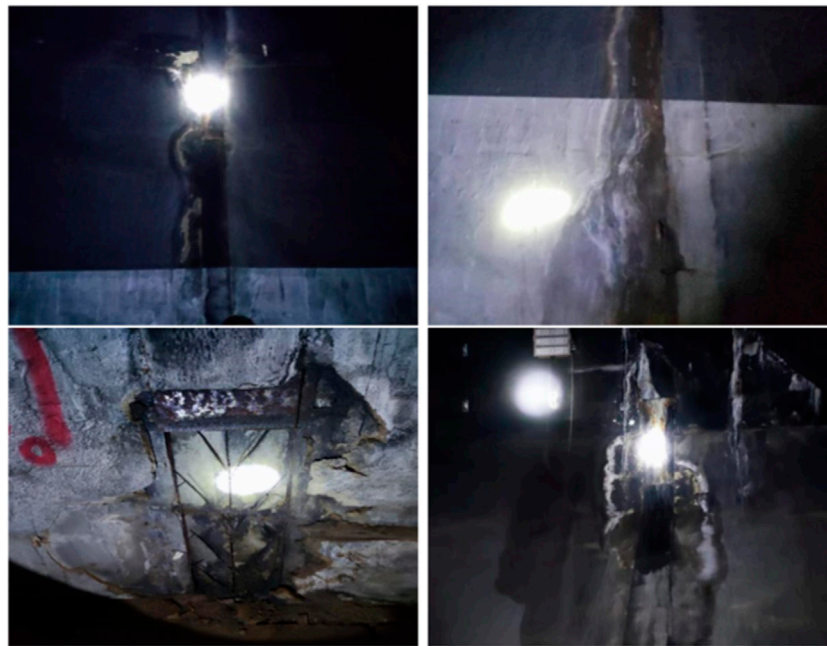
FIGURE 8
The image of water leakage disease in Huangmeishan Tunnel.

Preliminary studies indicated that the Huangmeishan Tunnel was leaking severely and extensively. Figure 8 shows the scene image of water leakage in the Huangmeishan Tunnel. Figure 9 gives the distribution ratio of water leakage area in the tunnel. Figure 10 presents the distribution of water leakage along the tunnel axis.

81 instances of water leakage were found in the left line of the Huangmeishan Tunnel, all of which were distributed in the haunch and side wall of the right tunnel. 76 instances of water leakage were found in the right line of the tunnel, with 89.5% of them occurring in

the haunch and side wall of the left tunnel. This shows that the water leakage in the partition wall area of Huangmeishan Tunnel is significant. The waterproof design of the mid-partition wall is a key point during the construction of the double-arch tunnel (Shi et al., 2020).

The reasons for this phenomenon are various, such as design factors, construction factors, hydrological factor, and crack diseases. The mid-partition wall of the double-arch tunnel was in the shape of the letter Y. Water seepage within the mountain was collected above the mid-partition wall, resulting in frequent cracking and water leakage. Figure 11 presents the exposed tunnel drainage pipes after the lining structure is removed, which are severely clogged. Clogging of the drainage system was caused by various factors such as concrete leakage during construction, the deposition of crystals from chemical reactions and the degradation of the degradation of drainage pipe performance (Zhang et al., 2022).

In the treatment of water seepage, instant sealants and high-performance waterproofing agents are used for direct sealing. A 1–2 mm thick cement-based penetrating crystalline waterproofing material is applied within a minimum range of 40 cm around the water seepage point. The treatment method for water leakage defects is correlated with the location of the leakage. Table 5 provides the treatment methods for different locations of water leakage.

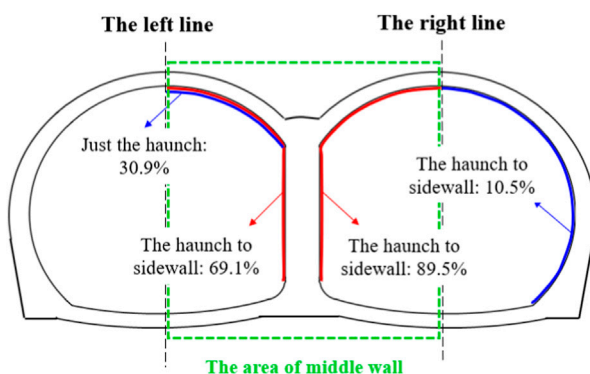
FIGURE 9
The distribution ratio of water leakage area in tunnel.

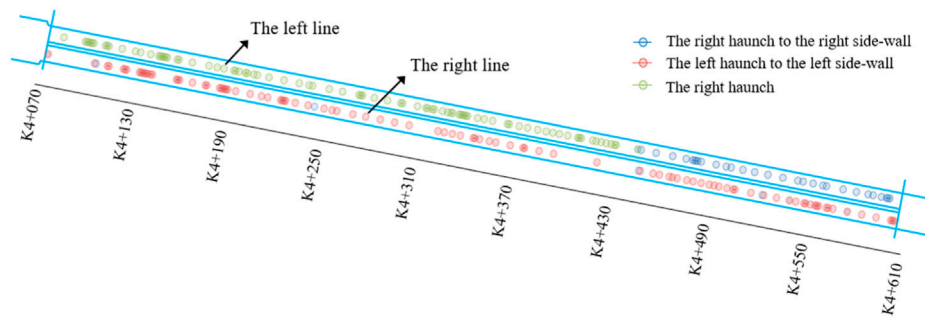
FIGURE 10
The distribution of water leakage along the tunnel axis.

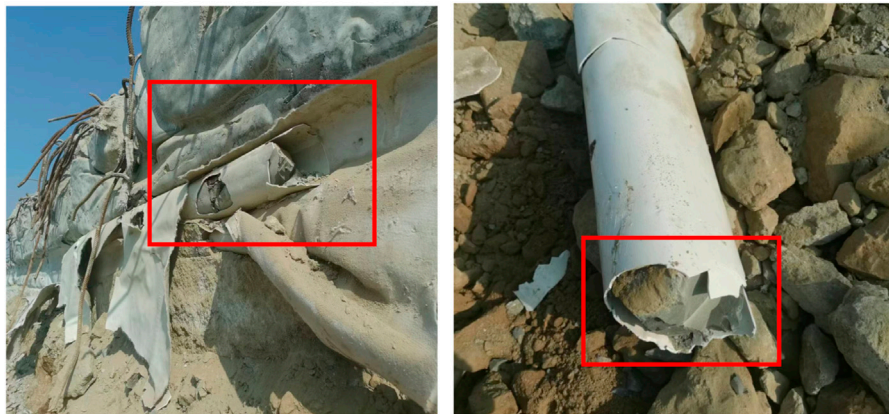
FIGURE 11
The clogged drainpipe in the Huangmeishan Tunnel.

The extent of damage caused by blocked drains was extensive and harmful. The pressure on the support structure increased due to groundwater collecting above the tunnel, potentially leading to cracks in the support structure. A total of 47 cracks were found in the left line of the Huangmeishan Tunnel, with 68.09% of them simultaneously leaking water. Ensuring the quality of tunnel construction is essential to prevent concrete or cement from clogging the drainage system during construction.

Therefore, when constructing tunnels in areas with high groundwater levels, new types of drains can be employed to minimize water seepage and leakage issues, such as siphon drains and drains under electromagnetic fields (Zhou et al., 2018). Siphon drainage pipes prevent blockages caused by particle deposits through separating water and soil, and pipes under electromagnetic fields can prevent the formation of crystals.

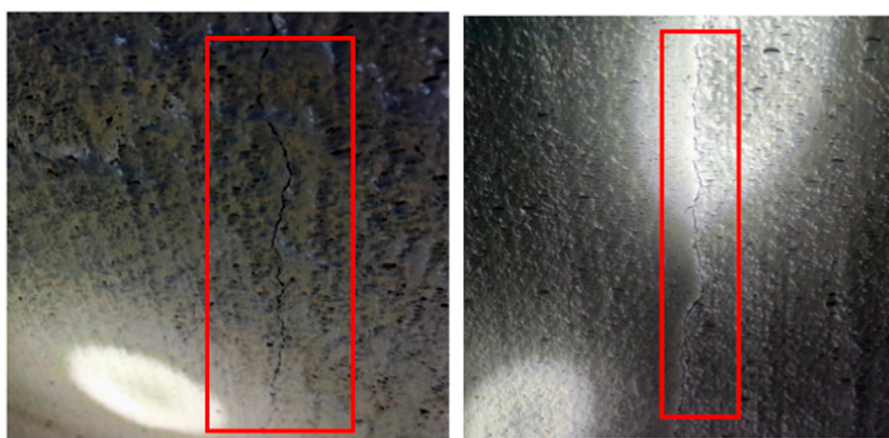
FIGURE 12
The image of crack disease in Huangmeishan Tunnel.

Figure 12 presents the image of crack disease in Huangmeishan Tunnel. Figure 13 gives the distribution ratio of crack disease in tunnel. Figure 14 shows the distribution of crack disease along the tunnel axis. During the crack disease detection in the Huangmeishan Tunnel, a total of 46 cracks were monitored in the left line. Among these, 1 crack occurred in the left side-wall, 42 cracks occurred from the left side-wall to the right side-wall, and 3 cracks occurred in the right side-wall. In the right line, 13 cracks were monitored, and all of them occurred from the left side-wall to the right side-wall.

Tunnel cracks may be caused by water leakage. Take the left line as an example, 32 cracks were found to be leaking water, accounting for 68.09% of the crack issues and 39.51% of the water leakage issues. The clogging of the tunnel drainage system accelerated the formation of sediments in the water. The lining was subjected to

Different widths of cracks require different treatment methods. The assessment of cracking is needed as it can be a serious structural issue and risk life. For cracks that do not jeopardize structural safety, Table 4 suggests the recommended treatment methods for cracks of different widths.

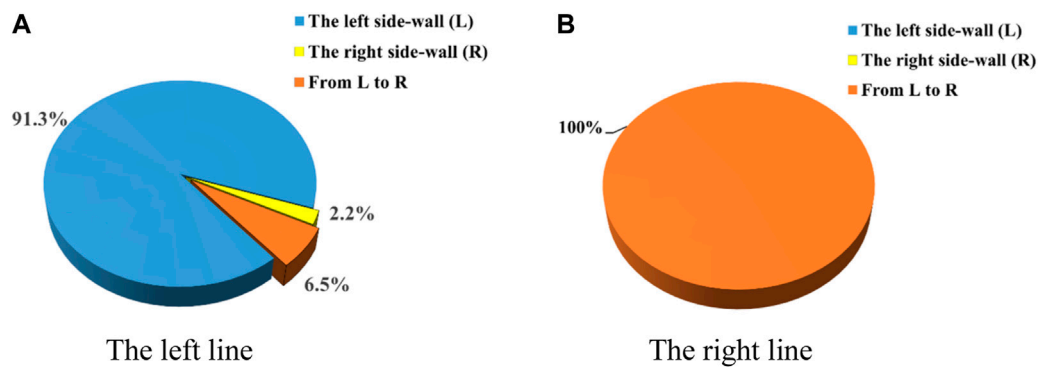
FIGURE 13
The distribution ratio of crack disease in tunnel. (A) The left line. (B) The right line.

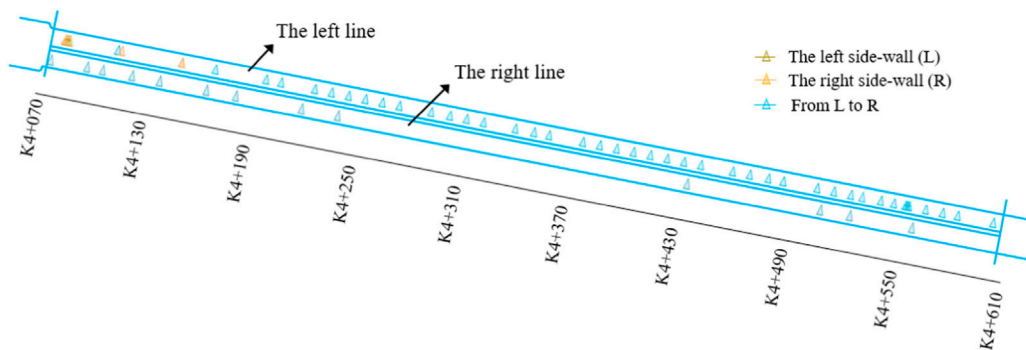
FIGURE 14
The distribution of crack disease along the tunnel axis.

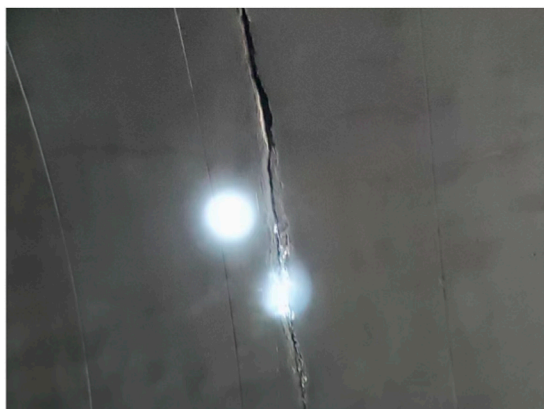
FIGURE 15
Crack at section YK4+576.

Most cracks have a length of less than 10 m and a width of less than 1 mm. The widest crack detected was found at section YK4+576, measuring 15 mm in width (as shown in Figure 15). It is worth noting that all the existing cracks in the Huangmeishan Tunnel were caused by construction joints.

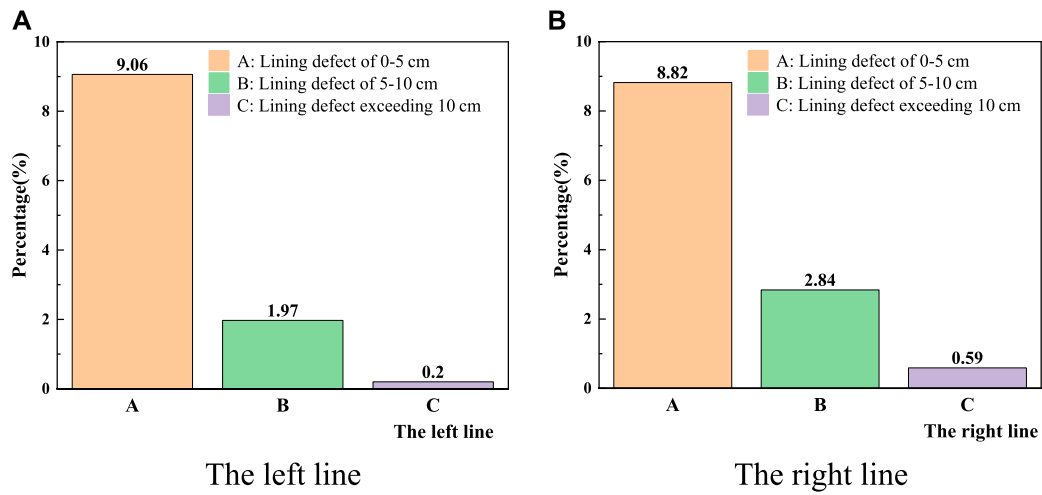
FIGURE 16 The percentage of insufficient lining thickness at the entrance of Huangmeishan Tunnel. (A) The left line. (B) The right line.

These results indicate that the thickness of the secondary lining in the Huangmeishan Tunnel fails to meet the requirements. Several factors may have contributed to this issue, including poor construction methods, limited construction monitoring, and inexperienced workers ([Lu et al., 2019](#)). Insufficient excavation during tunnel construction and untimely construction of the secondary lining may result in lining defects. This untimely construction could lead to significant deformations in the lining, and the inner contour of the primary lining exceeding the expected contour ([Lu et al., 2021](#); [Jiang et al., 2023](#)). Inadequate thickness of the lining can cause stress redistribution, reducing the stiffness of the lining and increasing the risk of collapse ([Liu et al., 2020](#)).

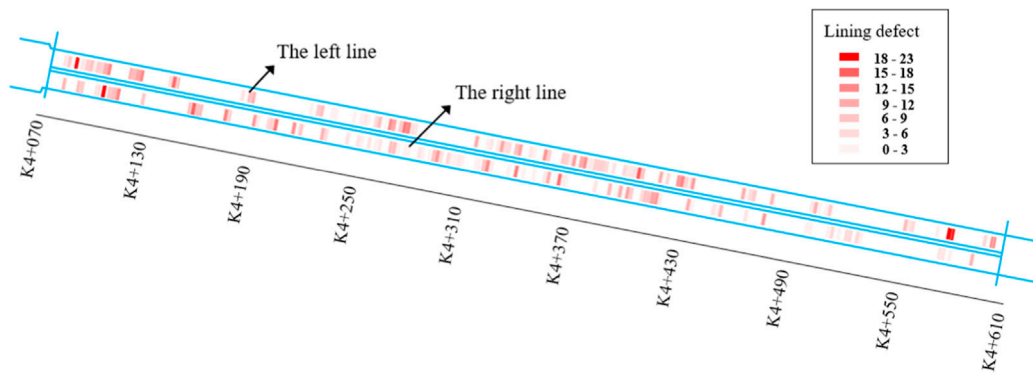
FIGURE 17 Distribution of insufficient thickness of the second lining along the axis of Huangmeishan Tunnel.

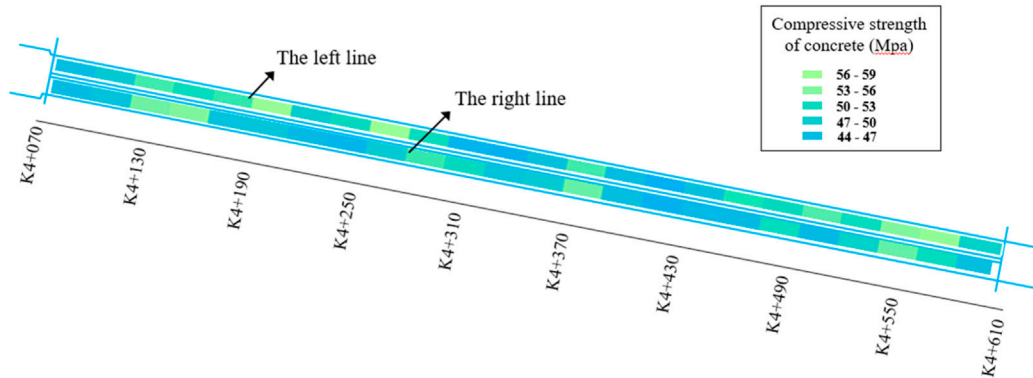
FIGURE 18 The distribution of concrete compressive strength along the tunnel axis.

The distribution of concrete compressive strength along the tunnel axis is shown in [Figure 18](#). The minimum values of concrete compressive strength often occur at the tunnel entrances or at the deepest part of the tunnel. This is primarily due to the susceptibility of the entrance section to environmental erosion, leading to degradation of the structural performance. Additionally, the

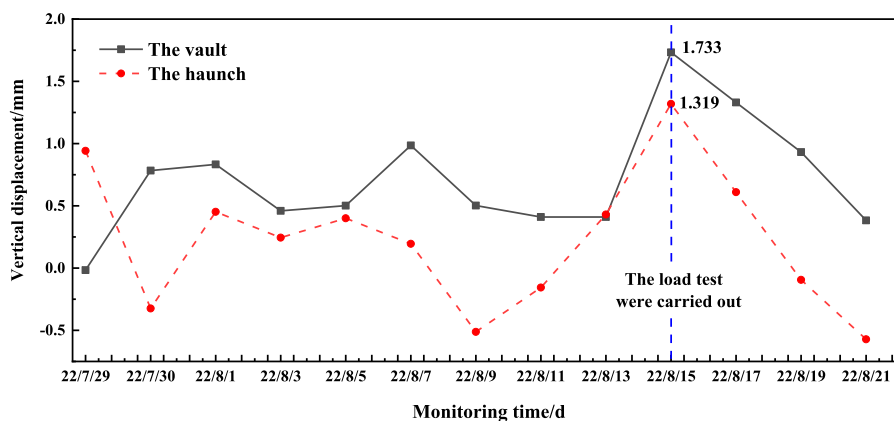
FIGURE 19 The time curves of the vertical displacement at the vault and the haunch at section ZK4+512.
