Failure mechanism of loess landslide induced by water stagnation on the combined surface

Dayong Hou¹, Farong Zeng¹, Junfeng Deng², Huan Wei² and
Rui Xu^{2*}

In order to reveal the destructive mechanism of loess landslide induced by stagnant water on the combined surface, and to clarify the influence of the main control factors, this paper takes a typical loess landslide in northern Shaanxi as the research object, analyzes the structure of the rock and soil body, and the excavation and filling construction through the geohazard survey, and analyzes the process of traction sliding caused by the stagnant water on the combined surface at the different stages of the project by combining with the calculation of the stability of the slope body. Further the article analyses the process of traction sliding caused by water on the combined area due to construction by means of a discrete element model, and delves into the mechanism of strength reduction of saturated loess. The results show that: 1) the combined surface stagnant water type loess landslide has the characteristics of sudden sliding and rapid evolution, which is highly hazardous and difficult to prevent and control; 2) the slope

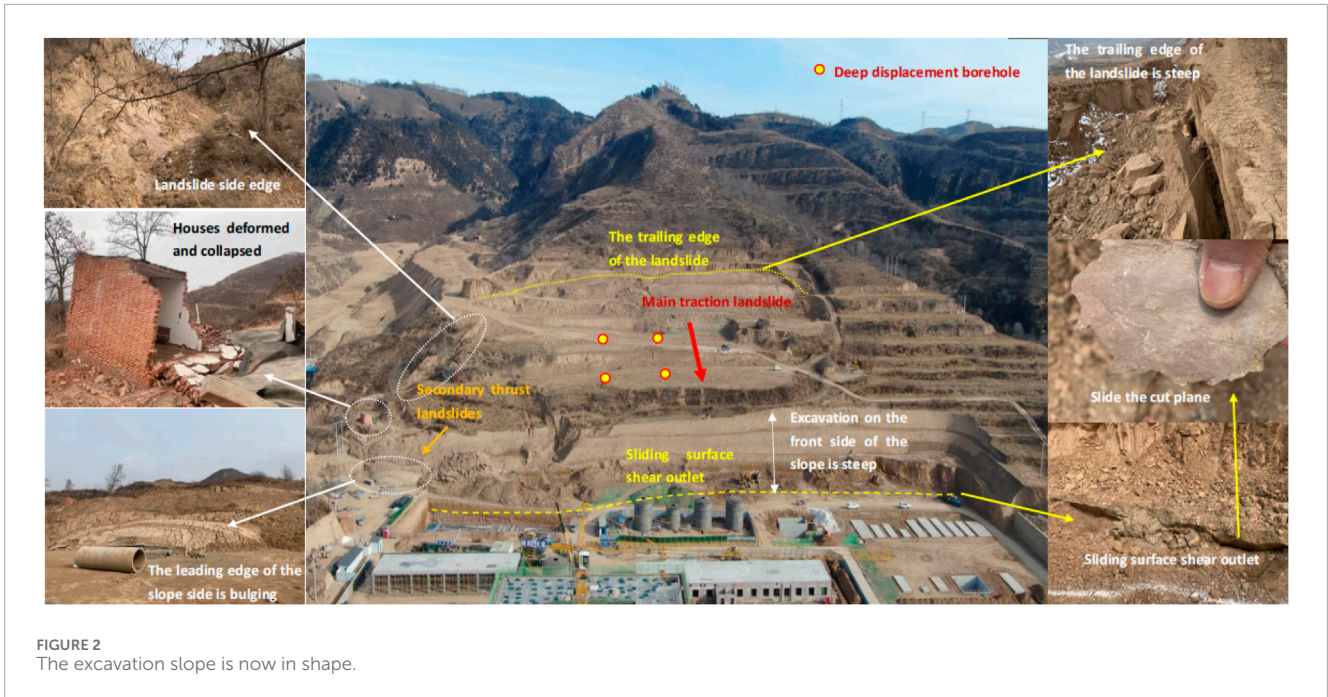
As shown in Figure 2, due to the construction of the section of the front edge of the landslide excavation, clearing the ancient landslide leading edge of the slip blocking section of the slide, resulting in the stabilization of the ancient landslide re-sliding, traction landslide deformation and destruction of the signs of obvious, only in the southwest side of the front edge of the slope local area due to the influence of the main body of the landslide pushed, the formation of a small secondary transfer type of landslides, and the formation of ground bulge bulging in the front of the edge of the slope. The entire landslide is generally a “chair” shape, and the perimeter is obvious. The front edge of the slide shear outlet in the artificial excavation surface has continuous distribution, and shows anti-dipping out of the wrong, the back edge of the tension cracking, and the formation of steep cans. The surrounding slip surface is smooth, and the scuff marks are visible.

FIGURE 2
The excavation slope is now in shape.

The location of the deep displacement measurement holes is shown in Figure 2. Representative monitoring results are shown in Figure 3. The deep displacement monitoring about half a year after the landslide occurred (February 2022) shows that the landslide body still has obvious and continuous deformation, and the destabilization damage potential of the slope body is still serious. As can be seen from the figure, the cumulative lateral horizontal displacement curve along the depth change in the measured hole, the lateral displacement at 14.5 m below

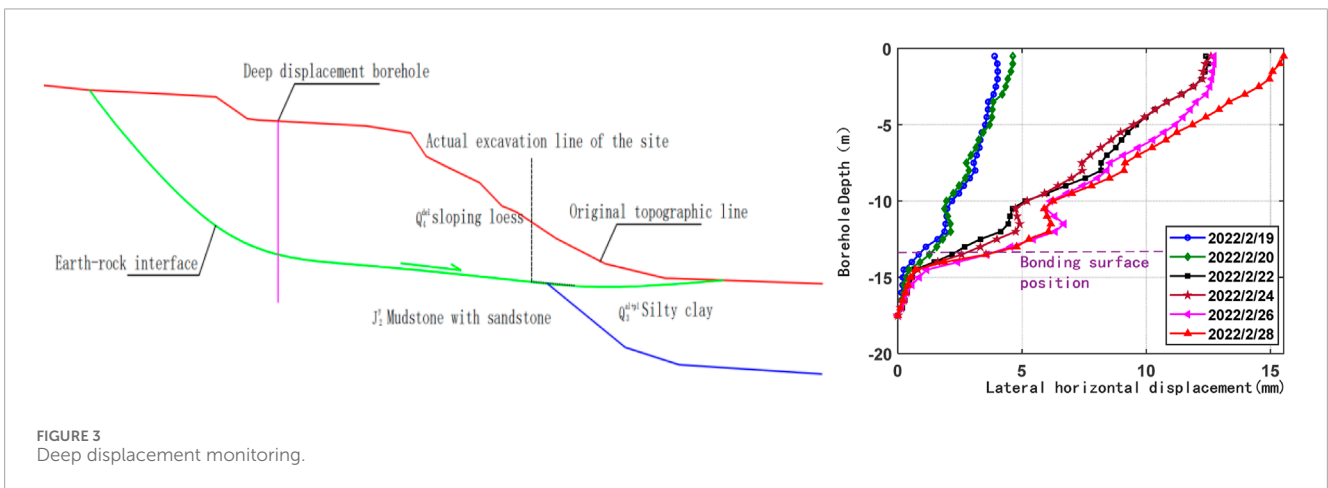
FIGURE 3
Deep displacement monitoring.

the ground surface of the lateral displacement occurs a large sudden change, the cumulative lateral horizontal displacement up to 5 mm, the lateral displacement below the place is small, above the displacement is larger, and the maximum cumulative lateral horizontal displacement within 10 days is as high as 16 mm, which indicates that the soil in the location near the combined surface has formed a more obvious sliding surface, which is in line with the engineering geological stratigraphy revealed by the engineering geology.

The deep displacement data in Figure 3 verifies that the landslide is located near the soil-rock combined surface, which is consistent with the location of the exposed sliding shear surface around the slope found in the field investigation shown in Figure 2, indicating that the landslide is a traction soil-rock combined surface landslide induced by engineering excavation at the foot of the slope, which is commonly found in the loess area of northern Shaanxi.

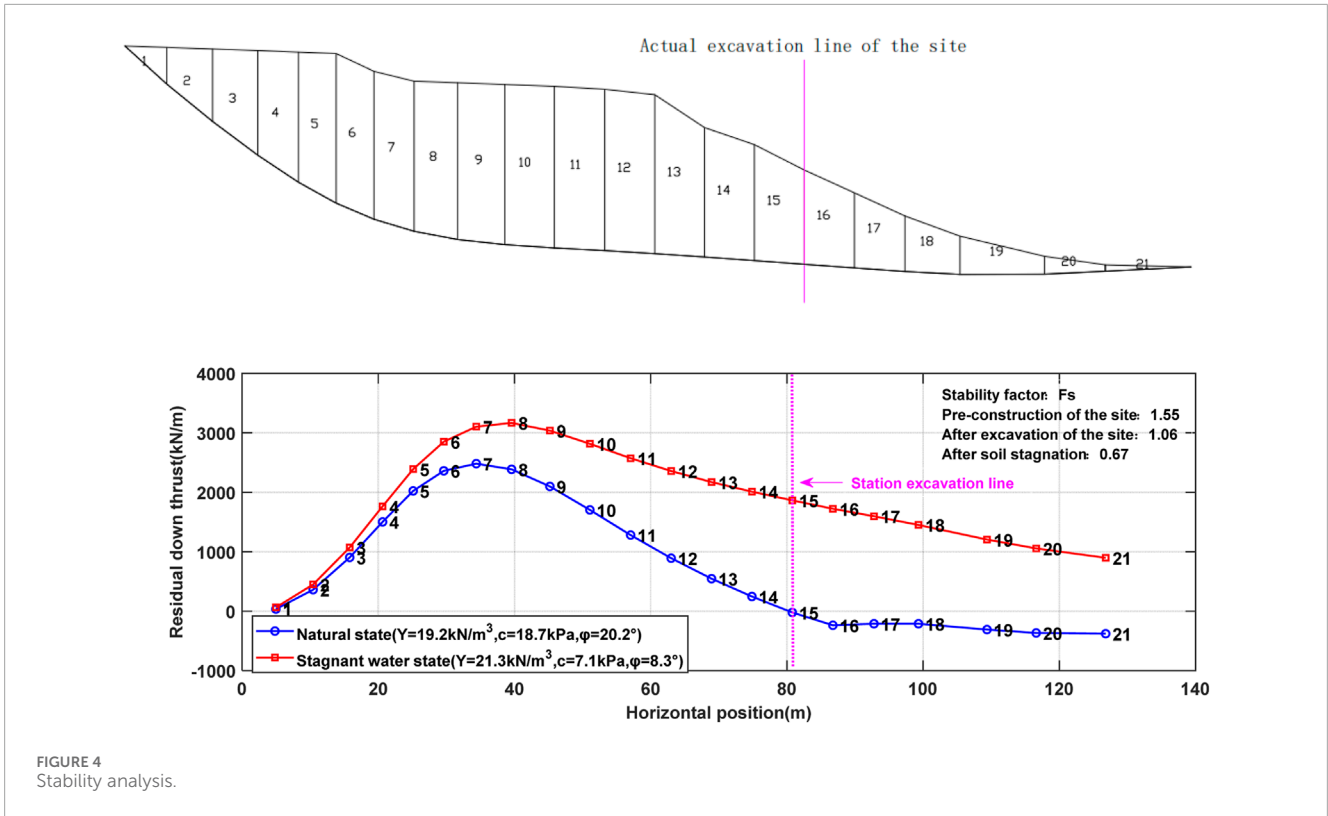
FIGURE 4 Stability analysis.

Based on the mechanical mechanism, this study conducted an in-depth analysis of the causes of landslide deformation based on the Design Code for Landslide Prevention and Control (GB/T 38509-2020) (Ministry of Natural Resources.GB/T 38509-2020, 2020) and executed a stability calculation of the landslide body. Using data from the geotechnical investigation report before July 2021, a computational profile model was established based on the test results of 112 *in-situ* soil samples (see Figure 4). The landslide control project was designated as Class I. Natural working conditions were simulated, and the unbalanced thrust transfer method was used to assess the stability and calculate the thrust (see blue line in Figure 4).

The calculation shows that the stability coefficient of the original slope is 1.55, which meets the stability standard and is consistent with the actual stable state of the slope before construction. However, the excavation caused by the construction of the field station resulted in the stability coefficient dropping to 1.06, and according to the code, the present slope body is in an unstable state and does not meet the safety requirements. In addition, the analysis of the residual sliding force after excavation showed that the actual excavation line was at the critical position where the residual sliding force changed from positive to negative, which was consistent with the stability coefficient critical value near 1.0, indicating that the slope

As can be seen in Figure 4, the stability coefficient of the current slope after excavation is near 1, which is close to the critical state of sliding damage, and the stability of the slope is evaluated as unstable. However, as shown in Figures 2, 3, the actual deformation and damage state of the landslide, and its continuous deformation process, indicate that the real stability of the slope body should be unstable, so only considering the effect of excavation at the foot of the slope cannot fully explain the occurrence of the landslide and its scale.

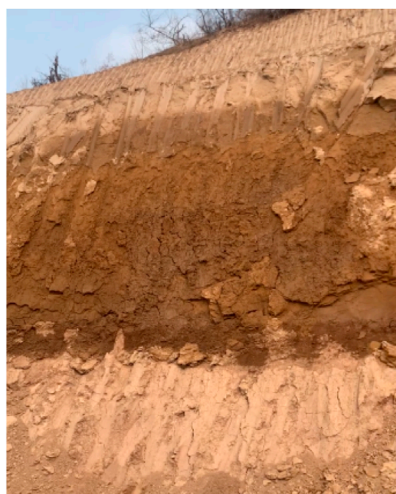
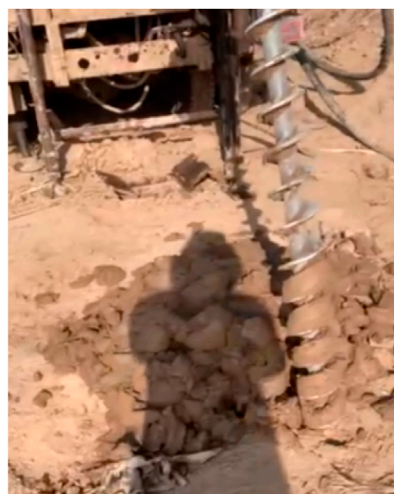
FIGURE 5

As shown in Figure 5, the field engineering investigation in February 2022 found that there was a saturated soil belt about 1–2 m high in the upper loess layer of the shear exit at the leading edge of the landslide, which was continuously exposed and distributed along the excavation of the foot of the slope. The water content of the soil is large, the soil is almost saturated, and it is a soft-plastic to fluid-plastic state. From the drilling process of the deep displacement borehole in the middle of the slope shown in Figure 3, it can also be found that the soil samples taken near the soil-rock combined surface are also saturated (Figure 4), which indicates that near the soil-rock combined surface of the landslide body, the water content of the soil is abnormal, and there is a saturated soil zone. Therefore, we should consider the possibility of landslides induced by the combined effect of stagnant water on the combined surface and excavation at the foot of the slope after the construction of the project.

(a) Outcropping of stagnant water at the foot of a steep slope

(b) Saturated loess in a deep displacement borehole

Water stagnation of soil-rock interface (A) Outcropping of stagnant water at the foot of a steep slope (B) Saturated loess in a deep displacement borehole.

As shown in Figure 5, after the construction of the project, the original geological environment was altered. There was stagnant water on the upper part of the soil-rock binding surface of the landslide body, which led to the saturation of the soil near the sliding surface and a significant reduction in its strength. This, coupled with the excavation at the foot of the slope, ultimately led to the formation of the landslide. However, a geotechnical engineering investigation conducted before the construction of the station in July 2021 found no obvious concentrated surface water system at the original site. Only temporary water flow appeared on the surface after rainfall, which flowed according to the inclination of the terrain elevation difference. The natural drainage conditions were favorable, and no groundwater was detected within the depth of exploration at each exploration point during the investigation period. Therefore, from a historical perspective, the possibility of the emergence of a long-term stagnant water layer on the slope, as shown in Figure 5, is extremely low. Moreover, the construction time of the station was in the fall and winter, during the dry season in northern Shaanxi. During this period, there was no significant record of precipitation in the field area, and no conditions existed for stagnant water in the upper layer of the slope formed by continuous infiltration of heavy rainfall.

The natural gullies on both sides of the landslide body serve as natural channels for surface water to converge and flow into the Luo River after rainfall, and they are also the primary pathways for groundwater discharge. Under natural conditions, groundwater from the slope body, including water from bedrock fissures, primarily exits through these natural gullies surrounding the slope body. Gully after large-scale filling project, due to the filling soil is mainly clayey silt or clayey soil, after filling compaction of low permeability, hindering the original groundwater drainage channel, resulting in bedrock fissure water accumulation, in the upper loess capillary phenomenon and other roles, seepage into the upper part of the soil layer on the combined surface, the formation of the combined surface stagnant layer shown in Figure 5.

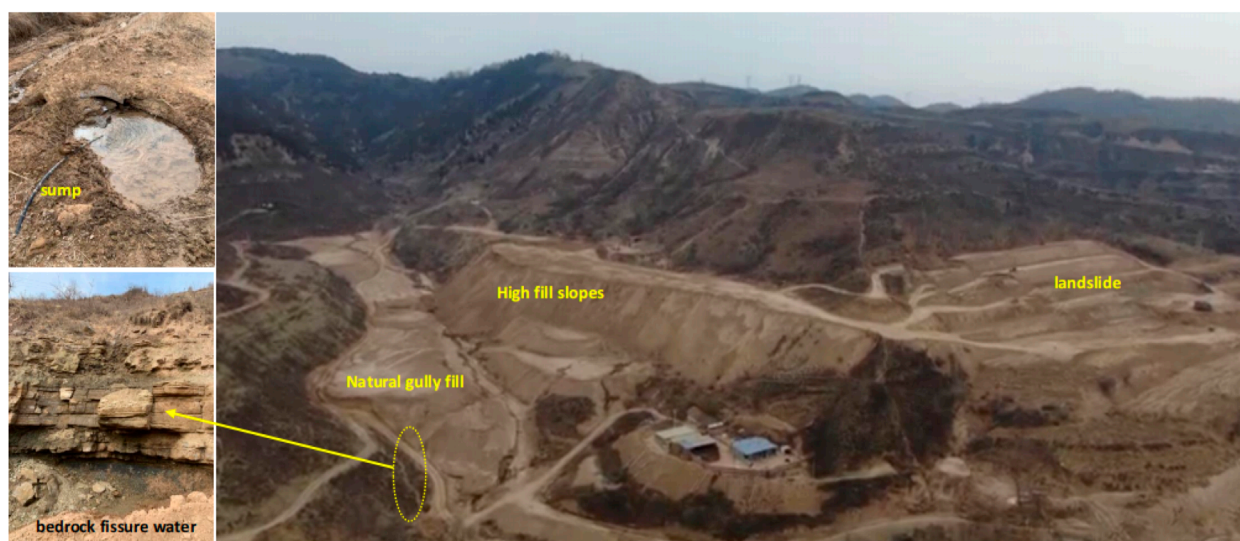
FIGURE 6
Overview of site filling works.

As depicted in Figure 6, during earthmoving operations in the site area, a substantial amount of earth was deposited in the natural gully on the side of the slope body, creating a large-scale gully filling site and a high filling slope adjacent to the landslide body. While the filling project serves to expand industrial or civil land significantly, it may also alter the hydrogeological conditions within the site area. As shown in Figure 6, on the other side of the natural side slopes within the gully that had not yet been covered by fill soil, there was significant bedrock fissure water outflow within the laminated mudstone or sandstone.

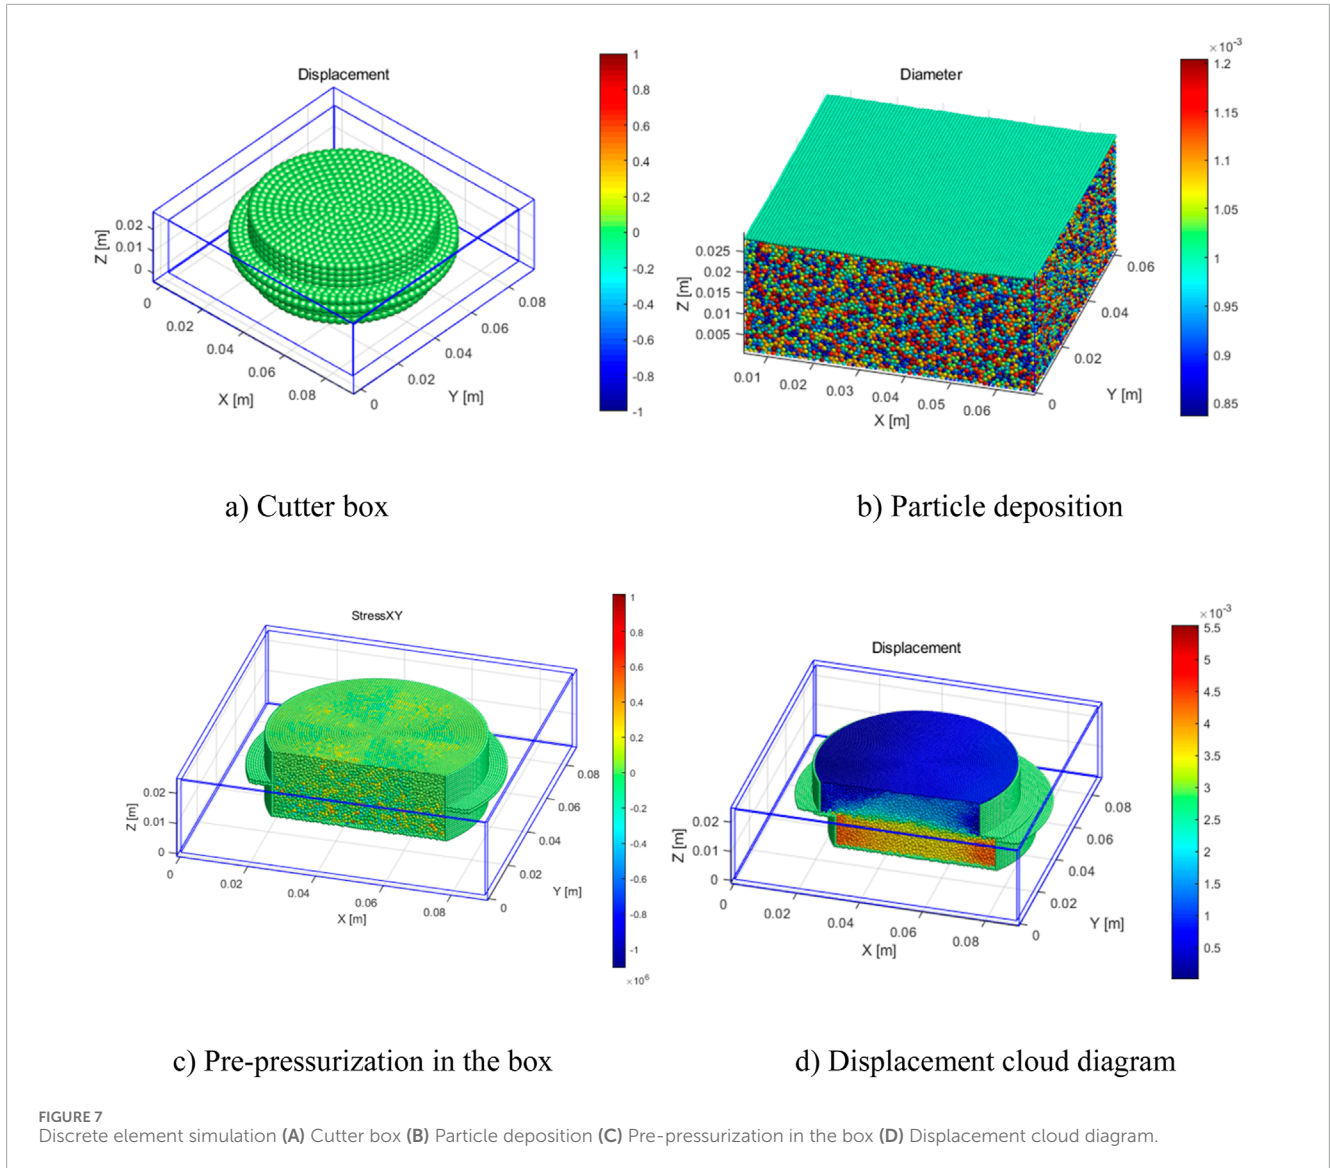
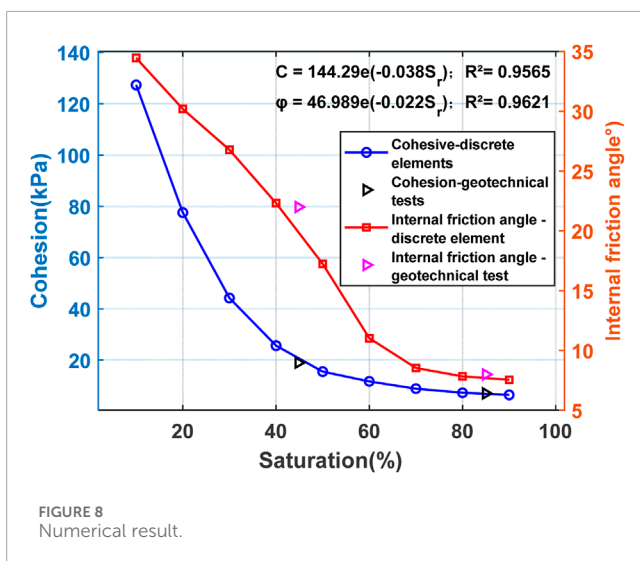
Through the discrete element model shown in Figure 7, the simulation results of consolidation fast shear of loess with different degrees of saturation shown in Figure 8 can be obtained, which are basically consistent with the results of consolidation fast shear in the test laboratory.

As shown in Figure 8, the soil body's cohesiveness decrease in the shape of an exponential function as the saturation degree increases, and the soil body's strength index reaches fundamental stabilization when the saturation degree exceeds 80%. In the actual project, the impact of water stagnation on the combined surface of the slope body would enhance the soil body's saturation level. According to the modeling results, this rise will result in a drop in the soil body's strength index, which would eventually cause macro-landslides. Compared with the traditional strength theory, as shown in Equations 1, 2, the discrete element model not only quantitatively explains the result of the decrease of soil strength due to the increase of loess saturation but also inverts the evolution of soil deformation and damage from a fine view, and explores the interaction characteristics between the particles and its deformation and damage mechanism, which is of universal significance in related research.

the distance between the box units is set to 70% of the radius. To make the specimen model study meet the unsaturated soil mechanical analysis, to obtain soil samples with different degrees of saturation at the macroscopic level, based on the matrix suction experiments of typical loess in Northwest China to obtain the function relationship between the water content of loess in the natural state and matrix suction (Wang and Tang, 2016; Ming-Jing et al., 2019), and to adjust the physical parameters under the corresponding particles to make quantitative changes to set up the effect of different degrees of saturation on the soil body structure. The model building and consolidation fast shear process includes original model stacking, shear box modeling, and shear completion. The data units in Figure 7 are all standard.

Adopting the strength index of soil body under different saturation degrees shown in Figure 8 as the calculation parameter, the stability safety coefficient of slope body under different working conditions shown in Figure 10 is calculated by strength discount method, which is basically the same as the specification calculation results shown in Figure 4. From the simulation results, after the excavation of the foot of the slope, there is no stagnant water on the combined surface, and the stability coefficient of the slope body is slightly larger than 1, which is close to the critical sliding state. With the beginning of the filling project, the original groundwater drainage environment of the site is changed. The water content of the soil near the combined surface begins to rise gradually. The saturation degree increases, resulting in the slope stability coefficient dropping rapidly to the critical state point of 1, and the slope body appears along the combined surface with a shear rupture surface. With the continuous development of the stagnant water on the combined surface, the combined surface forms a through-slip surface, the stability coefficient of the slope body continues to drop rapidly, and the slope body destroys rapidly. By analyzing the results of actual investigation and numerical modeling, it is found that the numerical simulation of FLAC3D can show the effect of water stagnation on the combined surface in a more graphic way, and confirms the mechanism of water stagnation on the combined surface inducing the damage of loess landslides.

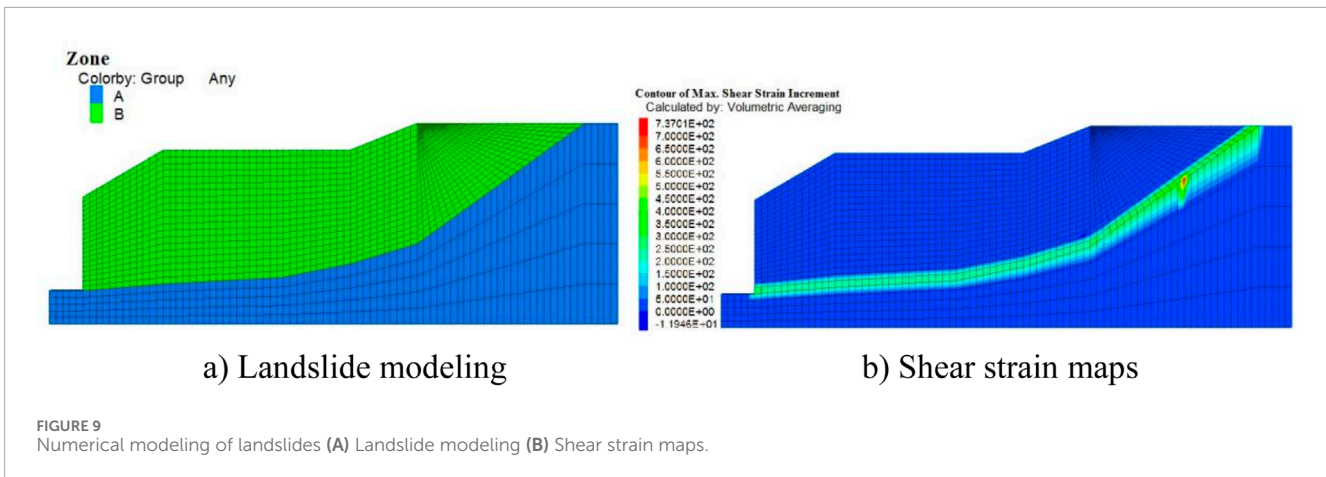
analysis, the FLAC^{3D} computational model was established after the excavation of the foot of the slope, as shown in Figure 9A. The simulation results found that the resistance of the leading edge of the slope body was relatively reduced after excavation, and local tensile stress and shear stress concentration phenomena appeared in the interior of the slope body due to traction sliding. As shown in the shear strain cloud diagram in Figure 9B, with the development of water stagnation in the bond surface, under this shear-tension stress environment, the maximum shear stress surface gradually forms a potential shear outlet along the bond surface, which will produce overall instability damage under certain conditions.
