Unveiling the prediction model and mechanism of the collapse of bank slope in the lancangjiang area

This study takes the bank collapse at the left bank of Badi Township of the Lidi Hydropower Station in the Lancang Area as an example. To address the lack of in-depth research on the prediction model and mechanisms of bank collapse, this study conducts field drilling surveys, investigates influencing factors, analyzes causal mechanisms, and proposes prediction methods based on the geological survey data of bank collapse in the reservoir area. The study explores the stratigraphic lithology, determines the key parameters for bank collapse prediction, and studies the failure modes and bank collapse mechanisms. It also proposes the finite element method of bank collapse to predict the width and elevation of bank collapse and provides the influence on the surrounding environment. The results show that the collapsed bank on the left bank of Badi Township is a high and steep soil-like slope, and forms the collapse and retreat type of failure mode after impoundment. The Kachukin method, the bank slope structure method, and the proposed finite element method are used to predict the width and

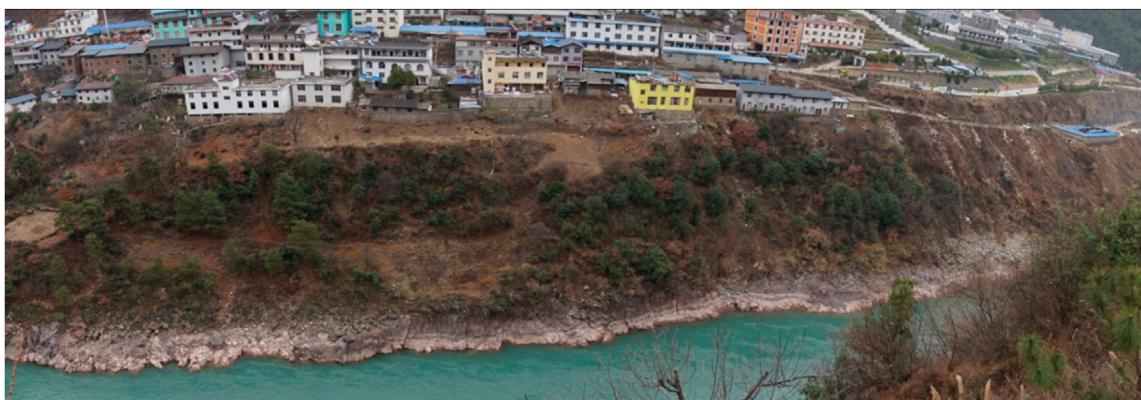
FIGURE 3
The topography of the left bank of Badi Township before the water storage.

The geomorphology before and after the water storage is shown in [Figures 3, 4](#).

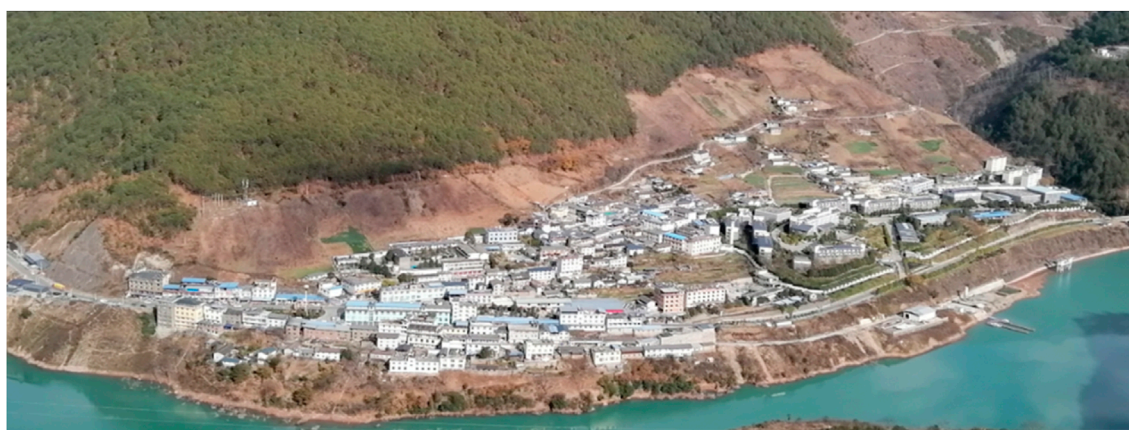
FIGURE 4
The topography of the left bank of Badi Township after the water storage.

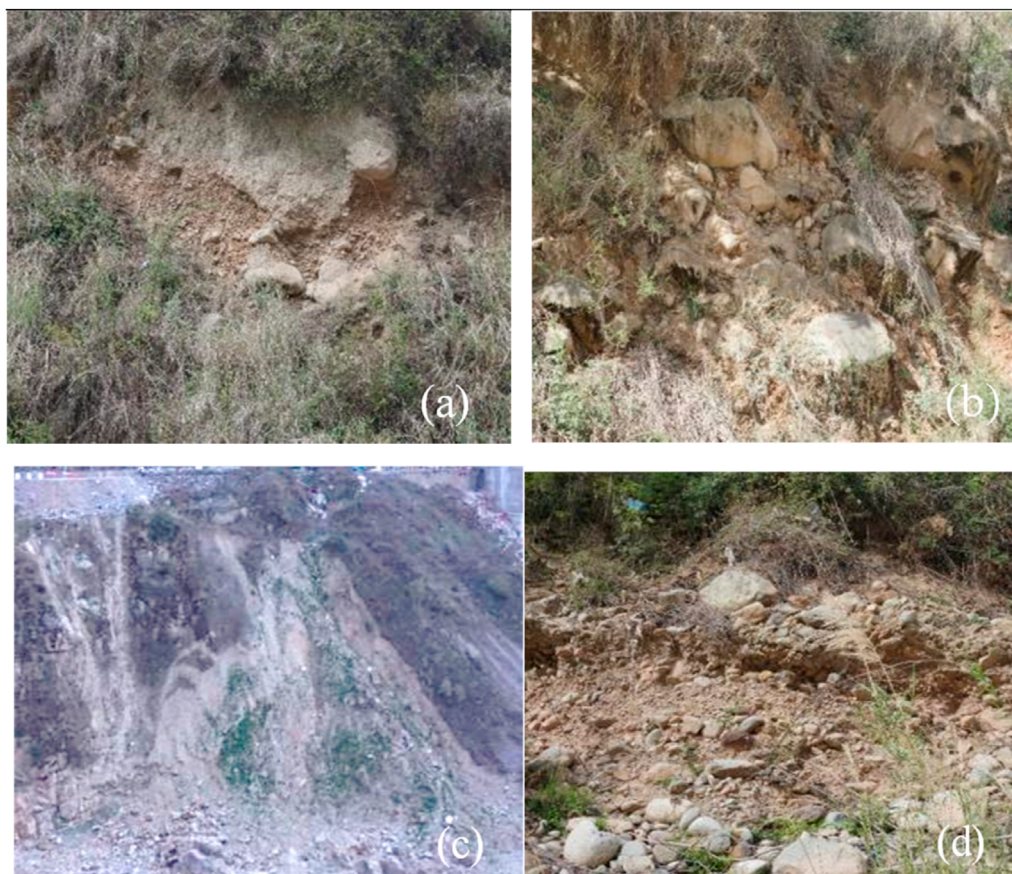
FIGURE 5
Overburden on the left bank of Badi Township. (A) The alluvial-diluvial strata exposed above; (B) The alluvial layer exposed at the edge of the highway; (C) The artificial accumulation next to the highway before water storage; (D) The alluvial sand and gravel along the riverbank before water storage.

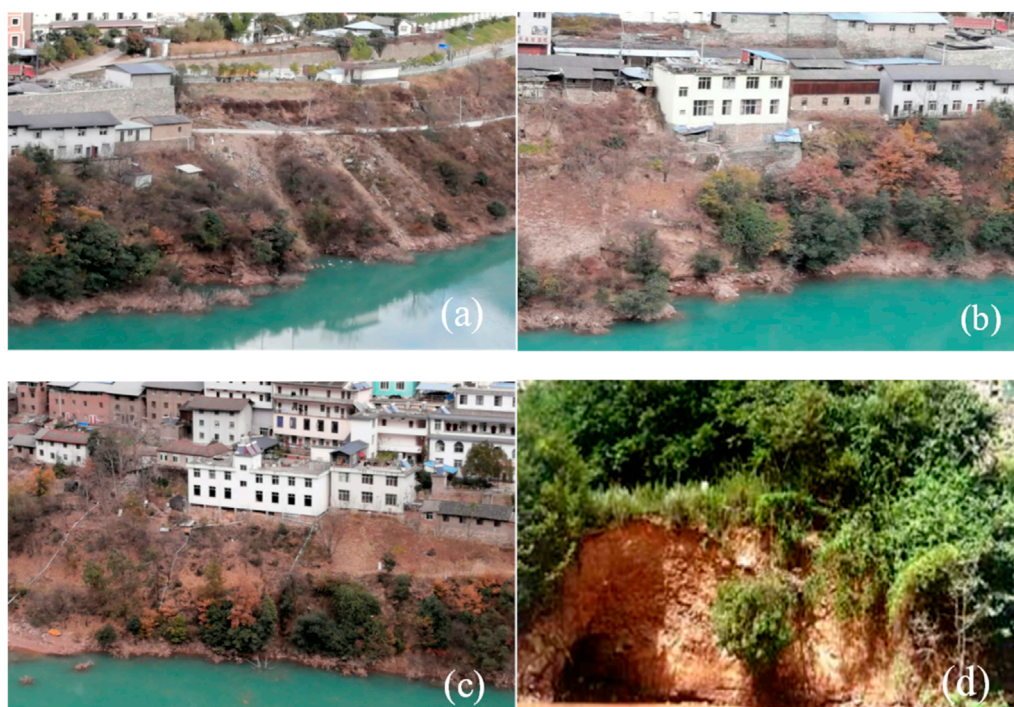
FIGURE 6

foundation of the upstream side terrace, and only occasionally reached the foot of the covering layer during high flood levels. When the water level was high on the downstream side, the flood temporarily submerged the first-level terrace, with overall scouring being relatively minor, and the overall stability of the bank slope remained stable for a long time. From the time of reservoir impoundment in 2018 to the start of the rainy season in 2020, this section was generally in a mostly stable state according to patrols and monitoring, and no evidence of bank collapse or deformation had been discovered. At the beginning of 2020, it was found that local erosion had formed a pit-like bank collapse on the slope, while a resident living on the downstream side reported that the soil occasionally collapsed into the water with a loud noise in front of their house, which they believed posed a threat to their living (Figure 6A). During the flood season in 2020, the bank collapse continued to develop, and the resident reported that the walls of their house had cracks and deformation (Figure 6B).

exceeding the range predicted earlier. According to the investigation, there are 6 pit-like depressions caused by bank collapse, distributed over a length of 230 m and usually extended into the bank slope-like pockets. The diameter of the pits is generally small, with an average mouth width of 3–5 m, extending into the bank slope by 5–8 m, and the collapse height above the water surface is 1–3 m. The distance to the nearest house foundation is generally 20–30 m (Figures 6A–C). The most severe part of the bank collapse is located below the aforementioned residential area, with 3 pits. The largest pit is elliptical on the plane, slanting towards the downstream right bank along the long axis, with a mouth width of about 6–8 m, and it extends into the bank slope up to about 10 m. The maximum collapse height is about 5 m, near the water surface of the local area, is inclined, and the distance from the bank collapse to the house foundation is about 12 m. Coarse particles are estimated to be exposed on the section, and the content of fine particles is relatively small (Figure 6D).

The geomorphological status of the bank collapsed on the left bank of Badi Township. (A) Bank collapse at the downstream side of the site; (B) Bank collapse in the middle of the site; (C) Bank collapse upstream of the site; (D) Bank collapse detail.

The analysis suggests that, given the current minor bank collapses and considering the proximity to a resident's house downstream, which has affected the residence's safety, it is recommended to relocate and resettle. At the same time, it is recommended to take appropriate protective measures for the front edge of the slope and to strengthen the inspection and monitoring measures during the operation period of the power station.

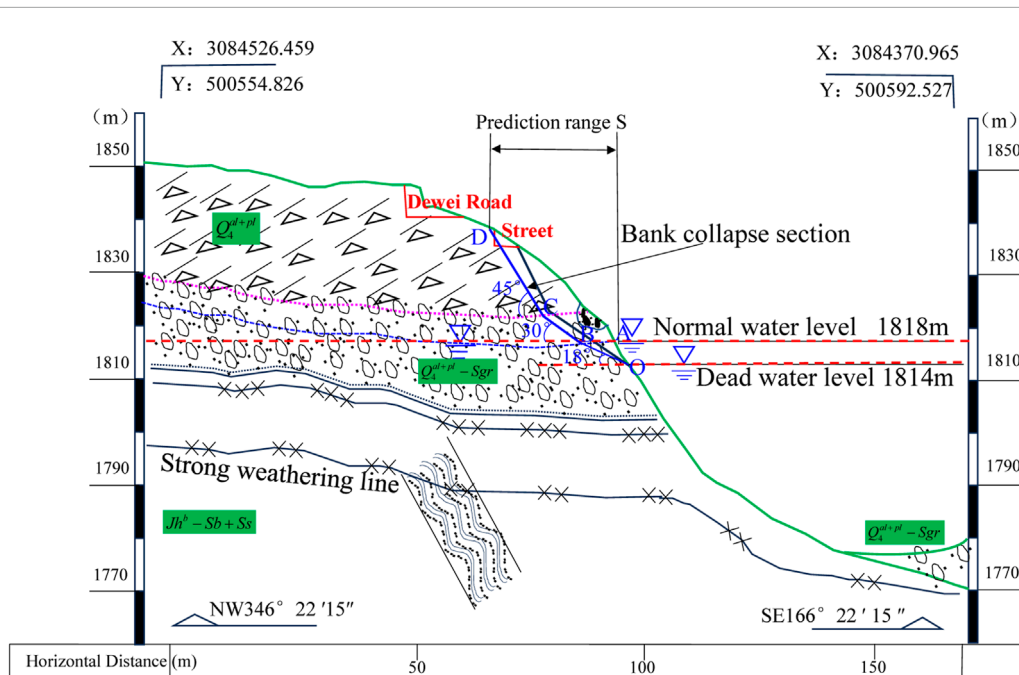
underwater stable slope angle are selected to predict the width and elevation of the bank collapse (Ma et al., 2023b; Zhang et al., 2024d), as shown in Figure 8. The Kakuchin method predicts the width of the reservoir bank collapse as in Formula 1:

- (1) Draw the calculated stratigraphy and geological section of the bank slope where the left bank of Badixiang is located, as shown in Figure 8.
- (2) Indicate the normal water storage danger level (normal water storage elevation 1818.0 m) and the dead water level line (design low water level 1,814 m).
- (3) Starting from the intersection point O of the dead water level line with the slope surface profile, use the scouring angle of the loose covering layer soil $\theta_1 = 18^\circ$ as the inclination to draw the prediction line for the lower part of the normal water storage bank collapse, intersecting with the base-rock boundary at point A.

- (4) Taking point A as the starting point, with the scouring angle of sand and gravel, crushed stone soil $\theta_2 = 20^\circ$ as the inclination, continue to draw the bank collapse prediction line, intersecting with the normal water level line of the reservoir at point B. It can be observed from the figure that line AD is steeper than the base-rock boundary, indicating that the strongly weathered rock mass within this range is relatively safe and will not experience bank collapse. Therefore, the base-rock boundary between points A and B is this section's predicted bank collapse line.

- (5) Taking point B as the starting point, with the stable slope angle of the loose covering layer above water $\gamma = 45^\circ$ as the inclination, draw the bank collapse line to intersect with the topographic line at point C. BC is the predicted bank collapse line above the normal water storage level.

- (6) The horizontal distance between points C and F, denoted as S represents the final predicted horizontal impact width of the bank collapse. According to the elevation on the geological profile, the elevation at point C is the expected impact elevation for the bank collapse profile.

FIGURE 8 Prediction of bank collapse at the left slope of Badi Township by bank slope structure method.

After the Lidi Hydropower Station is filled to an elevation of 1818.00 m, the covering layer soil between elevations 1814.00 m and 1818.00 m will become unstable and collapse under the action of reservoir water level fluctuations and waves, resulting in frontal bank collapse. Taking a typical section of the bank slope, as an example, the final bank collapse elevation is calculated to be 1843.0 m, with a bank collapse width of approximately 35.24 m. The houses of the residents of Badixiang Township and most of the Dewen Highway are distributed between elevations 1840.00–1850.00 m. It is predicted that after the normal water storage of the reservoir, bank collapse and reshaping within this reservoir bank range will occur, which may endanger the

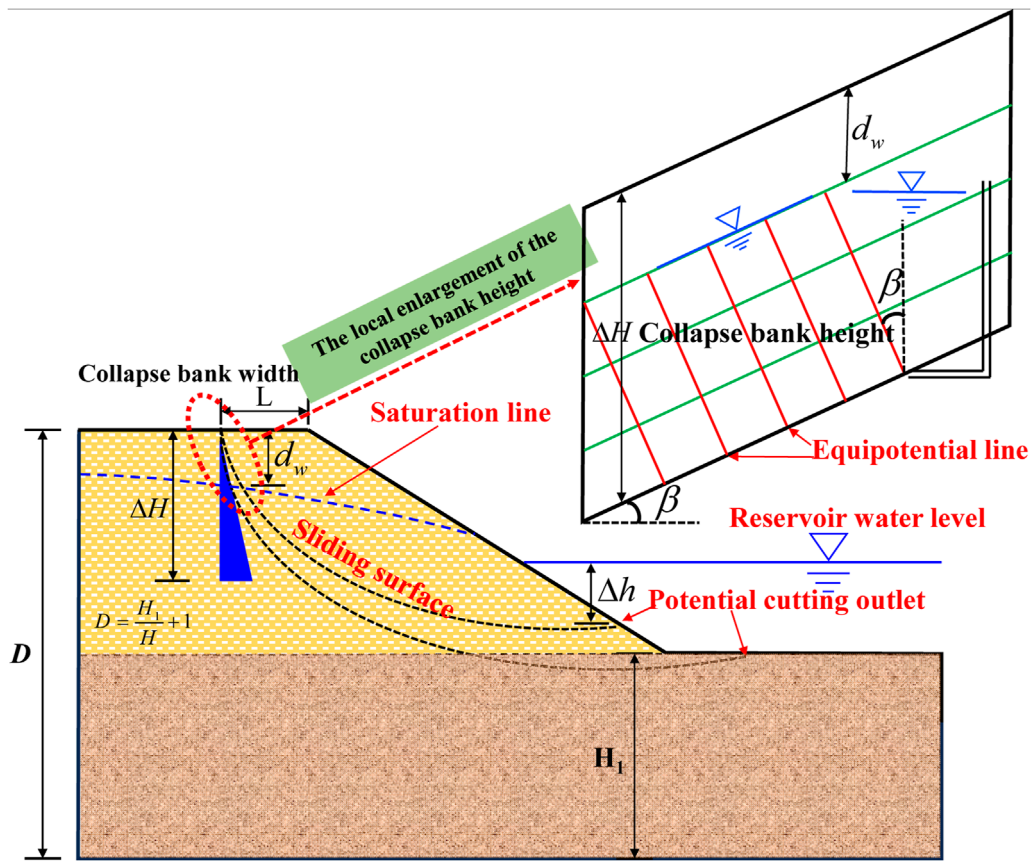
The geometric form of the slope: The main factor for the stability of loose accumulation bodies is the steepness and height of the terrain. The indicative index is the slope angle β and the custom slope height ratio D (defined as the ratio of the slope height H to the total slope height (or the depth of the geological layer H_1), as shown in Figure 9.

FIGURE 9 Generalization model for prediction of collapse bank range.

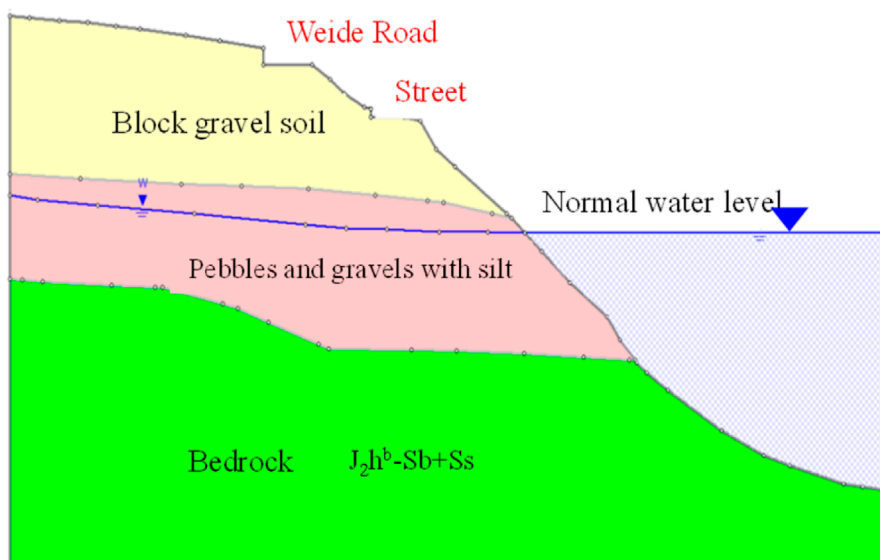
FIGURE 11
The calculation profile of the left bank of Badi Township.

Selecting the bank collapse section on the left bank of Badixiang Township, as shown in Figure 11, the comprehensive internal friction angle of the covering layer at the collapse section is approximately $42^\circ < 45^\circ$. The stability of the bank collapse and the range of instability can refer to Formula 2, and based on the parameters in Tables 1, 2, the position of the potential sliding surface and the morphology of the sliding surface can be calculated, as shown in Figure 12.

The potential sliding surface of the front edge bank collapse at the Cuzhong resettlement site can be seen in Figures 11, 12. The

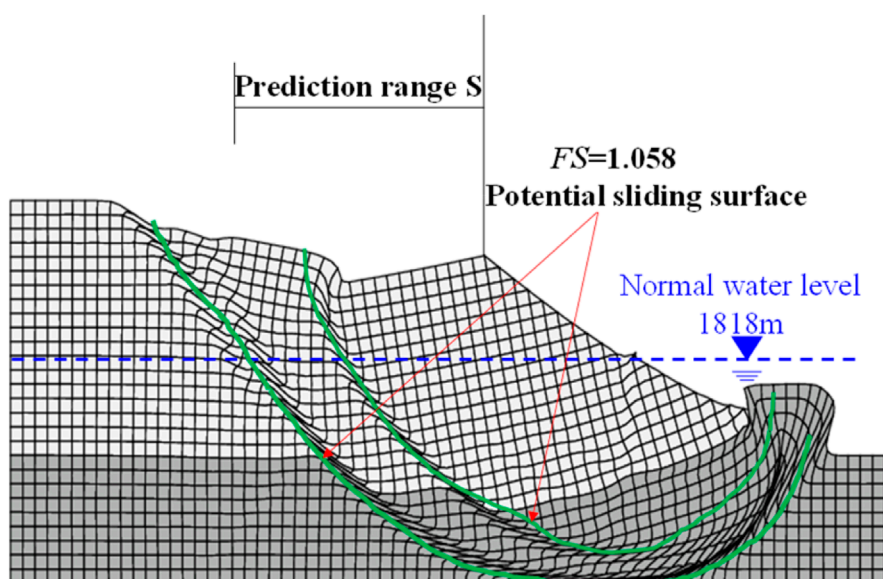
FIGURE 12
The potential sliding surface of the left bank of Badi Township.

bank collapse area takes into account the main loads such as the self-weight of the slope, the base of the upper building, and the static water pressure. Two critical sliding surfaces appear in the slopes, with the instability mode being the shallow and deep instability of the slopes. The deeper sliding arc is in contact with the base to form a deep instability mode, while the shallower sliding arc does not intersect with the base, is relatively shallow, and finally emerges and converges on the right bank of the slope. The safety factor FS of the shallow sliding surface is 1.058, which is basically in a state of poor stability to basically stable according to the standard of stable
