Critical Analysis of *in situ* Performance of Glass Fiber Core VIPs in Extreme Cold Climate

Keywords: vacuum insulation panel (VIP), glass fiber core, *in situ* performance, accelerated aging test, cold climate

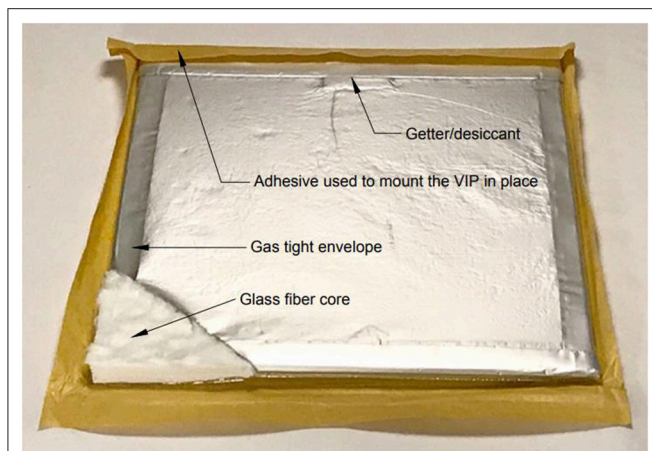
FIGURE 1 | Schematic of a glass fiber core VIP. One corner of the gas-tight envelope has been removed to show the evacuated open-pore core. The getter/desiccant is in a sachet in the raised area at the top-center. The brown wax paper backing covers the adhesive that is used to mount the VIP in place.

VIPs consist of an evacuated open-pore core enclosed within a gas-tight envelope, as shown in **Figure 1**. The core provides thermal resistance and adequate load bearing capacity to resist atmospheric pressure (Heinemann, 2017) while the single/multi-layer sealed envelope maintains the vacuum inside the panel. Opacifiers can be added to the core to reduce radiative heat transfer through the core, and getters/desiccants adsorb residual or permeating gas and moisture (Simmler et al., 2005) and thus slow the aging rate. In these ways, heat transfer across the panel is minimized and the service life is extended.

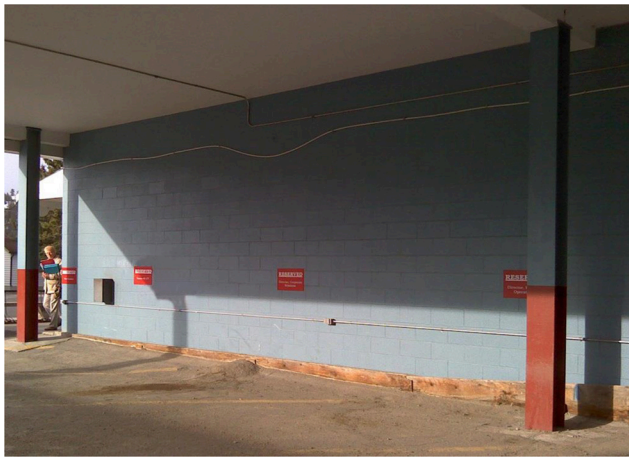
FIGURE 2 | Existing wall selected for retrofit (MacLean and Korn, 2011).

The existing exterior concrete block wall (**Figure 2**) was insulated with fiberglass batts. The thermal resistance of this existing wall was about $3.5 \text{ m}^2\cdot\text{K}/\text{W}$, and the retrofitting goal was to increase the wall's thermal resistance to $8.8\text{--}10.6 \text{ m}^2\cdot\text{K}/\text{W}$ (Mukhopadhyaya et al., 2014). The integrity of VIPs was verified by physical examination at the construction site before the assembly. Concerns regarding condensation in additional wall layers and mechanical rubbing on VIP surfaces caused by uneven proximate wall elements were addressed in the design described below (Mukhopadhyaya et al., 2014). In summary, additional layers of insulation were constructed on the exterior of the existing concrete block wall in the following order (Mukhopadhyaya et al., 2014):

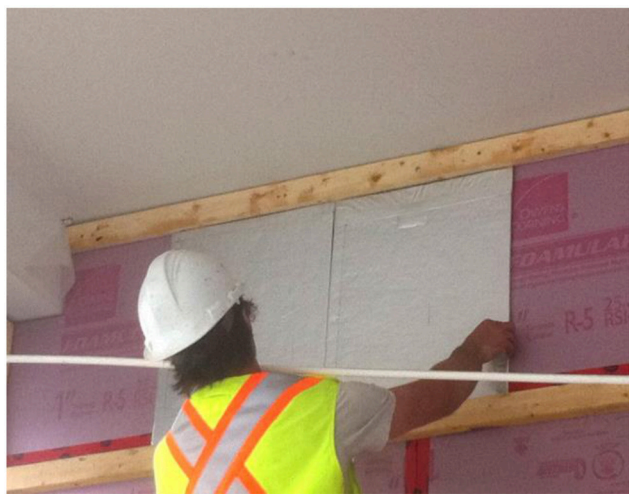
FIGURE 3 | Installation of VIPs over a layer of XPS and a 0.15 mm (6 mil) polyethylene air vapor barrier on the existing concrete block wall (MacLean and Korn, 2011).

- Then, 25 mm extruded polystyrene (XPS) board was adhered to the polyethylene barrier, creating an even surface for subsequent mounting of the VIPs.
- 50 × 75 mm wood strapping was then attached over top of the XPS board and affixed to the concrete wall with anchors.
- Glass fiber core VIPs were adhered to the XPS board between the wood straps, using a “peel and stick” adhesive on one side.
- The VIPs were then covered with a layer of 6 mm flexible polyurethane foam that was held in place with sheathing tape.
- Lastly, a layer of 25 mm thick polystyrene board was installed over the polyurethane foam to avoid the potential risk of condensation and damage from mechanical rubbing.

Installations proceeded quickly and smoothly as documented in **Figures 2– 5**.

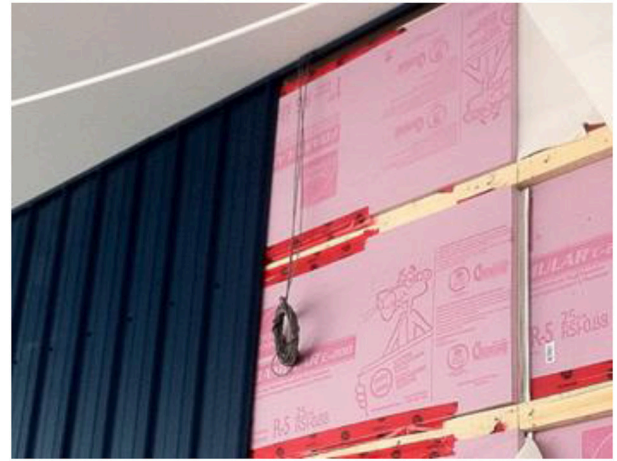
FIGURE 4 | The second layer of XPS is shown in place over 6 mm polyurethane foam. The XPS layer ensured that the bottom surface of each VIP was attached to a smooth surface and protected from abrasion. A layer of 6 mm flexible polyurethane foam was placed over the exterior surface of the VIPs to help prevent mechanical rubbing of the outside surface of each VIP against the 25 mm polystyrene foam board placed on top of it.

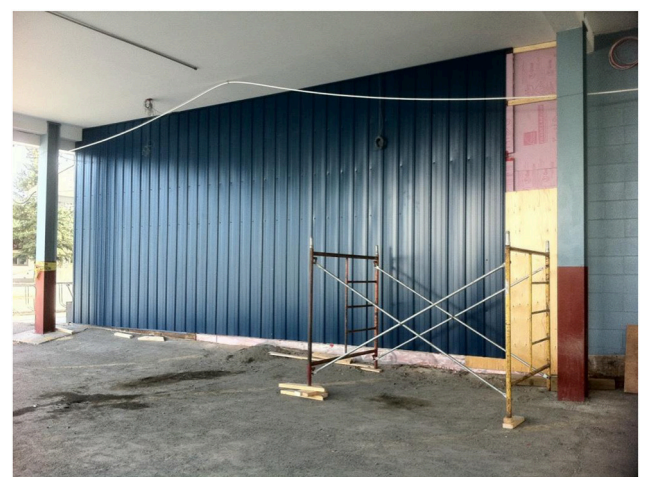
FIGURE 5 | Post-retrofit wall (MacLean and Korn, 2011). Because all holes for fasteners were drilled before the siding was put on the wall, it was possible to visually check that all fastening points were directly over the support members.

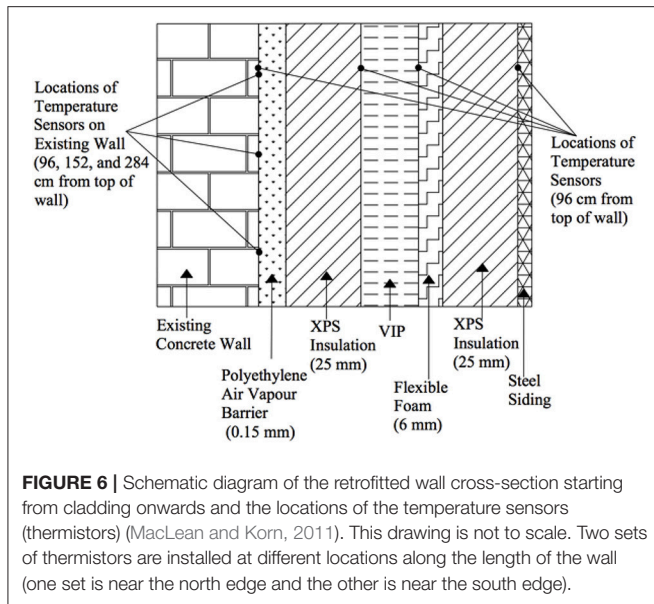
FIGURE 6 | Schematic diagram of the retrofitted wall cross-section starting from cladding onwards and the locations of the temperature sensors (thermistors) (MacLean and Korn, 2011). This drawing is not to scale. Two sets of thermistors are installed at different locations along the length of the wall (one set is near the north edge and the other is near the south edge).

Four thermistors were installed to monitor the temperature at the interface between insulation layers, as shown schematically in **Figure 6**. These thermistors were set up ~2 m from the south edge of the wall and 1 m down from the top of the wall (Mukhopadhyaya et al., 2014). Three sensors were placed on the existing wall ~2 m from the north edge of the wall retrofitted area. These sensors were located ~1, 1.5, and 3 m from the top of the wall, and they were used to monitor the thermal gradients from the top to the bottom of the wall (Mukhopadhyaya et al., 2014).

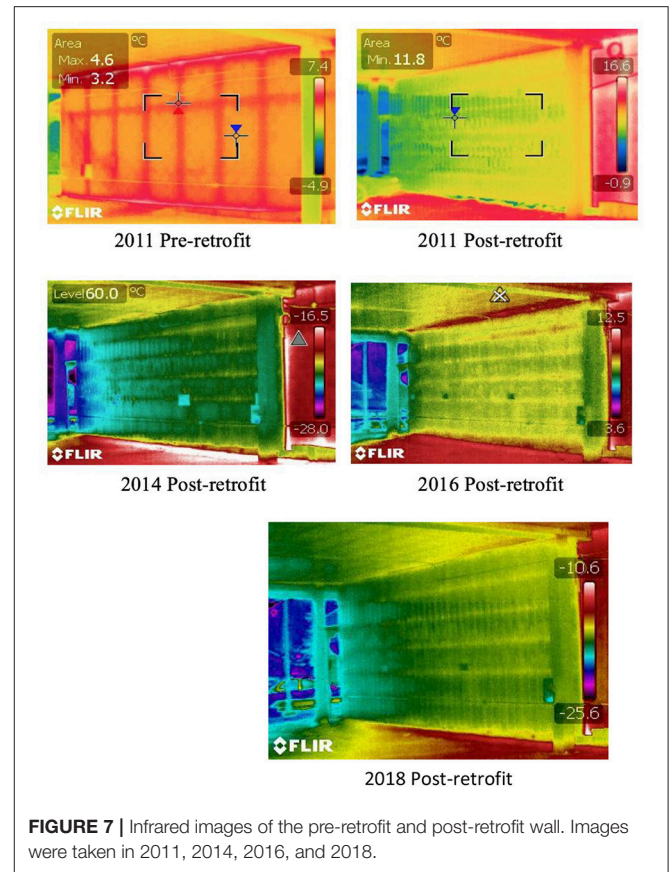
FIGURE 7 | Infrared images of the pre-retrofit and post-retrofit wall. Images were taken in 2011, 2014, 2016, and 2018.

Infrared thermal images of the retrofitted wall were taken in 2011, 2014, 2016, and 2018 are shown in **Figure 7**. These images confirm that all VIPs installed in 2011 remain functional after 8 years. Specifically, it is clear from the temperature of the wall over each VIP that none of the VIPs have lost their insulating value over 8 years (failed VIPs will be indicated by abrupt change of color in the infrared thermal images). This is a very significant finding for the long-term performance of glass fiber core VIPs in an extreme cold climate and demonstrates the effective integration of VIPs in an exterior building envelope retrofit. In order to gain greater insight into the thermal performance of the exterior wall and VIPs, the temperatures at the interfaces between insulation layers of the retrofitted wall were collected over the past 8 years (2011–2018) since the project started, and selected data were analyzed for the following colder winter time periods (summer data were not stable due to factors such as lack of thermal gradient, unstable indoor condition etc.):

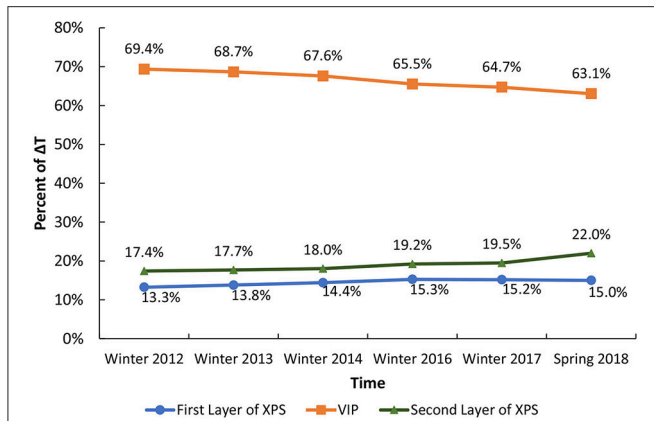
FIGURE 8 | Percentage of temperature drop across wall components, relative to the drop across the entire wall. Data averaged for the winter months 2011–2017 and spring months of 2018.

The temperature drops across each layer of the composite exterior insulation (XPS-VIP-XPS) were calculated as a percentage of total temperature drop across the composite exterior insulation. A sample calculation can be found in **Appendix A. Figure 8** shows the percentage of total temperature drop across each insulation layer averaged over the winter and/or spring months for six selected years. The average temperature drop for the VIP layer is about 66.49%, while that for the first

(interior) and second (exterior) layers of XPS are 14.48 and 18.95%, respectively. The exterior layer of XPS is a more effective thermal insulator than the identical interior XPS layer due to the cooler exterior temperature. This observation clearly validates a very basic physical principle of heat transfer and generates confidence in the recorded data and the analysis procedure. The graphical representation in **Figure 8** shows that the effectiveness of the VIP layer is decreasing very slowly, from about 69% initially in winter 2011 to 63% in spring 2018, at an average rate of 0.9% per annum, and this rate of aging appears to be linear. However, it is to be noted that the aging rate of VIPs cannot be linear forever and it is expected to increase rapidly as the internal pressure approaches atmospheric pressure. The transition from lower aging rate to higher aging rate depends on the functional relationship between thermal conductivity and internal pore pressure of the VIP core material.

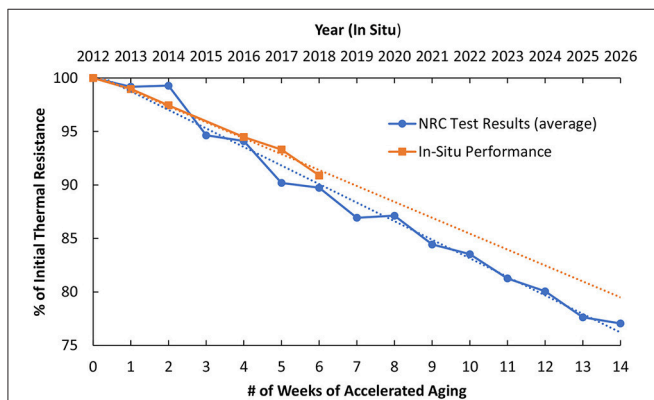
FIGURE 9 | Aging rate of glass fiber core VIP in terms of its pristine thermal resistance as a function of time determined from *in situ* performance and laboratory accelerated aging test results.

changed to 70°C, 5% RH for the next week. The specimens went through 14 weeks of total exposure (i.e., a total of seven cycles). The thermal resistance of the panels was measured at the end of each week using a 600 × 600 mm heat flow meter. One specimen failed after 8 weeks, and the average linear aging rate of the other two was found to be about 3.29% (Morlidge, 2012) per cycle as shown in **Figure 9**. The normalized *in situ* VIP aging rate (expressed as the percentage of its initial thermal resistance) was also plotted with the average of accelerated aging test results in **Figure 9**. It can be observed from the plot, that the 2-year *in situ* aging rate is nearly equal to one cycle (two weeks) of the accelerated aging rate for the time period where field data are available. Based on this correlation, the linear extrapolation of the *in situ* data predicts that the total reduction of thermal resistance in 2026 (14 years since construction) will be about 21% (thermal conductivity increased from 0.0034 to 0.00429 W/m·K).

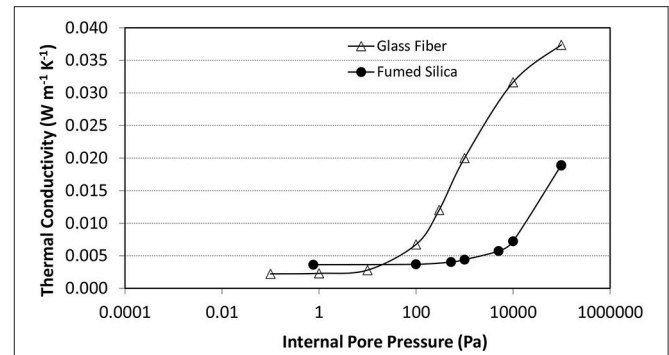
FIGURE 10 | Typical thermal conductivity of glass fiber and fumed silica VIPs as a function of internal pore gas (air) pressure (Heinemann, 2017).

The typical relationships between the thermal conductivity and internal pore pressure for glass fiber and fumed silica core VIPs are shown in **Figure 10** (Fricke et al., 2006). These relationships clearly indicate that the rate of increasing thermal conductivity with pore pressure (i.e., the aging rate) of VIPs is not linear during their service life. Derived from **Figure 10**, **11** shows the aging of glass fiber and fumed silica core VIPs in terms of their initial thermal resistance as a function of internal gas pressure.

Figure 11 indicates that glass fiber core VIPs lose about 20% of their initial thermal resistance when the internal pore pressure reaches about 10 Pa and that this change of thermal resistance is almost a linear function of time. However, **Figure 10** also shows that the thermal conductivity of glass fiber core VIPs will rise at a much faster rate between an internal pressure of 10 Pa and 100 Pa, but still thermal conductivity stays below 0.007 W/m·K at 100 Pa internal pore pressure. These observations further reinforce the relationship between accelerated aging and *in situ* performance of glass fiber core VIP presented in the previous section. Though *in situ* decrease in the thermal resistance is found to be slow and vary linearly with time until now. It is expected that the thermal resistance of glass fiber core VIPs will eventually decrease at a much faster rate. Hence, the *in situ* performance observations in the coming years will be of particular interest and will help us to establish the true relationship between accelerated aging test results and the long-term *in situ* performance of glass fiber core VIPs.

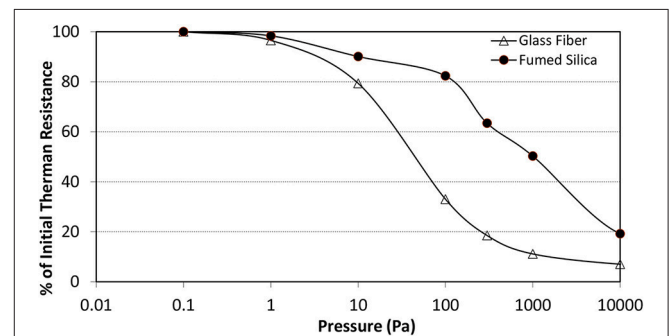
FIGURE 11 | Aging of glass fiber and fumed silica core VIPs in terms of their initial thermal resistance as a function of gas (air) pressure (derived from **Figure 10**).
